**Flood Control Project Maintenance
Levee Inspections**

Maintenance Issue Types Only, Levee Inspection Report By Mile - Fall 2018

Sacramento Maintenance Yard East Levee Yolo Bypass

Waterway	Bank	Unit Miles	Inspection Start/End	Inspector
Unit No. 01 Yolo Bypass	Left	2.01	11/07/2018 11/07/2018	Zach Jojola

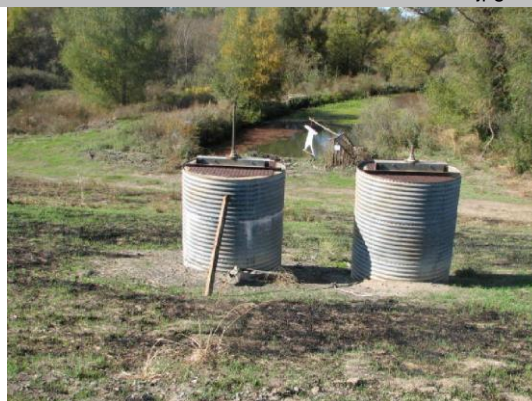
Photo 1 of 3 : UCIP_FA_2018_53253_60261.jpg

Comment Code						
Inspector Comment						
FS_ID:53253 DS_ID:838 EP_NO: N/A Repair Type: No Action Needed Crossing Status: Found UCIP Comments: 11/16/17 Ted Skidgel, pipe is closed on w/s and closed on L/S. Mud removed recently from WS pipes. FIELD_STRUCT_DESC: 1 of 2: 48-inch corrugated metal drainage pipe through the levee, 28.5 feet below the crown. 30-inch steel pipe sleeved through the 48-inch pipe. Slide gate in a 60-inch pipe riser on the waterside (WS) slope. [Additional Reference(s): DWR Levee Log, 1981. USACE Sacramento O&M Manual 123, August 1955, (Station 382+85)]. No permit or as-built drawing available. FS Date: 11/21/2018 8:31:59 AM

Waterside view: overview CMP standpipe and water body

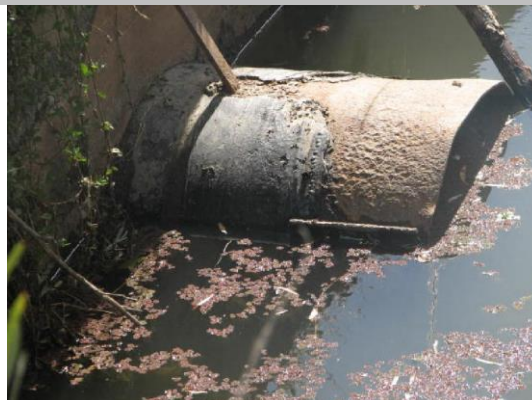
Photo 2 of 3 : UCIP_FA_2018_53253_60260.jpg

Waterside view: steel pipe and concrete headwall

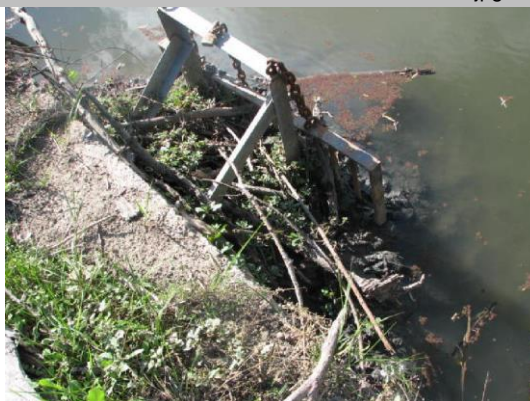
Photo 2 of 3 : UCIP_FA_2018_53254_60268.jpg

LM Start	1.71	Rating **	A/W	Issue No.	7 (cont)	
LM End	1.71	Issue Type +	Ma	Location *		
Category	Supplemental			GPS Latitude/Longitude		
				Start	End	
Item	DWR UCIP LMA Responsibility			38.740686 °	38.740686 °	
				-121.633979 °	-121.633979 °	
DWR ID	840					
Comment Code						
Inspector Comment						
FS_ID:53254						
DS_ID:840						
EP_NO: N/A						
Repair Type: No Action Needed						
Crossing Status: Found						
UCIP Comments:						
FIELD_STRUCT_DESC: 2 of 2: 48-inch corrugated metal drainage pipe through the levee, 28.5 feet below the crown. 30-inch steel pipe sleeved through the 48-inch pipe. Slide gate in a 60-inch pipe riser on the waterside (WS) slope. [Additional Reference(s): DWR Levee Log, 1981. USACE Sacramento O&M Manual 123, August 1955, (Station 382+85)]. No permit or as-built drawing available.						
FS Date: 11/21/2018 8:34:20 AM

Waterside view: mud clogged pipe, trash rack and headwall

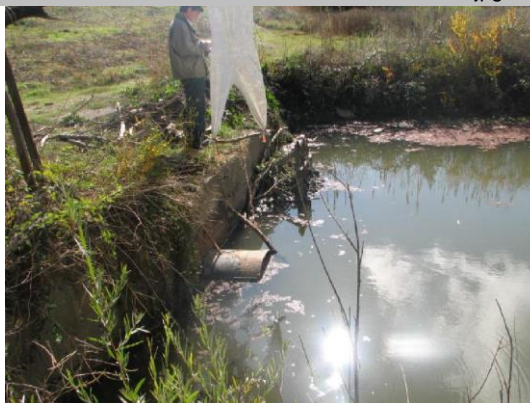
Photo 3 of 3 : UCIP_FA_2018_53254_60267.jpg

Waterside view: overview pipes and headwall
