**Flood Control Project Maintenance
Levee Inspections**

Maintenance Issue Types Only, Levee Inspection Report By Mile - Fall 2019

Sacramento Maintenance Yard East Levee Yolo Bypass

Waterway	Bank	Unit Miles	Inspection Start/End	Inspector
Unit No. 01 Yolo Bypass	Left	2.01	09/18/2019 09/18/2019	Zach Jojola

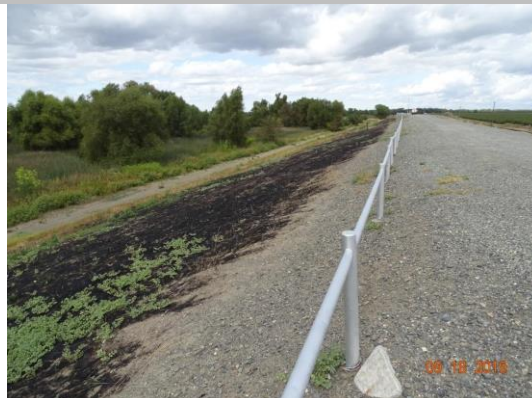
Photo 1 of 1 : FA_2019_ST0004_41_8_20190919_00011.jpg

LM Start	1.22	Rating **	A	Issue No.	8
LM End	1.22	Issue Type +	Ma	Location *	WS
Category	Earthen Levee			GPS Latitude/Longitude	
				Start	End
Item	Vegetation			38.747723 °	38.747723 °
				-121.634462 °	-121.634462 °
DWR ID	DWR_ST0004_01_f_2019_8				
Comment Code					
V1 : Control annual grass and weeds on the levee slopes and easements.					
Inspector Comment					
The LMA maintains the vegetation at a high level.

View of the maintained waterside slope. Fall 2019.

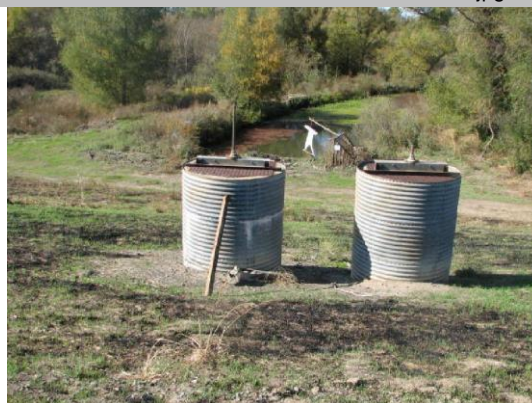
Photo 1 of 3 : UCIP_FA_2019_53253_60261.jpg

Comment Code						
Inspector Comment						
DS_ID:838						
FS_ID:53253						
EP_NO: N/A						
Repair Type: No Action Needed						
Crossing Status: Found						
UCIP Comments: 11/16/17 Ted Skidgel, pipe is closed on w/s and closed on L/S. Mud removed recently from WS pipes.						
FIELD_STRUCT_DESC: 1 of 2: 48-inch corrugated metal drainage pipe through the levee, 28.5 feet below the crown. 30-inch steel pipe sleeved through the 48-inch pipe. Slide gate in a 60-inch pipe riser on the waterside (WS) slope. [Additional Reference(s): DWR Levee Log, 1981. USACE Sacramento O&M Manual 123, August 1955, (Station 382+85)]. No permit or as-built drawing available.						
FS Date: 11/21/2018 8:31:59 AM

Waterside view: overview CMP standpipe and water body

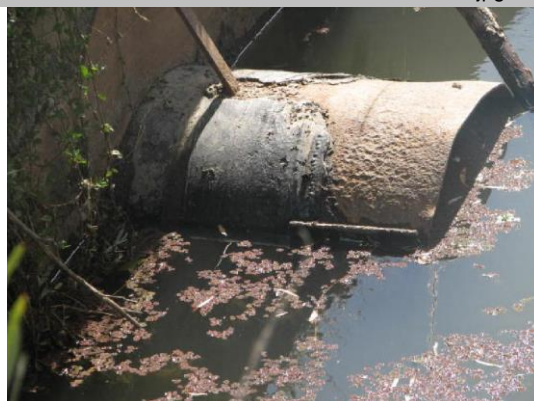
Photo 2 of 3 : UCIP_FA_2019_53253_60260.jpg

Comment Code						
Inspector Comment						
DS_ID:838 FS_ID:53253 EP_NO: N/A Repair Type: No Action Needed Crossing Status: Found UCIP Comments: 11/16/17 Ted Skidgel, pipe is closed on w/s and closed on L/S. Mud removed recently from WS pipes. FIELD_STRUCT_DESC: 1 of 2: 48-inch corrugated metal drainage pipe through the levee, 28.5 feet below the crown. 30-inch steel pipe sleeved through the 48-inch pipe. Slide gate in a 60-inch pipe riser on the waterside (WS) slope. [Additional Reference(s): DWR Levee Log, 1981. USACE Sacramento O&M Manual 123, August 1955, (Station 382+85)]. No permit or as-built drawing available. FS Date: 11/21/2018 8:31:59 AM

Waterside view: steel pipe and concrete headwall

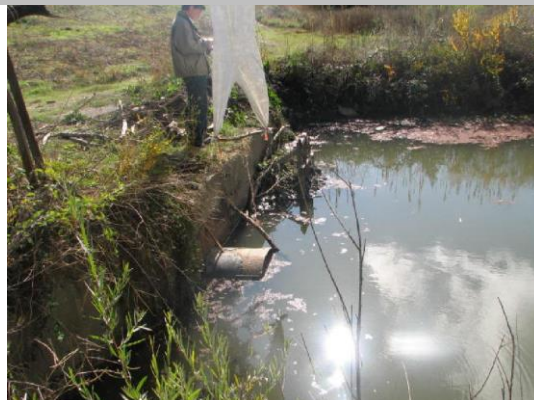
Photo 3 of 3 : UCIP_FA_2019_53253_60259.jpg

Waterside view: overview steel pipes and concrete headwall

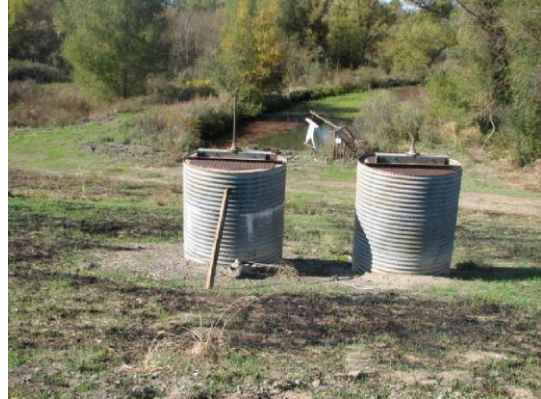
Photo 1 of 3 : UCIP_FA_2019_53254_60269.jpg

LM Start	1.71	Rating **	A/W	Issue No.	10	
LM End	1.71	Issue Type +	Ma	Location *		
Category	Supplemental			GPS Latitude/Longitude		
				Start	End	
Item	DRAFT DWR UCIP LMA Responsibility			38.740686 °	38.740686 °	
				-121.633979 °	-121.633979 °	
DWR ID	840					
Comment Code						
Inspector Comment						
DS_ID:840 FS_ID:53254 EP_NO: N/A Repair Type: No Action Needed Crossing Status: Found UCIP Comments: FIELD_STRUCT_DESC: 2 of 2: 48-inch corrugated metal drainage pipe through the levee, 28.5 feet below the crown. 30-inch steel pipe sleeved through the 48-inch pipe. Slide gate in a 60-inch pipe riser on the waterside (WS) slope. [Additional Reference(s): DWR Levee Log, 1981. USACE Sacramento O&M Manual 123, August 1955, (Station 382+85)]. No permit or as-built drawing available. FS Date: 11/21/2018 8:34:20 AM

Waterside view: overview of CMP standpipe and water body

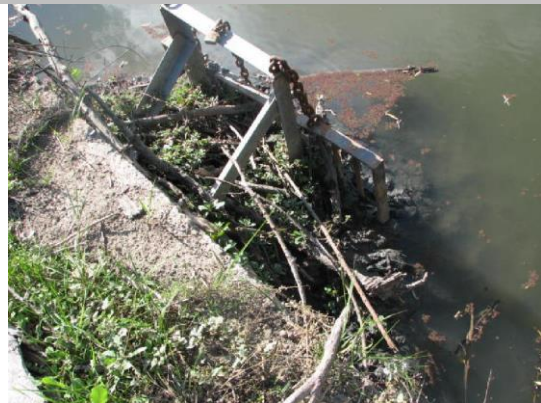
Photo 2 of 3 : UCIP_FA_2019_53254_60268.jpg

Waterside view: mud clogged pipe, trash rack and headwall

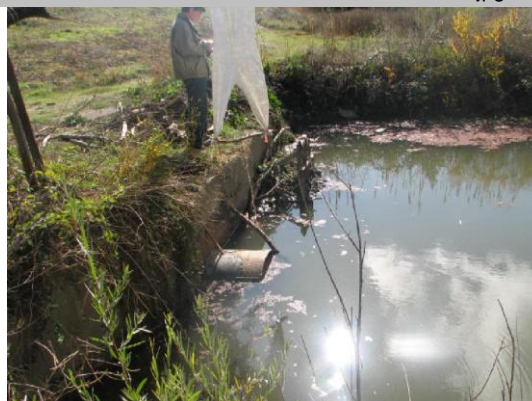
Photo 3 of 3 : UCIP_FA_2019_53254_60267.jpg

LM Start	1.71	Rating **	A/W	Issue No.	10 (cont)	
LM End	1.71	Issue Type +	Ma	Location *		
Category	Supplemental			GPS Latitude/Longitude		
				Start	End	
Item	DRAFT DWR UCIP LMA Responsibility			38.740686 °	38.740686 °	
				-121.633979 °	-121.633979 °	
DWR ID	840					
Comment Code						
Inspector Comment						
DS_ID:840 FS_ID:53254 EP_NO: N/A Repair Type: No Action Needed Crossing Status: Found UCIP Comments: FIELD_STRUCT_DESC: 2 of 2: 48-inch corrugated metal drainage pipe through the levee, 28.5 feet below the crown. 30-inch steel pipe sleeved through the 48-inch pipe. Slide gate in a 60-inch pipe riser on the waterside (WS) slope. [Additional Reference(s): DWR Levee Log, 1981. USACE Sacramento O&M Manual 123, August 1955, (Station 382+85)]. No permit or as-built drawing available. FS Date: 11/21/2018 8:34:20 AM

Waterside view: overview pipes and headwall
