**Flood Control Project Maintenance  
Levee Inspections**

**Maintenance Issue Types Only, Levee Inspection Report By Mile - Fall 2020**

**Sacramento Maintenance Yard East Levee Yolo Bypass**

Waterway	Bank	Unit Miles	Inspection Start/End	Inspector
Unit No. 01 Yolo Bypass	Left	2.01	10/28/2020 10/28/2020	Zach Jojola

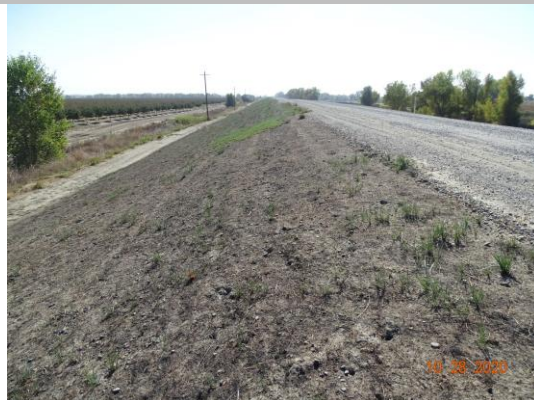
Photo 1 of 1 : FA\_2020\_ST0004\_41\_8\_20201028\_00010.jpg

LM Start	0.48	Rating **	A	Issue No.	8
LM End	0.48	Issue Type +	Ma	Location *	LS
Category	Earthen Levee			GPS Latitude/Longitude	
				Start	End
Item	Vegetation			38.758487 °	38.758487 °
				-121.635137 °	-121.635137 °
DWR ID	DWR_ST0004_01_f_2020_8				
Comment Code					
V1 : Control annual grass and weeds on the levee slopes and easements.					
Inspector Comment					
LMA maintains the vegetation at a high level.

View of maintained landside slope. Fall 2020.

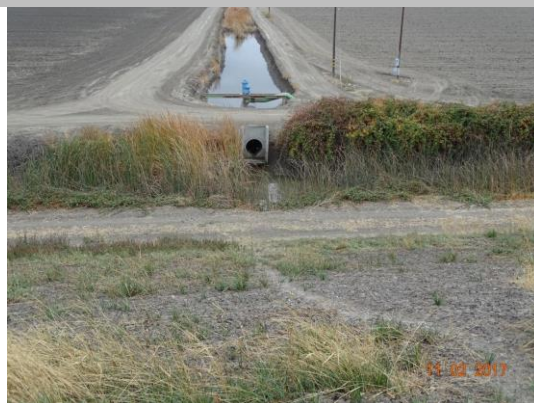
Photo 1 of 2 : FA\_2020\_ST0004\_41\_1\_20200813\_00001.jpg

LM Start	1.51	Rating **	A/W	Issue No.	1
LM End	1.51	Issue Type +	Ma	Location *	LS
Category	Earthen Levee			GPS Latitude/Longitude	
				Start	End
Item	Erosion / Bank Caving			38.743573 °	38.743573 °
				-121.634128 °	-121.634128 °
DWR ID	DWR_ST0004_01_s _ 2020_1				
Comment Code					
E1 : Note and monitor erosion site.					
Inspector Comment					
Erosion on a side of a ditch toward LS toe caused by water coming out of irrigation canal. Recommend monitoring.

View of erosion on toe road. Fall 2017.

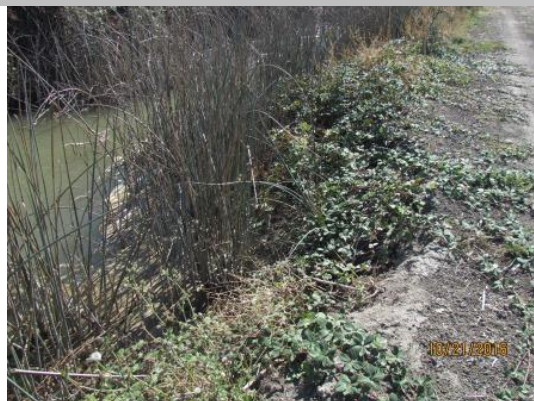
Photo 2 of 2 : FA\_2020\_ST0004\_41\_1\_20200813\_00002.jpg

Irrigation ditch erosion on landward side toward LS levee toe. Fall 2016.

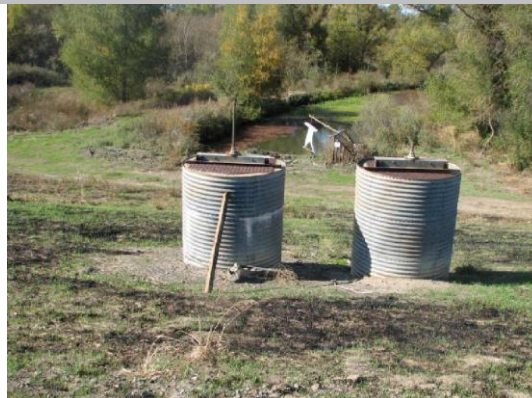
Photo 1 of 3 : UCIP\_FA\_2020\_53253\_60261.jpg

Comment Code						
Inspector Comment						
DS_ID:838						
FS_ID:53253						
EP_NO: N/A						
Repair Type: No Action Needed						
EVAL Issue:						
Crossing Status: Found						
UCIP Comments: 11/16/17 Ted Skidgel, pipe is closed on w/s and closed on L/S. Mud removed recently from WS pipes.						
FIELD_STRUCT_DESC: 1 of 2: 48-inch corrugated metal drainage pipe through the levee, 28.5 feet below the crown. 30-inch steel pipe sleeved through the 48-inch pipe. Slide gate in a 60-inch pipe riser on the waterside (WS) slope. [Additional Reference(s): DWR Levee Log, 1981. USACE Sacramento O&M Manual 123, August 1955, (Station 382+85)]. No permit or as-built drawing available.						
FS Date: 11/21/2018 8:31:59 AM

Waterside view: overview CMP standpipe and water body

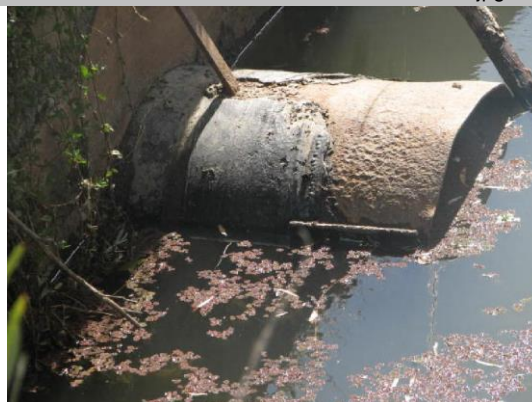
Photo 2 of 3 : UCIP\_FA\_2020\_53253\_60260.jpg

Waterside view: steel pipe and concrete headwall

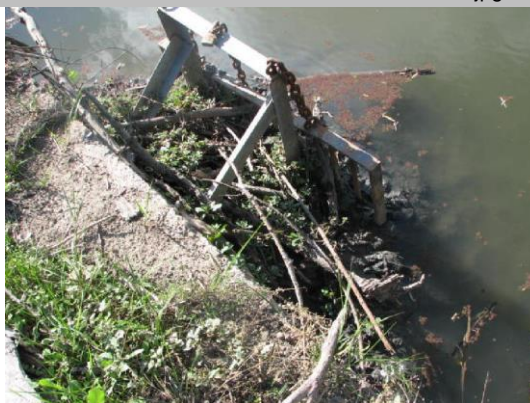
Photo 2 of 3 : UCIP\_FA\_2020\_53254\_60268.jpg

Waterside view: mud clogged pipe, trash rack and headwall

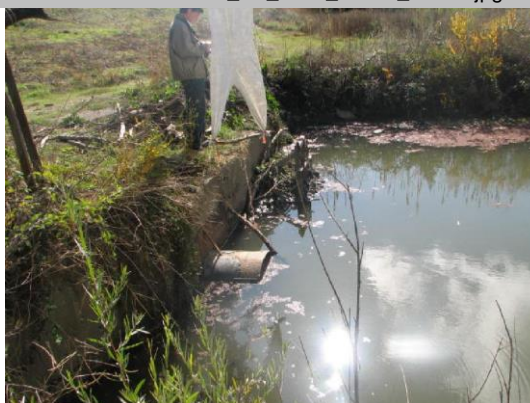
Photo 3 of 3 : UCIP\_FA\_2020\_53254\_60267.jpg

Waterside view: overview pipes and headwall
