**Flood Control Project Maintenance
Levee Inspections**

Maintenance Issue Types Only, Levee Inspection Report By Mile - Fall 2021

Sacramento Maintenance Yard East Levee Yolo Bypass

Waterway	Bank	Unit Miles	Inspection Start/End	Inspector
Unit No. 01 Yolo Bypass	Left	2.01	10/27/2021 10/27/2021	Zach Jojola

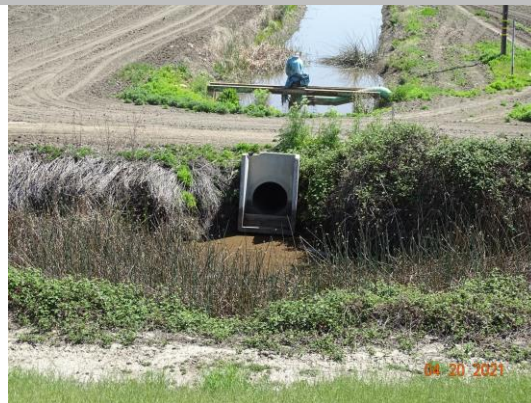
Photo 1 of 1 : FA_2021_ST0004_41_1_20210907_00001.jpg

LM Start	1.51	Rating **	A/W	Issue No.	1
LM End	1.51	Issue Type +	Ma	Location *	LS
Category	Earthen Levee			GPS Latitude/Longitude	
				Start	End
Item	Erosion / Bank Caving			38.743573 °	38.743573 °
				-121.634128 °	-121.634128 °
DWR ID	DWR_ST0004_01_s_2020_1				
Comment Code					
E1 : Note and monitor erosion site.					
Inspector Comment					
Erosion on a side of a ditch toward LS toe caused by water coming out of irrigation canal. Recommend monitoring.

View of erosion on landside irrigation canal. Spring 2021.

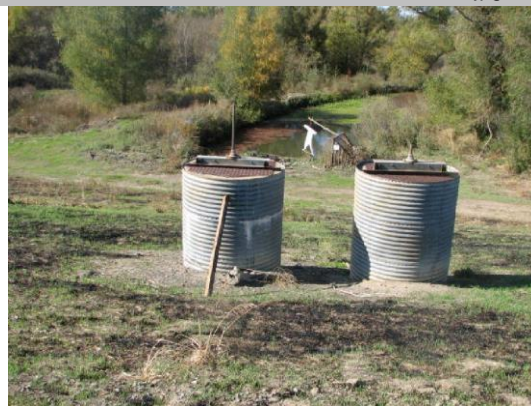
Photo 1 of 3 : UCIP_FA_2021_53253_60261.jpg

Comment Code						
Inspector Comment						
DS_ID:838 FS_ID:53253 EP_NO: N/A Repair Type: No Action Needed EVAL Issue: Crossing Status: Found UCIP Comments: 11/16/17 Ted Skidgel, pipe is closed on w/s and closed on L/S. Mud removed recently from WS pipes. FIELD_STRUCT_DESC: 1 of 2: 48-inch corrugated metal drainage pipe through the levee, 28.5 feet below the crown. 30-inch steel pipe sleeved through the 48-inch pipe. Slide gate in a 60-inch pipe riser on the waterside (WS) slope. [Additional Reference(s): DWR Levee Log, 1981. USACE Sacramento O&M Manual 123, August 1955, (Station 382+85)]. No permit or as-built drawing available. FS Date: 11/21/2018 8:31:59 AM

Waterside view: overview CMP standpipe and water body

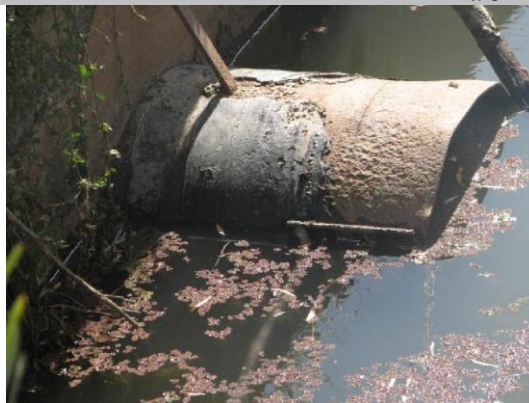
Photo 2 of 3 : UCIP_FA_2021_53253_60260.jpg

Waterside view: steel pipe and concrete headwall

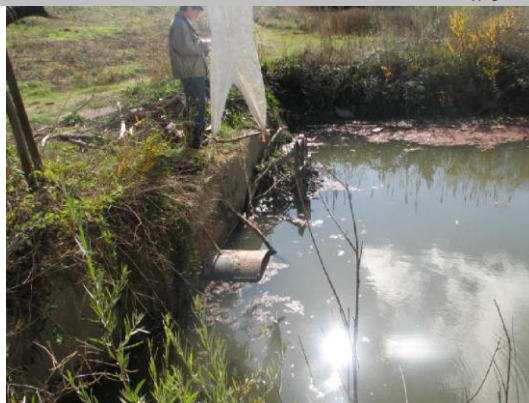
Photo 3 of 3 : UCIP_FA_2021_53253_60259.jpg

Waterside view: overview steel pipes and concrete headwall

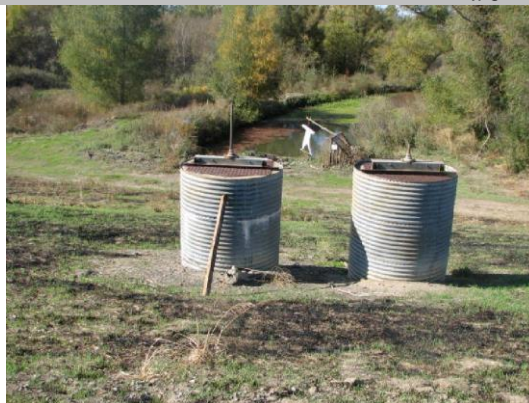
Photo 1 of 3 : UCIP_FA_2021_53254_60269.jpg

LM Start	1.71	Rating **	A/W	Issue No.	7	
LM End	1.71	Issue Type +	Ma	Location *		
Category	Supplemental			GPS Latitude/Longitude		
				Start		End
Item	DWR UCIP LMA Responsibility			38.740686 °	38.740686 °	
				-121.633979 °	-121.633979 °	
DWR ID	840					
Comment Code						
Inspector Comment						
DS_ID:840 FS_ID:53254 EP_NO: N/A Repair Type: No Action Needed EVAL Issue: Crossing Status: Found UCIP Comments: FIELD_STRUCT_DESC: 2 of 2: 48-inch corrugated metal drainage pipe through the levee, 28.5 feet below the crown. 30-inch steel pipe sleeved through the 48-inch pipe. Slide gate in a 60-inch pipe riser on the waterside (WS) slope. [Additional Reference(s): DWR Levee Log, 1981. USACE Sacramento O&M Manual 123, August 1955, (Station 382+85)]. No permit or as-built drawing available. FS Date: 11/21/2018 8:34:20 AM

Waterside view: overview of CMP standpipe and water body

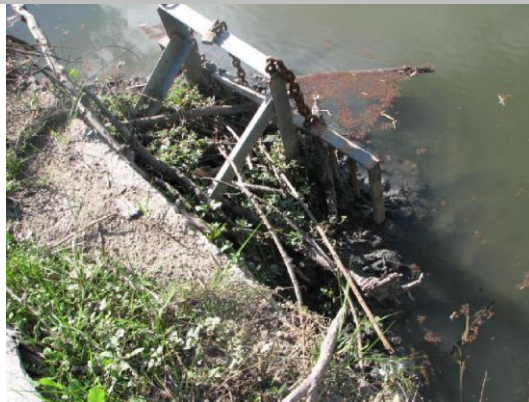
Photo 2 of 3 : UCIP_FA_2021_53254_60268.jpg

Waterside view: mud clogged pipe, trash rack and headwall

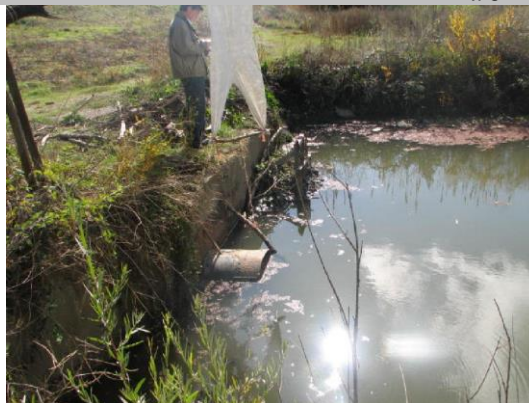
Photo 3 of 3 : UCIP_FA_2021_53254_60267.jpg

Waterside view: overview pipes and headwall
