**Flood Control Project Maintenance
Levee Inspections**

Maintenance Issue Types Only, Levee Inspection Report By Mile - Fall 2022

Sacramento Maintenance Yard East Levee Yolo Bypass

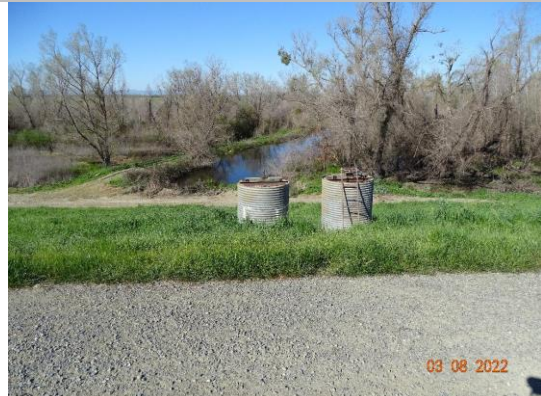
Photo 2 of 3 : UCIP_FA_2022_71979_106879.jpg

Comment Code						
Inspector Comment						
DS_ID:838 FS_ID:71979 EP_NO: N/A Repair Type: Non-Urgent EVAL Issue: 11, Maintenance Compliance Issue Crossing Status: Found UCIP Comments: 03/08/2022 Record updated from No Action Needed to Non-Urgent. Multiple sinkholes around headwall on waterside. A sinkhole measured 2-feet in diameter and 3-feet deep located on a shoulder of toe road located approximately 20 feet from levee toe in pipe alignment. No permit has been identified authorizing pipe. (O.Yakimov - DWR UCIP) 11/16/2017 Pipe is closed on w/s and closed on L/S. Mud removed recently from WS pipes. (Ted Skidgel - Sac Yard) FIELD_STRUCT_DESC: 1 of 2: 48-inch corrugated metal drainage pipe through the levee, 28.5 feet below the crown. 30-inch steel pipe sleeved through the 48-inch pipe. Slide gate in a 60-inch pipe riser on the waterside (WS) slope. [Additional Reference(s): DWR Levee Log, 1981. USACE Sacramento O&M Manual 123, August 1955, (Station 382+85)]. No permit or as-built drawing available. FS Date: 3/8/2022 3:46:12 PM

Water-Side: View of levee slope looking from crown. CMP riser on slope

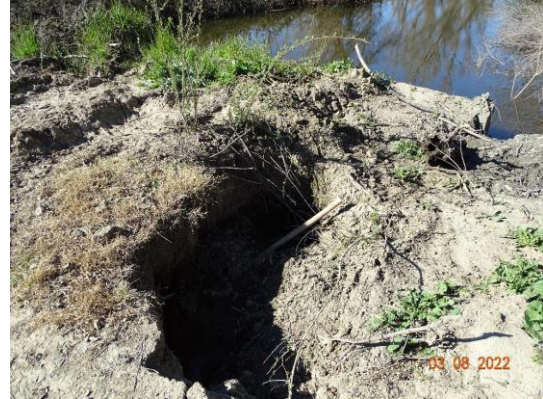
Photo 3 of 3 : UCIP_FA_2022_71979_106881.jpg

Water-Side: Multiple sinkholes filled with water around headwall

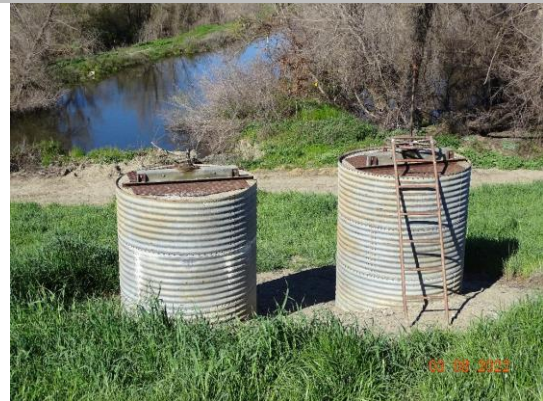
Photo 1 of 3 : UCIP_FA_2022_71980_106886.jpg

DS_ID:840
FS_ID:71980
EP_NO: N/A
Repair Type: Non-Urgent
EVAL Issue: 11, Maintenance Compliance Issue
Crossing Status: Found
UCIP Comments: 03/08/2022 Record updated from No Action Needed to Non-Urgent. Multiple sinkholes around headwall on waterside. A sinkhole measured 2-feet in diameter and 2-feet deep located on a shoulder of toe road located approximately 20 feet from levee toe in pipe alignment. No permit has been identified authorizing pipe.
(O.Yakimov - DWR UCIP)

FIELD_STRUCT_DESC: 2 of 2: 48-inch corrugated metal drainage pipe through the levee, 28.5 feet below the crown. 30-inch steel pipe sleeved through the 48-inch pipe. Slide gate in a 60-inch pipe riser on the waterside (WS) slope. [Additional Reference(s): DWR Levee Log, 1981. USACE Sacramento O&M Manual 123, August 1955, (Station 382+85)]. No permit or as-built drawing available.
FS Date: 3/8/2022 3:57:41 PM

Water-Side: View of levee slope looking from crown. CMP riser on slope

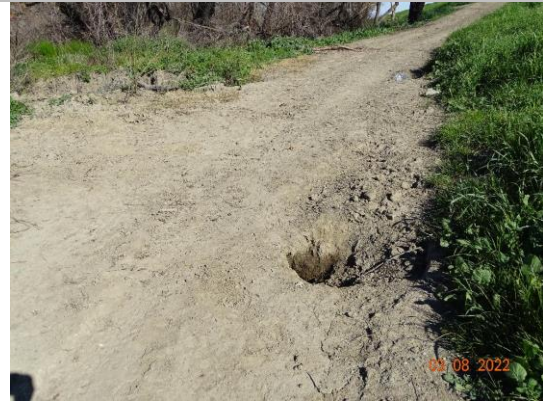
Photo 2 of 3 : UCIP_FA_2022_71980_106888.jpg

Water-Side: Sinkhole at the edge of toe road

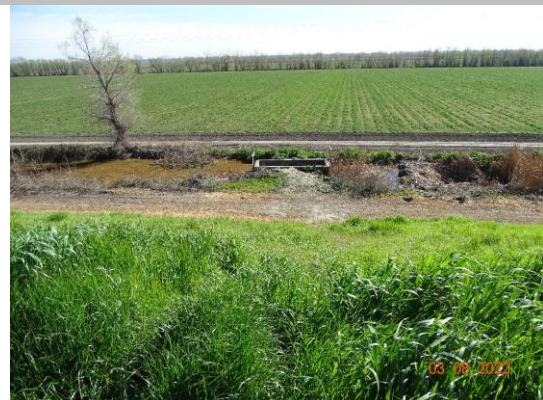
Photo 3 of 3 : UCIP_FA_2022_71980_106884.jpg

Land-Side: View of levee slope looking from crown
