**Flood Control Project Maintenance
Levee Inspections**

Maintenance Issue Types Only, Levee Inspection Report By Mile - Fall 2023

Sacramento Maintenance Yard East Levee Yolo Bypass

Waterway	Bank	Unit Miles	Inspection Start/End	Inspector
Unit No. 01 Yolo Bypass	Left	2.01	10/24/2023 10/24/2023	Nate Hicks

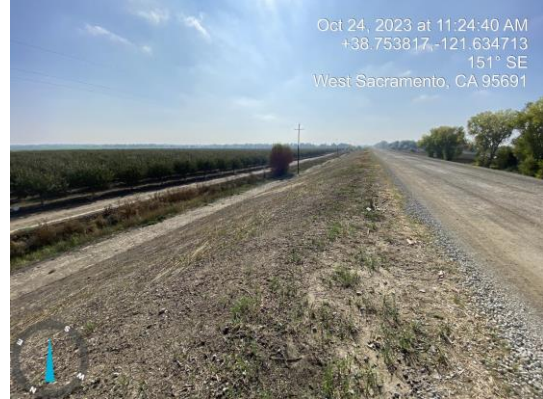
Photo 1 of 1 : FA_2023_ST0004_41_8_20231025_00009.jpg

LM Start	0.80	Rating **	A	Issue No.	8
LM End	0.80	Issue Type +	Ma	Location *	LS
Category	Earthen Levee			GPS Latitude/Longitude	
				Start	End
Item	Vegetation			38.753801°	38.753801°
				-121.634788°	-121.634788°
DWR ID	DWR_ST0004_01_f_2023_8				
Comment Code					
V1 : Control annual grass and weeds on the levee slopes and easements.					
Inspector Comment

View of acceptable vegetation on the landside slope (Fall 2023).

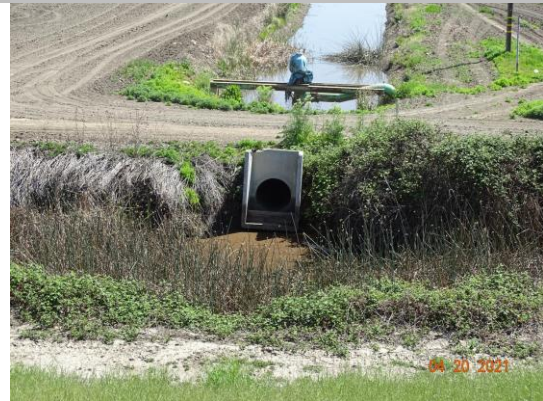
Photo 1 of 1 : FA_2023_ST0004_41_1_20231024_00001.jpg

LM Start	1.51	Rating **	A/W	Issue No.	1
LM End	1.51	Issue Type +	Ma	Location *	LS
Category	Earthen Levee			GPS Latitude/Longitude	
				Start	End
Item	Erosion / Bank Caving			38.743573°	38.743573°
				-121.634128°	-121.634128°
DWR ID	DWR_ST0004_01_s_2020_1				
Comment Code					
E1 : Note and monitor erosion site.					
Inspector Comment					
Erosion on a side of a ditch toward LS toe caused by water coming out of irrigation canal. Recommend monitoring.

View of erosion on landside irrigation canal. Spring 2021.

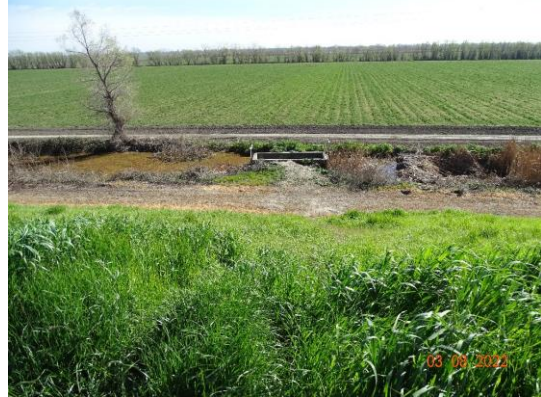
Photo 1 of 3 : UCIP_FA_2023_80055_106877.jpg

Comment Code					
Inspector Comment					
DS_ID:838 FS_ID:80055 EP_NO: N/A Repair Type: Non-Urgent EVAL Issue: 5, Pipe Damage Crossing Status: Found UCIP Comments: 05/23/2023 Record updated from Urgent to Non-Urgent. LoF grade is equal to 5 due to pipe surface damage corrosion, integrity issues are not found. Crossing will be monitored until funding becomes available for rehabilitation. (O.Yakimov - DWR UCIP). 12/15/2022 Record updated from Non-Urgent to Urgent. DMP internal video inspection has LOF of crossing is between 5 and 6. Crossing will be monitored until funding becomes available to address the issues. (O.Yakimov - DWR UCIP) 03/08/2022 Record updated from No Action Needed to Non-Urgent. Multiple sinkholes around headwall on waterside. A sinkhole measured 2-feet in diameter and 3-feet deep located on a shoulder of toe road located approximately 20 feet from levee toe in pipe alignment. No permit has been identified authorizing pipe. (O.Yakimov - DWR UCIP) 11/16/2017 Pipe is closed on w/s and closed on L/S. Mud removed recently from WS pipes. (Ted Skidgel - Sac Yard) FIELD_STRUCT_DESC: 1 of 2: 48-inch corrugated metal drainage pipe through the levee, 28.5 feet below the crown. 30-inch steel pipe sleeved through the 48-inch pipe. Slide gate in a 60-inch pipe riser on the waterside (WS) slope. [Additional Reference(s): DWR Levee Log, 1981. USACE Sacramento O&M Manual 123, August 1955, (Station 382+85)]. No permit or as-built drawing available. FS Date: 3/8/2022 10:33:40 AM

Land-Side: View of levee slope looking from crown

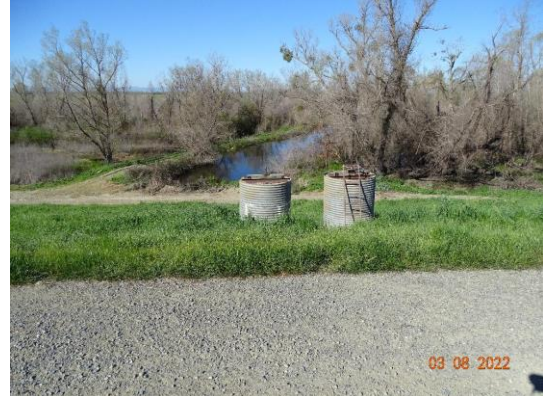
Photo 2 of 3 : UCIP_FA_2023_80055_106879.jpg

Water-Side: View of levee slope looking from crown. CMP riser on slope

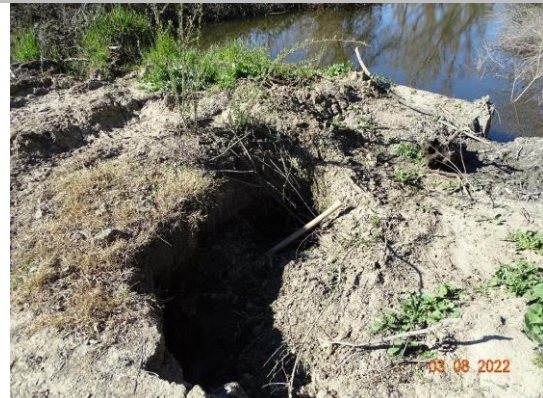
Photo 3 of 3 : UCIP_FA_2023_80055_106881.jpg

Water-Side: Multiple sinkholes filled with water around headwall

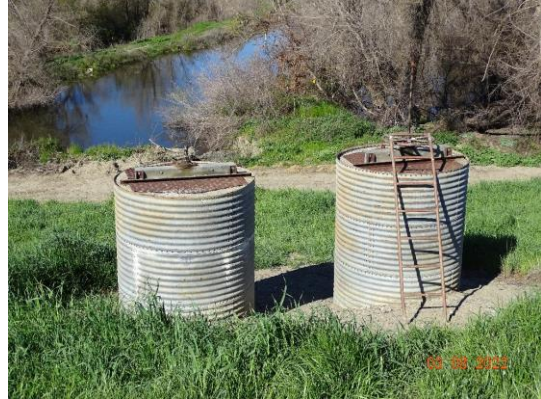
Photo 1 of 3 : UCIP_FA_2023_80056_106886.jpg

Comment Code						
Inspector Comment						
DS_ID:840 FS_ID:80056 EP_NO: N/A Repair Type: Non-Urgent EVAL Issue: 5, Pipe Damage Crossing Status: Found UCIP Comments: 05/23/2023 Record updated from Urgent to Non-Urgent. LoF grade is equal to 5 due to pipe surface damage corrosion, integrity issues are not found. Crossing will be monitored until funding becomes available for rehabilitation. (O.Yakimov - DWR UCIP). 12/15/2022 Record updated from Non-Urgent to Urgent. DMP internal video inspection has LOF of crossing is between 5 and 6. Crossing will be monitored until funding becomes available to address the issues. (O.Yakimov - DWR UCIP) 03/08/2022 Record updated from No Action Needed to Non-Urgent. Multiple sinkholes around headwall on waterside. A sinkhole measured 2-feet in diameter and 2-feet deep located on a shoulder of toe road located approximately 20 feet from levee toe in pipe alignment. No permit has been identified authorizing pipe. (O.Yakimov - DWR UCIP) FIELD_STRUCT_DESC: 2 of 2: 48-inch corrugated metal drainage pipe through the levee, 28.5 feet below the crown. 30-inch steel pipe sleeved through the 48-inch pipe. Slide gate in a 60-inch pipe riser on the waterside (WS) slope. [Additional Reference(s): DWR Levee Log, 1981. USACE Sacramento O&M Manual 123, August 1955, (Station 382+85)]. No permit or as-built drawing available. FS Date: 3/8/2022 10:34:05 AM

Water-Side: View of levee slope looking from crown. CMP riser on slope

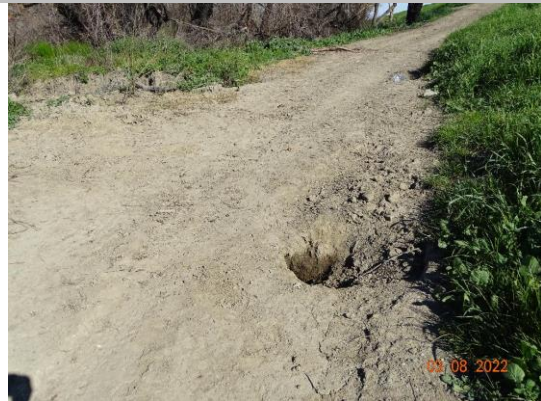
Photo 2 of 3 : UCIP_FA_2023_80056_106888.jpg

Water-Side: Sinkhole at the edge of toe road

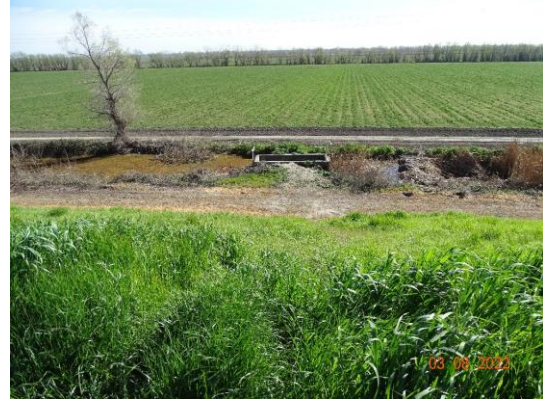
Photo 3 of 3 : UCIP_FA_2023_80056_106884.jpg

Land-Side: View of levee slope looking from crown
