**Flood Control Project Maintenance  
Levee Inspections**

**Maintenance Issue Types Only, Levee Inspection Report By Mile - Fall 2024**

**Sacramento Maintenance Yard East Levee Yolo Bypass**

Waterway	Bank	Unit Miles	Inspection Start/End	Inspector
Unit No. 01 Yolo Bypass	Left	2.01	10/28/2024 10/28/2024	Nate Hicks

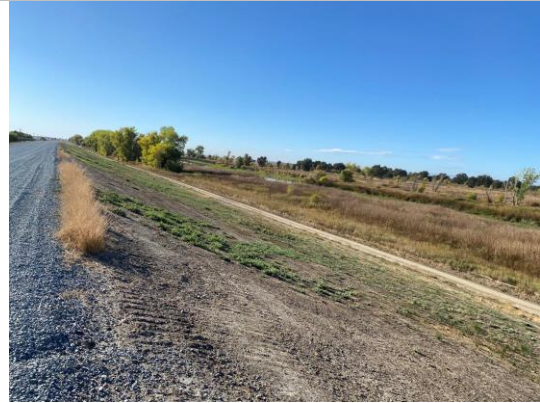
Photo 1 of 1 : FA\_2024\_ST0004\_41\_10\_20241104\_00009.jpg

LM Start	0.63	Rating **	A	Issue No.	10
LM End	0.63	Issue Type +	Ma	Location *	WS
Category	Earthen Levee			GPS Latitude/Longitude	
				Start	End
Item	Vegetation			38.756310°	38.756310°
				-121.635017°	-121.635017°
DWR ID	DWR_ST0004_01_f_2024_10				
Comment Code					
V1 : Control annual grass and weeds on the levee slopes and easements.					
Inspector Comment

View of good vegetation on the waterside (Fall 2024).

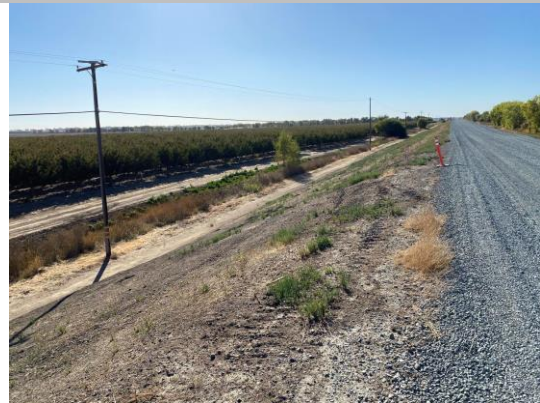
Photo 1 of 1 : FA\_2024\_ST0004\_41\_8\_20241104\_00010.jpg

LM Start	0.63	Rating **	A	Issue No.	8
LM End	0.63	Issue Type +	Ma	Location *	LS
Category	Earthen Levee			GPS Latitude/Longitude	
				Start	End
Item	Vegetation			38.756309°	38.756309°
				-121.635017°	-121.635017°
DWR ID	DWR_ST0004_01_f_2024_8				
Comment Code					
V1 : Control annual grass and weeds on the levee slopes and easements.					
Inspector Comment

View of good vegetation on the landside (Fall 2024).

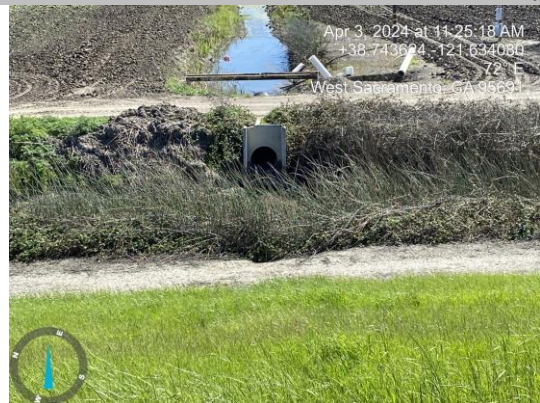
Photo 1 of 1 : FA\_2024\_ST0004\_41\_1\_20241028\_00001.jpg

LM Start	1.51	Rating **	A/W	Issue No.	1
LM End	1.51	Issue Type +	Ma	Location *	LS
Category	Earthen Levee			GPS Latitude/Longitude	
				Start	End
Item	Erosion / Bank Caving			38.743573°	38.743573°
				-121.634128°	-121.634128°
DWR ID	DWR_ST0004_01_s_2024_1				
Comment Code					
E1 : Note and monitor erosion site.					
Inspector Comment					
Erosion on a side of a ditch toward LS toe caused by water coming out of irrigation canal. Recommend monitoring.

View of erosion on landside irrigation canal (Spring 2024).

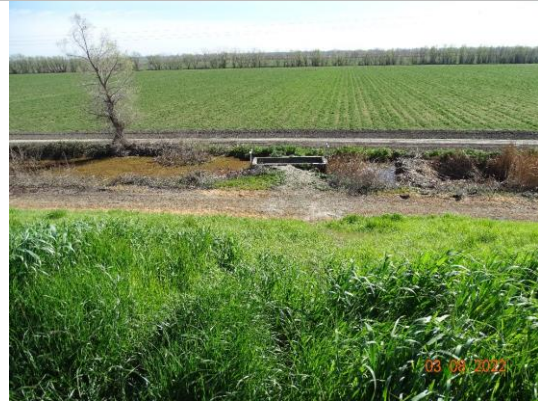
Photo 1 of 3 : UCIP\_FA\_2024\_80055\_106877.jpg

Comment Code						
Inspector Comment						
DS_ID:838 FS_ID:80055 EP_NO: N/A Repair Type: Non-Urgent EVAL Issue: 5, Pipe Damage Crossing Status: Found UCIP Comments: 05/23/2023 Record updated from Urgent to Non-Urgent. LoF grade is equal to 5 due to pipe surface damage corrosion, integrity issues are not found. Crossing will be monitored until funding becomes available for rehabilitation. (O.Yakimov - DWR UCIP). 12/15/2022 Record updated from Non-Urgent to Urgent. DMP internal video inspection has LOF of crossing is between 5 and 6. Crossing will be monitored until funding becomes available to address the issues. (O.Yakimov - DWR UCIP) 03/08/2022 Record updated from No Action Needed to Non-Urgent. Multiple sinkholes around headwall on waterside. A sinkhole measured 2-feet in diameter and 3-feet deep located on a shoulder of toe road located approximately 20 feet from levee toe in pipe alignment. No permit has been identified authorizing pipe. (O.Yakimov - DWR UCIP) 11/16/2017 Pipe is closed on w/s and closed on L/S. Mud removed recently from WS pipes. (Ted Skidgel - Sac Yard) FIELD_STRUCT_DESC: 1 of 2: 48-inch corrugated metal drainage pipe through the levee, 28.5 feet below the crown. 30-inch steel pipe sleeved through the 48-inch pipe. Slide gate in a 60-inch pipe riser on the waterside (WS) slope. (Two 48-inch pipes authorized under Permit No. 973, 1944 - Reclamation District 1600). [Additional Reference(s): DWR Levee Log, 1981 (HLM 1.68). USACE Sacramento O&M Manual, Unit 123, August 1955, Revised 17 December 2020, (Station 382+85), listed as two 48-inch pipes. USACE As-Built Drawing No. 50-04-1310, October 1931, Sheet 2, Station 382+85]. FS Date: 3/8/2022 10:33:40 AM

Land-Side: View of levee slope looking from crown

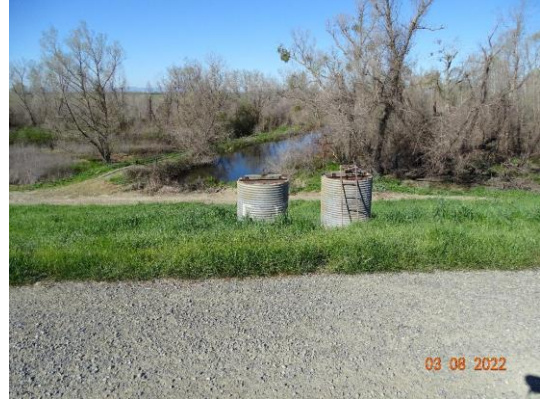
Photo 2 of 3 : UCIP\_FA\_2024\_80055\_106879.jpg

Water-Side: View of levee slope looking from crown. CMP riser on slope

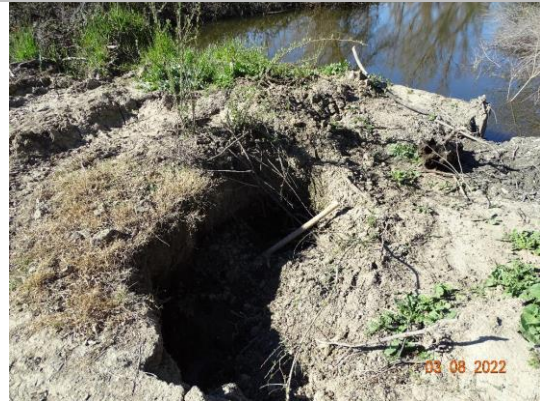
Photo 3 of 3 : UCIP\_FA\_2024\_80055\_106881.jpg

Water-Side: Multiple sinkholes filled with water around headwall

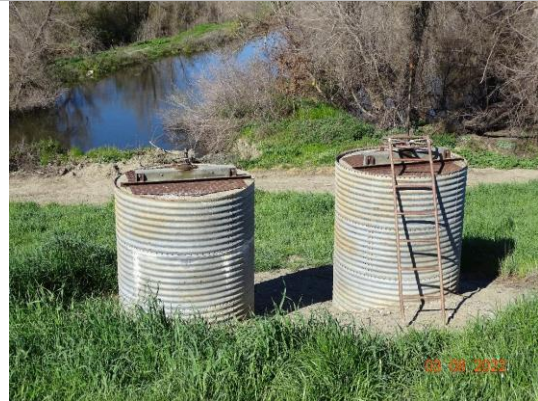
Photo 1 of 3 : UCIP\_FA\_2024\_80056\_106886.jpg

DS\_ID:840  
FS\_ID:80056  
EP\_NO: N/A  
Repair Type: Non-Urgent  
EVAL Issue: 5, Pipe Damage  
Crossing Status: Found  
UCIP Comments: 05/23/2023 Record updated from Urgent to Non-Urgent. LoF grade is equal to 5 due to pipe surface damage corrosion, integrity issues are not found. Crossing will be monitored until funding becomes available for rehabilitation. (O.Yakimov - DWR UCIP).  
12/15/2022 Record updated from Non-Urgent to Urgent. DMP internal video inspection has LOF of crossing is between 5 and 6. Crossing will be monitored until funding becomes available to address the issues. (O.Yakimov - DWR UCIP)  
03/08/2022 Record updated from No Action Needed to Non-Urgent. Multiple sinkholes around headwall on waterside. A sinkhole measured 2-feet in diameter and 2-feet deep located on a shoulder of toe road located approximately 20 feet from levee toe in pipe alignment. No permit has been identified authorizing pipe. (O.Yakimov - DWR UCIP)

FIELD\_STRUCT\_DESC: 2 of 2: 48-inch corrugated metal drainage pipe through the levee, 28.5 feet below the crown. 30-inch steel pipe sleeved through the 48-inch pipe. Slide gate in a 60-inch pipe riser on the waterside (WS) slope. (Two 48-inch pipes authorized under Permit No. 973, 1944 - Reclamation District 1600). [Additional Reference(s): DWR Levee Log, 1981 (HLM 1.68). USACE Sacramento O&M Manual, Unit 123, August 1955, Revised 17 December 2020, (Station 382+85), listed as two 48-inch pipes. USACE As-Built Drawing No. 50-04-1310, October 1931, Sheet 2, Station 382+85].  
FS Date: 3/8/2022 10:34:05 AM

Water-Side: View of levee slope looking from crown. CMP riser on slope

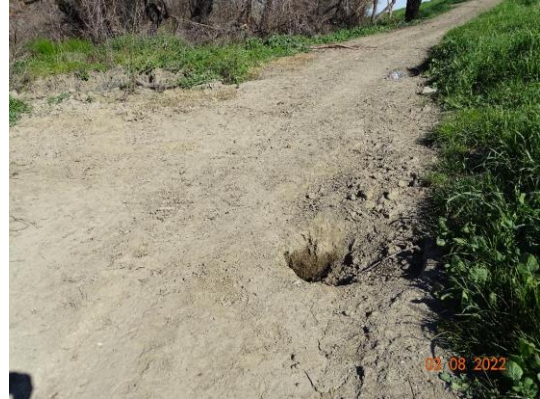
Photo 2 of 3 : UCIP\_FA\_2024\_80056\_106888.jpg

Water-Side: Sinkhole at the edge of toe road
