**Flood Control Project Maintenance
Levee Inspections**

Maintenance Issue Types Only, Levee Inspection Report By Mile - Spring 2016

Sacramento Maintenance Yard East Levee Yolo Bypass

Waterway	Bank	Unit Miles	Inspection Start/End	Inspector
Unit No. 01 Yolo Bypass	Left	2.01	03/29/2016 03/29/2016	Jai Lor

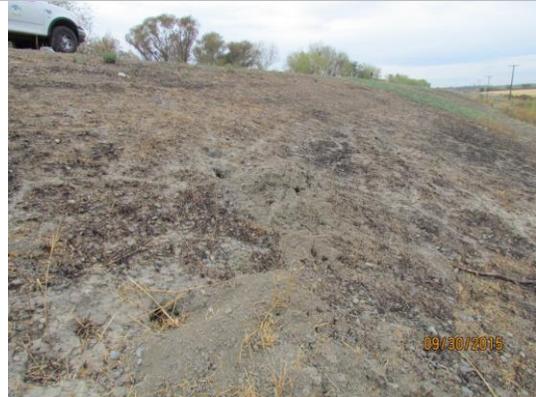
Photo 1 of 1 : SP_2016_ST0004_41_6_20160304_00001.jpg

LM Start	1.65	Rating **	M	Issue No.	6
LM End	1.65	Issue Type +	Ma	Location *	LS
Category	Earthen Levee		GPS Latitude/Longitude		
			Start	End	
Item	Animal Control		38.741579 °	38.741579 °	
			-121.634007 °	-121.634007 °	
DWR ID	DWR_ST0004_01_f_2015_6				
Comment Code					
A3 : No rodents visible, but rodent burrows visible; need to backfill and compact or grout burrows.					
Inspector Comment

View of the rodent holes on the landward side of the levee looking upstream. Fall 2015.
