**Flood Control Project Maintenance
Levee Inspections**

Fall 2014 Levee Maintenance Deficiency Summary Report

Sutter Maintenance Yard Hamilton Bend

Waterway		Bank	Unit Miles
Unit No. 01 Feather River Hamilton Bend		Right	3.39
	Spring (March - May)	Summer (June - August)	(September - November) Fall Winter (December - February)
Unit Maintenance Rating (Fall Only)			U
Date of Inspection	03/18/2014 - 03/18/2014		11/19/2014 - 11/19/2014
DWR Inspector	Matthew Hoffman		Matthew Hoffman
Accompanied By	Jason Cooper Sutter Maintenance Yard		Jason Cooper Sutter Maintenance Yard

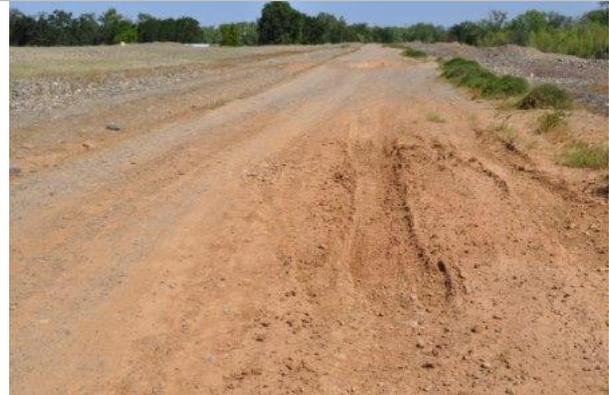
Photo 1 of 1 : FA_2014_ST0005_289_2_20141110_00001.jpg

LM Start	0.36	Rating **	M	Issue No.	2
LM End	0.36	Issue Type +	Ma	Location *	CR
Category	Earthen Levee		GPS Latitude/Longitude		
			Start	End	
Item	Crown Surface / Depressions / Rutting		39.444939 °	39.444939 °	
			-121.641780 °	-121.641780 °	
DWR ID	DWR_ST0005_01_s_2013_2				
Action/Comments					
Repair depressions or ruts in the crown or slope.

Deep rut in crown. Repair prior to flood season.

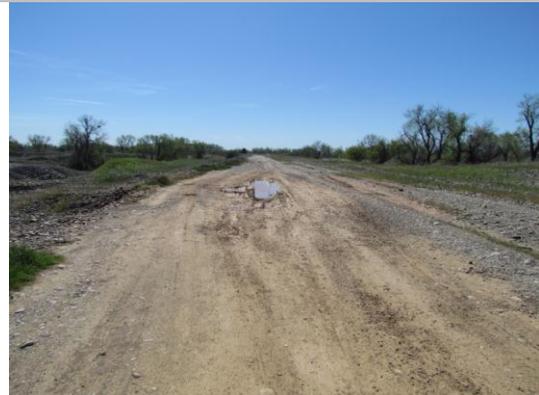
Photo 1 of 1 : FA_2014_ST0005_289_12_20141110_00004.jpg

LM Start	0.40	Rating **	M	Issue No.	12
LM End	0.40	Issue Type +	Ma	Location *	CR
Category	Earthen Levee		GPS Latitude/Longitude		
			Start	End	
Item	Crown Surface / Depressions / Rutting		39.445560 °	39.445560 °	
			-121.641784 °	-121.641784 °	
DWR ID	DWR_ST0005_01_s_2014_12				
Action/Comments					
Repair depressions or ruts in the crown or slope.

This photo was taken from the levee crown facing north looking at crown surface depressions caused by vehicle traffic. Spring 2014.

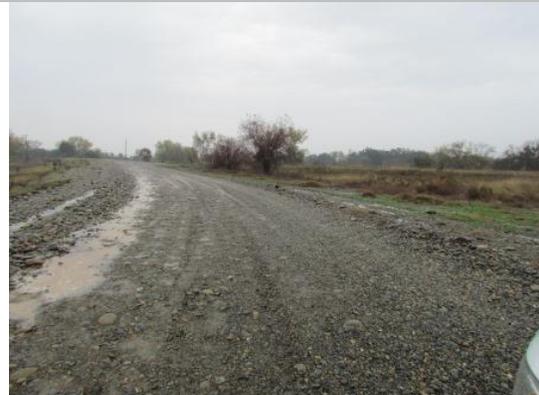
Photo 1 of 1 : FA_2014_ST0005_289_13_20141124_00010.jpg

LM Start	0.66	Rating **	A	Issue No.	13
LM End	0.66	Issue Type +	Ma	Location *	CR
Category	Earthen Levee		GPS Latitude/Longitude		
			Start	End	
Item	Crown Surface / Depressions / Rutting		39.449232 °	39.449232 °	
			-121.641063 °	-121.641063 °	
DWR ID	DWR_ST0005_01_f_2014_13				
Action/Comments					
Add appropriate material and re-grade the levee to bring the crown above the design elevation.

This photo was taken from the crown facing north looking at the crown patrol road at an acceptable all weather driving surface. Fall 2014.

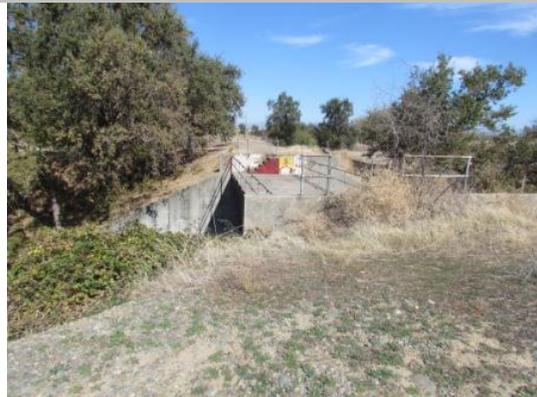
Photo 1 of 1 : FA_2014_ST0005_289_28_20141110_00005.jpg

LM Start	1.04	Rating **	A/W	Issue No.	28
LM End	1.04	Issue Type +	En	Location *	CR
Category	Earthen Levee		GPS Latitude/Longitude		
			Start	End	
Item	Encroachments		39.454464 °	39.454464 °	
			-121.640361 °	-121.640361 °	
DWR ID	DWR_ST0005_01_f_2013_28				
Action/Comments					
Building Inspector Comments: Abandoned inlet structure.

This photo was taken facing north looking down the levee crown at an old inlet structure. Fall 2013.

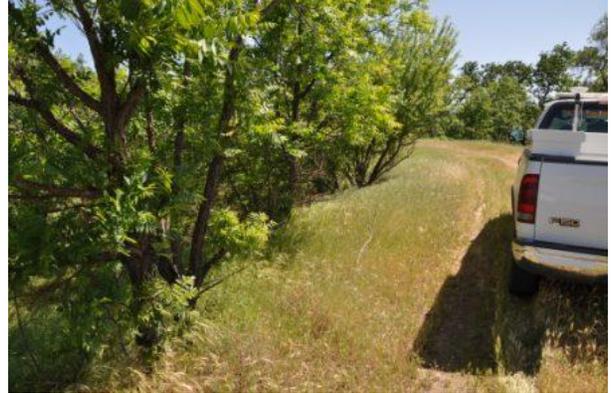
Photo 1 of 1 : FA_2014_ST0005_289_4_20141110_00002.jpg

LM Start	1.41	Rating **	M	Issue No.	4
LM End	3.18	Issue Type +	Ma	Location *	LS
Category	Earthen Levee		GPS Latitude/Longitude		
			Start	End	
Item	Trim / Thin Trees		39.458060 °	39.470433 °	
			-121.636332 °	-121.609200 °	
DWR ID	DWR_ST0005_01_s_ 2013_4				
Action/Comments					
Trim and thin trees to allow visibility of the ground and room to flood fight.

L/S trees.

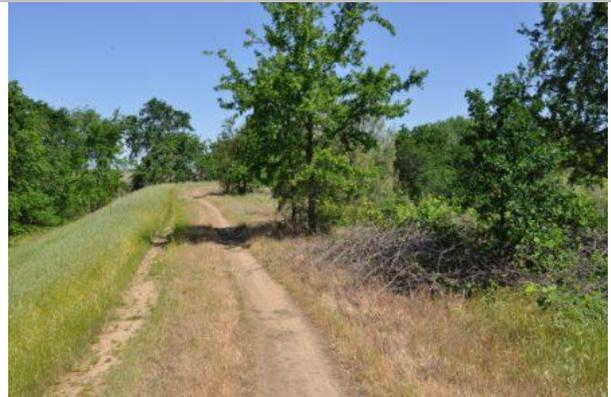
Photo 1 of 1 : FA_2014_ST0005_289_5_20141110_00003.jpg

LM Start	1.44	Rating **	M	Issue No.	5
LM End	1.62	Issue Type +	Ma	Location *	WS
Category	Earthen Levee		GPS Latitude/Longitude		
			Start	End	
Item	Trim / Thin Trees		39.458255 °	39.459451 °	
			-121.635808 °	-121.633670 °	
DWR ID	DWR_ST0005_01_s_ 2013_5				
Action/Comments					
Trim and thin trees to allow visibility of the ground and room to flood fight.

W/S trees.
