**Flood Control Project Maintenance
Levee Inspections
LMA District Cover Sheet
Spring 2014 Levee Inspection Results**

Sutter Maintenance Yard Hamilton Bend

Waterway		Bank	Unit Miles
Unit No. 01 Feather River Hamilton Bend		Right	3.22

Levee Inspection Report By Mile - Spring 2014

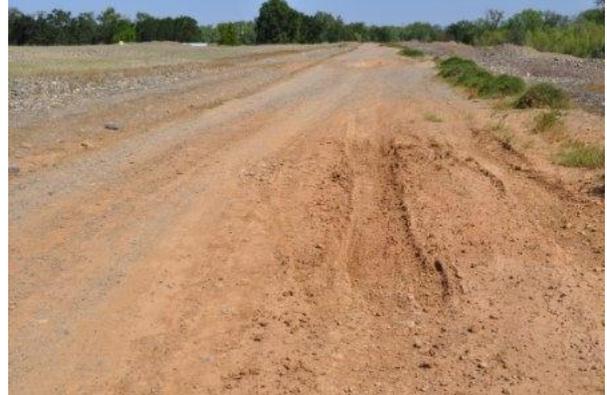
Photo 1 of 1 : mhoffman_s_20140306_252.jpg

LM Start	0.36	Rating **	M	Issue No.	2
LM End	0.36	Issue Type +	Ma	Location *	CR
Category	Earthen Levee		GPS Latitude/Longitude		
			Start	End	
Item	Crown Surface / Depressions / Rutting		39.444939 °	39.444939 °	
			-121.641780 °	-121.641780 °	
DWR ID	DWR_ST0005_01_s_2013_2				
Action/Comments					
Repair depressions or ruts in the crown or slope.

Deep rut in crown. Repair prior to flood season.

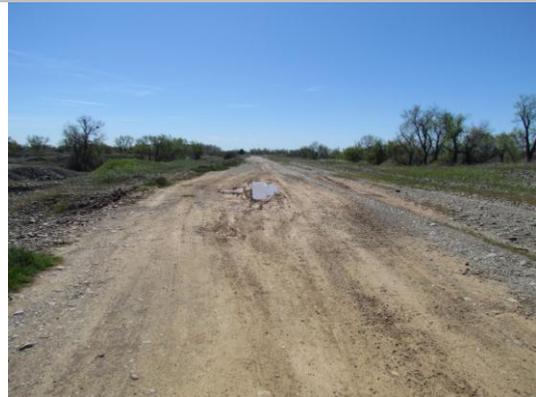
Photo 1 of 1 : mhoffman_s_20140320_271.jpg

LM Start	0.40	Rating **	M	Issue No.	12
LM End	0.40	Issue Type +	Ma	Location *	CR
Category	Earthen Levee		GPS Latitude/Longitude		
			Start	End	
Item	Crown Surface / Depressions / Rutting		39.445560 °	39.445560 °	
			-121.641784 °	-121.641784 °	
DWR ID	DWR_ST0005_01_s_2014_12				
Action/Comments					
Repair depressions or ruts in the crown or slope.

This photo was taken from the levee crown facing north looking at crown surface depressions caused by vehicle traffic. Spring 2014.

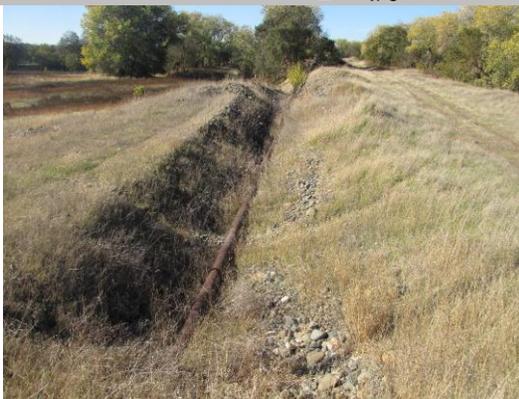
Photo 1 of 1 : UCIP_820.jpg

LM Start	0.80	Rating **	M	Issue No.	1
LM End	0.80	Issue Type +	En	Location *	CR
Category	Supplemental		GPS Latitude/Longitude		
			Start	End	
Item	DWR UCIP Field Study		39.451078 °	39.451078 °	
			-121.640773 °	-121.640773 °	
DWR ID	DWR_ST0005_01_s_2014_1				
Action/Comments					
Inspector Comments: FS_ID:13237 EP_NO: 927 Repair Type: Crossing Status: UCIP Comments: low spot on WS slope; sink hole or section dug-unable to tell; hole on levee toe. This crossing was listed in the USACE Periodic Inspection as ID# USACE_CESPK_HAM1_2010_a_0029 no issues reported 5/14/2013 SBFCA project recommends removal 5/14/2013 Same as last inspection. FIELD_STRUCT_DESC: Abandoned 10-inch steel pipe through the levee 10.4 feet below the crown. (Permit No. 927) FS Date: 5/14/2013 12:46:25 PM

View of ditch and pipe running along landward side.

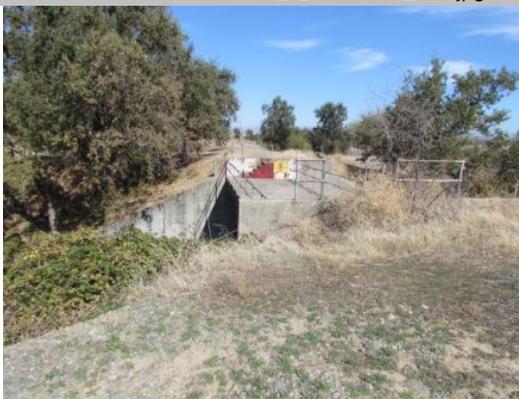
Photo 1 of 1 : mhoffman_s_20140306_255.jpg

LM Start	1.04	Rating **	A/W	Issue No.	28
LM End	1.04	Issue Type +	En	Location *	CR
Category	Earthen Levee		GPS Latitude/Longitude		
			Start	End	
Item	Encroachments		39.454464 °	39.454464 °	
			-121.640361 °	-121.640361 °	
DWR ID	DWR_ST0005_01_f_2013_28				
Action/Comments					
Building Inspector Comments: Abandoned inlet structure.

This photo was taken facing north looking down the levee crown at an old inlet structure. Fall 2013.

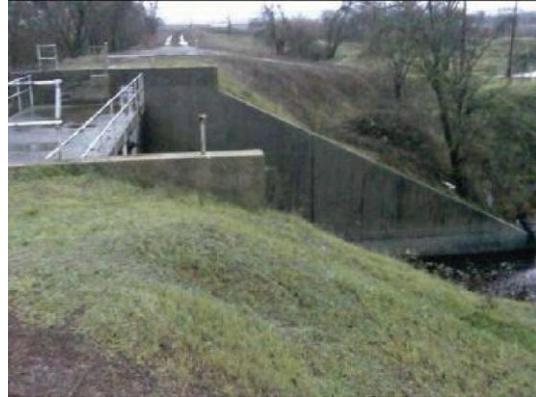
Photo 1 of 1 : UCIP_827.jpg

LM Start	1.05	Rating **	M	Issue No.	3
LM End	1.05	Issue Type +	En	Location *	CR
Category	Supplemental			GPS Latitude/Longitude	
				Start	End
Item	DWR UCIP Field Study			39.454557 °	39.454557 °
				-121.640274 °	-121.640274 °
DWR ID	DWR_ST0005_01_s_2014_3				
Action/Comments					
Inspector Comments: FS_ID:13241 EP_NO: N/A Repair Type: Crossing Status: UCIP Comments: abandoned WS gates closed; handles broken; Structure needs to be properly abandoned. This crossing was listed in the USACE Periodic Inspection as ID# USACE_CESPK_HAM1_2010_a_0043 no issues reported 6/14/2013 Same as last inspection. FIELD_STRUCT_DESC: Abandoned Sutter Butte Canal head gate structure, Six 6 by 8 foot concrete culvert 35.8 feet below the crown. Stems on gates are removed and gates are in a closed position. This entry matches the Drainage or Irrigation Structure referenced in O&M manual (Historic Station 47+00). (USACE O&M Manual, 1957) FS Date: 5/14/2013 12:56:41 PM

View of concrete structure, Photo 1 of 2.

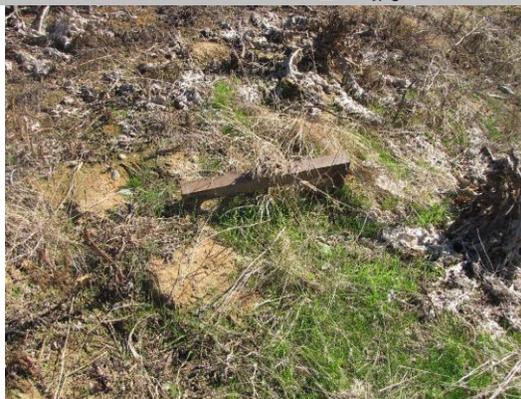
Photo 1 of 1 : UCIP_823.jpg

LM Start	1.17	Rating **	M	Issue No.	6
LM End	1.17	Issue Type +	En	Location *	CR
Category	Supplemental		GPS Latitude/Longitude		
			Start	End	
Item	DWR UCIP Field Study		39.456287 °	39.456287 °	
			-121.639530 °	-121.639530 °	
DWR ID	DWR_ST0005_01_s_2014_6				
Action/Comments					
Inspector Comments: FS_ID:13238 EP_NO: N/A Repair Type: Crossing Status: UCIP Comments: Abandoned structure: Structure is non-operational, slide gate is completely buried; top of slide gate barely visible from levee 5/14/2013 Same as last inspection. FIELD_STRUCT_DESC: Abandoned 24-inch pipe through the levee 16.5 feet below the crown. Slide gate in CM riser on the waterward slope. No features of structure were found with the exception of slide gate frame. FS Date: 5/14/2013 12:48:22 PM

Slide gate completely buried-non-functional.

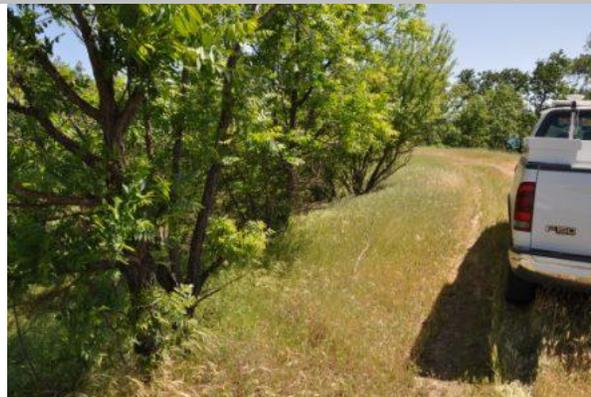
Photo 1 of 1 : mhoffman_s_20140306_253.jpg

LM Start	1.41	Rating **	M	Issue No.	4
LM End	3.18	Issue Type +	Ma	Location *	LS
Category	Earthen Levee		GPS Latitude/Longitude		
			Start	End	
Item	Trim / Thin Trees		39.458060 °	39.470433 °	
			-121.636332 °	-121.609200 °	
DWR ID	DWR_ST0005_01_s_2013_4				
Action/Comments					
Trim and thin trees to allow visibility of the ground and room to flood fight.

L/S trees.

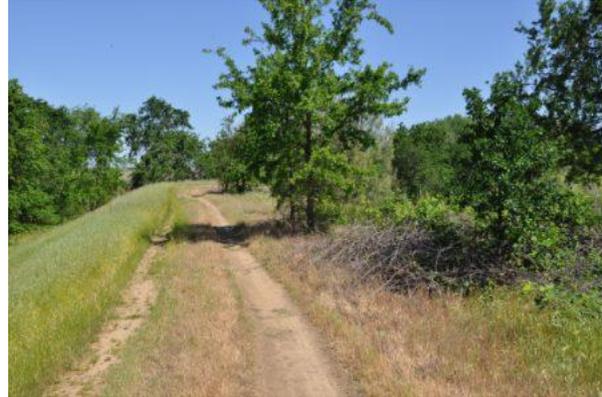
Photo 1 of 1 : mhoffman_s_20140306_254.jpg

LM Start	1.44	Rating **	M	Issue No.	5
LM End	1.62	Issue Type +	Ma	Location *	WS
Category	Earthen Levee			GPS Latitude/Longitude	
				Start	End
Item	Trim / Thin Trees			39.458255 °	39.459451 °
				-121.635808 °	-121.633670 °
DWR ID	DWR_ST0005_01_s_2013_5				
Action/Comments					
Trim and thin trees to allow visibility of the ground and room to flood fight.

W/S trees.

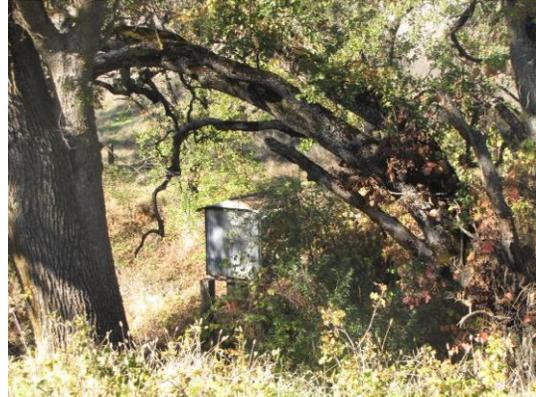
Photo 1 of 1 : UCIP_838.jpg

LM Start	3.17	Rating **	M	Issue No.	11
LM End	3.17	Issue Type +	En	Location *	WS
Category	Supplemental			GPS Latitude/Longitude	
				Start	End
Item	DWR UCIP Field Study			39.470269 °	39.470269 °
				-121.609229 °	-121.609229 °
DWR ID	DWR_ST0005_01_s_2014_11				
Action/Comments					
Inspector Comments: FS_ID:13242 EP_NO: N/A Repair Type: Crossing Status: UCIP Comments: Abandoned Structure: WS- remince of gates and concrete standpipe; LS-remince of concrete headwall and pump station 5/14/2013 Same as last inspection. FIELD_STRUCT_DESC: Abandoned western canal head gate inlet structure. One (1) of 2 culverts, 8 by 8-foot concrete culverts through the levee 25.0 feet below the crown. Three slide gates on the waterward end. Concrete stairs on the waterward slope. Concrete headwall at both toes. This entry matches the Drainage or Irrigation Structure referenced in O&M manual (Historic Station 170+00). (USACE O&M Manual, 1957) FS Date: 5/14/2013 12:57:57 PM

Pump station located on landward side.
