**Flood Control Project Maintenance  
Levee Inspections**  
**LMA District Cover Sheet**  
**Spring 2016 Levee Inspection Results**

**Sutter Maintenance Yard Hamilton Bend**

**Levee Inspection Report By Mile - Spring 2016**

Waterway	Bank	Unit Miles	Inspection Start/End	Inspector
Unit No. 01 Feather River Hamilton Bend	Right	3.39	04/05/2016 04/08/2016	Sterling York

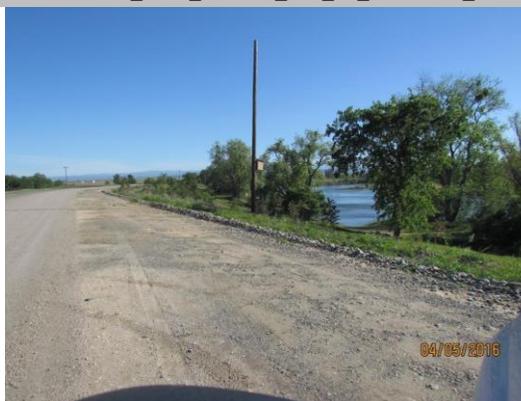
Photo 1 of 1 : SP\_2016\_ST0005\_289\_14\_20160418\_00027.jpg

LM Start	<b>0.73</b>	Rating **	M	Issue No.	<b>14</b>
LM End	<b>0.91</b>	Issue Type +	Ma	Location *	WS
Category	Earthen Levee			GPS Latitude/Longitude	
				Start	End
Item	Trim / Thin Trees			39.450109 °	39.452643 °
				-121.640851 °	-121.640316 °
DWR ID	DWR_ST0005_01_s_2016_14				
Comment Code					
T3 : Trim and thin trees to allow visibility of the ground and room to flood fight.					
Inspector Comment					
trees smaller than 4" in diameter at chest height should be removed before they get any bigger.

View looking upstream of trees. Small trees 4" in diameter at chest height should be removed before they get to big., Spring 2016.

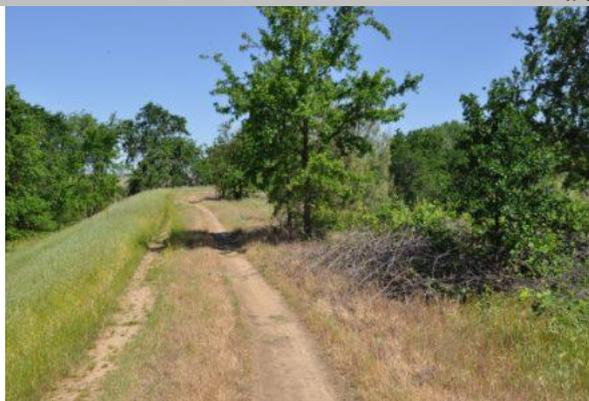
Photo 1 of 1 : SP\_2016\_ST0005\_289\_5\_20160307\_00003.jpg

LM Start	<b>1.69</b>	Rating **	M	Issue No.	<b>5</b>
LM End	<b>3.04</b>	Issue Type +	Ma	Location *	WS
Category	Earthen Levee		GPS Latitude/Longitude		
			Start	End	
Item	Trim / Thin Trees		39.459451 °	39.469081 °	
			-121.633670 °	-121.612535 °	
DWR ID	DWR_ST0005_01_s_2013_5				
Comment Code					
T3 : Trim and thin trees to allow visibility of the ground and room to flood fight.					
Inspector Comment					
Trees smaller than 4" in diameter at chest height should be removed before they get any bigger.

W/S trees 4" in diameter at chest height should be removed before they get to big..

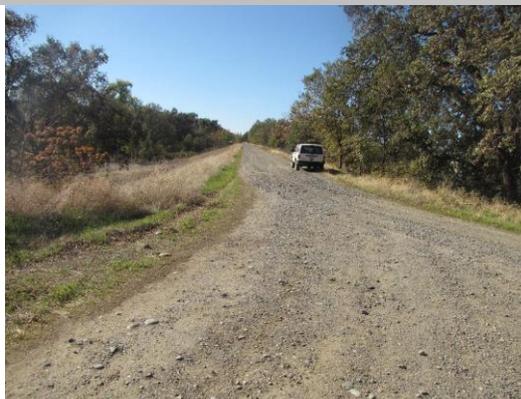
Photo 1 of 2 : UCIP\_SP\_2016\_47972\_21682.jpg

Item	DWR UCIP Field Study			39.470269 °	39.470269 °
				-121.609229 °	-121.609229 °
DWR ID					
Comment Code					
Inspector Comment					
FS_ID:47972 DS_ID:17044 EP_NO: N/A Repair Type: Non-Urgent Crossing Status: Indicator Found UCIP Comments: 4/26/2016 Unable to access area near structure.5/14/2013 Same as last inspection.11/14/2012 Abandoned Structure: WS- reminince of gates and concrete standpipe; LS-reminince of concrete headwall and pump station. FIELD_STRUCT_DESC: *ABANDONED* 1 of 2: [Western Canal Head Gate Inlet Structure]. 8 by 8-foot concrete culverts through the levee 25.0 feet below the crown. Three slide gates on the waterside (WS) end. Concrete stairs on the WS slope. Concrete headwall at both toes. This entry matches the Drainage or Irrigation Structure referenced in O&M manual (Historic Station 170+00). (USACE O&M Manual, 1957) FS Date: 5/3/2016 12:36:00 PM

View of levee crown looking downstream.

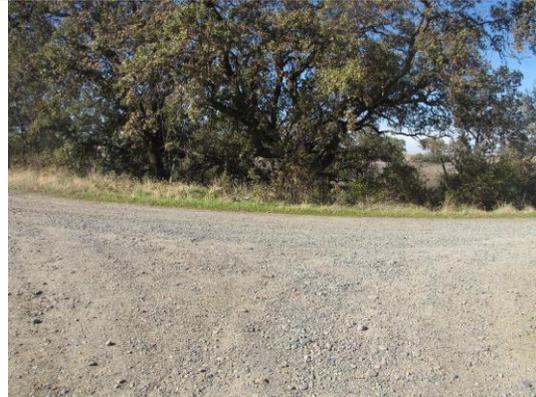
Photo 2 of 2 : UCIP\_SP\_2016\_47972\_21681.jpg

Item	DWR UCIP Field Study			39.470269 °	39.470269 °
				-121.609229 °	-121.609229 °
DWR ID					
Comment Code					
Inspector Comment					
FS_ID:47972 DS_ID:17044 EP_NO: N/A Repair Type: Non-Urgent Crossing Status: Indicator Found UCIP Comments: 4/26/2016 Unable to access area near structure.5/14/2013 Same as last inspection.11/14/2012 Abandoned Structure: WS- reminince of gates and concrete standpipe; LS-reminince of concrete headwall and pump station. FIELD_STRUCT_DESC: *ABANDONED* 1 of 2: [Western Canal Head Gate Inlet Structure]. 8 by 8-foot concrete culverts through the levee 25.0 feet below the crown. Three slide gates on the waterside (WS) end. Concrete stairs on the WS slope. Concrete headwall at both toes. This entry matches the Drainage or Irrigation Structure referenced in O&M manual (Historic Station 170+00). (USACE O&M Manual, 1957) FS Date: 5/3/2016 12:36:00 PM

View of levee crown at right bend.

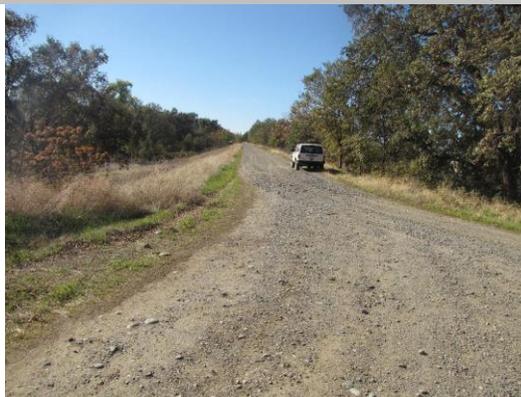
Photo 1 of 2 : UCIP\_SP\_2016\_47973\_21697.jpg

Item	DWR UCIP Field Study			39.470269 °	39.470269 °
				-121.609229 °	-121.609229 °
DWR ID					
Comment Code					
Inspector Comment					
FS_ID:47973 DS_ID:17056 EP_NO: N/A Repair Type: Non-Urgent Crossing Status: Indicator Found UCIP Comments: 4/26/2016 Unable to access area near structure.5/14/2013 Same as last inspection.11/14/2012 Abandoned Structure: WS- reminince of gates and concrete standpipe; LS-reminince of concrete headwall and pump station. FIELD_STRUCT_DESC: *ABANDONED* 2 of 2: [Western Canal Head Gate Inlet Structure] 8 by 8-foot concrete culvert through the levee 25.0 feet below the crown. Three slide gates on the waterside (WS) end. Concrete stairs on the WS slope. Concrete headwall at both toes. This entry matches the Drainage or Irrigation Structure referenced in O&M manual (Historic Station 170+00). (USACE O&M Manual, 1957) FS Date: 5/3/2016 12:37:00 PM

View of levee crown looking downstream.

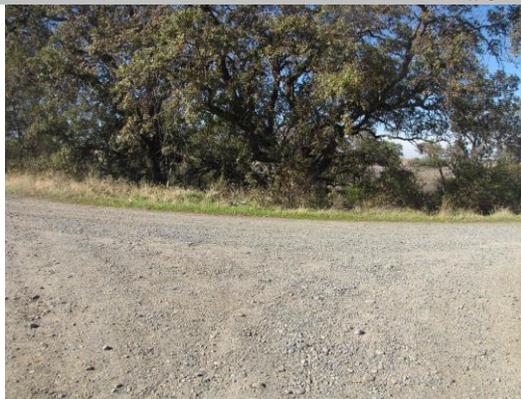
Photo 2 of 2 : UCIP\_SP\_2016\_47973\_21696.jpg

LM Start	<b>3.25</b>	Rating **	M	Issue No.	<b>30 (cont)</b>
LM End	<b>3.25</b>	Issue Type +	En	Location *	WS

View of levee crown at a right bend.

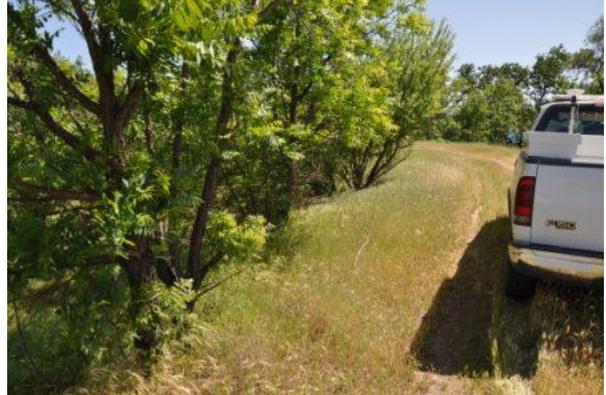
Photo 1 of 1 : SP\_2016\_ST0005\_289\_4\_20160307\_00002.jpg

LM Start	<b>3.26</b>	Rating **	M	Issue No.	<b>4</b>
LM End	<b>3.27</b>	Issue Type +	Ma	Location *	LS
Category	Earthen Levee			GPS Latitude/Longitude	
				Start	End
Item	Trim / Thin Trees			39.470433 °	39.470558 °
				-121.609200 °	-121.609215 °
DWR ID	DWR_ST0005_01_s_2013_4				
Comment Code					
T3 : Trim and thin trees to allow visibility of the ground and room to flood fight.					
Inspector Comment					
Small trees 4" in diameter at chest height should be removed before they get to big.

L/S trees. Small trees 4" in diameter at chest height should be removed before they get to big.
