**Flood Control Project Maintenance  
Levee Inspections**

**Maintenance Issue Types Only, Levee Inspection Report By Mile - Fall 2014**

**Sutter Maintenance Yard Hamilton Bend**

Waterway	Bank	Unit Miles	Inspection Start/End	Inspector
Unit No. 01 Feather River Hamilton Bend	Right	3.39	11/19/2014 11/19/2014	Matthew Hoffman

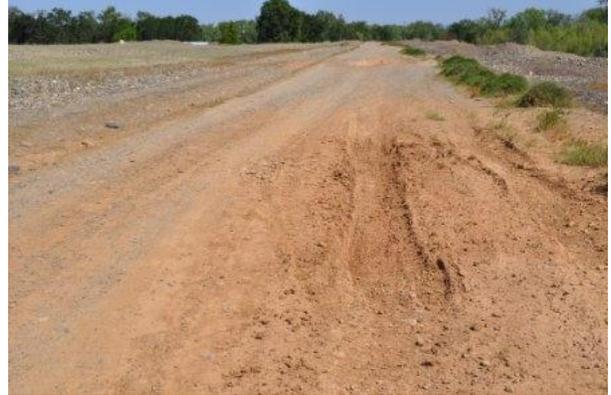
Photo 1 of 1 : FA\_2014\_ST0005\_289\_2\_20141110\_00001.jpg

LM Start	<b>0.36</b>	Rating **	M	Issue No.	<b>2</b>
LM End	<b>0.36</b>	Issue Type +	Ma	Location *	CR
Category	Earthen Levee		GPS Latitude/Longitude		
			Start	End	
Item	Crown Surface / Depressions / Rutting		39.444939 °	39.444939 °	
			-121.641780 °	-121.641780 °	
DWR ID	DWR_ST0005_01_s_2013_2				
Action/Comments					
Repair depressions or ruts in the crown or slope.

Deep rut in crown. Repair prior to flood season.

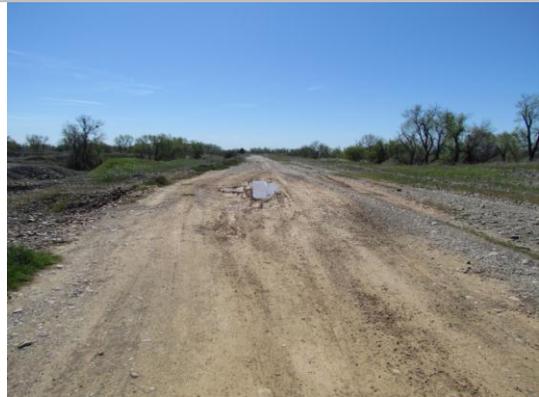
Photo 1 of 1 : FA\_2014\_ST0005\_289\_12\_20141110\_00004.jpg

LM Start	<b>0.40</b>	Rating **	M	Issue No.	<b>12</b>
LM End	<b>0.40</b>	Issue Type +	Ma	Location *	CR
Category	Earthen Levee		GPS Latitude/Longitude		
			Start	End	
Item	Crown Surface / Depressions / Rutting		39.445560 °	39.445560 °	
			-121.641784 °	-121.641784 °	
DWR ID	DWR_ST0005_01_s_2014_12				
Action/Comments					
Repair depressions or ruts in the crown or slope.

This photo was taken from the levee crown facing north looking at crown surface depressions caused by vehicle traffic. Spring 2014.

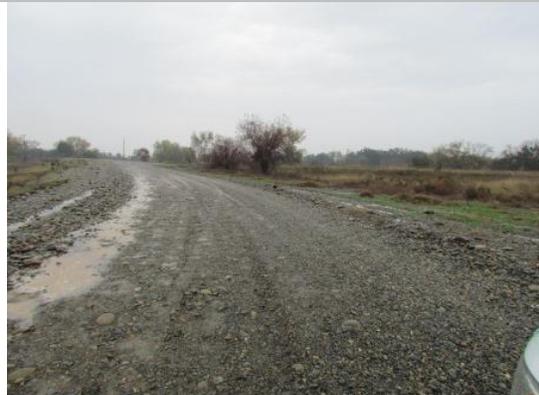
Photo 1 of 1 : FA\_2014\_ST0005\_289\_13\_20141124\_00010.jpg

LM Start	<b>0.66</b>	Rating **	A	Issue No.	<b>13</b>
LM End	<b>0.66</b>	Issue Type +	Ma	Location *	CR
Category	Earthen Levee		GPS Latitude/Longitude		
			Start	End	
Item	Crown Surface / Depressions / Rutting		39.449232 °	39.449232 °	
			-121.641063 °	-121.641063 °	
DWR ID	DWR_ST0005_01_f_2014_13				
Action/Comments					
Add appropriate material and re-grade the levee to bring the crown above the design elevation.

This photo was taken from the crown facing north looking at the crown patrol road at an acceptable all weather driving surface. Fall 2014.
