**Flood Control Project Maintenance  
Levee Inspections**

**Fall 2012 Levee Maintenance Deficiency Summary Report**

**Sutter Maintenance Yard Nelson Bend**

Waterway	Bank	Unit Miles
Unit No. 01 Feather River West Levee-Nelson Bend		0.50

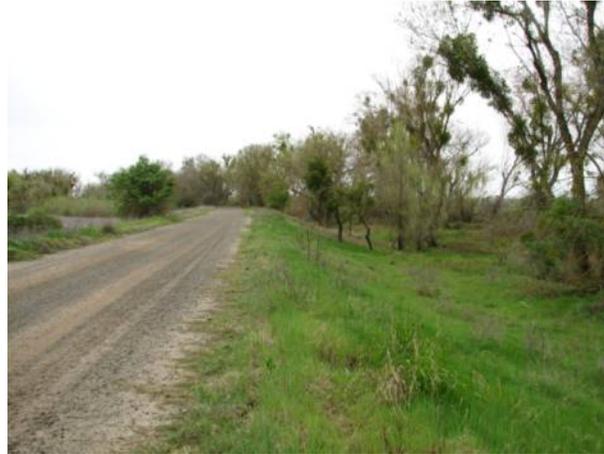
Levee Mile Report Line	2
Start Levee Mile	0.01
End Levee Mile	0.45
Location	Land Side
Category	Earthen Levee
Item	Vegetation
<p>This photo was taken at levee mile 0.00 looking downstream at the landside vegetation.</p>	
<p>cathom_f_20120912_039.JPG</p>

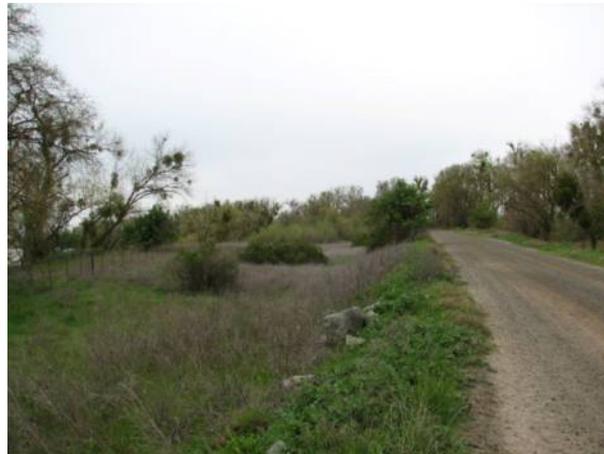
Levee Mile Report Line	4
Start Levee Mile	0.02
End Levee Mile	0.45
Location	Water Side
Category	Earthen Levee
Item	Vegetation
<p>This photo was taken at levee mile 0.00 looking downstream at the waterside vegetation.</p>	
<p>cathom_f_20120912_040.JPG</p>
