**Flood Control Project Maintenance  
Levee Inspections**

**Fall 2014 Levee Maintenance Deficiency Summary Report**

**Sutter Maintenance Yard Nelson Bend**

Waterway		Bank	Unit Miles
Unit No. 01 Feather River West Levee-Nelson Bend			0.50
	Spring (March - May)	Summer (June - August)	(September - November) Fall Winter (December - February)
Unit Maintenance Rating (Fall Only)			<b>U</b>
Date of Inspection	05/01/2014 - 05/01/2014		10/14/2014 - 10/14/2014
DWR Inspector	Matthew Hoffman		Matthew Hoffman
Accompanied By

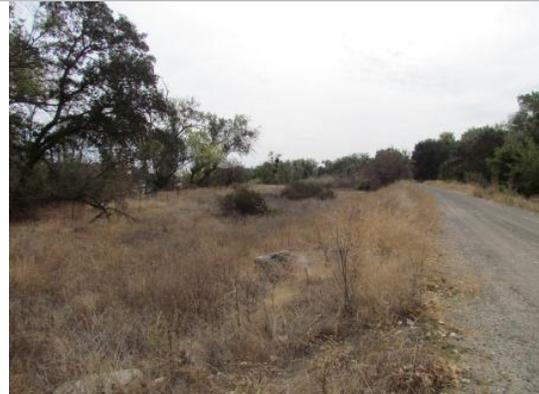
Photo 1 of 1 : FA\_2014\_ST0006\_471\_1\_20141017\_00004.jpg

LM Start	<b>0.01</b>	Rating **	M	Issue No.	<b>1</b>
LM End	<b>0.45</b>	Issue Type +	Ma	Location *	WS
Category	Earthen Levee		GPS Latitude/Longitude		
			Start	End	
Item	Vegetation		38.886937 °	38.880822 °	
			-121.614752 °	-121.614565 °	
DWR ID	DWR_ST0006_01_s_2012_1				
Action/Comments					
Remove the wild growth other than native grasses from the levee slopes.

This photo was taken from the crown facing south looking down the waterward levee slope at vegetation needing annual maintenance. Fall 2014.

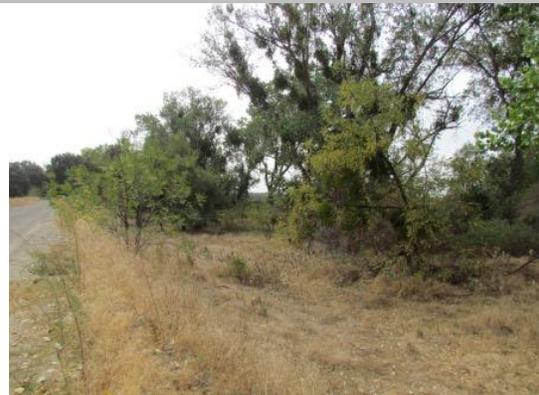
Photo 1 of 1 : FA\_2014\_ST0006\_471\_3\_20141017\_00005.jpg

LM Start	<b>0.01</b>	Rating **	M	Issue No.	<b>3</b>
LM End	<b>0.45</b>	Issue Type +	Ma	Location *	LS
Category	Earthen Levee		GPS Latitude/Longitude		
			Start	End	
Item	Trim / Thin Trees		38.886933 °	38.880857 °	
			-121.614753 °	-121.614555 °	
DWR ID	DWR_ST0006_01_s_2012_3				
Action/Comments					
Thin trees to allow visibility of the ground and room to flood fight.

This photo was taken from the crown facing south looking down the landward levee slope at trees that need to be trimmed up 5 feet to allow for slope visibility. Fall 2014.

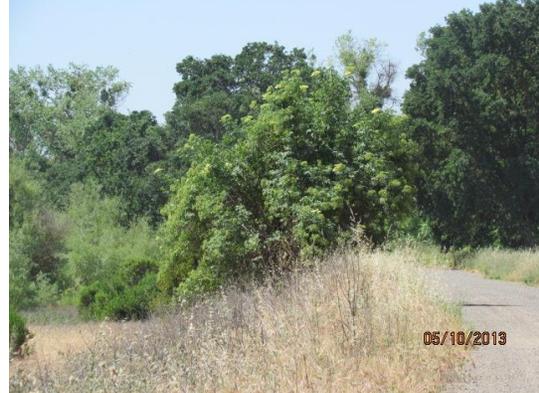
Photo 1 of 1 : FA\_2014\_ST0006\_471\_4\_20141013\_00003.jpg

LM Start	<b>0.05</b>	Rating **	M	Issue No.	<b>4</b>
LM End	<b>0.05</b>	Issue Type +	Ma	Location *	WS
Category	Earthen Levee		GPS Latitude/Longitude		
			Start	End	
Item	Vegetation		38.886408 °	38.886408 °	
			-121.615092 °	-121.615092 °	
DWR ID	DWR_ST0006_01_s_2012_4				
Action/Comments					
Elderberries are blocking visibility and flood fight capability.

View of the elderberries that are blocking visibility.
