**Flood Control Project Maintenance
Levee Inspections**

Fall 2015 Levee Maintenance Deficiency Summary Report

Sutter Maintenance Yard Nelson Bend

Waterway	Bank	Unit Miles	Inspection Start/End	Inspector
Unit No. 01 Feather River West Levee - Nelson Bend		0.50	11/18/2015 11/18/2015	Bob Duffey

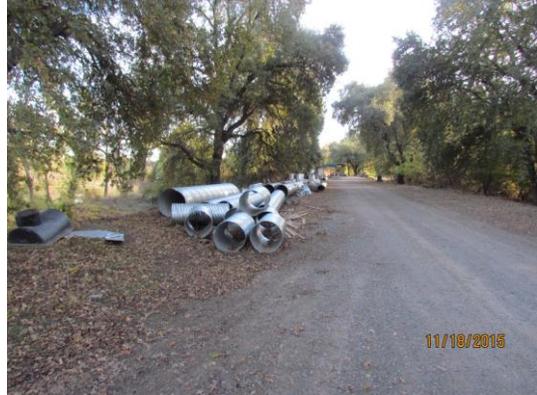
Photo 1 of 1 : FA_2015_ST0006_471_16_20151120_00004.jpg

LM Start	0.40	Rating **	M	Issue No.	16
LM End	0.46	Issue Type +	En	Location *	WS
Category	Earthen Levee		GPS Latitude/Longitude		
			Start	End	
Item	Encroachments		38.881638 °	38.880795 °	
			-121.614647 °	-121.614427 °	
DWR ID	DWR_ST0006_01_f_2015_16				
Action/Comments					
Pipe Inspector Comments: The pipe is laying along the waterside berm.

View of the pipe along the waterside berm.

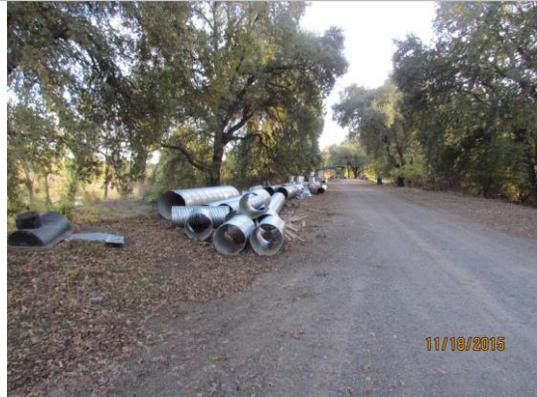
Photo 1 of 1 : FA_2015_ST0006_471_8_20151123_00007.jpg

LM Start	0.47	Rating **	U	Issue No.	8
LM End	0.47	Issue Type +	En	Location *	CR
Category	Earthen Levee		GPS Latitude/Longitude		
			Start	End	
Item	Encroachments		38.880664 °	38.880664 °	
			-121.614335 °	-121.614335 °	
DWR ID	DWR_ST0006_01_s_2012_8				
Action/Comments					
Building Inspector Comments: the building is directly behind the pipe that is laying along the waterside berm.

View of the building directly behind the pipe on the waterside berm.
