**Flood Control Project Maintenance
Levee Inspections**
LMA District Cover Sheet
Spring 2016 Levee Inspection Results

Sutter Maintenance Yard Nelson Bend

Levee Inspection Report By Mile - Spring 2016

Waterway	Bank	Unit Miles	Inspection Start/End	Inspector
Unit No. 01 Feather River West Levee - Nelson Bend		0.50	03/30/2016 03/30/2016	Sterling York

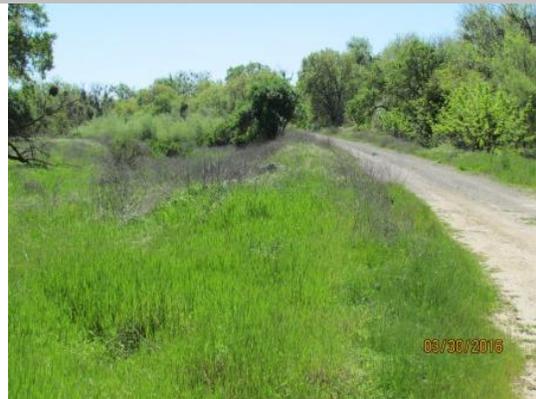
Photo 1 of 1 : SP_2016_ST0006_471_1_20160404_00007.jpg

LM Start	0.01	Rating **	U	Issue No.	1
LM End	0.47	Issue Type +	Ma	Location *	LS
Category	Earthen Levee		GPS Latitude/Longitude		
			Start	End	
Item	Vegetation		38.887006 °	38.886640 °	
			-121.614735 °	-121.614335 °	
DWR ID	DWR_ST0006_01_s_2016_1				
Comment Code					
V1 : Control annual grass and weeds on the levee slopes and easements.					
Inspector Comment

Vegetation landside looking downstream.

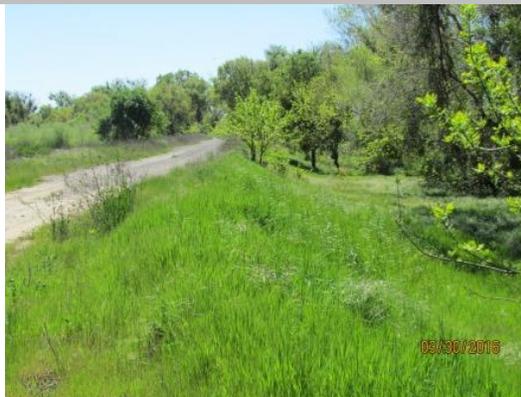
Photo 1 of 1 : SP_2016_ST0006_471_3_20160404_00006.jpg

LM Start	0.01	Rating **	U	Issue No.	3
LM End	0.47	Issue Type +	Ma	Location *	WS
Category	Earthen Levee		GPS Latitude/Longitude		
			Start	End	
Item	Vegetation		38.887006 °	38.880664 °	
			-121.614735 °	-121.614335 °	
DWR ID	DWR_ST0006_01_s_2016_3				
Comment Code					
V1 : Control annual grass and weeds on the levee slopes and easements.					
Inspector Comment

Vegetation waterside looking downstream.

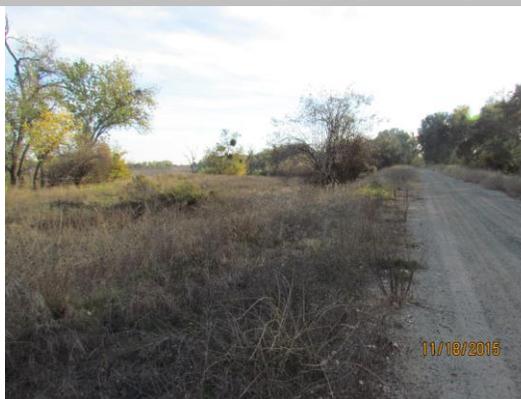
Photo 1 of 1 : SP_2016_ST0006_471_15_20160307_00004.jpg

LM Start	0.02	Rating **	U	Issue No.	15
LM End	0.42	Issue Type +	Ma	Location *	WS
Category	Earthen Levee		GPS Latitude/Longitude		
			Start	End	
Item	Vegetation		38.886883 °	38.881287 °	
			-121.614797 °	-121.614490 °	
DWR ID	DWR_ST0006_01_f_2015_15				
Comment Code					
V2 : Remove the wild growth other than native grasses from the levee slopes.					
Inspector Comment					
Remove the vegetation and trim up the trees 5 feet for visibility.

View of the trees, vegetation and elderberries along the waterside slope.

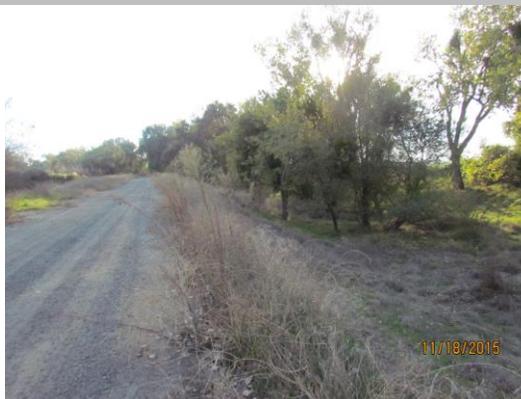
Photo 1 of 1 : SP_2016_ST0006_471_2_20160307_00001.jpg

LM Start	0.02	Rating **	U	Issue No.	2
LM End	0.46	Issue Type +	Ma	Location *	LS
Category	Earthen Levee		GPS Latitude/Longitude		
			Start	End	
Item	Vegetation		38.886883 °	38.880833 °	
			-121.614797 °	-121.614387 °	
DWR ID	DWR_ST0006_01_f_2015_2				
Comment Code					
V2 : Remove the wild growth other than native grasses from the levee slopes.					
Inspector Comment					
Remove the vegetation and trim up the trees 5 feet for visibility.

View of the vegetation, trees and elderberries along the landside slope.

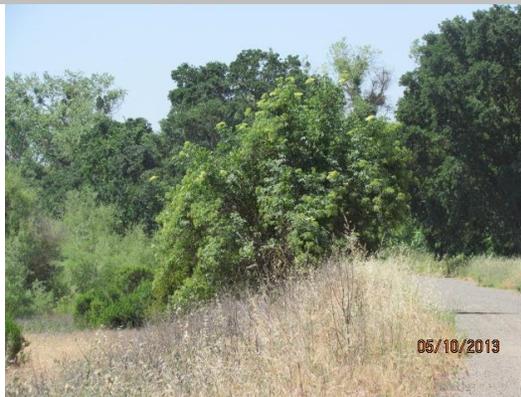
Photo 1 of 1 : SP_2016_ST0006_471_4_20160307_00002.jpg

LM Start	0.06	Rating **	M	Issue No.	4
LM End	0.06	Issue Type +	Ma	Location *	WS
Category	Earthen Levee		GPS Latitude/Longitude		
			Start	End	
Item	Vegetation		38.886277 °	38.886277 °	
			-121.615129 °	-121.615129 °	
DWR ID	DWR_ST0006_01_s_2012_4				
Comment Code					
V4 : Elderberries are blocking visibility and flood fight capability.					
Inspector Comment					
Elderberries are partially blocking visibility.

View of the elderberries that are blocking visibility.

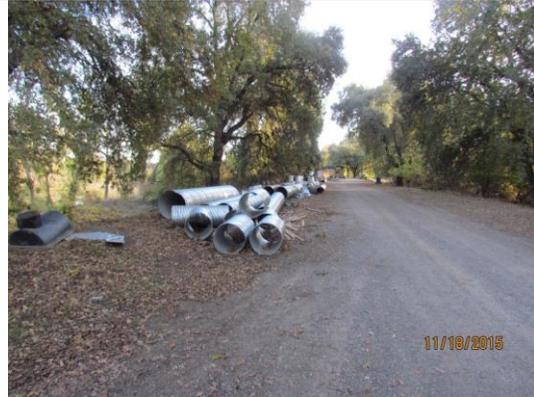
Photo 1 of 1 : SP_2016_ST0006_471_16_20160307_00005.jpg

LM Start	0.40	Rating **	M	Issue No.	16
LM End	0.46	Issue Type +	En	Location *	WS
Category	Earthen Levee		GPS Latitude/Longitude		
			Start	End	
Item	Encroachments		38.881638 °	38.880795 °	
			-121.614647 °	-121.614427 °	
DWR ID	DWR_ST0006_01_f_2015_16				
Comment Code					
PI : Pipe					
Inspector Comment					
The pipe is laying along the waterside berm.

View of the pipe along the waterside berm.

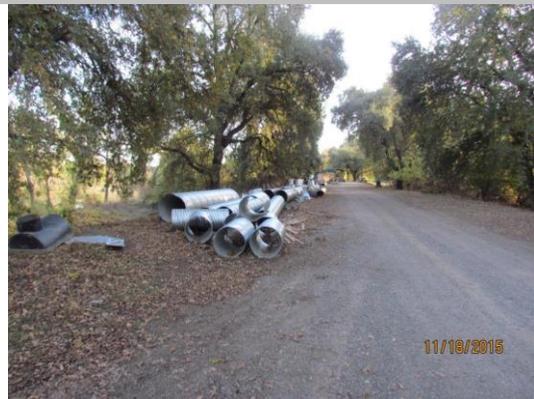
Photo 1 of 1 : SP_2016_ST0006_471_8_20160307_00003.jpg

LM Start	0.47	Rating **	U	Issue No.	8
LM End	0.47	Issue Type +	En	Location *	CR
Category	Earthen Levee		GPS Latitude/Longitude		
			Start	End	
Item	Encroachments		38.880664 °	38.880664 °	
			-121.614335 °	-121.614335 °	
DWR ID	DWR_ST0006_01_s_2012_8				
Comment Code					
BU : Building					
Inspector Comment					
the building is directly behind the pipe that is laying along the waterside berm.

View of the building directly behind the pipe on the waterside berm.
