**Flood Control Project Maintenance
Levee Inspections**

Maintenance Issue Types Only, Levee Inspection Report By Mile - Fall 2014

Sutter Maintenance Yard Nelson Bend

| Waterway | Bank | Unit Miles | Inspection Start/End | Inspector |
|--|---|---|---|---|
| Unit No. 01 Feather River West Levee-Nelson Bend | | 0.50 | 10/14/2014 10/14/2014 | Matthew Hoffman |

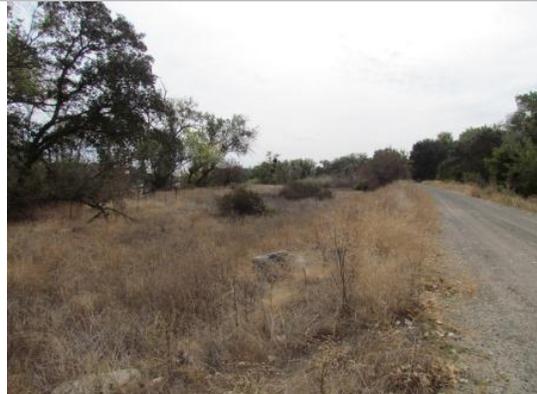
Photo 1 of 1 : FA_2014_ST0006_471_1_20141017_00004.jpg

| LM Start | 0.01 | Rating ** | M | Issue No. | 1 |
| Item | Vegetation | | 38.886937 ° | 38.880822 ° | |

This photo was taken from the crown facing south looking down the waterward levee slope at vegetation needing annual maintenance. Fall 2014.

| Remove the wild growth other than native grasses from the levee slopes. | | | | | |

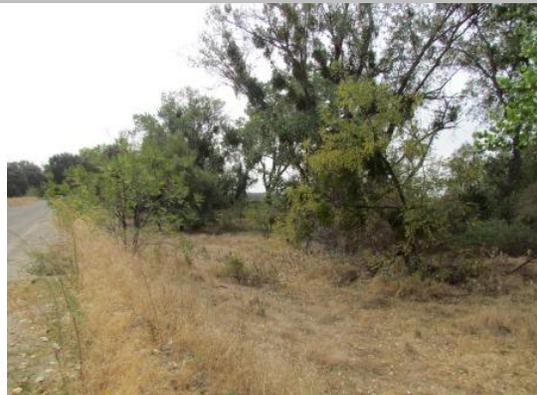
Photo 1 of 1 : FA_2014_ST0006_471_3_20141017_00005.jpg

| LM Start | 0.01 | Rating ** | M | Issue No. | 3 |
| Item | Trim / Thin Trees | | 38.886933 ° | 38.880857 ° | |

This photo was taken from the crown facing south looking down the landward levee slope at trees that need to be trimmed up 5 feet to allow for slope visibility. Fall 2014.

| Thin trees to allow visibility of the ground and room to flood fight. | | | | | |

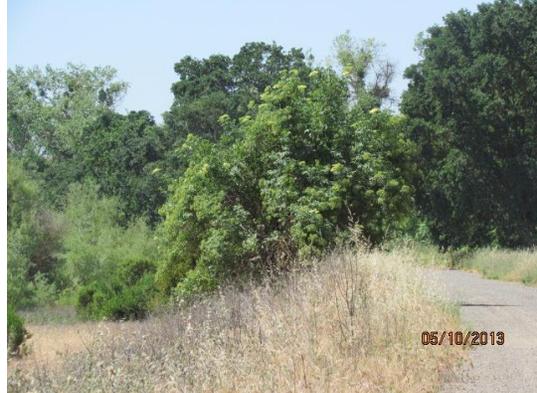
Photo 1 of 1 : FA_2014_ST0006_471_4_20141013_00003.jpg

| LM Start | 0.05 | Rating ** | M | Issue No. | 4 |
| Elderberries are blocking visibility and flood fight capability. | | | | | |

View of the elderberries that are blocking visibility.
