**Flood Control Project Maintenance
Levee Inspections**

Maintenance Issue Types Only, Levee Inspection Report By Mile - Spring 2015

Sutter Maintenance Yard Nelson Bend

Waterway	Bank	Unit Miles	Inspection Start/End	Inspector
Unit No. 01 Feather River West Levee-Nelson Bend		0.50	05/14/2015 05/14/2015	Michael Pitta

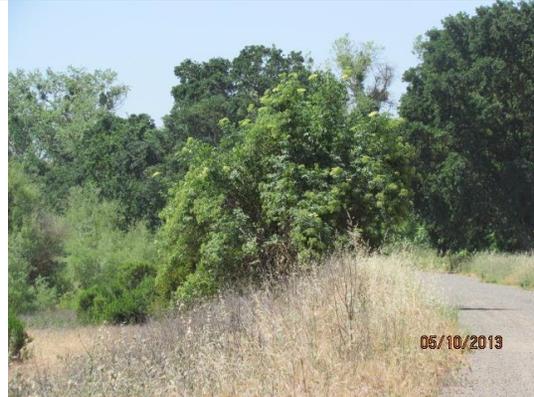
Photo 1 of 1 : SP_2015_ST0006_471_4_20150401_00003.jpg

LM Start	0.06	Rating **	M	Issue No.	4
LM End	0.06	Issue Type +	Ma	Location *	WS
Category	Earthen Levee		GPS Latitude/Longitude		
			Start	End	
Item	Vegetation		38.886277 °	38.886277 °	
			-121.615129 °	-121.615129 °	
DWR ID	DWR_ST0006_01_s_2012_4				
Action/Comments					
Elderberries are blocking visibility and flood fight capability.

View of the elderberries that are blocking visibility.
