**Flood Control Project Maintenance  
Levee Inspections**

**Maintenance Issue Types Only, Levee Inspection Report By Mile - Spring 2016**

**Sutter Maintenance Yard Nelson Bend**

Waterway	Bank	Unit Miles	Inspection Start/End	Inspector
Unit No. 01 Feather River West Levee - Nelson Bend		0.50	03/30/2016 03/30/2016	Sterling York

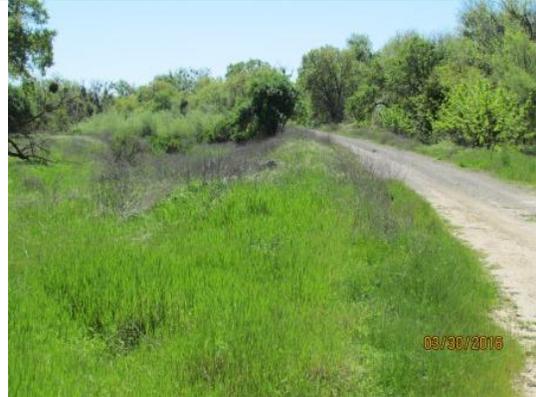
Photo 1 of 1 : SP\_2016\_ST0006\_471\_1\_20160404\_00007.jpg

LM Start	<b>0.01</b>	Rating **	U	Issue No.	<b>1</b>
LM End	<b>0.47</b>	Issue Type +	Ma	Location *	LS
Category	Earthen Levee		GPS Latitude/Longitude		
			Start	End	
Item	Vegetation		38.887006 °	38.886640 °	
			-121.614735 °	-121.614335 °	
DWR ID	DWR_ST0006_01_s_2016_1				
Comment Code					
V1 : Control annual grass and weeds on the levee slopes and easements.					
Inspector Comment

Vegetation landside looking downstream.

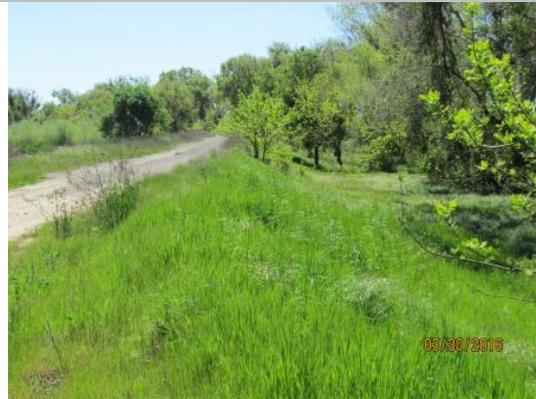
Photo 1 of 1 : SP\_2016\_ST0006\_471\_3\_20160404\_00006.jpg

LM Start	<b>0.01</b>	Rating **	U	Issue No.	<b>3</b>
LM End	<b>0.47</b>	Issue Type +	Ma	Location *	WS
Category	Earthen Levee		GPS Latitude/Longitude		
			Start	End	
Item	Vegetation		38.887006 °	38.880664 °	
			-121.614735 °	-121.614335 °	
DWR ID	DWR_ST0006_01_s_2016_3				
Comment Code					
V1 : Control annual grass and weeds on the levee slopes and easements.					
Inspector Comment

Vegetation waterside looking downstream.

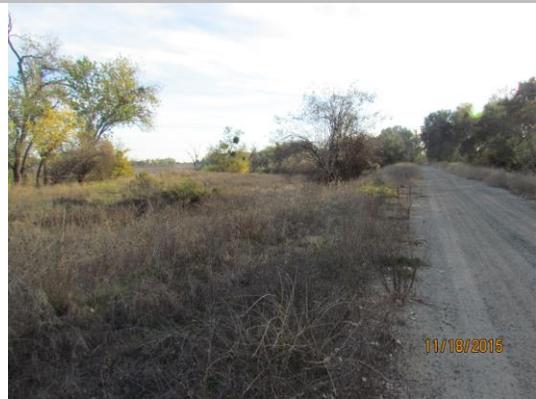
Photo 1 of 1 : SP\_2016\_ST0006\_471\_15\_20160307\_00004.jpg

LM Start	<b>0.02</b>	Rating **	U	Issue No.	<b>15</b>
LM End	<b>0.42</b>	Issue Type +	Ma	Location *	WS
Category	Earthen Levee		GPS Latitude/Longitude		
			Start	End	
Item	Vegetation		38.886883 °	38.881287 °	
			-121.614797 °	-121.614490 °	
DWR ID	DWR_ST0006_01_f_2015_15				
Comment Code					
V2 : Remove the wild growth other than native grasses from the levee slopes.					
Inspector Comment					
Remove the vegetation and trim up the trees 5 feet for visibility.

View of the trees, vegetation and elderberries along the waterside slope.

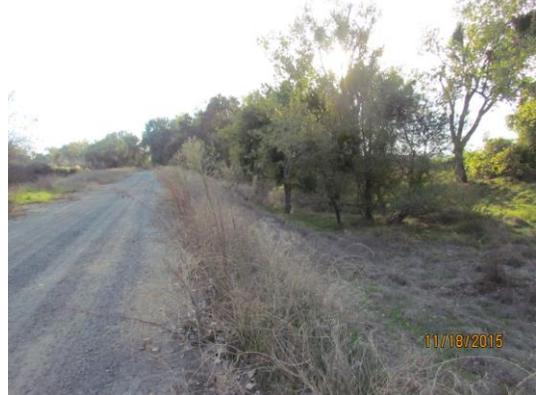
Photo 1 of 1 : SP\_2016\_ST0006\_471\_2\_20160307\_00001.jpg

LM Start	<b>0.02</b>	Rating **	U	Issue No.	<b>2</b>
LM End	<b>0.46</b>	Issue Type +	Ma	Location *	LS
Category	Earthen Levee		GPS Latitude/Longitude		
			Start	End	
Item	Vegetation		38.886883 °	38.880833 °	
			-121.614797 °	-121.614387 °	
DWR ID	DWR_ST0006_01_f_2015_2				
Comment Code					
V2 : Remove the wild growth other than native grasses from the levee slopes.					
Inspector Comment					
Remove the vegetation and trim up the trees 5 feet for visibility.

View of the vegetation, trees and elderberries along the landside slope.

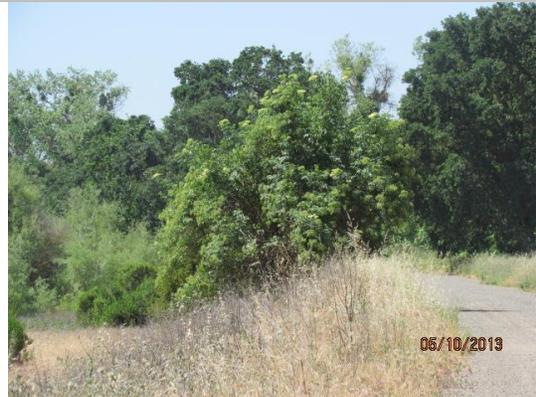
Photo 1 of 1 : SP\_2016\_ST0006\_471\_4\_20160307\_00002.jpg

LM Start	<b>0.06</b>	Rating **	M	Issue No.	<b>4</b>
LM End	<b>0.06</b>	Issue Type +	Ma	Location *	WS
Category	Earthen Levee		GPS Latitude/Longitude		
			Start	End	
Item	Vegetation		38.886277 °	38.886277 °	
			-121.615129 °	-121.615129 °	
DWR ID	DWR_ST0006_01_s_2012_4				
Comment Code					
V4 : Elderberries are blocking visibility and flood fight capability.					
Inspector Comment					
Elderberries are partially blocking visibility.

View of the elderberries that are blocking visibility.
