**Flood Control Project Maintenance  
Levee Inspections**

**Fall 2013 Levee Maintenance Deficiency Summary Report**

**Sacramento Maintenance Yard Putah Creek**

**Levee Inspection Report By Mile - Fall 2013**

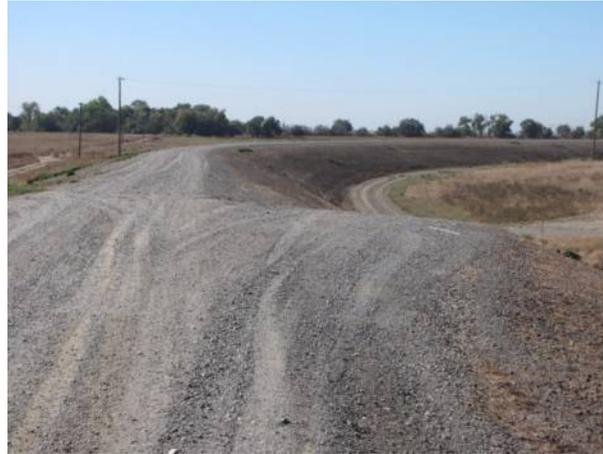
Levee Mile Report Line	4
Start Levee Mile	0.01
End Levee Mile	8.90
Location	Land Side
Category	Earthen Levee
Item	Vegetation

Putah Creek Unit 1 looking downstream from levee mile 0.00 landward slope. Slopes have been well maintained. Photo taken 9-19-2013.

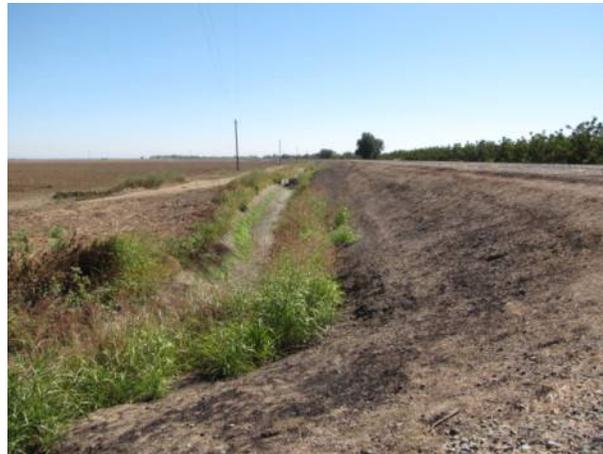
Levee Mile Report Line	8
Start Levee Mile	1.51
End Levee Mile	2.73
Location	Land Side
Category	Earthen Levee
Item	Encroachments

Standing at levee mile 2.70.looking back upstream at ditch within 10-foot of landward toe. Photo taken 9-19-2013.

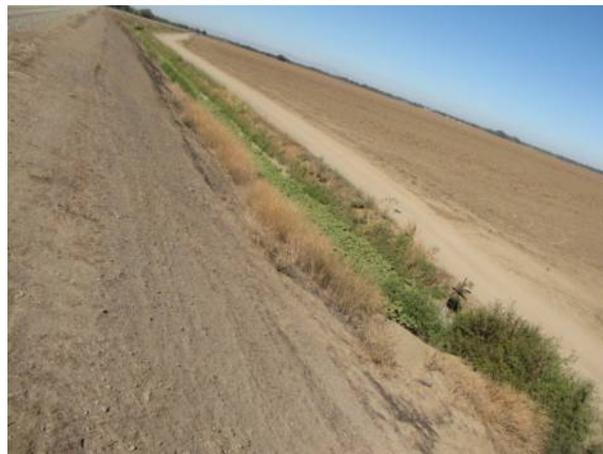
Levee Mile Report Line	9
Start Levee Mile	2.11
End Levee Mile	2.17
Location	Water Side
Category	Earthen Levee
Item	Encroachments

Putah Creek Unit 1 Looking downstream from levee mile 1.51 at drain ditch within 10-foot of landward toe. Photo taken 9-19-2013.

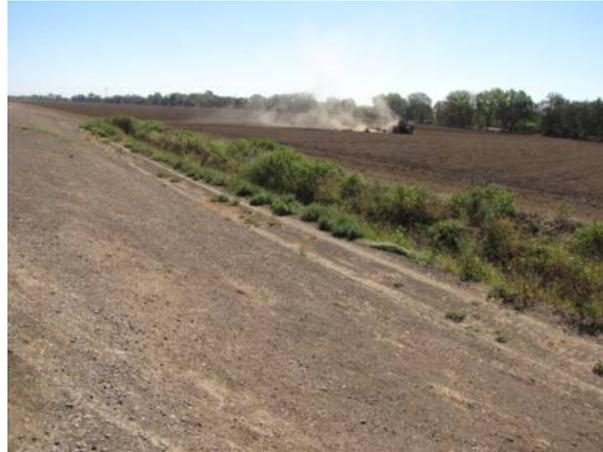
Levee Mile Report Line	10
Start Levee Mile	2.18
End Levee Mile	2.22
Location	Water Side
Category	Earthen Levee
Item	Encroachments
Putah Creek Unit 1 looking back at ditch on waterward within 10-foot of levee toe. Photo taken 9-19-2013.	
phillips_f_20130919_451.JPG

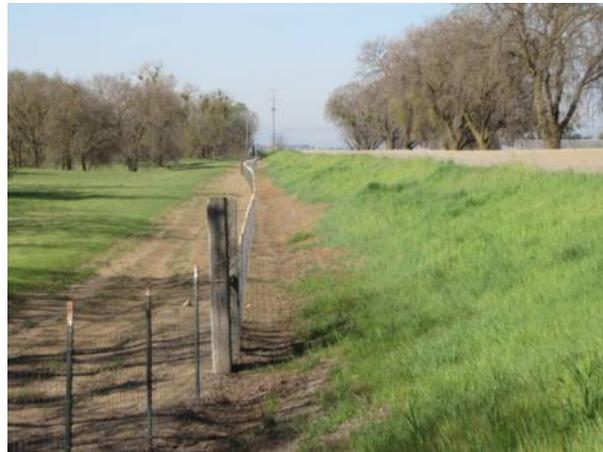
Levee Mile Report Line	11
Start Levee Mile	3.31
End Levee Mile	3.69
Location	Water Side
Category	Earthen Levee
Item	Encroachments
This fence has no permit and is within 10-foot of levee toe waterside. Photo taken 3-12-2013. No new photo was taken 9-19-2013.	
phillips_f_20130912_309.JPG

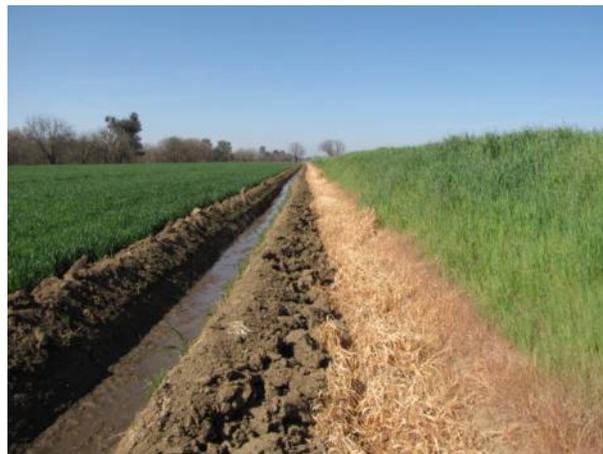
Levee Mile Report Line	15
Start Levee Mile	5.55
End Levee Mile	6.57
Location	Water Side
Category	Earthen Levee
Item	Encroachments
Agricultural ditch within 10-foot of waterward toe. Photo taken 3-12-2013.	
phillips_f_20130912_311.JPG

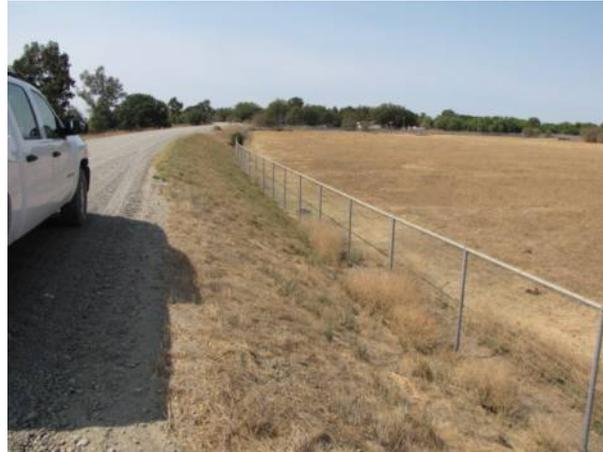
Levee Mile Report Line	16
Start Levee Mile	6.76
End Levee Mile	6.84
Location	Land Side
Category	Earthen Levee
Item	Encroachments

Fence at levee mile 6.70-6.84 landside within 10-foot of toe. This is not a new encroachment. Photo taken 9-25-2012. No picture taken 9-19-2013. Fence still in place.

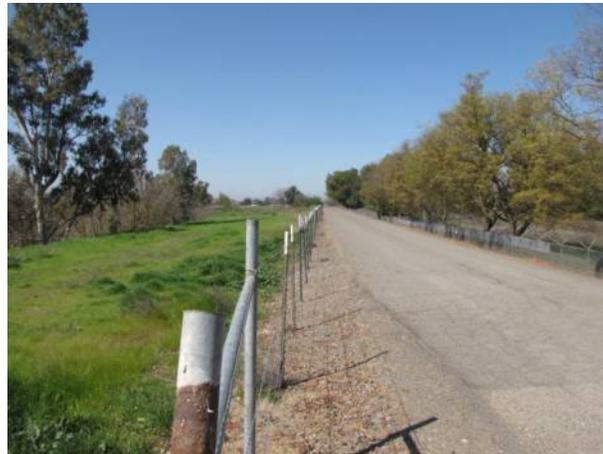
Levee Mile Report Line	20
Start Levee Mile	7.03
End Levee Mile	7.23
Location	Water Side
Category	Earthen Levee
Item	Encroachments

Fence at levee miles 7.03-7.23. Photo taken 3-12-2013.

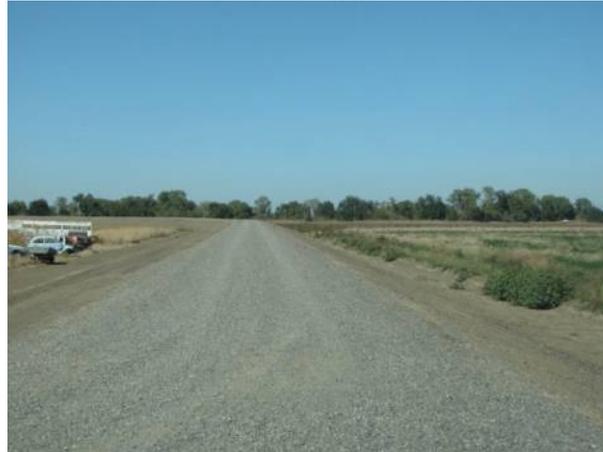
Levee Mile Report Line	1
Start Levee Mile	0.00
End Levee Mile	0.55
Location	Land Side
Category	Earthen Levee
Item	Vegetation
Putah Creek Unit 2 levee mile 0.00 looking downstream, both slopes are in view. Photo taken 9-19-2013.	
phillips_f_20130923_455.JPG

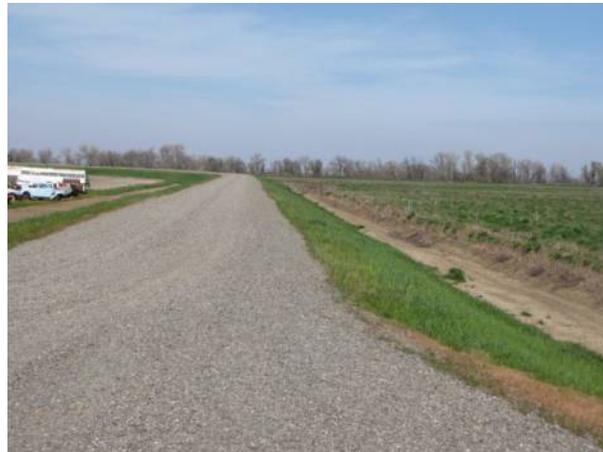
Levee Mile Report Line	3
Start Levee Mile	0.18
End Levee Mile	0.29
Location	Water Side
Category	Earthen Levee
Item	Encroachments
Looking downstream from levee mile 0.00 waterside. Photo taken 3-12-2013. No new photo taken of this Ag. Ditch 9-19-2013.	
phillips_f_20130912_922.JPG

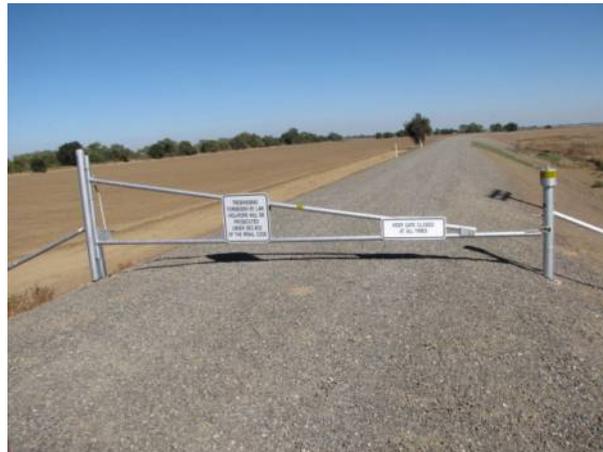
Levee Mile Report Line	4
Start Levee Mile	0.55
End Levee Mile	0.55
Location	Crown
Category	Earthen Levee
Item	Encroachments
Unit 2 Levee mile 0.55 Cross fence placed across crown roadway and both slopes. Photo taken 9-19-2013.	
phillips_f_20130919_453.JPG

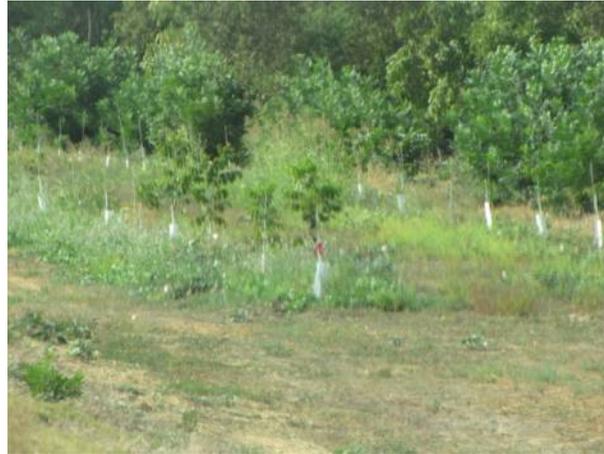
Levee Mile Report Line	11
Start Levee Mile	6.54
End Levee Mile	6.67
Location	Water Side
Category	Earthen Levee
Item	Encroachments

Putah Creek levee mile 6.54-6.76 unauthorized planting of walnut trees waterward berm. Photo taken 9-25-2012. These trees are still at location, no new photo was taken. These trees are still here, no new picture was taken 9-19-2013.

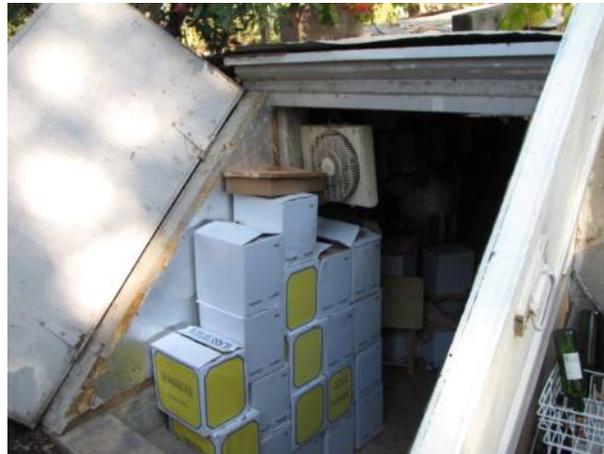
Levee Mile Report Line	17
Start Levee Mile	6.79
End Levee Mile	6.79
Location	Land Side
Category	Earthen Levee
Item	Encroachments

Unauthorized wine cellar.
