**Flood Control Project Maintenance  
Levee Inspections  
LMA District Cover Sheet  
Spring 2015 Levee Inspection Results**

**Sacramento Maintenance Yard Putah Creek**

**Spring 2015 Levee Inspection Results**

Waterway		Bank	Unit Miles	
Unit No. 01 Putah Creek or North Levee		Left	8.79	
	Spring (March - May)	Summer (June - August)	(September - November) Fall	Winter (December - February)
Unit Maintenance Rating (Fall Only)				
Date of Inspection	04/24/2015 - 04/24/2015			
DWR Inspector	Herman Phillips			
Accompanied By

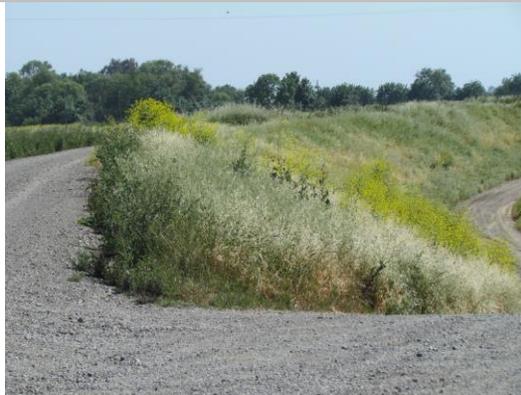
Photo 1 of 1 : SP\_2015\_ST0007\_282\_24\_20150427\_00006.jpg

LM Start	<b>0.01</b>	Rating **	U	Issue No.	<b>24</b>
LM End	<b>0.97</b>	Issue Type +	Ma	Location *	LS
Category	Earthen Levee		GPS Latitude/Longitude		
			Start	End	
Item	Vegetation		38.523523 °	38.518232 °	
			-121.631402 °	-121.645863 °	
DWR ID	DWR_ST0007_01_s_2015_24				
Action/Comments					
Remove the wild growth other than native grasses from the levee slopes. Inspector Comments: Weeds on the landside shoulder and slope range from 3.0 to 6.0 feet tall.

Unacceptable tall weeds on landside levee section.

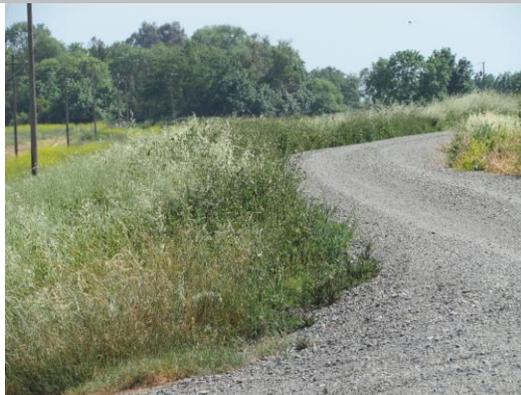
Photo 1 of 1 : SP\_2015\_ST0007\_282\_22\_20150427\_00007.jpg

LM Start	<b>0.01</b>	Rating **	U	Issue No.	<b>22</b>
LM End	<b>1.29</b>	Issue Type +	Ma	Location *	WS
Category	Earthen Levee		GPS Latitude/Longitude		
			Start	End	
Item	Vegetation		38.523523 °	38.516242 °	
			-121.631402 °	-121.651170 °	
DWR ID	DWR_ST0007_01_s_2015_22				
Action/Comments					
Remove the wild growth other than native grasses from the levee slopes. Inspector Comments: Wild milk weed and other wild weed growth range from 3.0 to 4.5 feet tall on waterside shoulder and slope.

Unsatisfactory tall weeds and grasses on the waterside levee shoulder and slope.

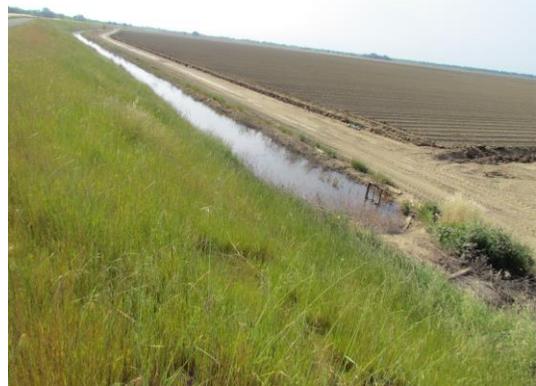
Photo 1 of 1 : SP\_2015\_ST0007\_282\_34\_20150427\_00008.jpg

LM Start	<b>1.51</b>	Rating **	U	Issue No.	<b>34</b>
LM End	<b>2.67</b>	Issue Type +	En	Location *	LS
Category	Earthen Levee		GPS Latitude/Longitude		
			Start	End	
Item	Encroachments		38.515305 °	38.517412 °	
			-121.655045 °	-121.676118 °	
DWR ID	DWR_ST0007_01_s_2015_34				
Action/Comments					
Ditch

Agriculture ditch within the 10-foot easement, landside levee toe.

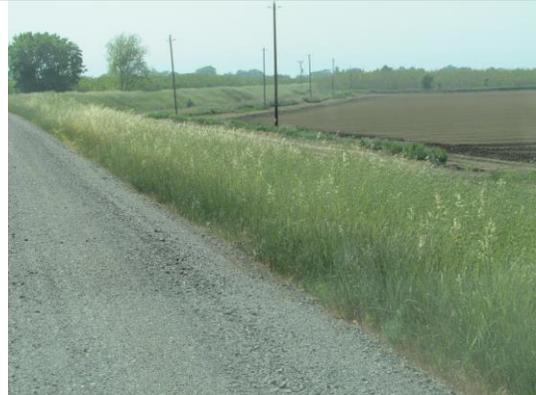
Photo 1 of 1 : SP\_2015\_ST0007\_282\_36\_20150427\_00012.jpg

LM Start	<b>2.17</b>	Rating **	U	Issue No.	<b>36</b>
LM End	<b>2.25</b>	Issue Type +	Ma	Location *	LS
Category	Earthen Levee		GPS Latitude/Longitude		
			Start	End	
Item	Vegetation		38.515845 °	38.515967 °	
			-121.667135 °	-121.668553 °	
DWR ID	DWR_ST0007_01_s_2015_36				
Action/Comments					
Control annual grass and weeds on the levee slopes and easements. Inspector Comments: Tall annual weeds exceed 24 inches high.

Tall weeds on levee slope exceed 24-inches tall.

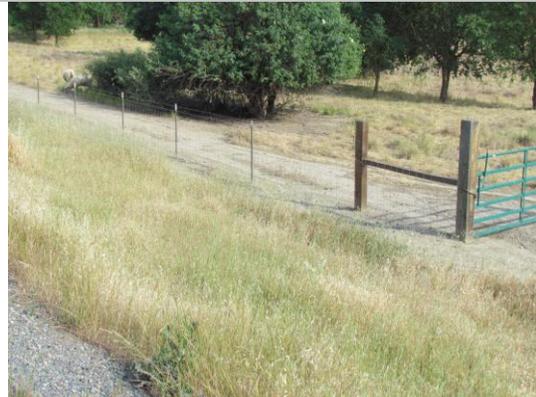
Photo 1 of 1 : SP\_2015\_ST0007\_282\_4\_20150427\_00013.jpg

LM Start	<b>3.25</b>	Rating **	M	Issue No.	<b>4</b>
LM End	<b>3.43</b>	Issue Type +	En	Location *	WS
Category	Earthen Levee			GPS Latitude/Longitude	
				Start	End
Item	Encroachments			38.519831 °	38.520011 °
				-121.686263 °	-121.689552 °
DWR ID	DWR_ST0007_01_s_2013_4				
Action/Comments					
Fence Inspector Comments: No permit for this wire fence waterside levee slope.

This fence located on the waterside within the 10 foot easement has no permit on file.

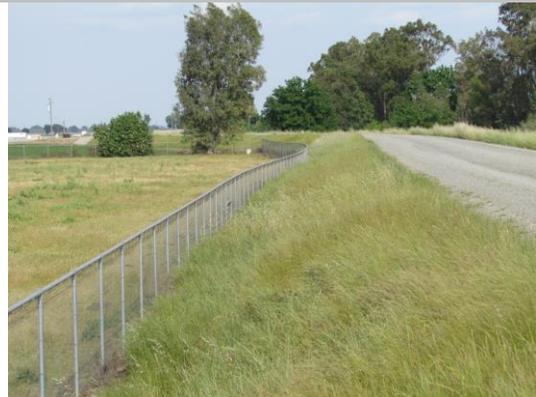
Photo 1 of 1 : SP\_2015\_ST0007\_282\_5\_20150427\_00010.jpg

LM Start	<b>6.63</b>	Rating **	M	Issue No.	<b>5</b>
LM End	<b>6.71</b>	Issue Type +	En	Location *	LS
Category	Earthen Levee			GPS Latitude/Longitude	
				Start	End
Item	Encroachments			38.517746 °	38.517647 °
				-121.747220 °	-121.748679 °
DWR ID	DWR_ST0007_01_s_2012_5				
Action/Comments					
Fence Inspector Comments: This fence has been in the area for many years. It is located on the landside within 10-foot of the toe.

The fence has been at this location for many years and does not have a permit on file.

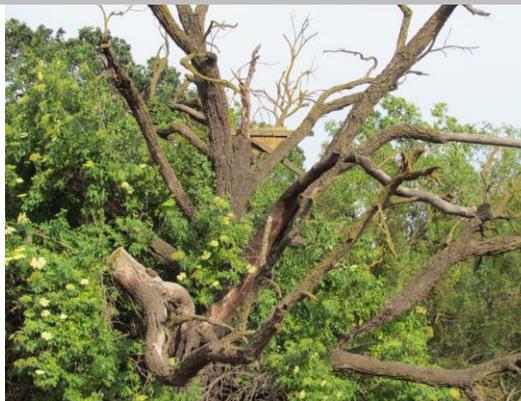
Photo 1 of 1 : SP\_2015\_ST0007\_282\_42\_20150427\_00011.jpg

LM Start	<b>6.91</b>	Rating **	U	Issue No.	<b>42</b>
LM End	<b>6.91</b>	Issue Type +	Ma	Location *	WS
Category	Earthen Levee		GPS Latitude/Longitude		
			Start	End	
Item	Vegetation		38.517518 °	38.517518 °	
			-121.752432 °	-121.752432 °	
DWR ID	DWR_ST0007_01_s_2014_42				
Action/Comments					
Trees / Woody Vegetation					
Inspector Comments: This tree needs to be removed before it falls and causes problems to the levee section or injures pedestrians.

This dead tree on the waterside levee shoulder limbs has been falling on to levee section.

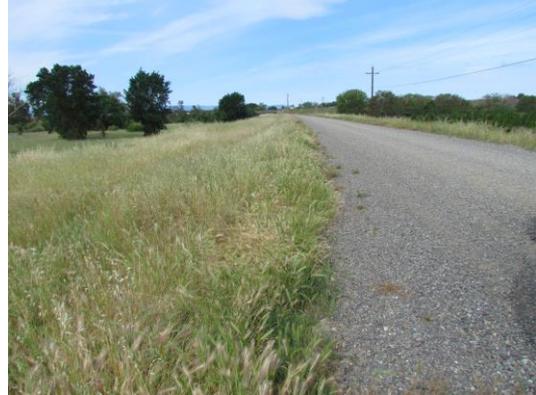
Photo 1 of 1 : SP\_2015\_ST0007\_282\_45\_20150427\_00014.jpg

LM Start	<b>7.65</b>	Rating **	U	Issue No.	<b>45</b>
LM End	<b>7.87</b>	Issue Type +	Ma	Location *	WS
Category	Earthen Levee		GPS Latitude/Longitude		
			Start	End	
Item	Vegetation		38.518922 °	38.518515 °	
			-121.765863 °	-121.769858 °	
DWR ID	DWR_ST0007_01_s_2015_45				
Action/Comments					
Control annual grass and weeds on the levee slopes and easements. Inspector Comments: Weeds taller than 24 inches.

Tall weeds on the waterside levee section.

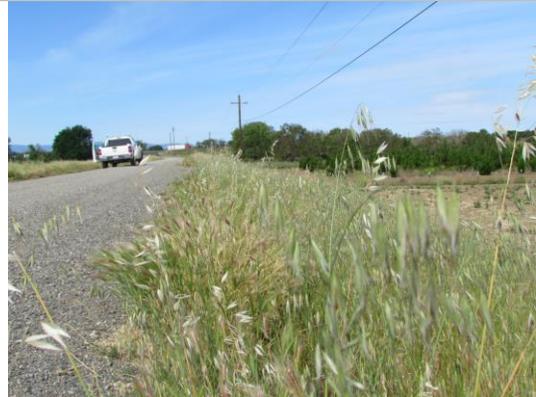
Photo 1 of 1 : SP\_2015\_ST0007\_282\_46\_20150427\_00019.jpg

LM Start	<b>7.66</b>	Rating **	U	Issue No.	<b>46</b>
LM End	<b>7.89</b>	Issue Type +	Ma	Location *	LS
Category	Earthen Levee		GPS Latitude/Longitude		
			Start	End	
Item	Vegetation		38.518913 °	38.518422 °	
			-121.766142 °	-121.770220 °	
DWR ID	DWR_ST0007_01_s_2015_46				
Action/Comments					
Control annual grass and weeds on the levee slopes and easements. Inspector Comments: Tall annual weeds on the levee slope.

Tall annual weeds on the landside levee shoulder and slope.

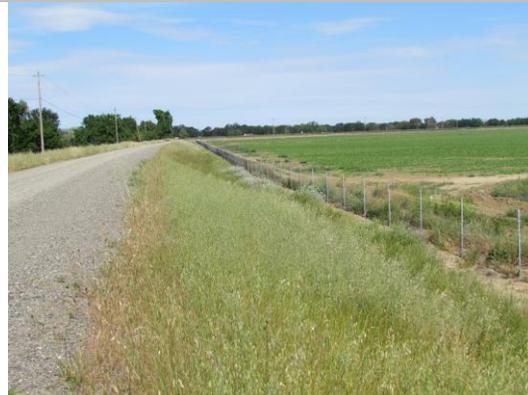
Photo 1 of 1 : SP\_2015\_ST0007\_282\_48\_20150427\_00017.jpg

LM Start	<b>8.05</b>	Rating **	U	Issue No.	<b>48</b>
LM End	<b>8.31</b>	Issue Type +	Ma	Location *	LS
Category	Earthen Levee		GPS Latitude/Longitude		
			Start	End	
Item	Vegetation		38.519475 °	38.521542 °	
			-121.773048 °	-121.777035 °	
DWR ID	DWR_ST0007_01_s_2015_48				
Action/Comments					
Control annual grass and weeds on the levee slopes and easements. Inspector Comments: Weeds exceed 24 inches in height.

Tall weeds on the landside levee slope.

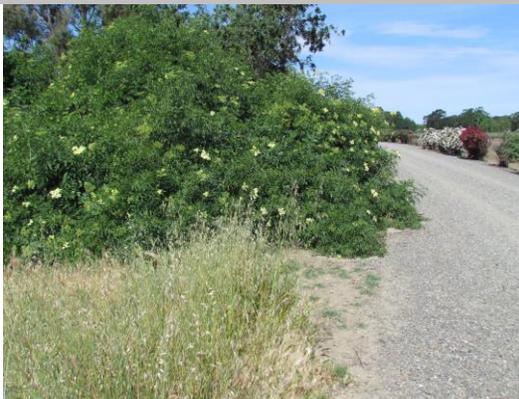
Photo 1 of 1 : SP\_2015\_ST0007\_282\_9\_20150427\_00020.jpg

LM Start	<b>8.52</b>	Rating **	M	Issue No.	<b>9</b>
LM End	<b>8.52</b>	Issue Type +	Ma	Location *	WS
Category	Earthen Levee		GPS Latitude/Longitude		
			Start	End	
Item	Vegetation		38.523159 °	38.523159 °	
			-121.780208 °	-121.780208 °	
DWR ID	DWR_ST0007_01_s_2015_9				
Action/Comments					
Elderberries are blocking visibility and flood fight capability.

This elderberry tree blocks the view of the levee section underneath the tree.

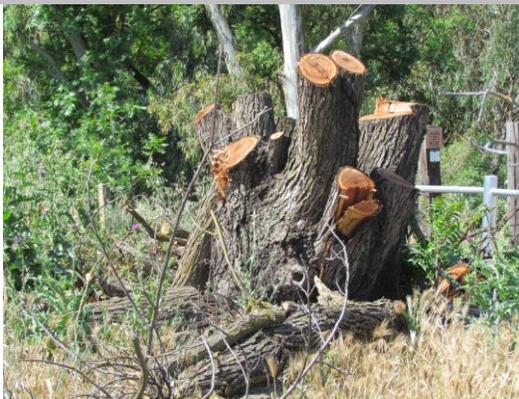
Photo 1 of 1 : SP\_2015\_ST0007\_282\_50\_20150427\_00018.jpg

LM Start	<b>8.63</b>	Rating **	M	Issue No.	<b>50</b>
LM End	<b>8.63</b>	Issue Type +	En	Location *	WS
Category	Earthen Levee		GPS Latitude/Longitude		
			Start	End	
Item	Encroachments		38.523913 °	38.523913 °	
			-121.782035 °	-121.782035 °	
DWR ID	DWR_ST0007_01_s_2015_50				
Action/Comments					
Tree or limb Inspector Comments: A cut up walnut tree is on the waterside levee section.

Cut up walnut on the waterside levee shoulder.

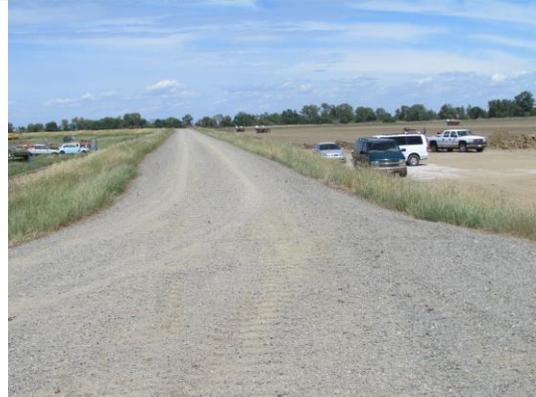
Photo 1 of 1 : SP\_2015\_ST0007\_283\_35\_20150427\_00006.jpg

LM Start	<b>0.00</b>	Rating **	M	Issue No.	<b>35</b>
LM End	<b>0.00</b>	Issue Type +	Ma	Location *	LS
Category	Earthen Levee		GPS Latitude/Longitude		
			Start	End	
Item	Vegetation		38.504635 °	38.504635 °	
			-121.663180 °	-121.663179 °	
DWR ID	DWR_ST0007_02_f_2014_35				
Action/Comments					
Control annual grass and weeds on the levee slopes and easements.

Looking downstream at both slopes with tall weeds present.

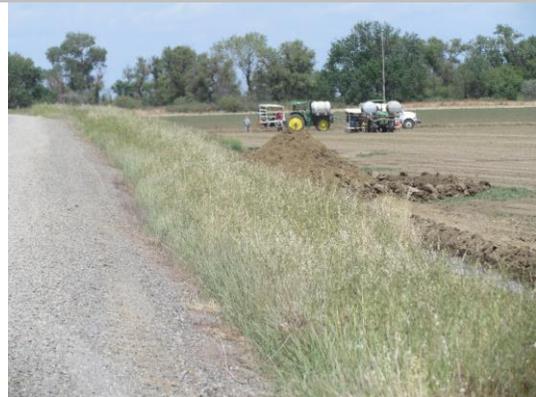
Photo 1 of 1 : SP\_2015\_ST0007\_283\_28\_20150427\_00009.jpg

LM Start	<b>0.04</b>	Rating **	U	Issue No.	<b>28</b>
LM End	<b>0.90</b>	Issue Type +	Ma	Location *	WS
Category	Earthen Levee		GPS Latitude/Longitude		
			Start	End	
Item	Vegetation		38.505262 °	38.510900 °	
			-121.663103 °	-121.673887 °	
DWR ID	DWR_ST0007_02_s_2015_28				
Action/Comments					
Control annual grass and weeds on the levee slopes and easements. Inspector Comments: Weeds taller than 24 inches on shoulder and slope.

Tall weeds on the waterside levee slope.

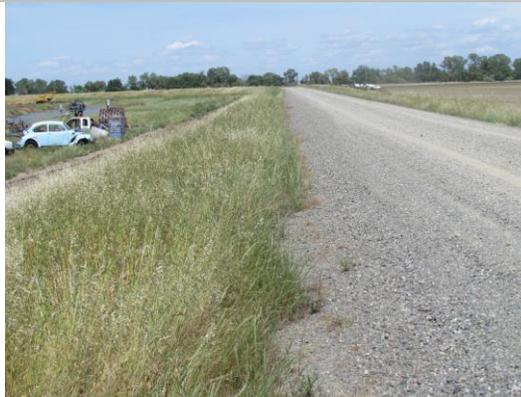
Photo 1 of 1 : SP\_2015\_ST0007\_283\_17\_20150427\_00007.jpg

LM Start	<b>0.04</b>	Rating **	U	Issue No.	<b>17</b>
LM End	<b>1.34</b>	Issue Type +	Ma	Location *	LS
Category	Earthen Levee		GPS Latitude/Longitude		
			Start	End	
Item	Vegetation		38.505262 °	38.513002 °	
			-121.663103 °	-121.681510 °	
DWR ID	DWR_ST0007_02_s_2015_17				
Action/Comments					
Control annual grass and weeds on the levee slopes and easements. Inspector Comments: Weeds taller than 36 inches on slope and shoulder.

Tall weeds on the landside levee slope.

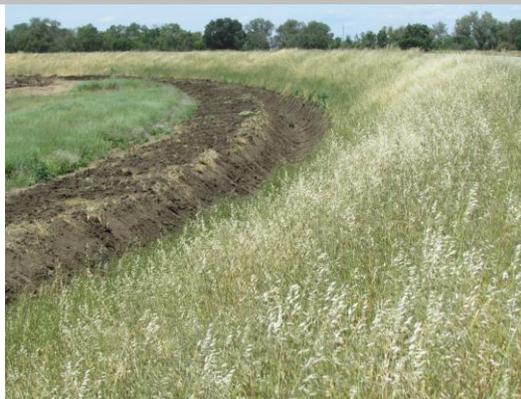
Photo 1 of 1 : SP\_2015\_ST0007\_283\_33\_20150427\_00008.jpg

LM Start	<b>0.18</b>	Rating **	U	Issue No.	<b>33</b>
LM End	<b>0.31</b>	Issue Type +	En	Location *	LS
Category	Earthen Levee		GPS Latitude/Longitude		
			Start	End	
Item	Encroachments		38.507332 °	38.509077 °	
			-121.662837 °	-121.663515 °	
DWR ID	DWR_ST0007_02_s_2015_33				
Action/Comments					
Ditch Inspector Comments: Ditch approximate 4.0 foot deep with the 10-foot easement.

Agriculture ditch 4.0 foot deep with the landside toe.

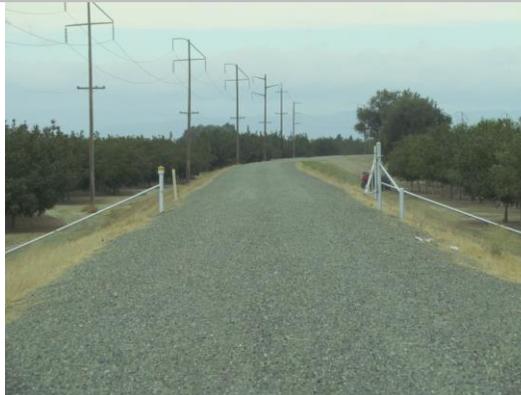
Photo 1 of 1 : SP\_2015\_ST0007\_283\_29\_20150312\_00003.jpg

LM Start	<b>0.55</b>	Rating **	U	Issue No.	<b>29</b>
LM End	<b>0.55</b>	Issue Type +	En	Location *	LS
Category	Earthen Levee		GPS Latitude/Longitude		
			Start	End	
Item	Encroachments		38.510249 °	38.510249 °	
			-121.667551 °	-121.667551 °	
DWR ID	DWR_ST0007_02_s_2013_29				
Action/Comments					
Fence Inspector Comments: This fence does not have a CVFPB Permit.

There is no permit for this fence and gate crossing levee crown roadway.

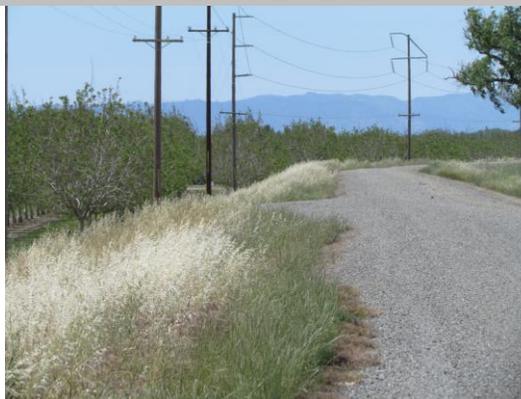
Photo 1 of 1 : SP\_2015\_ST0007\_283\_42\_20150427\_00010.jpg

LM Start	<b>2.19</b>	Rating **	U	Issue No.	<b>42</b>
LM End	<b>2.75</b>	Issue Type +	Ma	Location *	LS
Category	Earthen Levee		GPS Latitude/Longitude		
			Start	End	
Item	Vegetation		38.515418 °	38.514947 °	
			-121.695498 °	-121.705698 °	
DWR ID	DWR_ST0007_02_s_2015_42				
Action/Comments					
Control annual grass and weeds on the levee slopes and easements. Inspector Comments: Control the tall weeds on the levee slope.

Tall annual weeds on the landside levee slope.

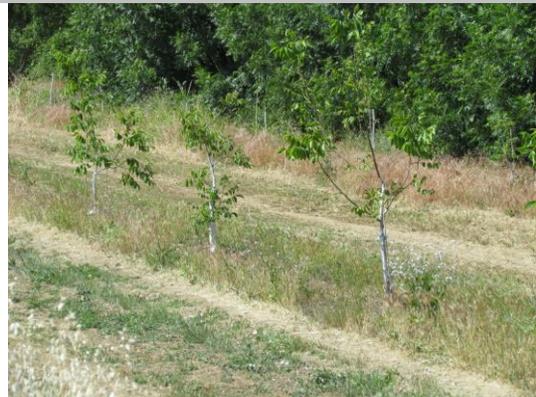
Photo 1 of 2 : SP\_2015\_ST0007\_283\_10\_20150427\_00012.jpg

A view of the walnut trees planted along the waterward levee berm without a permit.

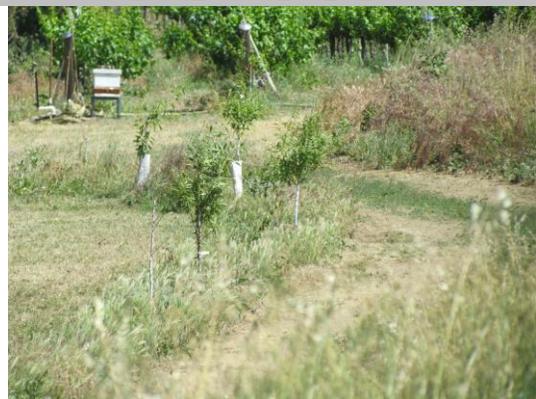
Photo 2 of 2 : SP\_2015\_ST0007\_283\_10\_20150427\_00013.jpg

LM Start	<b>6.38</b>	Rating **	U	Issue No.	<b>10 (cont)</b>
LM End	<b>6.51</b>	Issue Type +	En	Location *	WS

Another view of the walnut trees planted in waterside berm no permit..

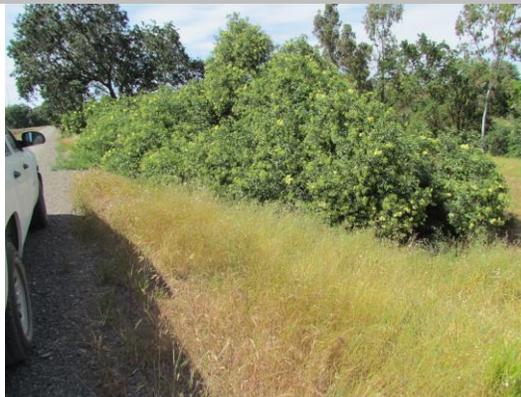
Photo 1 of 1 : SP\_2015\_ST0007\_283\_55\_20150427\_00014.jpg

View of the elderberry trees blocking the view of the levee section.
