**Flood Control Project Maintenance
Levee Inspections**

Maintenance Issue Types Only, Levee Inspection Report By Mile - Fall 2015

Sacramento Maintenance Yard Putah Creek

Waterway	Bank	Unit Miles	Inspection Start/End	Inspector
Unit No. 01 Putah Creek or North Levee	Left	8.79	09/30/2015 09/30/2015	Herman Phillips

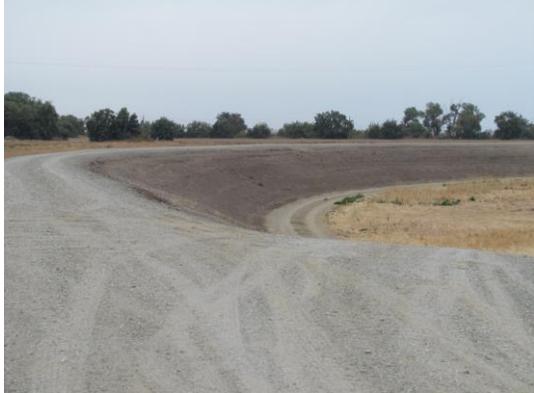
Photo 1 of 1 : FA_2015_ST0007_282_22_20151006_00006.jpg

LM Start	0.00	Rating **	A	Issue No.	22
LM End	8.52	Issue Type +	Ma	Location *	LS
Category	Earthen Levee		GPS Latitude/Longitude		
			Start	End	
Item	Vegetation		38.523630 °	38.523227 °	
			-121.631460 °	-121.780180 °	
DWR ID	DWR_ST0007_01_f_2015_22				
Action/Comments					
Control annual grass and weeds on the levee slopes and easements. Inspector Comments: Maintaining Agency has burned and dragged the landside slope.

Putah Creek looking downstream from levee mile 0.00 landside levee slope.

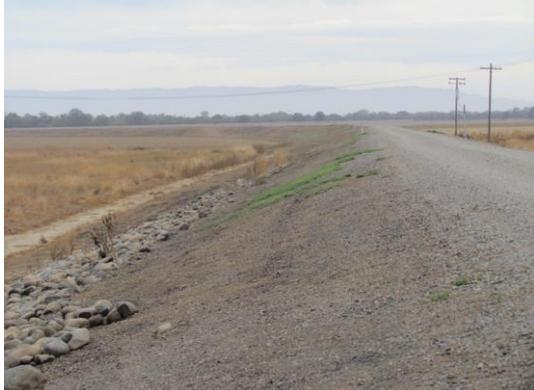
Photo 1 of 1 : FA_2015_ST0007_282_24_20151006_00005.jpg

LM Start	0.00	Rating **	A	Issue No.	24
LM End	8.52	Issue Type +	Ma	Location *	WS
Category	Earthen Levee		GPS Latitude/Longitude		
			Start	End	
Item	Vegetation		38.523630 °	38.523227 °	
			-121.631460 °	-121.780180 °	
DWR ID	DWR_ST0007_01_f_2015_24				
Action/Comments					
Control annual grass and weeds on the levee slopes and easements. Inspector Comments: The maintaining agency has both burned and dragged the waterside levee slope.

Putah Creek looking downstream from levee mile 0.00 waterside levee slope.

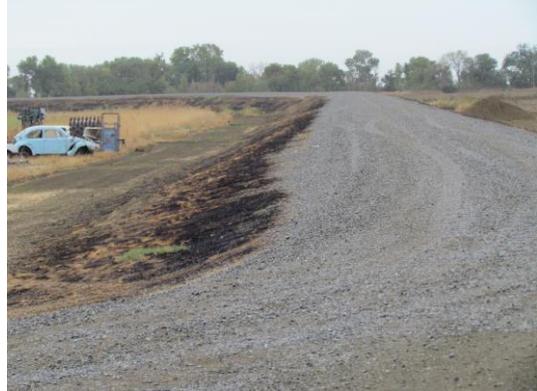
Photo 1 of 1 : FA_2015_ST0007_283_17_20151006_00005.jpg

LM Start	0.02	Rating **	A	Issue No.	17
LM End	0.55	Issue Type +	Ma	Location *	LS
Category	Earthen Levee			GPS Latitude/Longitude	
				Start	End
Item	Vegetation			38.505045 °	38.510265 °
				-121.663118 °	-121.667545 °
DWR ID	DWR_ST0007_02_f_2015_17				
Action/Comments					
Control annual grass and weeds on the levee slopes and easements. Inspector Comments: Burned and dragged.

Putah Creek looking downstream from levee mile 0.00 landside levee slope.
