**Flood Control Project Maintenance
Levee Inspections**

Maintenance Issue Types Only, Levee Inspection Report By Mile - Spring 2015

Sacramento Maintenance Yard Putah Creek

Waterway	Bank	Unit Miles	Inspection Start/End	Inspector
Unit No. 01 Putah Creek or North Levee	Left	8.79	04/24/2015 04/24/2015	Herman Phillips

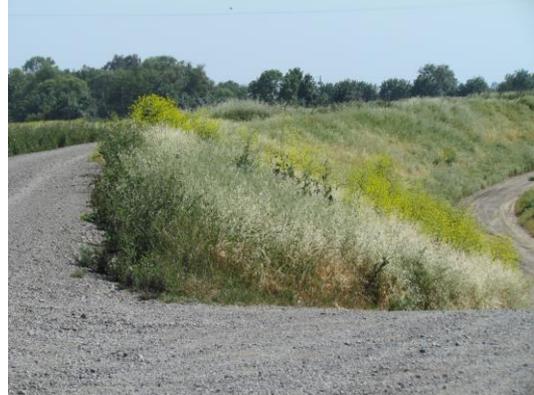
Photo 1 of 1 : SP_2015_ST0007_282_24_20150427_00006.jpg

LM Start	0.01	Rating **	U	Issue No.	24
LM End	0.97	Issue Type +	Ma	Location *	LS
Category	Earthen Levee		GPS Latitude/Longitude		
			Start	End	
Item	Vegetation		38.523523 °	38.518232 °	
			-121.631402 °	-121.645863 °	
DWR ID	DWR_ST0007_01_s_2015_24				
Action/Comments					
Remove the wild growth other than native grasses from the levee slopes. Inspector Comments: Weeds on the landside shoulder and slope range from 3.0 to 6.0 feet tall.

Unacceptable tall weeds on landside levee section.

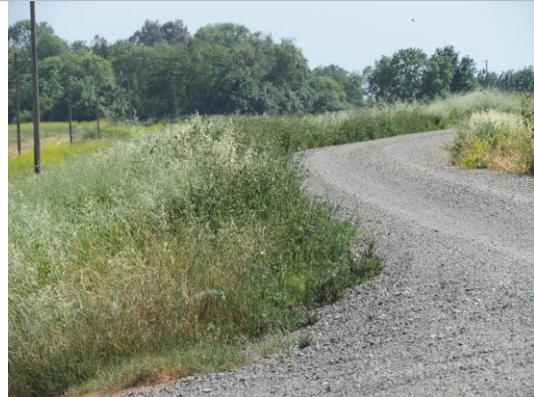
Photo 1 of 1 : SP_2015_ST0007_282_22_20150427_00007.jpg

LM Start	0.01	Rating **	U	Issue No.	22
LM End	1.29	Issue Type +	Ma	Location *	WS
Category	Earthen Levee		GPS Latitude/Longitude		
			Start	End	
Item	Vegetation		38.523523 °	38.516242 °	
			-121.631402 °	-121.651170 °	
DWR ID	DWR_ST0007_01_s_2015_22				
Action/Comments					
Remove the wild growth other than native grasses from the levee slopes. Inspector Comments: Wild milk weed and other wild weed growth range from 3.0 to 4.5 feet tall on waterside shoulder and slope.

Unsatisfactory tall weeds and grasses on the waterside levee shoulder and slope.

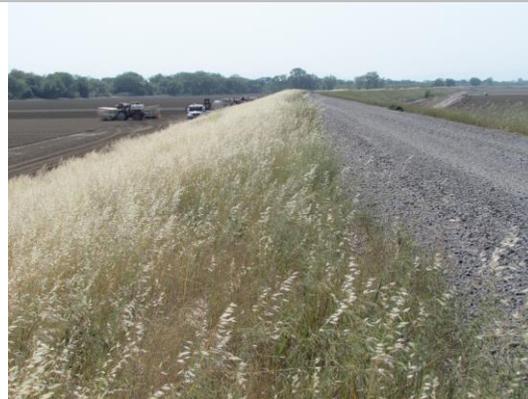
Photo 1 of 1 : SP_2015_ST0007_282_33_20150427_00009.jpg

LM Start	1.48	Rating **	U	Issue No.	33
LM End	2.20	Issue Type +	Ma	Location *	WS
Category	Earthen Levee		GPS Latitude/Longitude		
			Start	End	
Item	Vegetation		38.515310 °	38.515852 °	
			-121.654427 °	-121.667588 °	
DWR ID	DWR_ST0007_01_s_2015_33				
Action/Comments					
Control annual grass and weeds on the levee slopes and easements. Inspector Comments: Weeds on waterside shoulder and slope are 3.0 to 4.0 feet tall.

Weeds on the water side levee slope are taller than 24 inches.

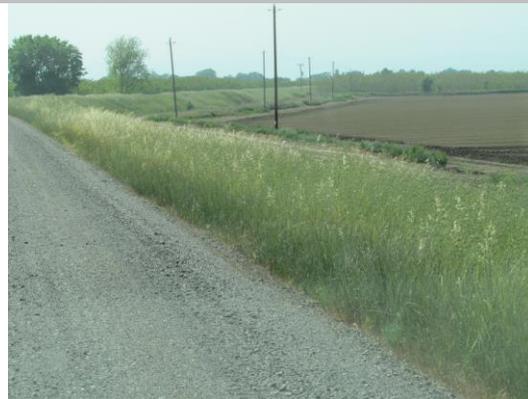
Photo 1 of 1 : SP_2015_ST0007_282_36_20150427_00012.jpg

LM Start	2.17	Rating **	U	Issue No.	36
LM End	2.25	Issue Type +	Ma	Location *	LS
Category	Earthen Levee		GPS Latitude/Longitude		
			Start	End	
Item	Vegetation		38.515845 °	38.515967 °	
			-121.667135 °	-121.668553 °	
DWR ID	DWR_ST0007_01_s_2015_36				
Action/Comments					
Control annual grass and weeds on the levee slopes and easements. Inspector Comments: Tall annual weeds exceed 24 inches high.

Tall weeds on levee slope exceed 24-inches tall.

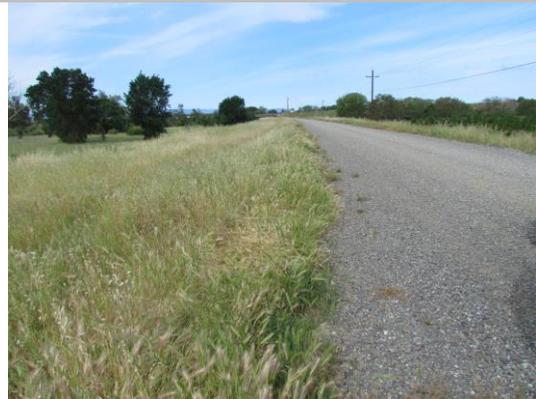
Photo 1 of 1 : SP_2015_ST0007_282_45_20150427_00014.jpg

LM Start	7.65	Rating **	U	Issue No.	45
LM End	7.87	Issue Type +	Ma	Location *	WS
Category	Earthen Levee		GPS Latitude/Longitude		
			Start	End	
Item	Vegetation		38.518922 °	38.518515 °	
			-121.765863 °	-121.769858 °	
DWR ID	DWR_ST0007_01_s_2015_45				
Action/Comments					
Control annual grass and weeds on the levee slopes and easements. Inspector Comments: Weeds taller than 24 inches.

Tall weeds on the waterside levee section.

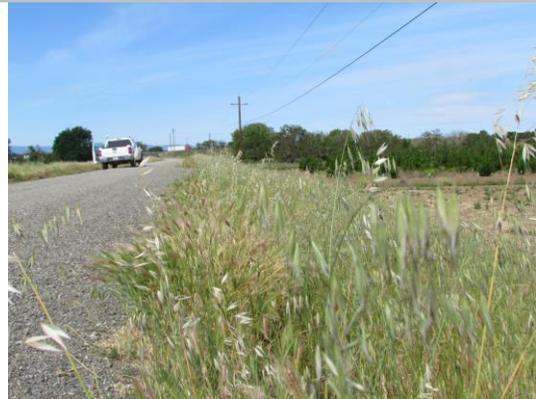
Photo 1 of 1 : SP_2015_ST0007_282_46_20150427_00019.jpg

LM Start	7.66	Rating **	U	Issue No.	46
LM End	7.89	Issue Type +	Ma	Location *	LS
Category	Earthen Levee		GPS Latitude/Longitude		
			Start	End	
Item	Vegetation		38.518913 °	38.518422 °	
			-121.766142 °	-121.770220 °	
DWR ID	DWR_ST0007_01_s_2015_46				
Action/Comments					
Control annual grass and weeds on the levee slopes and easements. Inspector Comments: Tall annual weeds on the levee slope.

Tall annual weeds on the landside levee shoulder and slope.

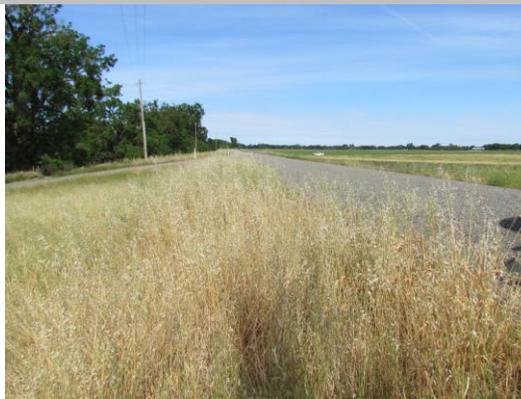
Photo 1 of 1 : SP_2015_ST0007_282_47_20150427_00016.jpg

LM Start	7.99	Rating **	U	Issue No.	47
LM End	8.62	Issue Type +	Ma	Location *	WS
Category	Earthen Levee		GPS Latitude/Longitude		
			Start	End	
Item	Vegetation		38.519002 °	38.523835 °	
			-121.772098 °	-121.781810 °	
DWR ID	DWR_ST0007_01_s_2015_47				
Action/Comments					
Control annual grass and weeds on the levee slopes and easements. Inspector Comments: Weeds exceeds 35 inches tall.

Tall annual weeds on the waterside levee slope.

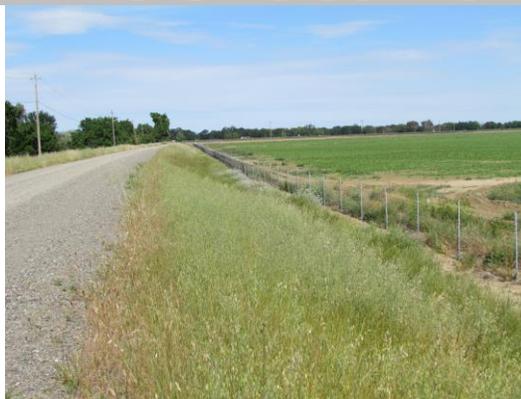
Photo 1 of 1 : SP_2015_ST0007_282_48_20150427_00017.jpg

LM Start	8.05	Rating **	U	Issue No.	48
LM End	8.31	Issue Type +	Ma	Location *	LS
Category	Earthen Levee		GPS Latitude/Longitude		
			Start	End	
Item	Vegetation		38.519475 °	38.521542 °	
			-121.773048 °	-121.777035 °	
DWR ID	DWR_ST0007_01_s_2015_48				
Action/Comments					
Control annual grass and weeds on the levee slopes and easements. Inspector Comments: Weeds exceed 24 inches in height.

Tall weeds on the landside levee slope.

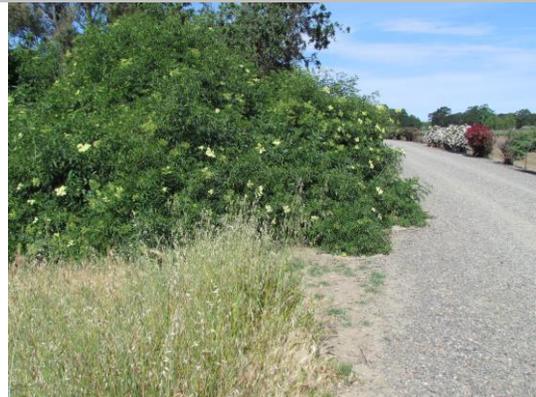
Photo 1 of 1 : SP_2015_ST0007_282_9_20150427_00020.jpg

LM Start	8.52	Rating **	M	Issue No.	9
LM End	8.52	Issue Type +	Ma	Location *	WS
Category	Earthen Levee		GPS Latitude/Longitude		
			Start	End	
Item	Vegetation		38.523159 °	38.523159 °	
			-121.780208 °	-121.780208 °	
DWR ID	DWR_ST0007_01_s_2015_9				
Action/Comments					
Elderberries are blocking visibility and flood fight capability.

This elderberry tree blocks the view of the levee section underneath the tree.

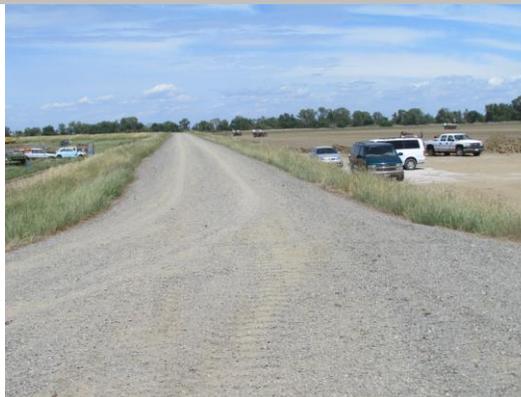
Photo 1 of 1 : SP_2015_ST0007_283_35_20150427_00006.jpg

LM Start	0.00	Rating **	M	Issue No.	35
LM End	0.00	Issue Type +	Ma	Location *	LS
Category	Earthen Levee			GPS Latitude/Longitude	
				Start	End
Item	Vegetation			38.504635 °	38.504635 °
				-121.663180 °	-121.663179 °
DWR ID	DWR_ST0007_02_f_2014_35				
Action/Comments					
Control annual grass and weeds on the levee slopes and easements.

Looking downstream at both slopes with tall weeds present.

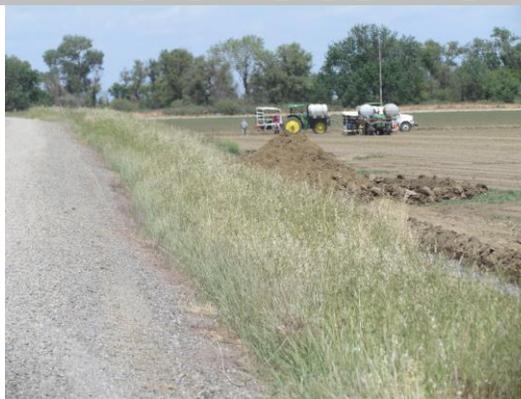
Photo 1 of 1 : SP_2015_ST0007_283_28_20150427_00009.jpg

LM Start	0.04	Rating **	U	Issue No.	28
LM End	0.90	Issue Type +	Ma	Location *	WS
Category	Earthen Levee			GPS Latitude/Longitude	
				Start	End
Item	Vegetation			38.505262 °	38.510900 °
				-121.663103 °	-121.673887 °
DWR ID	DWR_ST0007_02_s_2015_28				
Action/Comments					
Control annual grass and weeds on the levee slopes and easements. Inspector Comments: Weeds taller than 24 inches on shoulder and slope.

Tall weeds on the waterside levee slope.

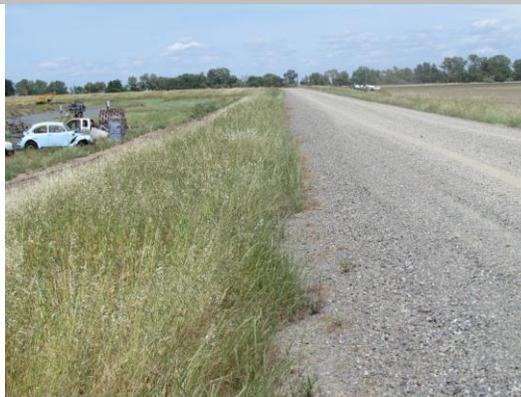
Photo 1 of 1 : SP_2015_ST0007_283_17_20150427_00007.jpg

LM Start	0.04	Rating **	U	Issue No.	17
LM End	1.34	Issue Type +	Ma	Location *	LS
Category	Earthen Levee			GPS Latitude/Longitude	
				Start	End
Item	Vegetation			38.505262 °	38.513002 °
				-121.663103 °	-121.681510 °
DWR ID	DWR_ST0007_02_s_2015_17				
Action/Comments					
Control annual grass and weeds on the levee slopes and easements. Inspector Comments: Weeds taller than 36 inches on slope and shoulder.

Tall weeds on the landside levee slope.

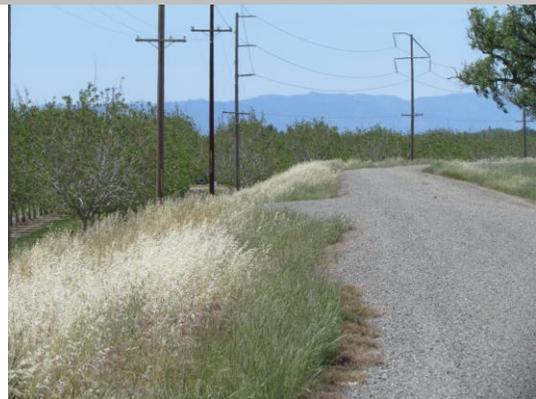
Photo 1 of 1 : SP_2015_ST0007_283_42_20150427_00010.jpg

LM Start	2.19	Rating **	U	Issue No.	42
LM End	2.75	Issue Type +	Ma	Location *	LS
Category	Earthen Levee		GPS Latitude/Longitude		
			Start	End	
Item	Vegetation		38.515418 °	38.514947 °	
			-121.695498 °	-121.705698 °	
DWR ID	DWR_ST0007_02_s_2015_42				
Action/Comments					
Control annual grass and weeds on the levee slopes and easements. Inspector Comments: Control the tall weeds on the levee slope.

Tall annual weeds on the landside levee slope.

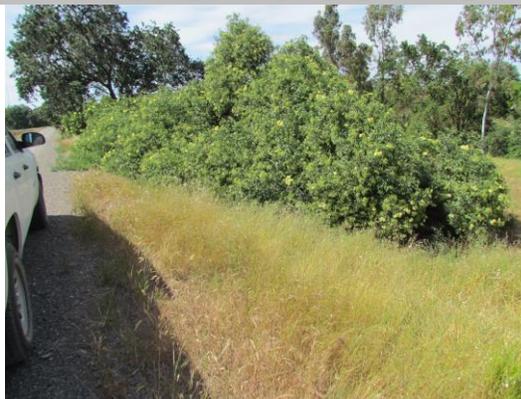
Photo 1 of 1 : SP_2015_ST0007_283_55_20150427_00014.jpg

LM Start	6.88	Rating **	U	Issue No.	55
LM End	6.90	Issue Type +	Ma	Location *	WS
Category	Earthen Levee		GPS Latitude/Longitude		
			Start	End	
Item	Vegetation		38.521422 °	38.521538 °	
			-121.779715 °	-121.779978 °	
DWR ID	DWR_ST0007_02_s_2015_55				
Action/Comments					
Elderberries are blocking visibility and flood fight capability.

View of the elderberry trees blocking the view of the levee section.
