**Flood Control Project Maintenance
Levee Inspections**

Maintenance Issue Types Only, Levee Inspection Report By Mile - Spring 2016

Sacramento Maintenance Yard Putah Creek

Waterway	Bank	Unit Miles	Inspection Start/End	Inspector
Unit No. 01 Putah Creek or North Levee	Left	8.79	03/10/2016 03/10/2016	Herman Phillips

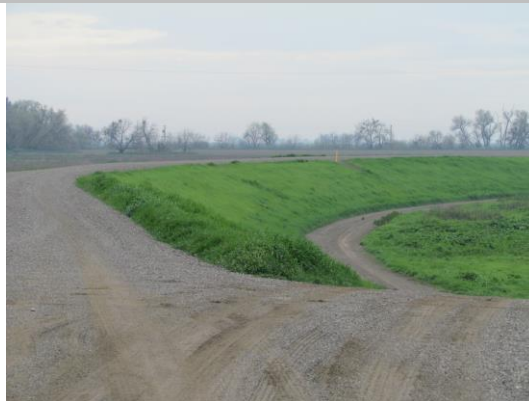
Photo 1 of 1 : SP_2016_ST0007_282_22_20160314_00024.jpg

LM Start	0.00	Rating **	A	Issue No.	22
LM End	0.27	Issue Type +	Ma	Location *	LS
Category	Earthen Levee			GPS Latitude/Longitude	
				Start	End
Item	Vegetation			38.523618 °	38.520310 °
				-121.631445 °	-121.633297 °
DWR ID	DWR_ST0007_01_s_2016_22				
Comment Code					
V1 : Control annual grass and weeds on the levee slopes and easements.					
Inspector Comment					
The grasses along this levee section aren't causing a problem.

Looking downstream from the levee mile 0.00 landward levee slope.
There are grasses present on the levee section.

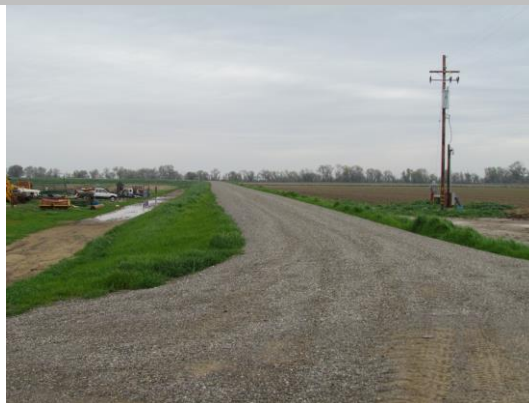
Photo 1 of 1 : SP_2016_ST0007_283_17_20160517_00023.jpg

LM Start	0.01	Rating **	M	Issue No.	17
LM End	2.10	Issue Type +	Ma	Location *	LS
Category	Earthen Levee			GPS Latitude/Longitude	
				Start	End
Item	Vegetation			38.504863 °	38.515455 °
				-121.663160 °	-121.695022 °
DWR ID	DWR_ST0007_02_s_2016_17				
Comment Code					
V1 : Control annual grass and weeds on the levee slopes and easements.					
Inspector Comment

Putah Creek Unit 2 levee mile 0.01 -2.10 looking downstream.
