**Flood Control Project Maintenance
Levee Inspections**

Maintenance Issue Types Only, Levee Inspection Report By Mile - Spring 2017

Sacramento Maintenance Yard Putah Creek

Waterway	Bank	Unit Miles	Inspection Start/End	Inspector
Unit No. 01 Putah Creek or North Levee	Left	8.79	04/19/2017 04/18/2017	Herman Phillips

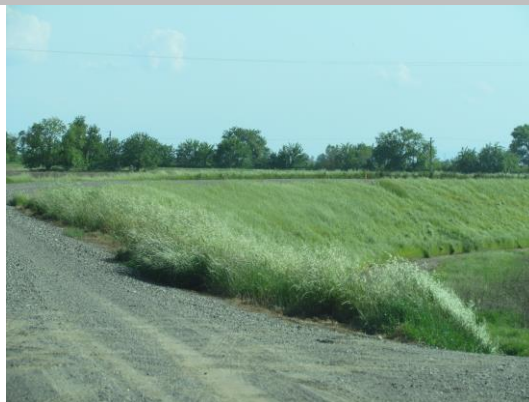
Photo 1 of 1 : SP_2017_ST0007_282_36_20170509_00059.jpg

LM Start	0.01	Rating **	U	Issue No.	36
LM End	8.31	Issue Type +	Ma	Location *	LS
Category	Earthen Levee			GPS Latitude/Longitude	
				Start	End
Item	Vegetation			38.523537 °	38.521547 °
				-121.631462 °	-121.776958 °
DWR ID	DWR_ST0007_01_s_2017_36				
Comment Code					
V1 : Control annual grass and weeds on the levee slopes and easements.					
Inspector Comment					
Due to the wet winter months weeds has been encouraged to grow out of control. Control the annual grasses and weeds on the slope and levee toe.

Looking upstream from levee mile 0.01 landside shoulder. Unwanted tall weeds present on the levee slope and shoulder.

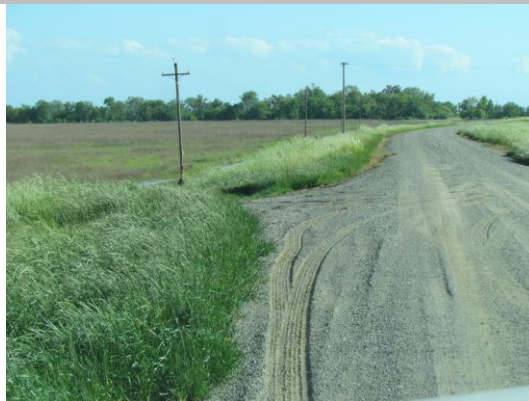
Photo 1 of 1 : SP_2017_ST0007_282_37_20170509_00060.jpg

Looking upstream from levee mile 0.01 waterside levee shoulder. Tall weeds present on the levee section.

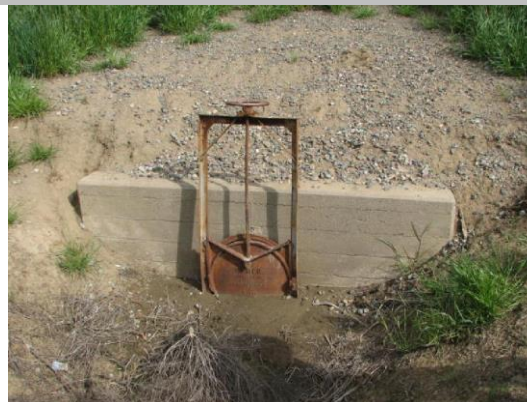
Photo 1 of 3 : UCIP_SP_2017_33408_60493.jpg

WS slide gate and headwall

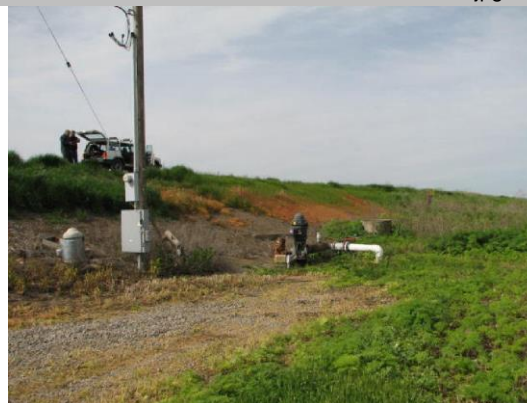
Photo 2 of 3 : UCIP_SP_2017_33408_60495.jpg

LS pump and appurtenances

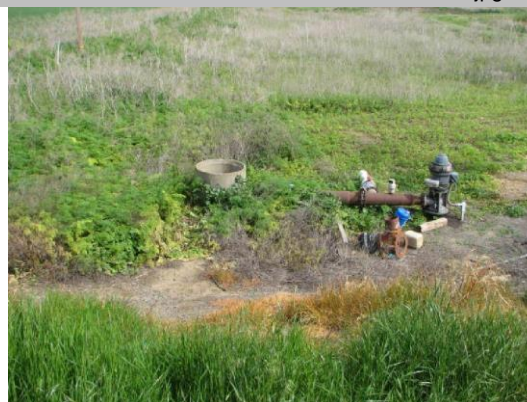
Photo 3 of 3 : UCIP_SP_2017_33408_60494.jpg

LS pump and appurtenances

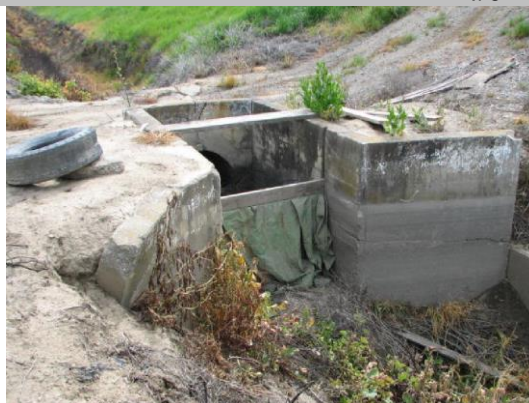
Photo 2 of 3 : UCIP_SP_2017_43033_60467.jpg

LS distribution box

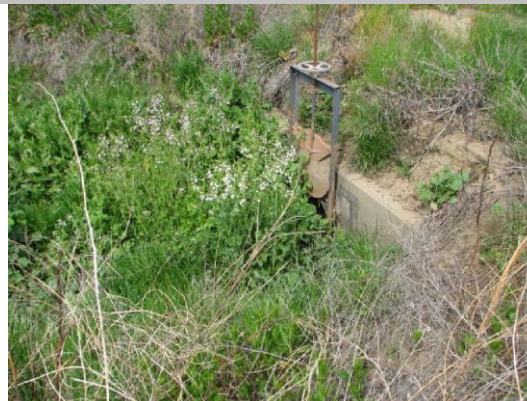
Photo 3 of 3 : UCIP_SP_2017_43033_60466.jpg

Comment Code						
Inspector Comment						
FS_ID:43033						
DS_ID:491						
EP_NO: 10262						
Repair Type: Non-Urgent						
Crossing Status: Found						
UCIP Comments: Pipe has significant rust and exfoliation of metal showing at ends. Reccomend video inspection.						
FIELD_STRUCT_DESC: 24-inch irrigation pipe of unknown material through levee, 15.5 feet below crown. Slide gate is located on the waterside (WS) end. Concrete headwall is located on the landside (LS) end. (24-inch pipe authorized under Automatic Board Order (ABO) issued as Permit No. 10262, 1974 - Wells Fargo Bank, Trustee for S.H. Cowell Foundation) [Additional Reference(s): DWR Levee Log, 1981 and 2005. USACE Sacramento O&M Manual Unit 119, December 1952, (Station XX+XX)]						
FS Date: 4/10/2014 2:45:00 PM

WS slide gate with vegetation

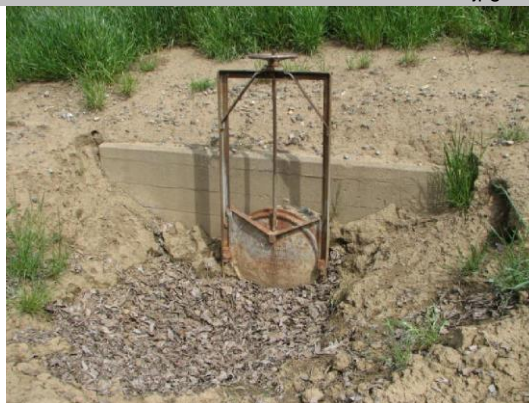
Photo 1 of 2 : UCIP_SP_2017_33394_60458.jpg

WS Slide gate

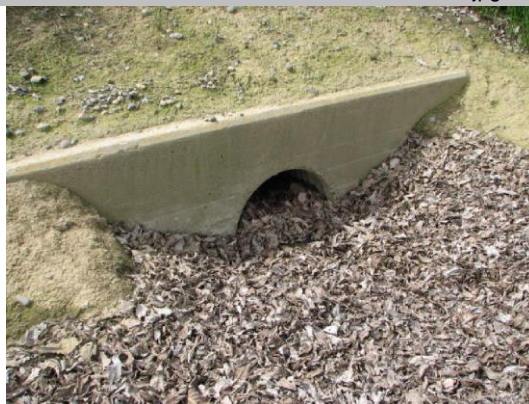
Photo 2 of 2 : UCIP_SP_2017_33394_60457.jpg

LS headwall

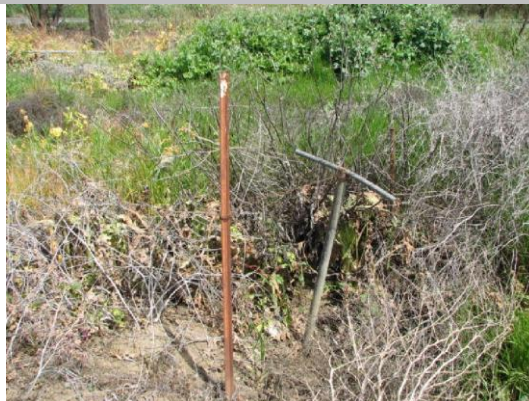
Photo 1 of 3 : UCIP_SP_2017_33381_60439.jpg

WS toe at T handle. No access to pipe.

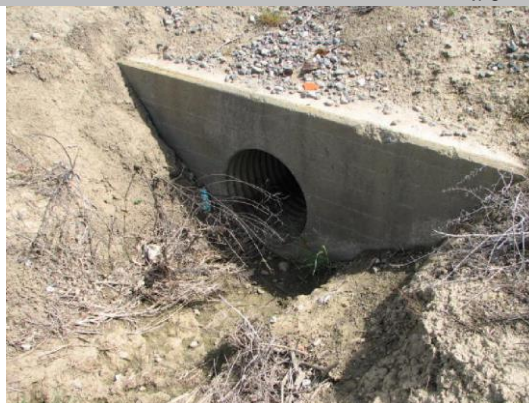
Photo 2 of 3 : UCIP_SP_2017_33381_60441.jpg

LS headwall and pipe

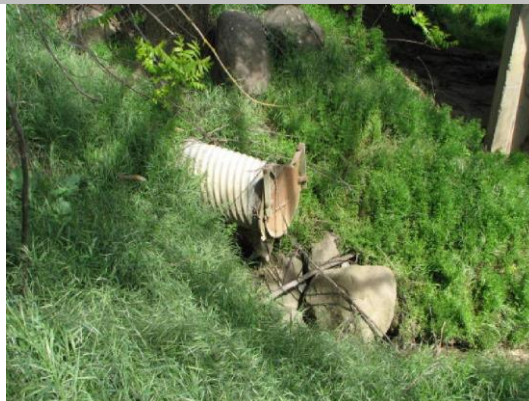
Photo 3 of 3 : UCIP_SP_2017_33381_60440.jpg

Outfall at creek with flap gate.

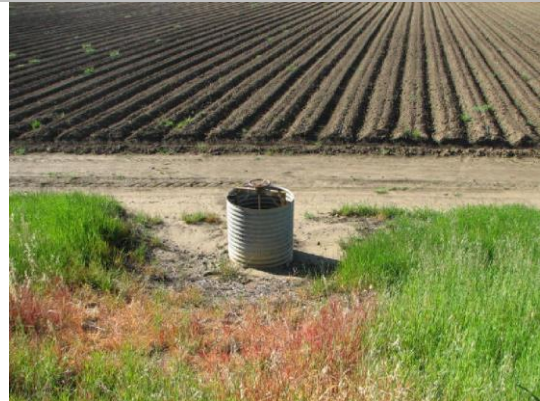
Photo 1 of 1 : UCIP_SP_2017_33379_60436.jpg

Slide gate in 36-inch Standpipe on WS toe.

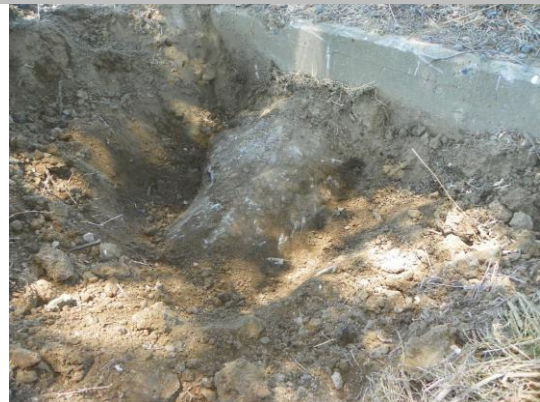
Photo 1 of 3 : UCIP_SP_2017_33374_60426.jpg

FS_ID:33374
DS_ID:499
EP_NO: 10256
Repair Type: No Action Needed
Crossing Status: Found
UCIP Comments: inlet and outlet are capped with concrete. See pictures
FIELD_STRUCT_DESC: *ABANDONED* 24-inch irrigation pipe through levee 9.5 feet below the crown. Headwalls on both ends. (ABO No. 10256 - Lederer)
FS Date: 4/10/2014 2:38:21 PM

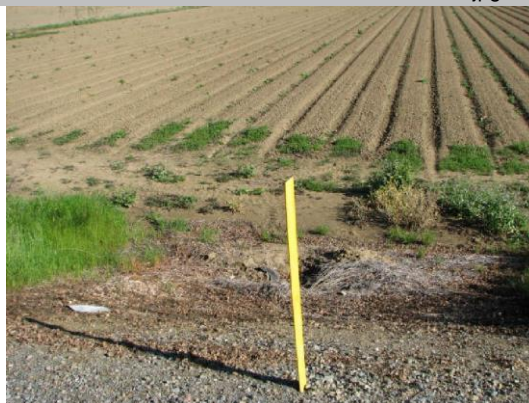
Photo 2 of 3 : UCIP_SP_2017_33374_60423.jpg

LS shoulder looking down on headwall

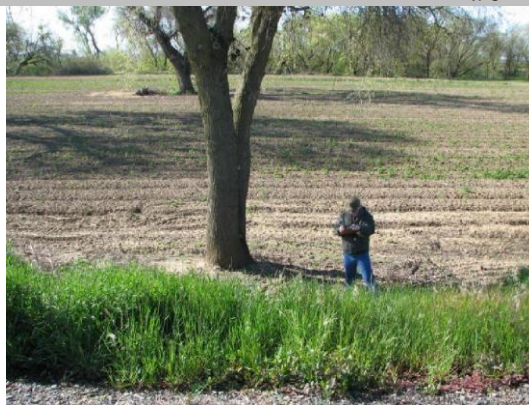
Photo 3 of 3 : UCIP_SP_2017_33374_60425.jpg

WS toe looking down from shoulder

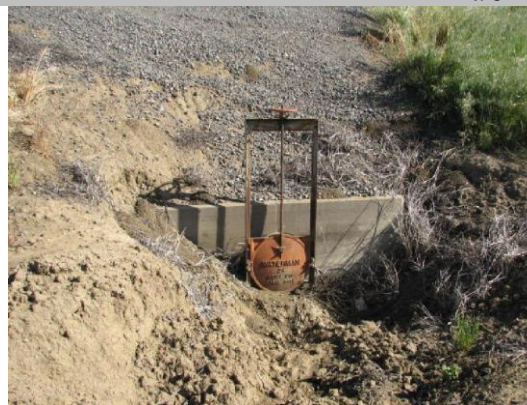
Photo 2 of 3 : UCIP_SP_2017_33371_60416.jpg

WS slide gate

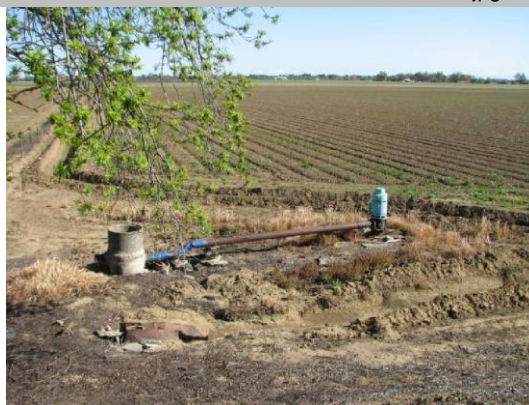
Photo 1 of 2 : UCIP_SP_2017_33370_60415.jpg

LS pump and stand pipe

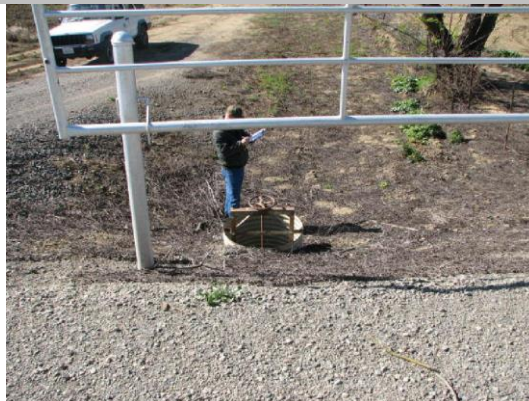
Photo 2 of 2 : UCIP_SP_2017_33370_60414.jpg

WS slide gate in 36-inch cmp standpipe

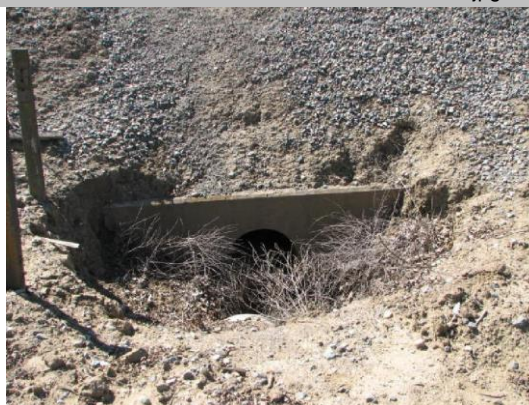
Photo 1 of 2 : UCIP_SP_2017_33368_60410.jpg

LS headwall

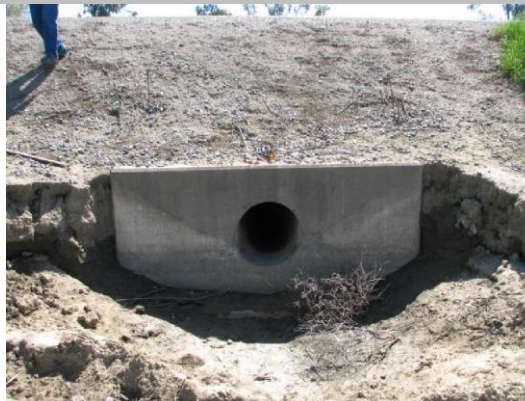
Photo 2 of 2 : UCIP_SP_2017_33349_60371.jpg

LS Headwall

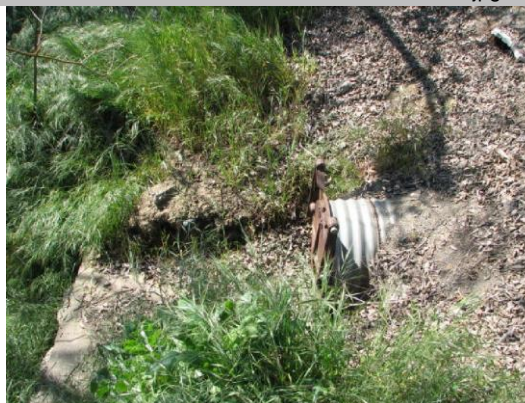
Photo 1 of 3 : UCIP_SP_2017_33343_60357.jpg

WS flap gate

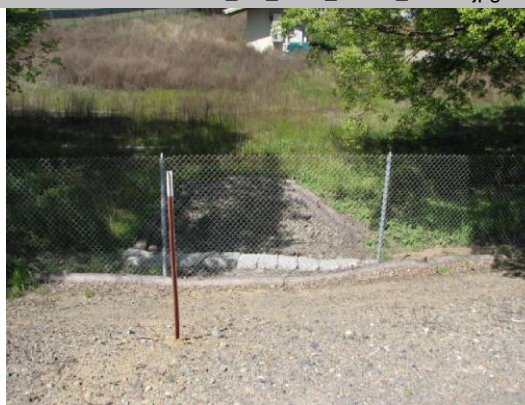
Photo 2 of 3 : UCIP_SP_2017_33343_60359.jpg

LS headwall

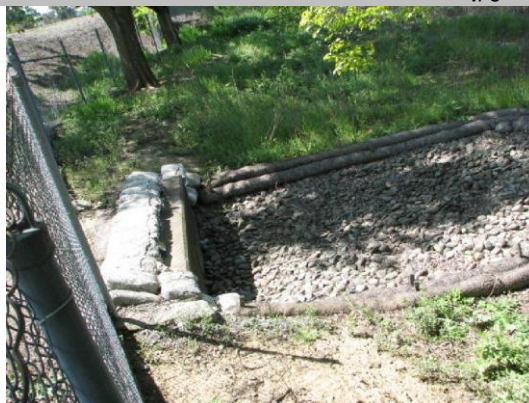
Photo 3 of 3 : UCIP_SP_2017_33343_60358.jpg

LS headwall

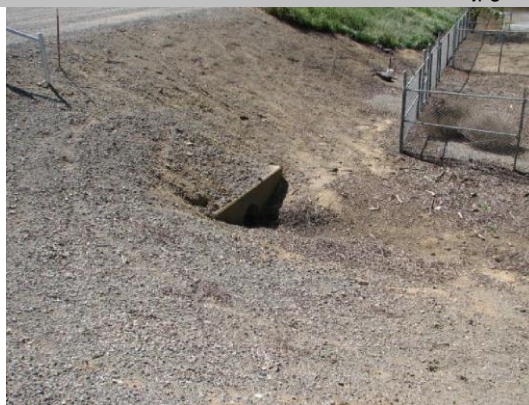
Photo 1 of 2 : UCIP_SP_2017_42952_60353.jpg

LS Headwall

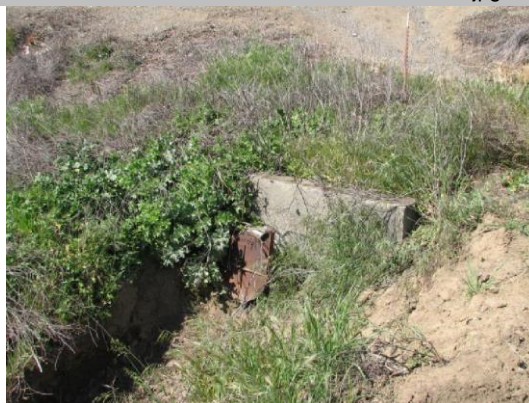
Photo 2 of 2 : UCIP_SP_2017_42952_60352.jpg

WS Flapgate

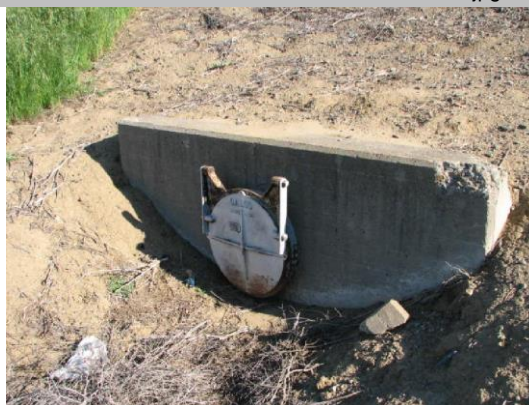
Photo 1 of 2 : UCIP_SP_2017_41353_60345.jpg

WS Flap Gate and headwall.

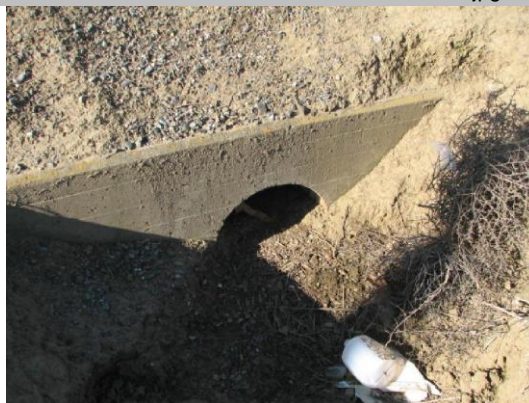
Photo 2 of 2 : UCIP_SP_2017_41353_60344.jpg

LS headwall showing pipe partially blocked with soil.

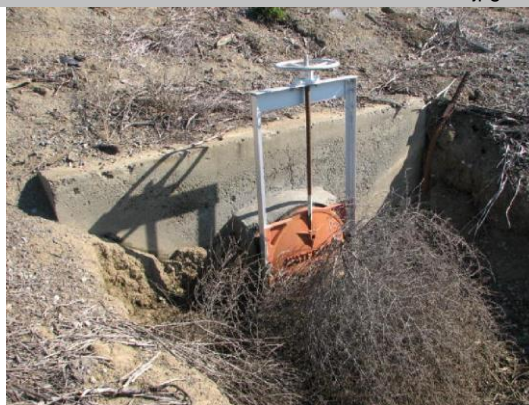
Photo 1 of 2 : UCIP_SP_2017_33333_60342.jpg

WS headwall and slide gate

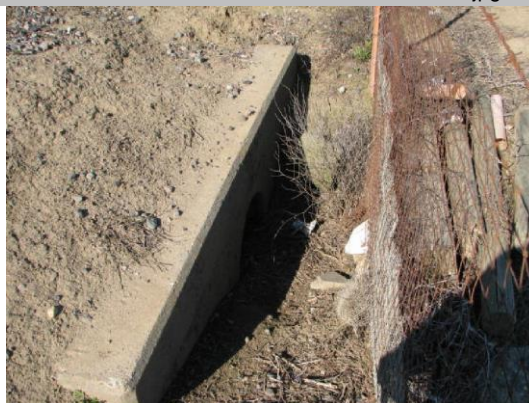
Photo 2 of 2 : UCIP_SP_2017_33333_60341.jpg

LS headwall showing fence and soil buildup.

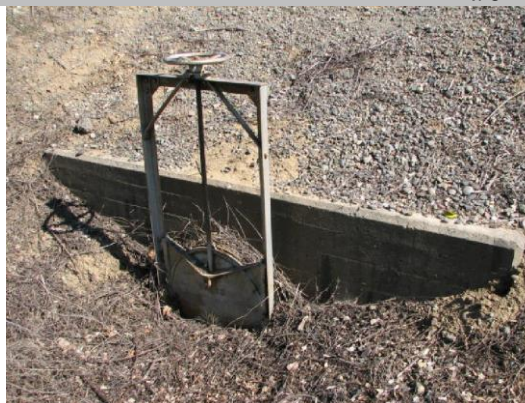
Photo 3 of 3 : UCIP_SP_2017_33328_60328.jpg

WS slide gate showing some blockage with soil.

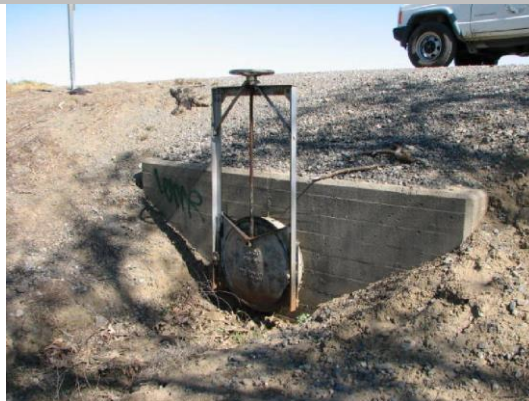
Photo 1 of 2 : UCIP_SP_2017_33327_60326.jpg

WS headwall and slidegate

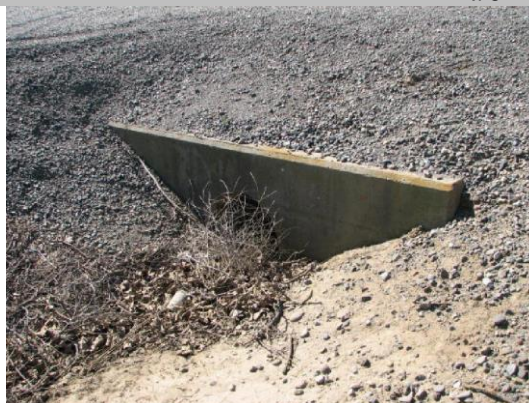
Photo 2 of 2 : UCIP_SP_2017_33327_60325.jpg

LS headwall showing partial blockage

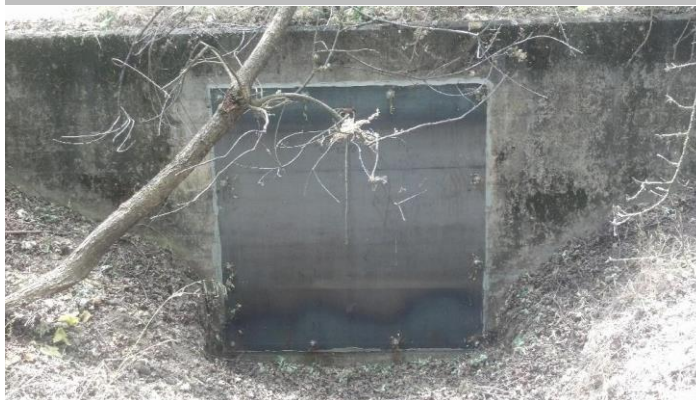
Photo 1 of 3 : UCIP_SP_2017_41129_60301.jpg

Steel plate installed over pipe off LS toe.

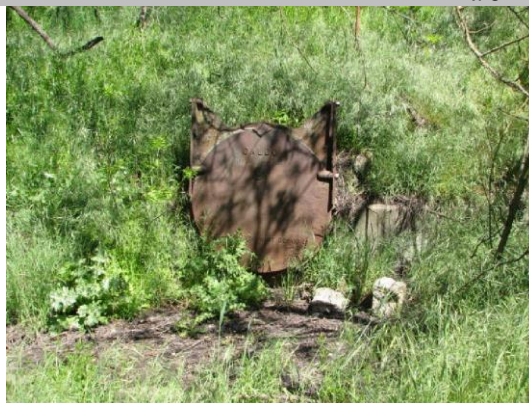
Photo 3 of 3 : UCIP_SP_2017_41129_60300.jpg

WS flap gate

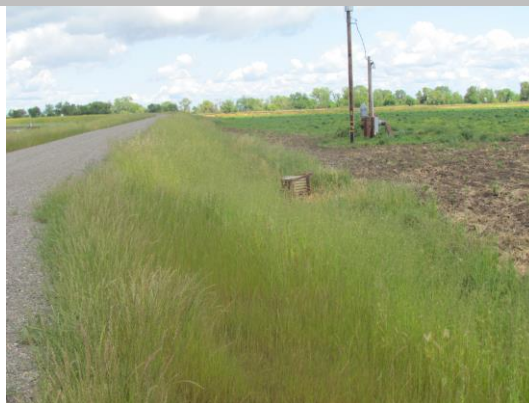
Photo 1 of 1 : SP_2017_ST0007_283_43_20170510_00057.jpg

Looking upstream from levee mile 0.01 Unit 2 waterside slope.

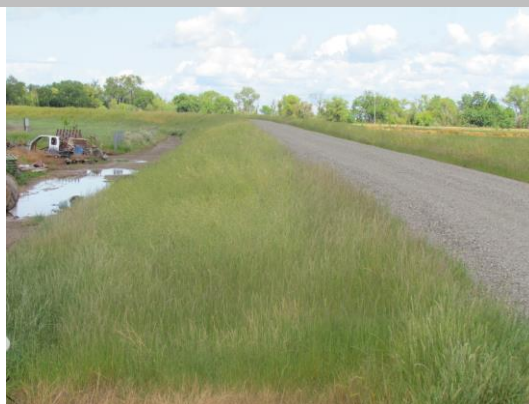
Photo 1 of 1 : SP_2017_ST0007_283_42_20170510_00058.jpg

Looking upstream from levee mile 0.01 landside shoulder at the weed growth on the landward slope.

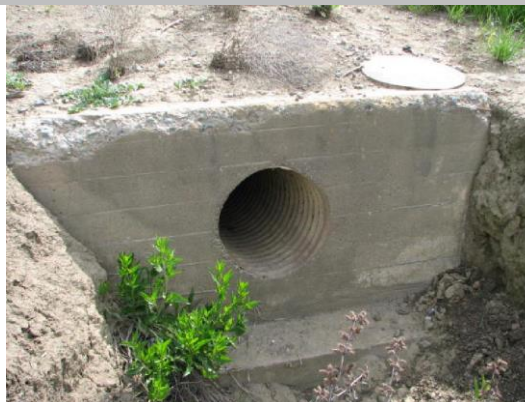
Photo 1 of 3 : UCIP_SP_2017_33410_60496.jpg

L/S headwall and pipe

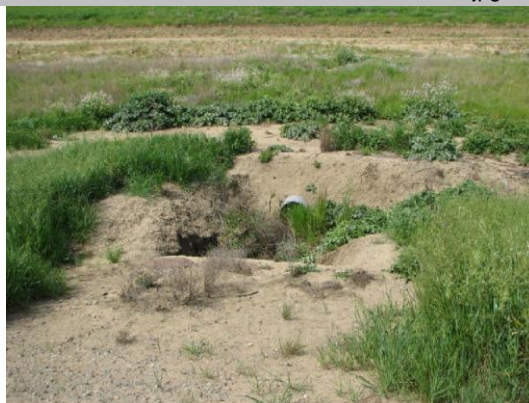
Photo 2 of 3 : UCIP_SP_2017_33410_60498.jpg

L/S headwall at pipe

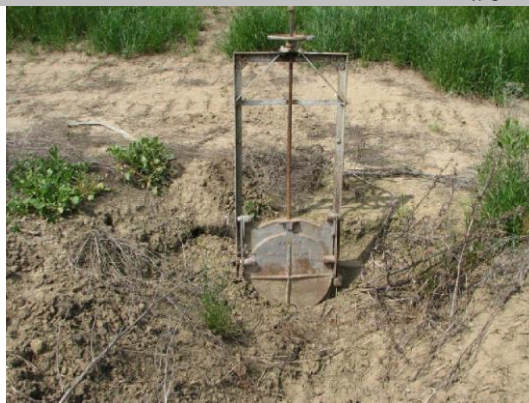
Photo 3 of 3 : UCIP_SP_2017_33410_60497.jpg

W/S slide gate

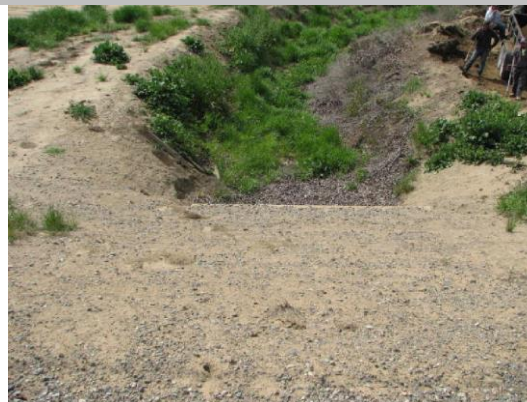
Photo 1 of 3 : UCIP_SP_2017_33407_60489.jpg

L/S inlet

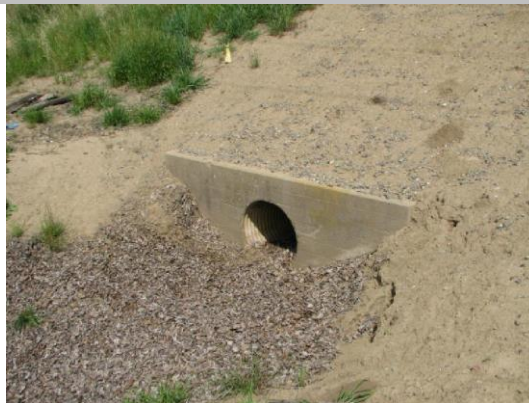
Photo 2 of 3 : UCIP_SP_2017_33407_60492.jpg

L/S headwall

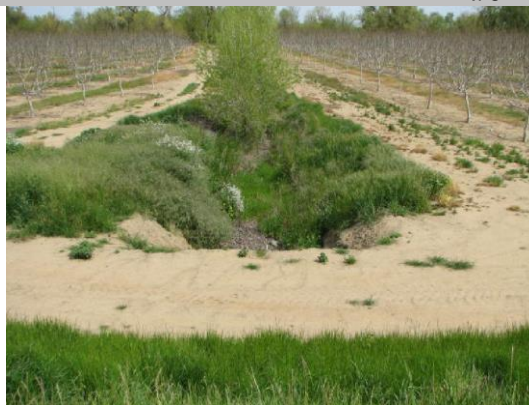
Photo 3 of 3 : UCIP_SP_2017_33407_60491.jpg

W/S Channel

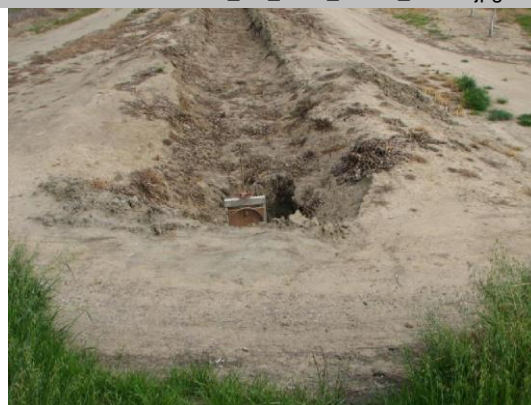
Photo 2 of 3 : UCIP_SP_2017_33401_60478.jpg

WS Channel and Slide gate

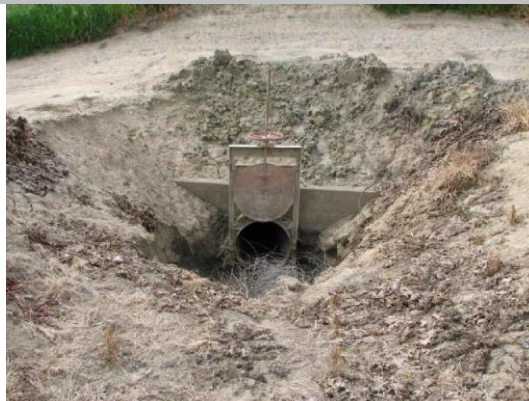
Photo 3 of 3 : UCIP_SP_2017_33401_60477.jpg

WS slide gate

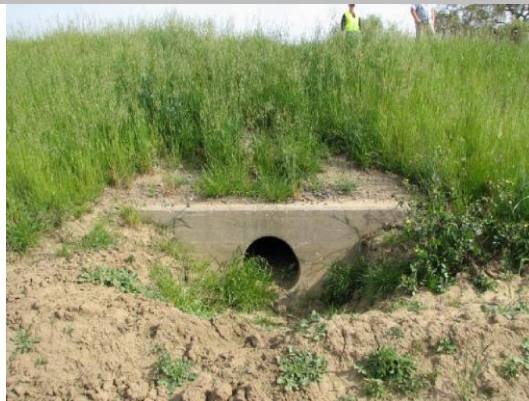
Photo 1 of 2 : UCIP_SP_2017_33395_60460.jpg

LS headwall

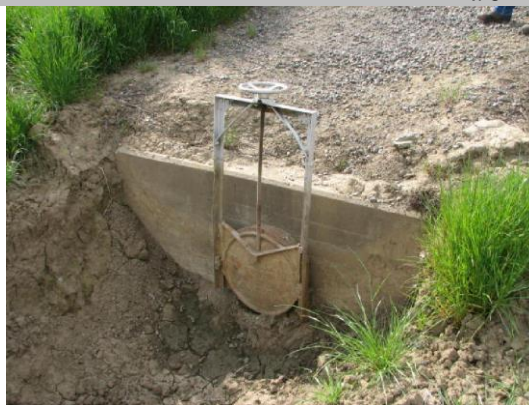
Photo 2 of 2 : UCIP_SP_2017_33395_60459.jpg

WS headwall and slidegate

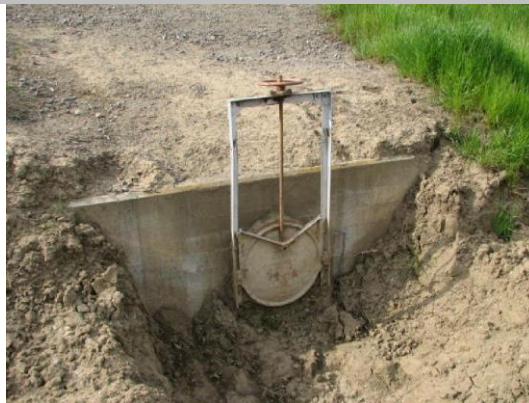
Photo 1 of 2 : UCIP_SP_2017_33393_60456.jpg

WS headwall and slide gate

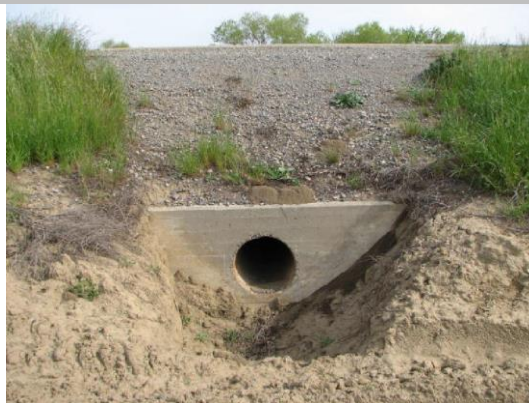
Photo 2 of 2 : UCIP_SP_2017_33393_60455.jpg

LS headwall and pipe

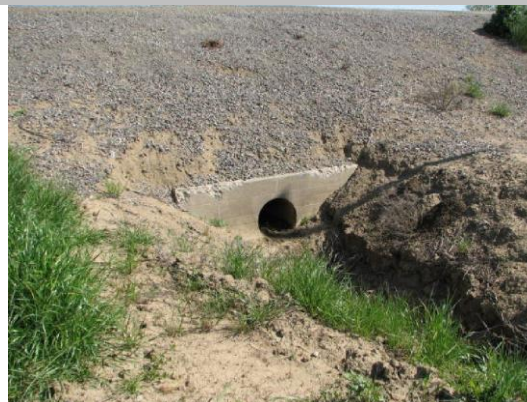
Photo 1 of 2 : UCIP_SP_2017_33378_60435.jpg

LS headwall

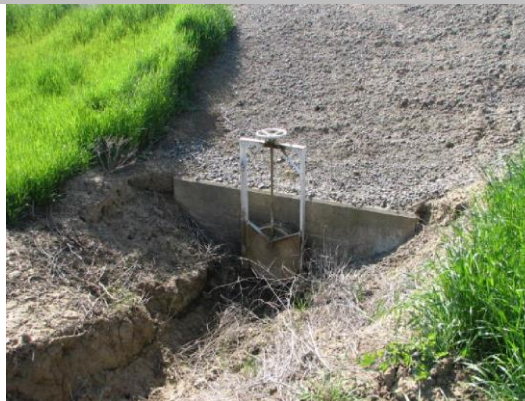
Photo 2 of 2 : UCIP_SP_2017_33378_60434.jpg

WS slide gate and headwall

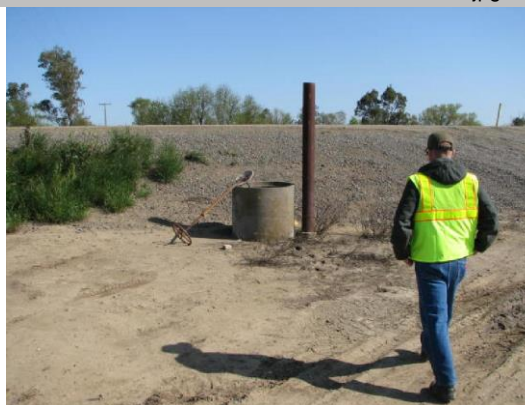
Photo 1 of 3 : UCIP_SP_2017_33375_60427.jpg

LS 36-inch standpipe

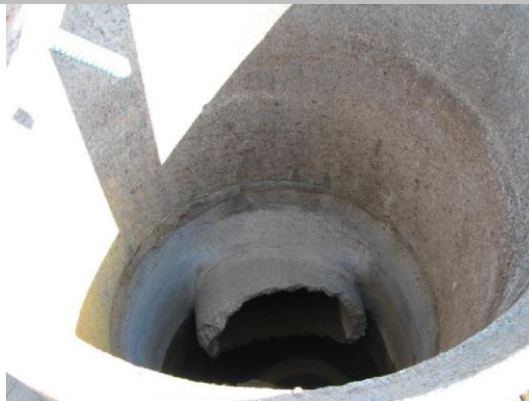
Photo 3 of 3 : UCIP_SP_2017_33375_60428.jpg

LS looking down standpipe at CC pipe

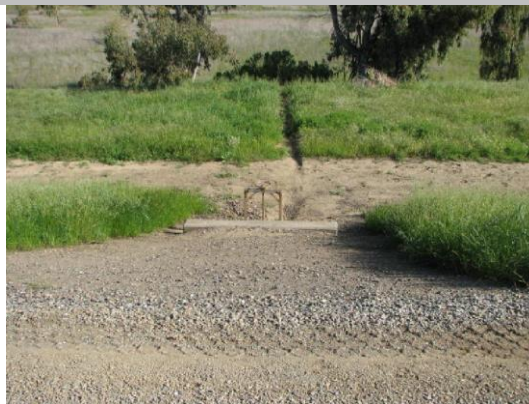
Photo 1 of 3 : UCIP_SP_2017_33369_60411.jpg

W/S

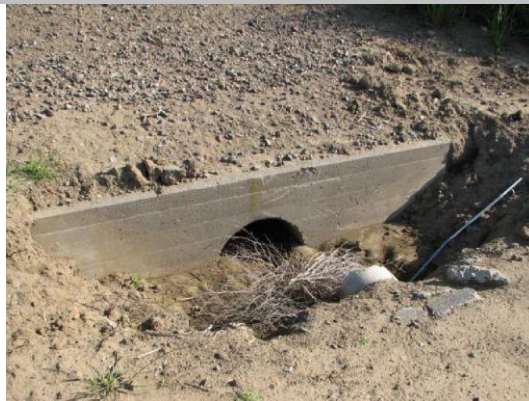
Photo 2 of 3 : UCIP_SP_2017_33369_60413.jpg

L/S Clogged

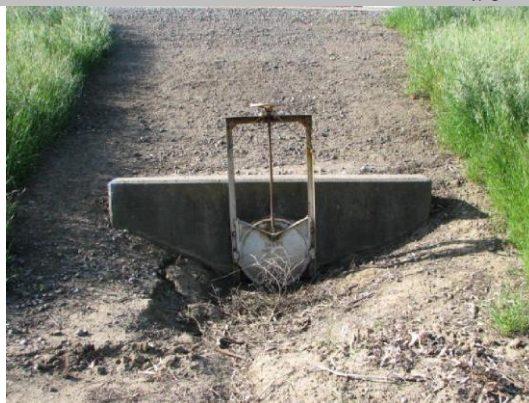
Photo 3 of 3 : UCIP_SP_2017_33369_60412.jpg

W/S positive closure device

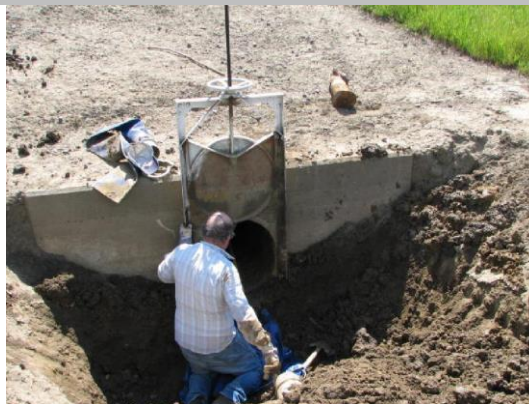
Photo 1 of 2 : UCIP_SP_2017_33363_60399.jpg

WS slide gate and headwall. 6-inch irrigation pipe just inside 24-inch pipe.

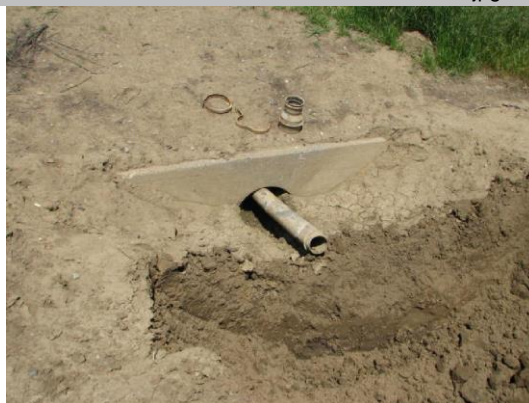
Photo 2 of 2 : UCIP_SP_2017_33363_60398.jpg

LS headwall showing sedimentation and 6-inch pipe sleeved through 24-inch pipe.

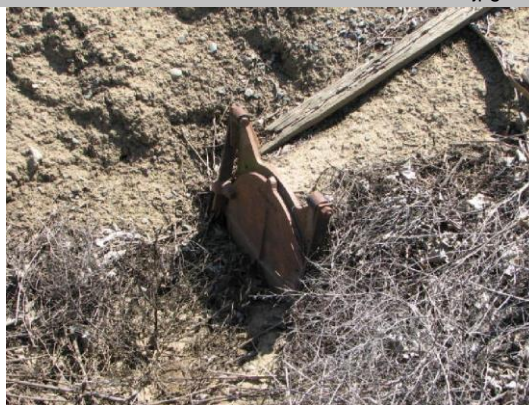
Photo 1 of 2 : UCIP_SP_2017_42953_60397.jpg

WS Flapgate blocked by sedimentation

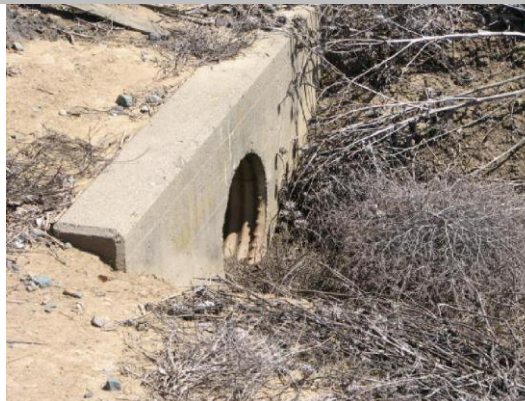
Photo 2 of 2 : UCIP_SP_2017_42953_60396.jpg

LS headwall

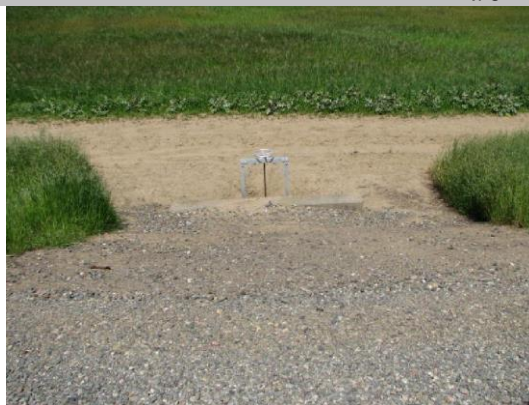
Photo 2 of 2 : UCIP_SP_2017_33353_60379.jpg

WS slide gate

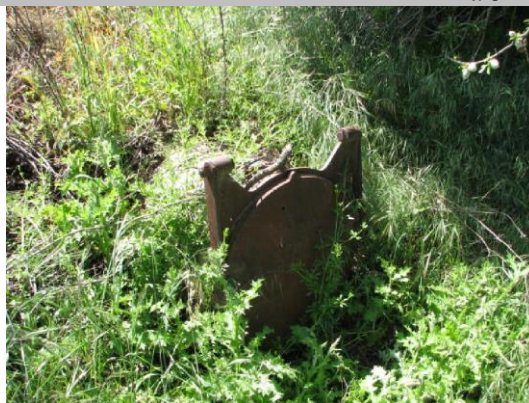
Photo 2 of 2 : UCIP_SP_2017_42959_60373.jpg

WS flap gate

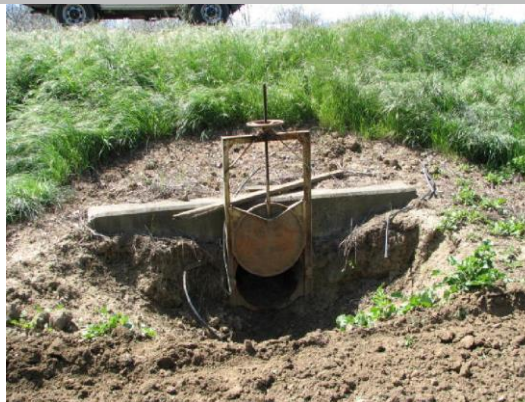
Photo 1 of 2 : UCIP_SP_2017_33346_60364.jpg

WS slide gate showing soil plug

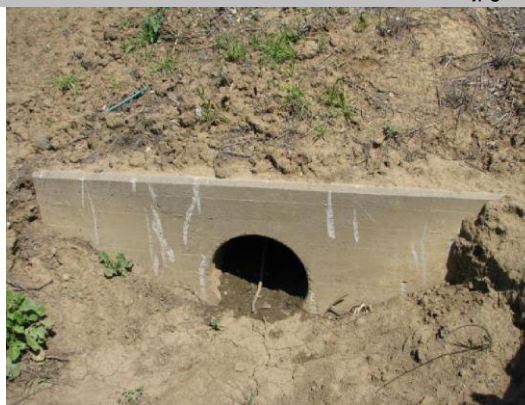
Photo 2 of 2 : UCIP_SP_2017_33346_60363.jpg

LS headwall showing soil plug

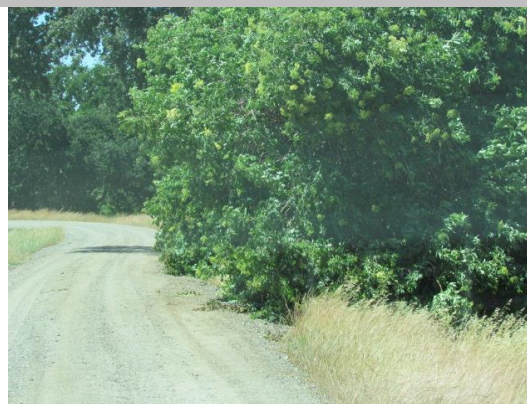
Photo 1 of 1 : SP_2017_ST0007_283_47_20170511_00061.jpg

Elderberry bushes blocking view of waterside shoulder at this location.
