**Flood Control Project Maintenance  
Levee Inspections**

## Maintenance Issue Types Only, Levee Inspection Report By Mile - Spring 2018

### Sacramento Maintenance Yard Putah Creek

Waterway	Bank	Unit Miles	Inspection Start/End	Inspector
Unit No. 01 Putah Creek or North Levee	Left	8.79	03/08/2018 03/08/2018	Keith Millard

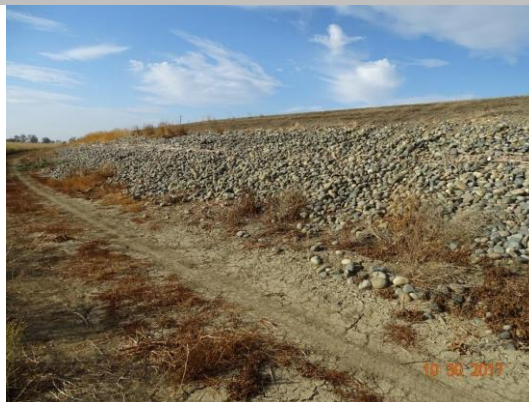
Photo 1 of 1 : SP\_2018\_ST0007\_282\_2\_20180305\_00001.jpg

LM Start	0.04	Rating **	A/W	Issue No.	2
LM End	0.12	Issue Type +	Ma	Location *	WS
Category	Supplemental			GPS Latitude/Longitude	
				Start	End
Item	2015 USACE Erosion Survey, DRAFT			38.523119 °	38.521968 °
				-121.631356 °	-121.631519 °
DWR ID	DWR_ST0007_01_f_2016_2				
Comment Code					
Inspector Comment					
2011 - Old cobble site is unraveling, likely causing the toe of the bank to become unstable. 2015: Site is part of the extended inventory, last inspected 2011. [2015 Site ID: PUC_0-1_L]. 10/30/17: Cobbles and waterside toe appear intact; similar to conditions extending to 0.46.

10/30/17: Cobbles and waterside toe appear intact; similar to conditions extending to 0.46.

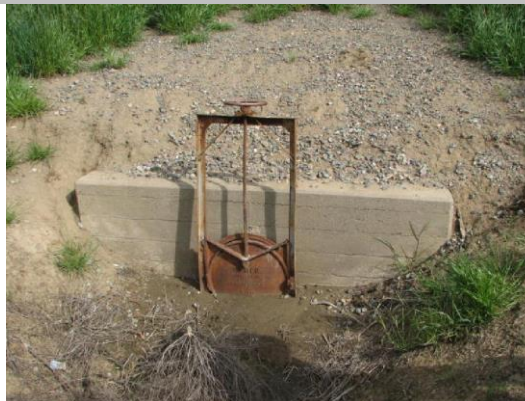
Photo 1 of 3 : UCIP\_SP\_2018\_33408\_60493.jpg

FS\_ID:33408  
DS\_ID:488  
EP\_NO: 10261  
Repair Type: No Action Needed  
Crossing Status: Found  
UCIP Comments:  
FIELD\_STRUCT\_DESC: 24-inch drainage pipe of unknown material through the levee, 12.5 feet below the crown. Slide gate is located on the waterside (WS) end. Concrete headwall is located on the WS. (24-inch pipe [HLM 0.58] authorized under Automatic Board Order (ABO) issued as Permit No. 10261, 1974 - Tufts) [Additional Reference(s): DWR Levee Log, 1981 and 2005. USACE Sacramento O&M Manual Unit 119, December 1952, (Station XX+XX)]  
FS Date: 4/10/2014 2:49:52 PM

WS slide gate and headwall

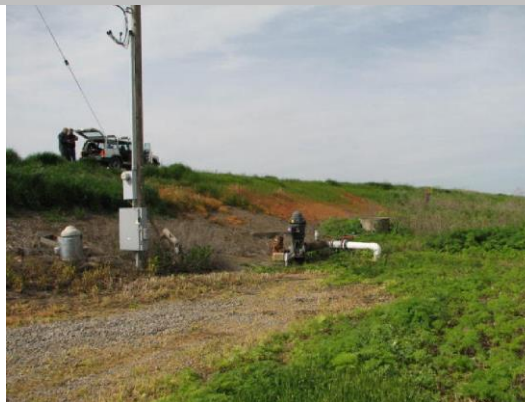
Photo 2 of 3 : UCIP\_SP\_2018\_33408\_60495.jpg

LS pump and appurtenances

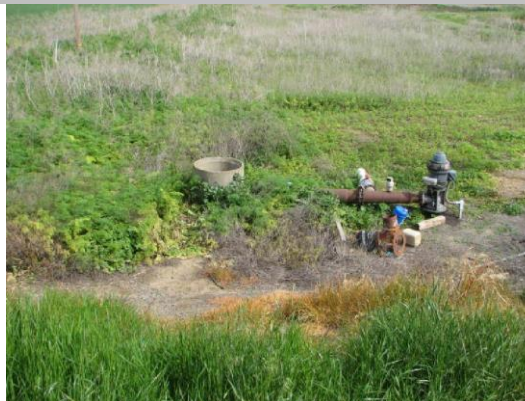
Photo 3 of 3 : UCIP\_SP\_2018\_33408\_60494.jpg

LS pump and appurtenances

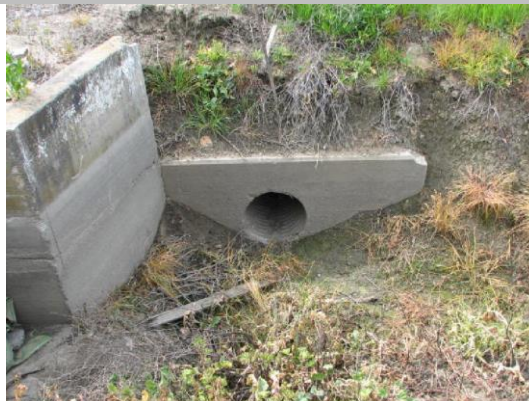
Photo 1 of 3 : UCIP\_SP\_2018\_43033\_60465.jpg

FS\_ID:43033  
DS\_ID:491  
EP\_NO: 10262  
Repair Type: Non-Urgent  
Crossing Status: Found  
UCIP Comments: 09/21/2017 Pipe was permitted as an irrigation structure under ABO issued as Permit No. 10262. (DWR UCIP - O. Magana)  
04/03/2012 Pipe has significant rust and exfoliation of metal showing at ends. Recommend video inspection. (DWR UCIP - W. Wylie)  
FIELD\_STRUCT\_DESC: 24-inch irrigation pipe of unknown material through levee, 15.5 feet below crown. Slide gate is located on the waterside (WS) end. Concrete headwall is located on the landside (LS) end. (24-inch pipe [HLM 2.17] authorized under Automatic Board Order (ABO) issued as Permit No. 10262, 1974 - Wells Fargo Bank, Trustee for S.H. Cowell Foundation) [Additional Reference(s): DWR Levee Log, 1981 and 2005. USACE Sacramento O&M Manual Unit 119, December 1952, (Station XX+XX)]  
FS Date: 4/10/2014 2:45:00 PM

LS headwall

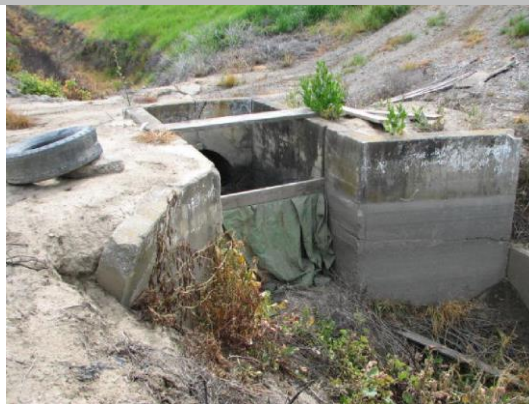
Photo 2 of 3 : UCIP\_SP\_2018\_43033\_60467.jpg

LS distribution box

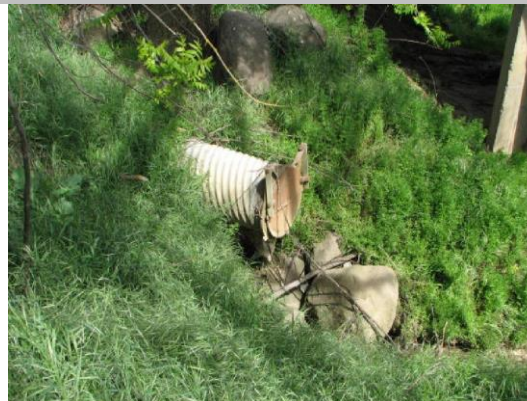
Photo 3 of 3 : UCIP\_SP\_2018\_33381\_60440.jpg

FS\_ID:33381  
 DS\_ID:496  
 EP\_NO: 10251  
 Repair Type: No Action Needed  
 Crossing Status: Found  
 UCIP Comments:  
 FIELD\_STRUCT\_DESC: 24-inch corrugated metal drainage pipe through levee, 15 feet below the crown. Two metal cutoff walls were installed through the levee. A T-post and T-handle are located on the landside (LS) toe. The outfall structure and flap gate are located on the west side of bridge, waterside (WS). (24-inch pipe [HLM 3.87] authorized under Automatic Board Order (ABO) issued as Permit No. 10251, 1974 - F.M.C. Corp.) [Additional Reference(s): DWR Levee Log, 1981 and 2005. USACE Sacramento O&M Manual Unit 119, December 1952, (Station XX+XX)]  
 FS Date: 4/10/2014 2:40:30 PM

Outfall at creek with flap gate.

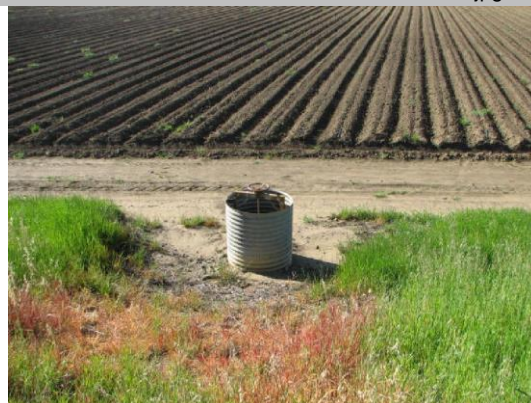
Photo 1 of 1 : UCIP\_SP\_2018\_33379\_60436.jpg

FS\_ID:33379  
 DS\_ID:497  
 EP\_NO: 10251  
 Repair Type: No Action Needed  
 Crossing Status: Found  
 UCIP Comments:  
 FIELD\_STRUCT\_DESC: PENDING CONSTRUCTION STATUS - 20-inch irrigation welded HDPE pipe sleeved through an existing 24-inch pipe through levee, 16 feet below the crown. Annular space between pipes was filled with grout. 36-inch galvanized corrugated metal pipe (CMP) riser and hinged lid are located on the waterside (WS) slope. (20-inch HDPE installed with a 36-inch galvanized CMP riser and hinged lid, work also included the removal of existing CMP riser authorized under Permit No. 10251-1, 2014 - Harris Moran Seed Company; 24-inch pipe [HLM 4.13] authorized under Automatic Board Order (ABO) issued as Permit No. 10251, 1974 - F.M.C. Corp.; assumed original 24-inch pipe was installed in 12/12/1952 per O&M manual) [Additional Reference(s): DWR Levee Log, 1981 and 2005. USACE Sacramento O&M Manual Unit 119, December 1952, (Station XX+XX)]

Slide gate in 36-inch Standpipe on WS toe.

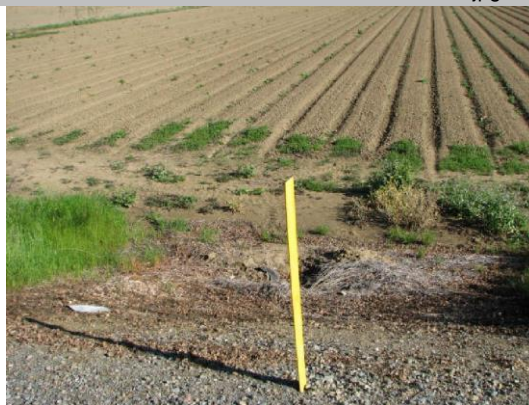
Photo 2 of 3 : UCIP\_SP\_2018\_33374\_60423.jpg

LS shoulder looking down on headwall

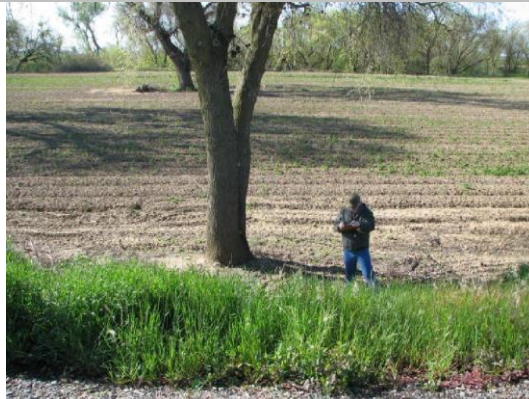
Photo 3 of 3 : UCIP\_SP\_2018\_33374\_60425.jpg

WS toe looking down from shoulder

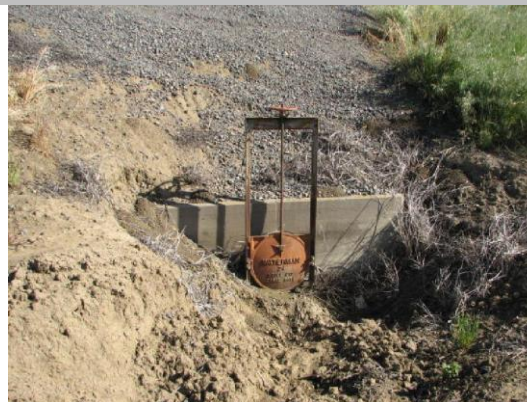
Photo 2 of 3 : UCIP\_SP\_2018\_33371\_60416.jpg

WS slide gate

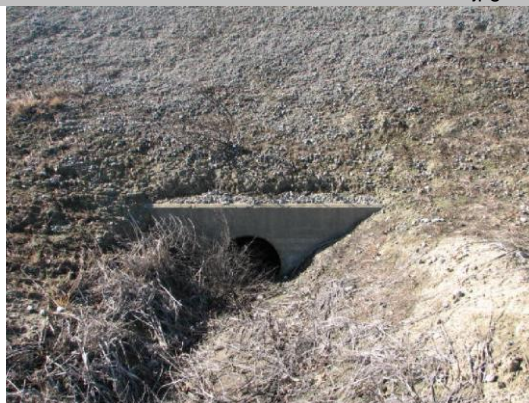
Photo 3 of 3 : UCIP\_SP\_2018\_33371\_60417.jpg

Comment Code						
Inspector Comment						
FS_ID:33371						
DS_ID:500						
EP_NO: 10256						
Repair Type: No Action Needed						
Crossing Status: Found						
UCIP Comments: Debris removed. See picture						
FIELD_STRUCT_DESC: 24-inch corrugated metal drainage pipe						
through the levee, 15 feet below the crown. Slide gate on the waterside						
(WS) end. Concrete headwall on the landside (LS) end. (24-inch pipe						
[HLM 5.39] authorized under Automatic Board Order (ABO) issued as						
Permit No. 10256, 1974 - Albert H. Lederer). [Additional Reference(s):						
DWR Levee Log, 2005. USACE Sacramento O&M Manual 119,						
December 1952, (Station 83+70 PCT)].						
FS Date: 4/10/2014 2:37:39 PM

LS headwall showing debris

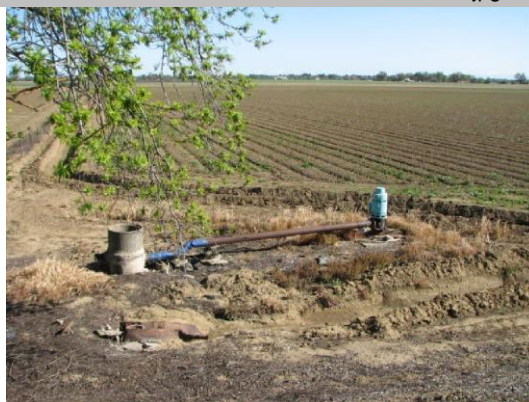
Photo 1 of 2 : UCIP\_SP\_2018\_33370\_60415.jpg

LS pump and stand pipe

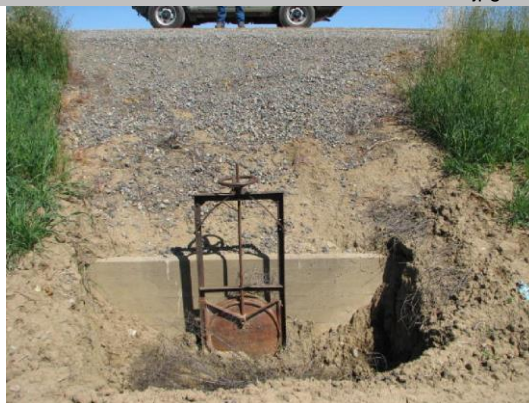
Photo 2 of 2 : UCIP\_SP\_2018\_33364\_60400.jpg

Comment Code					
Inspector Comment					
FS_ID:33364 DS_ID:503 EP_NO: 10252 Repair Type: No Action Needed Crossing Status: Found UCIP Comments: owner of pipe needs to clean out obstruction in pipe. FIELD_STRUCT_DESC: 24-inch corrugated metal drainage pipe through the levee, 12 feet below the crown. Slide gate on the waterside (WS) end. Concrete headwall on the landside (LS) end. (24-inch pipe [HLM 5.86] authorized under Automatic Board Order (ABO) issued as Permit No. 10252, 1974 - John F. Hamel). [Additional Reference(s): DWR Levee Log, 2005. USACE Sacramento O&M Manual 119, December 1952, (Station 108+00 PCT)]. FS Date: 4/10/2014 2:34:15 PM

WS headwall and slidegate

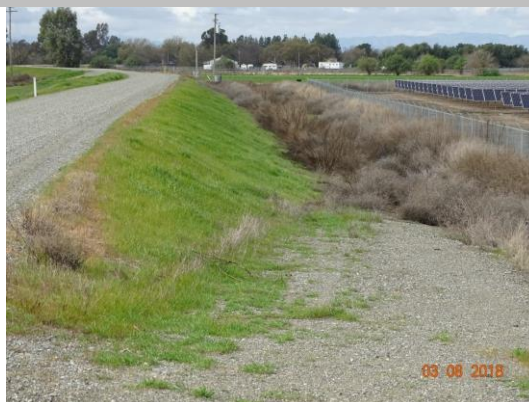
Photo 1 of 1 : SP\_2018\_ST0007\_282\_36\_20180312\_00109.jpg

LM Start	6.33	Rating **	M	Issue No.	36
LM End	6.44	Issue Type +	Ma	Location *	LS
Category	Earthen Levee			GPS Latitude/Longitude	
				Start	End
Item	Vegetation			38.518278 °	38.518217 °
				-121.741786 °	-121.743914 °
DWR ID	DWR_ST0007_01_s_2018_36				
Comment Code					
V2 : Remove the wild growth other than native grasses from the levee slopes.					
Inspector Comment					
Remove tall weeds from LS toe to allow inspection and access.

Large weeds at levee toe are dead, but should be removed to allow inspection and access.

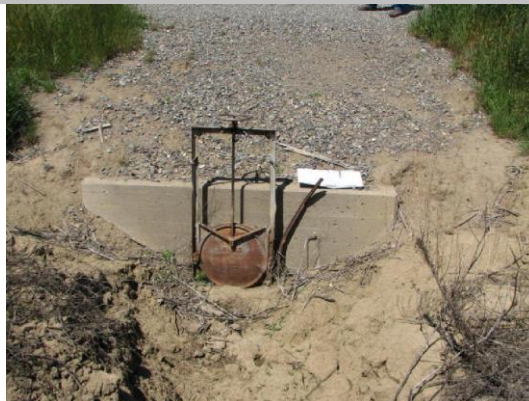
Photo 1 of 2 : UCIP\_SP\_2018\_33349\_60372.jpg

WS Slide Gate

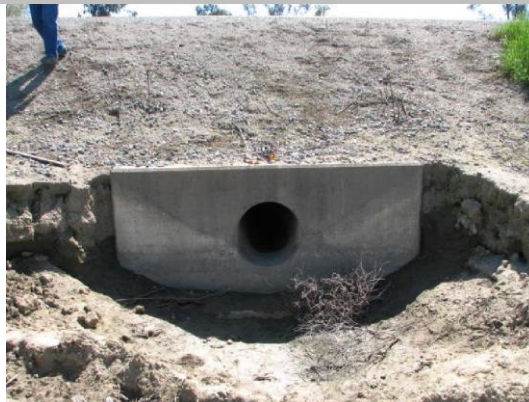
Photo 2 of 2 : UCIP\_SP\_2018\_33349\_60371.jpg

LS Headwall

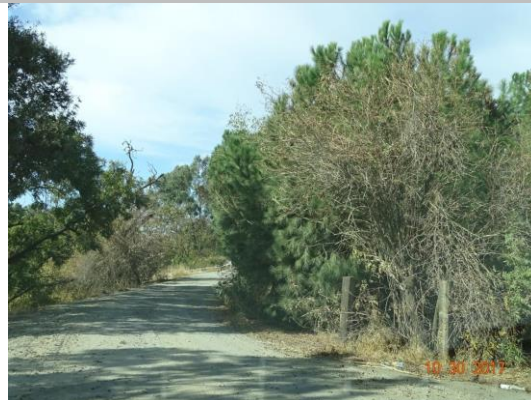
Photo 1 of 1 : SP\_2018\_ST0007\_282\_56\_20180305\_00009.jpg

Trees and bushes on landside block visibility and access. Includes elderberries.

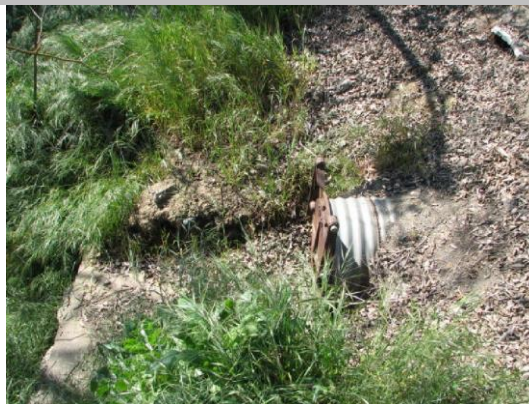
Photo 1 of 3 : UCIP\_SP\_2018\_33343\_60357.jpg

WS flap gate

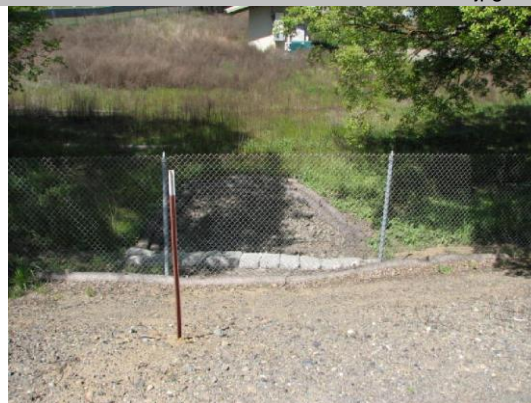
Photo 2 of 3 : UCIP\_SP\_2018\_33343\_60359.jpg

LS headwall

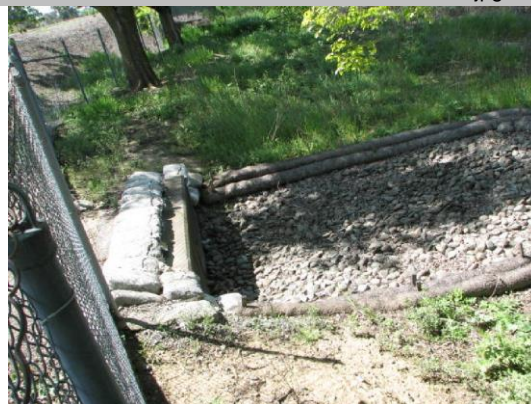
Photo 3 of 3 : UCIP\_SP\_2018\_33343\_60358.jpg

LS headwall

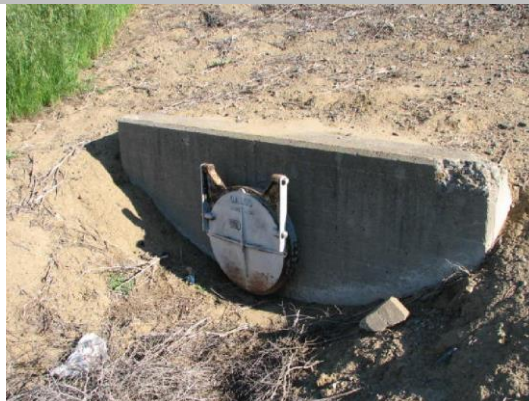
Photo 1 of 2 : UCIP\_SP\_2018\_41353\_60345.jpg

WS Flap Gate and headwall.

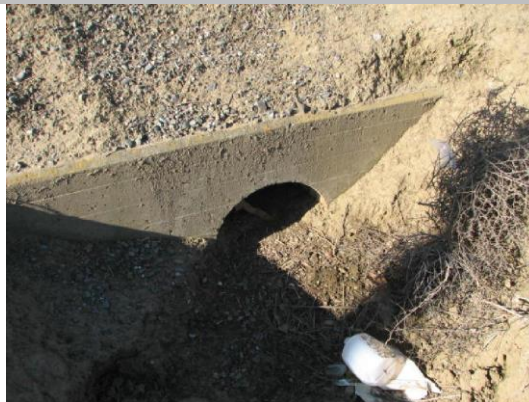
Photo 2 of 2 : UCIP\_SP\_2018\_41353\_60344.jpg

FS\_ID:41353  
DS\_ID:516  
EP\_NO: 10260  
Repair Type: Non-Urgent  
Crossing Status: Found  
UCIP Comments: Pipe is partially obstructed with sedimentation.  
Owner of pipe may have to clean sediment  
FIELD\_STRUCT\_DESC: 24-inch corrugated metal drainage pipe through the levee, 12 feet below the crown. Flap gate on the waterside (WS) end. (24-inch pipe [HLM 7.52] authorized under Automatic Board Order (ABO) issued as Permit No. 10260, 1974 - Southern Pacific Transportation Company). [Additional Reference(s): DWR Levee Log, 2005. USACE Sacramento O&M Manual 119, December 1952, (Station 193+20 PCT)].  
FS Date: 4/10/2014 2:25:00 PM

LS headwall showing pipe partially blocked with soil.

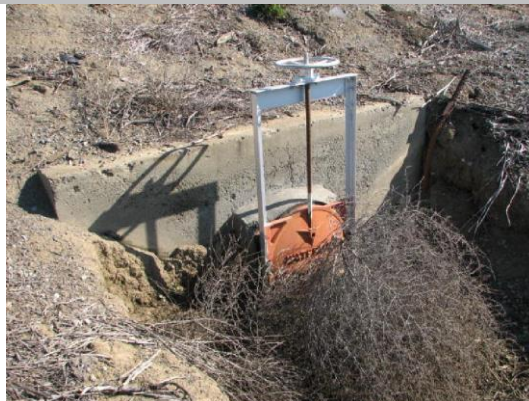
Photo 1 of 2 : UCIP\_SP\_2018\_33333\_60342.jpg

WS headwall and slide gate

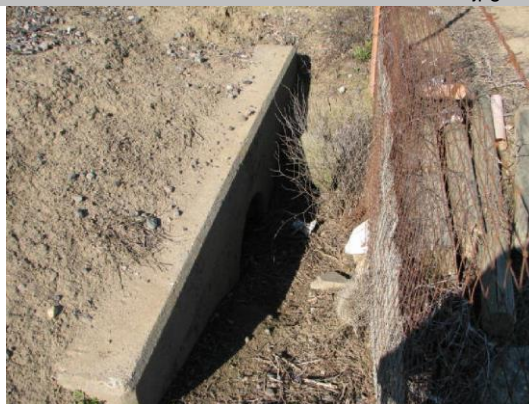
Photo 2 of 2 : UCIP\_SP\_2018\_33333\_60341.jpg

FS\_ID:33333  
DS\_ID:518  
EP\_NO: 10247  
Repair Type: No Action Needed  
Crossing Status: Found  
UCIP Comments: Fence blocking inlet. Owner of fence needs to move fence away from inlet.  
FIELD\_STRUCT\_DESC: 24-inch corrugated metal drainage pipe through the levee, 12 feet below the crown. Slide gate on the waterside (WS) slope, and headwalls on both sides. (24-inch pipe [HLM 7.75] authorized under Automatic Board Order (ABO) issued as Permit No. 10247, 1974 - University of California, Office of the Regents).  
[Additional Reference(s): DWR Levee Log, 2005. USACE Sacramento O&M Manual 119, December 1952, (Station 204+00 PCT)].  
FS Date: 4/10/2014 2:24:52 PM

LS headwall showing fence and soil buildup.

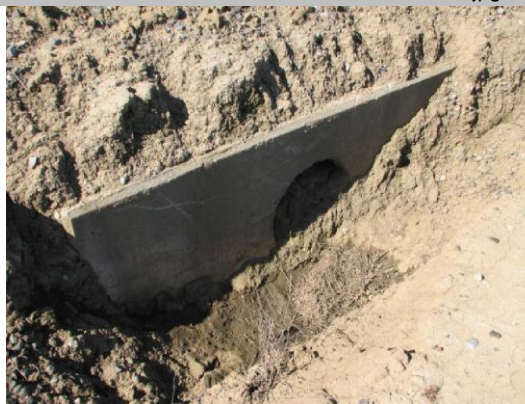
Photo 2 of 3 : UCIP\_SP\_2018\_33328\_60327.jpg

FS\_ID:33328  
 DS\_ID:520  
 EP\_NO: 10247  
 Repair Type: No Action Needed  
 Crossing Status: Found  
 UCIP Comments: Cleaned inlet and outlets. Owner of pipe may need to clean pipe  
 FIELD\_STRUCT\_DESC: 24-inch corrugated metal drainage pipe through the levee, 8 feet below the crown. Slide gate on the waterside (WS) end. (24-inch pipe [HLM 8.45] authorized under Automatic Board Order (ABO) issued as Permit No. 10247, 1974 - University of California, Office of the Regents). [Additional Reference(s): DWR Levee Log, 2005. USACE Sacramento O&M Manual 119, December 1952, (Station 241+50 PCT)].  
 FS Date: 4/10/2014 2:23:46 PM

LS headwall showing pipe plugged with soil

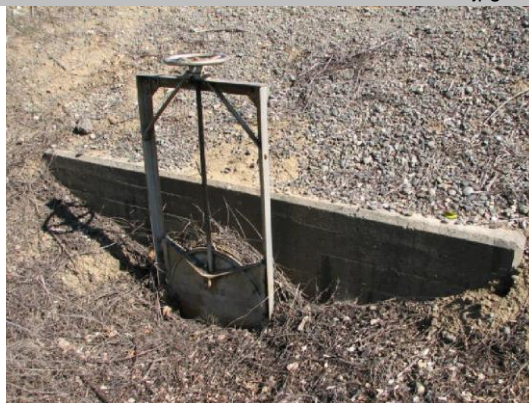
Photo 3 of 3 : UCIP\_SP\_2018\_33328\_60328.jpg

WS slide gate showing some blockage with soil.

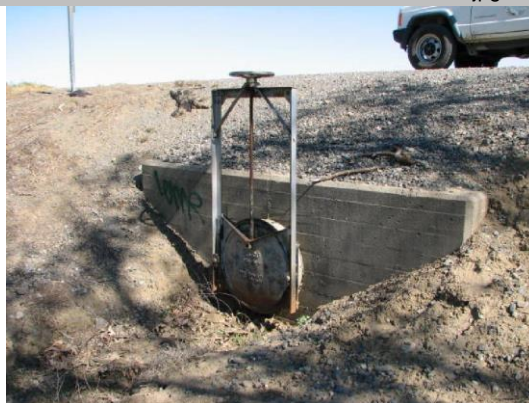
Photo 1 of 2 : UCIP\_SP\_2018\_33327\_60326.jpg

WS headwall and slidegate

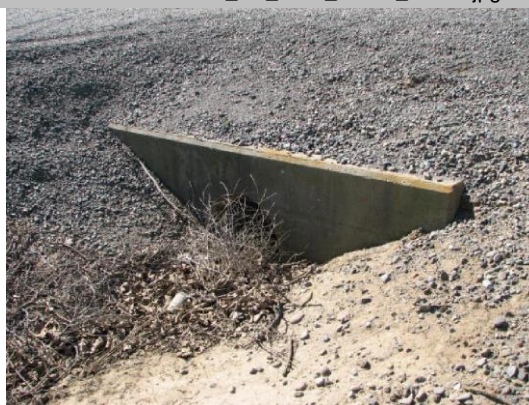
Photo 2 of 2 : UCIP\_SP\_2018\_33327\_60325.jpg

FS\_ID:33327  
DS\_ID:521  
EP\_NO: 10247  
Repair Type: No Action Needed  
Crossing Status: Found  
UCIP Comments: Removed material at slidegate and inlet.  
FIELD\_STRUCT\_DESC: 24-inch corrugated metal drainage pipe through the levee, 7 feet below the crown. Slide gate on the waterside (WS) end. Headwalls on both ends. (24-inch pipe [HLM 8.50] authorized under Automatic Board Order (ABO) issued as Permit No. 10247, 1974 - University of California, Office of the Regents. Also mentioned in Permit No. 5896, 1967 - The Regents of the University of California, Office of Architects and Engineers, University of California, Davis Campus). [Additional Reference(s): DWR Levee Log, 2005. USACE Sacramento O&M Manual 119, December 1952, (Station 244+20 PCT)].  
FS Date: 4/10/2014 2:23:16 PM

LS headwall showing partial blockage

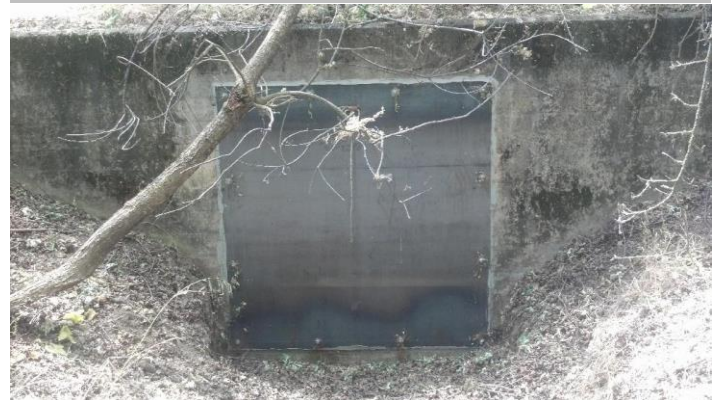
Photo 1 of 3 : UCIP\_SP\_2018\_41129\_60301.jpg

Comment Code					
Inspector Comment					
FS_ID:41129 DS_ID:523 EP_NO: 10247 Repair Type: Non-Urgent Crossing Status: Found UCIP Comments: *ABANDONED* FIELD_STRUCT_DESC: *ABANDONED* 48-inch drainage pipe of an unknown material through the levee, 15 feet below the crown. Steel plate installed over inlet off the landside (LS) toe. Pipe not grouted. Flap gate on waterside (WS) end. Headwalls on both ends. (48-inch pipe [HLM 8.88] authorized under Automatic Board Order (ABO) issued as Permit No. 10247, 1974 - University of California, Office of the Regents). [Additional Reference(s): DWR Levee Log, 2005. USACE Sacramento O&M Manual 119, December 1952, (Station 262+30 PCT)]. FS Date: 4/10/2014 2:21:00 PM

Steel plate installed over pipe off LS toe.

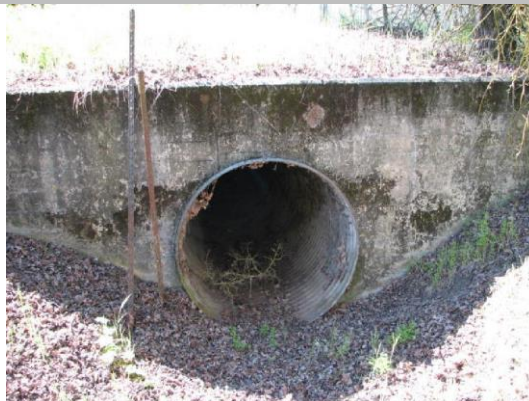
Photo 2 of 3 : UCIP\_SP\_2018\_41129\_60299.jpg

LS headwall and pipe before steel plate was installed over pipe to abandon it.

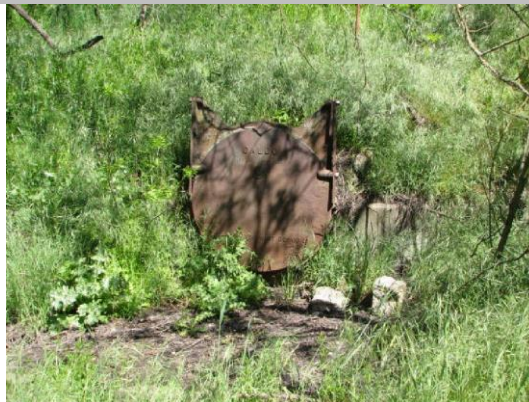
Photo 3 of 3 : UCIP\_SP\_2018\_41129\_60300.jpg

WS flap gate

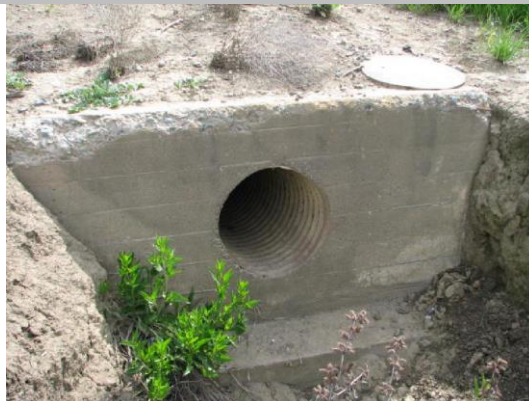
Photo 1 of 3 : UCIP\_SP\_2018\_33410\_60496.jpg

L/S headwall and pipe

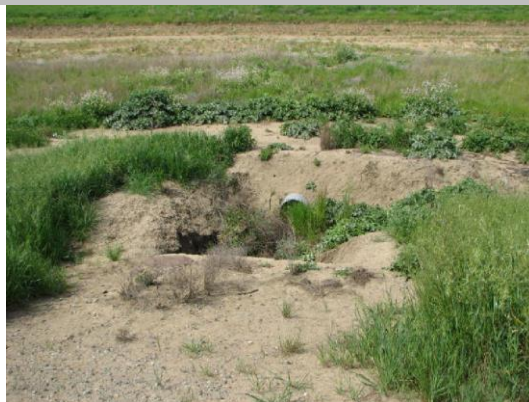
Photo 2 of 3 : UCIP\_SP\_2018\_33410\_60498.jpg

L/S headwall at pipe

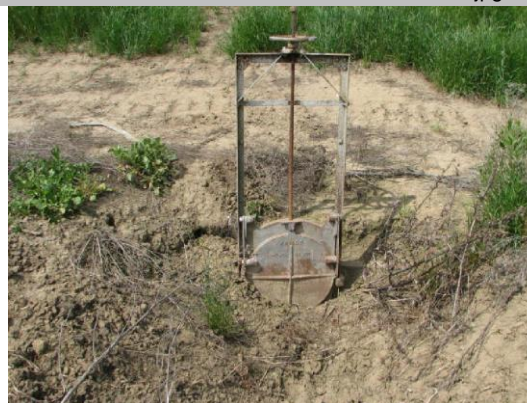
Photo 3 of 3 : UCIP\_SP\_2018\_33410\_60497.jpg

W/S slide gate

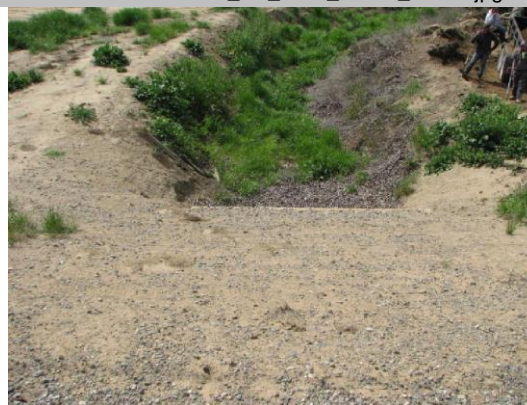
Photo 1 of 3 : UCIP\_SP\_2018\_33407\_60489.jpg

L/S inlet

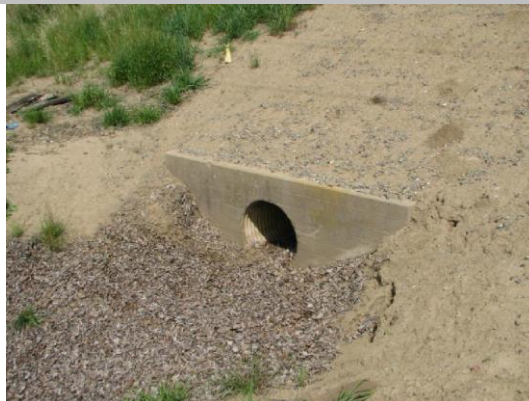
Photo 2 of 3 : UCIP\_SP\_2018\_33407\_60492.jpg

L/S headwall

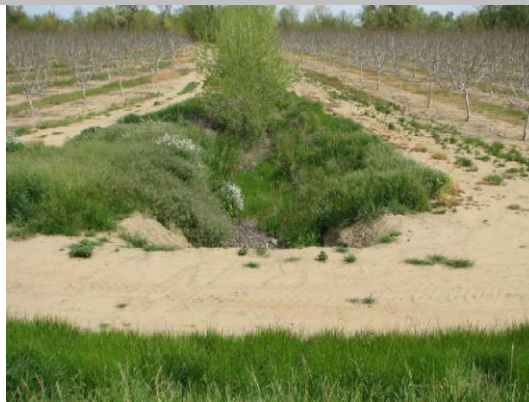
Photo 3 of 3 : UCIP\_SP\_2018\_33407\_60491.jpg

W/S Channel

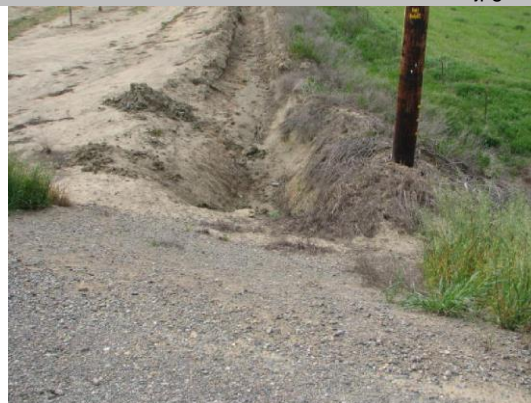
Photo 1 of 3 : UCIP\_SP\_2018\_33401\_60475.jpg

LS channel

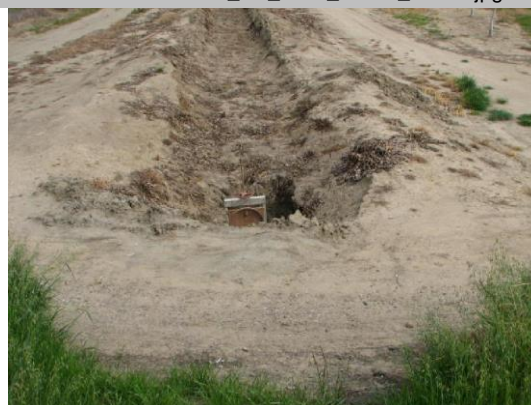
Photo 2 of 3 : UCIP\_SP\_2018\_33401\_60478.jpg

WS Channel and Slide gate

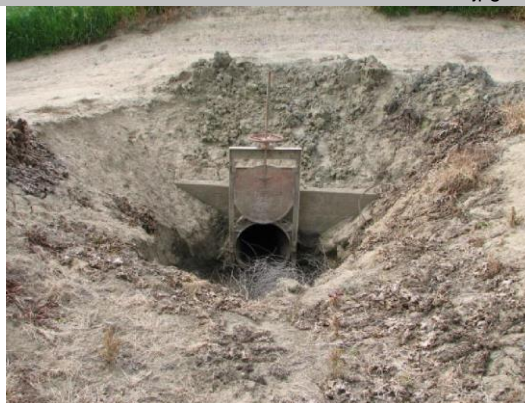
Photo 3 of 3 : UCIP\_SP\_2018\_33401\_60477.jpg

WS slide gate

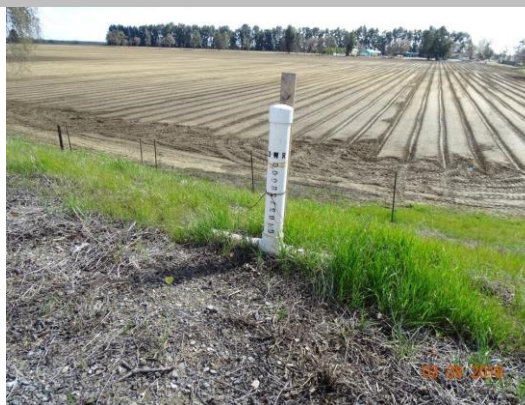
Photo 1 of 1 : SP\_2018\_ST0007\_283\_9\_20180312\_00094.jpg

Rodent bait station at LM 2.09.

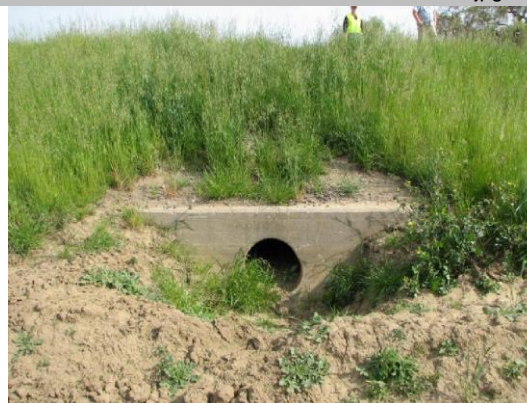
Photo 1 of 2 : UCIP\_SP\_2018\_33395\_60460.jpg

LS headwall

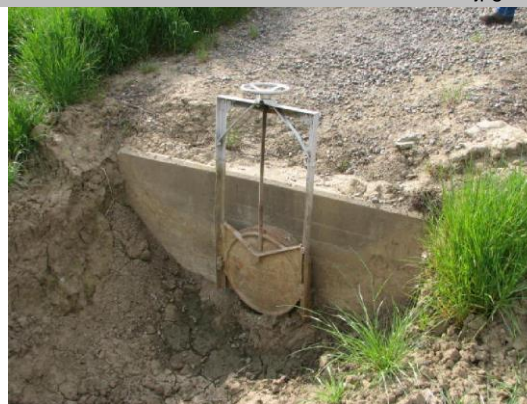
Photo 2 of 2 : UCIP\_SP\_2018\_33395\_60459.jpg

WS headwall and slidegate

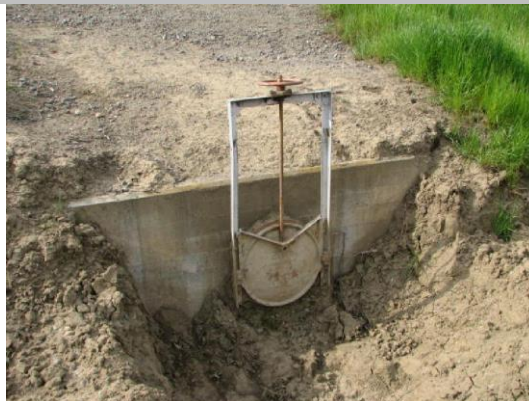
Photo 1 of 2 : UCIP\_SP\_2018\_33393\_60456.jpg

WS headwall and slide gate

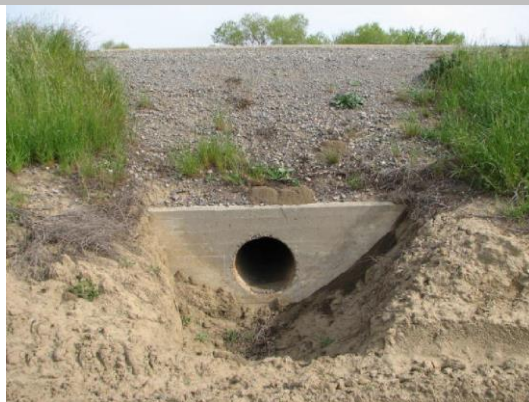
Photo 2 of 2 : UCIP\_SP\_2018\_33393\_60455.jpg

LS headwall and pipe

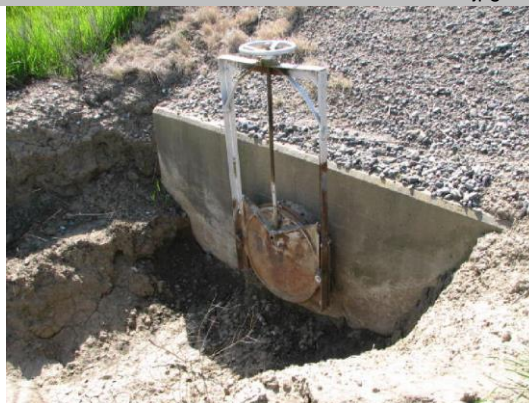
Photo 1 of 2 : UCIP\_SP\_2018\_33380\_60438.jpg

WS headwall and slide gate

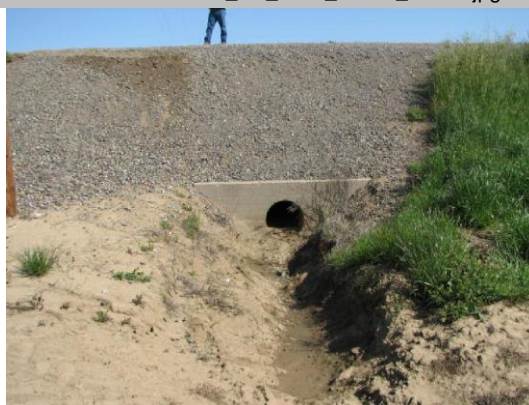
Photo 2 of 2 : UCIP\_SP\_2018\_33380\_60437.jpg

LS headwall

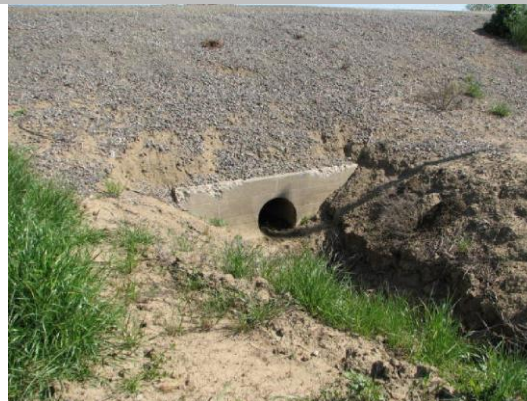
Photo 1 of 2 : UCIP\_SP\_2018\_33378\_60435.jpg

LS headwall

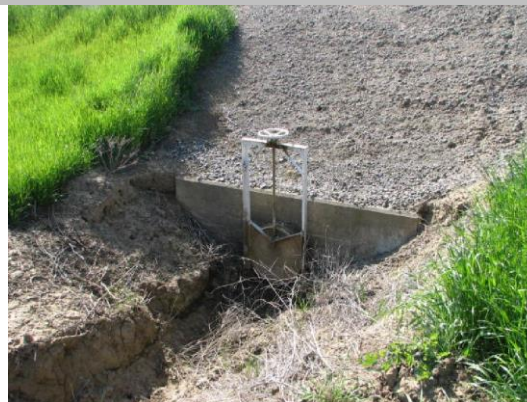
Photo 2 of 2 : UCIP\_SP\_2018\_33378\_60434.jpg

WS slide gate and headwall

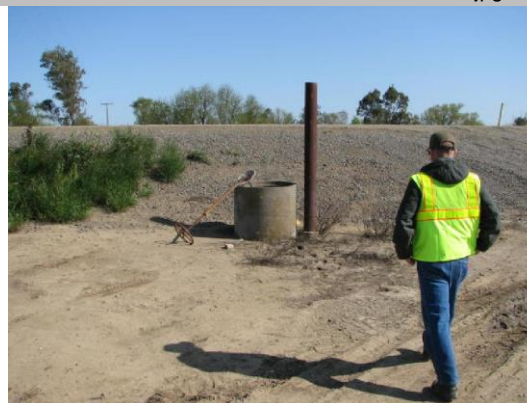
Photo 1 of 3 : UCIP\_SP\_2018\_33375\_60427.jpg

LS 36-inch standpipe

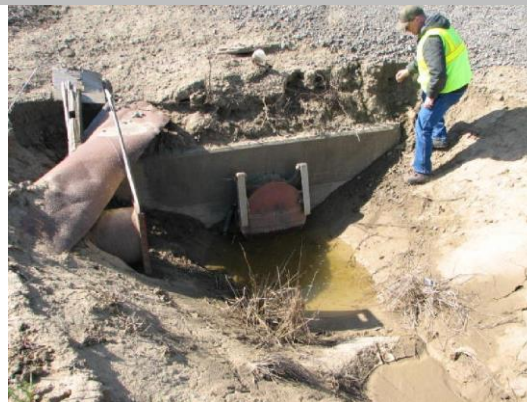
Photo 2 of 3 : UCIP\_SP\_2018\_33375\_60429.jpg

WS headwall and flapgate.

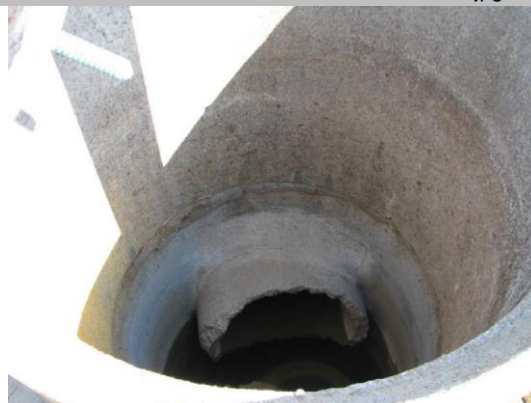
Photo 3 of 3 : UCIP\_SP\_2018\_33375\_60428.jpg

LS looking down standpipe at CC pipe

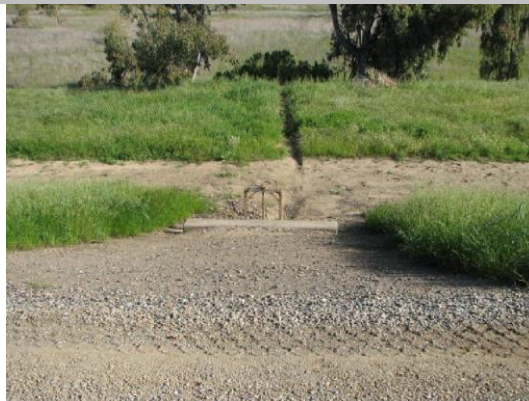
Photo 1 of 3 : UCIP\_SP\_2018\_33369\_60411.jpg

W/S

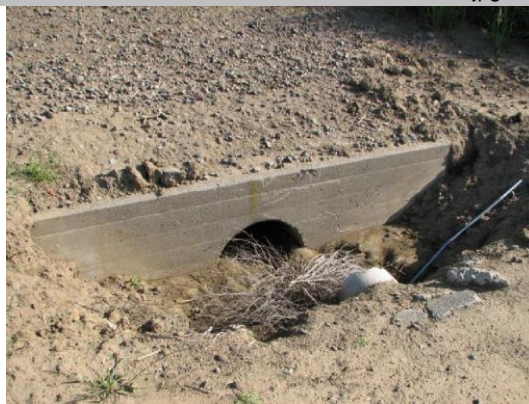
Photo 2 of 3 : UCIP\_SP\_2018\_33369\_60413.jpg

L/S Clogged

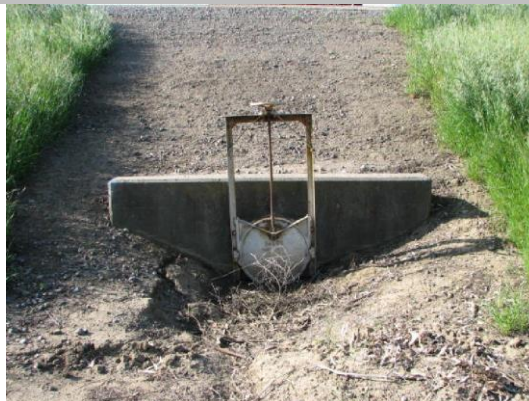
Photo 3 of 3 : UCIP\_SP\_2018\_33369\_60412.jpg

W/S positive closure device

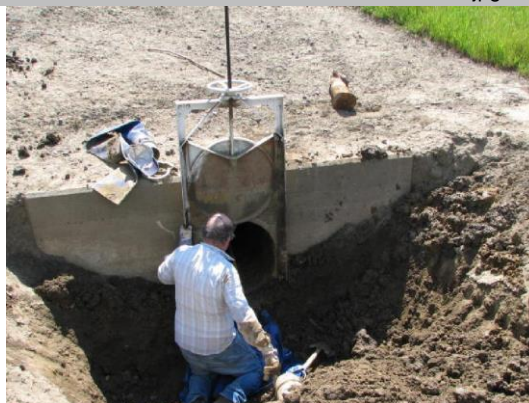
Photo 1 of 2 : UCIP\_SP\_2018\_33363\_60399.jpg

WS slide gate and headwall. 6-inch irrigation pipe just inside 24-inch pipe.

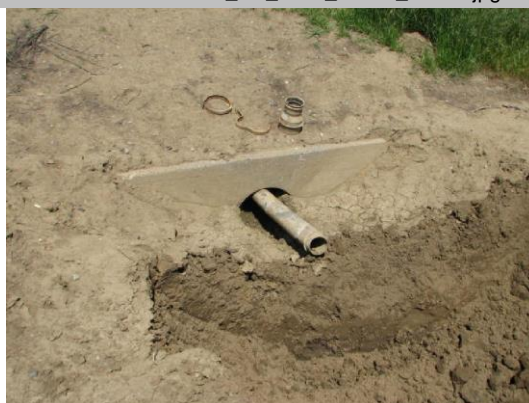
Photo 2 of 2 : UCIP\_SP\_2018\_33363\_60398.jpg

LS headwall showing sedimentation and 6-inch pipe sleeved through 24-inch pipe.

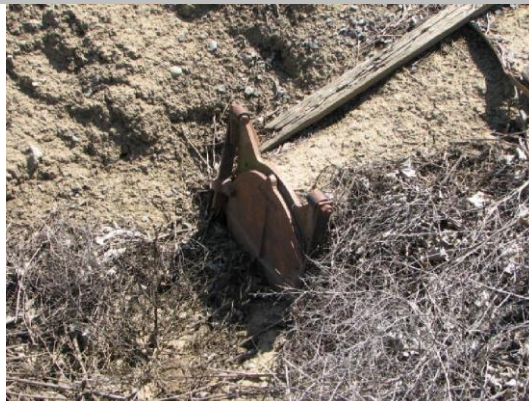
Photo 1 of 2 : UCIP\_SP\_2018\_42953\_60397.jpg

WS Flapgate blocked by sedimentation

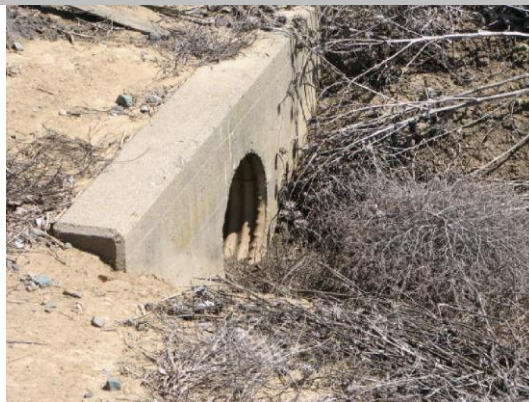
Photo 2 of 2 : UCIP\_SP\_2018\_42953\_60396.jpg

LS headwall

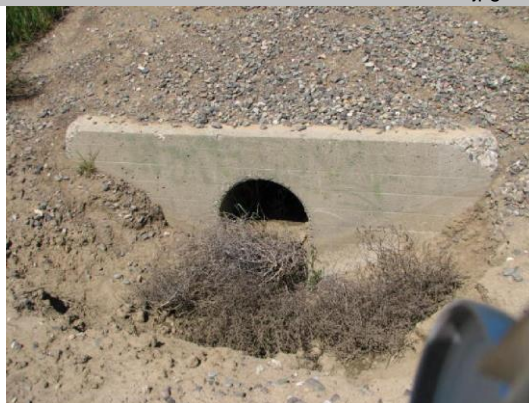
Photo 1 of 2 : UCIP\_SP\_2018\_33353\_60380.jpg

LS headwall and pipe showing sediment buildup.

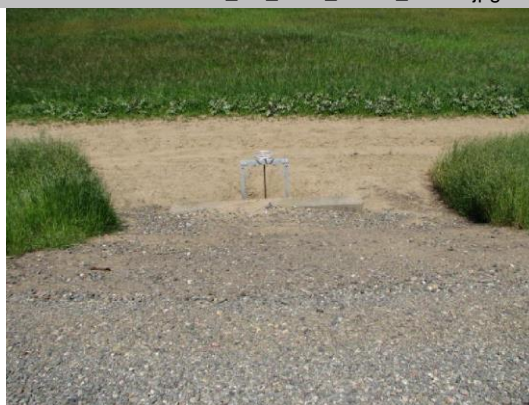
Photo 2 of 2 : UCIP\_SP\_2018\_33353\_60379.jpg

WS slide gate

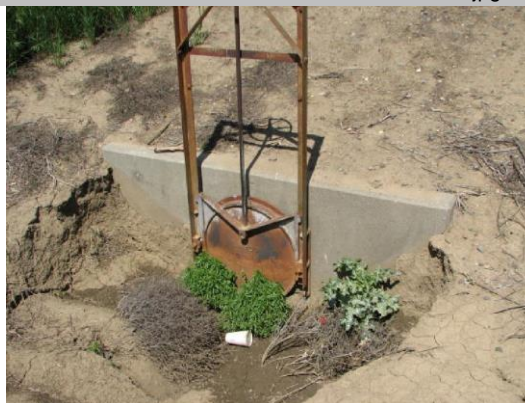
Photo 1 of 2 : UCIP\_SP\_2018\_42959\_60374.jpg

LS slide gate

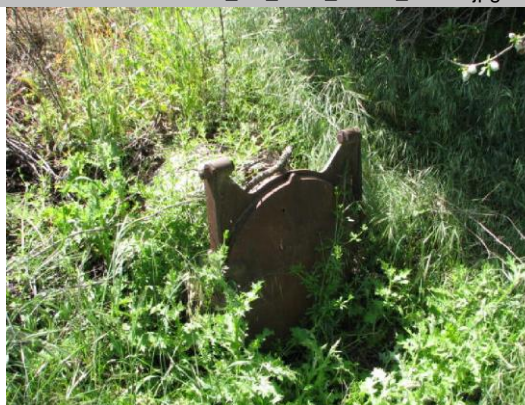
Photo 2 of 2 : UCIP\_SP\_2018\_42959\_60373.jpg

WS flap gate

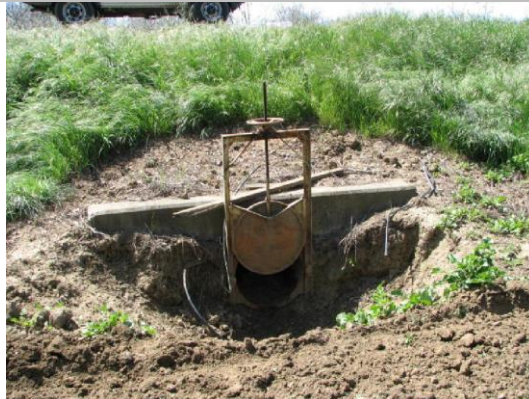
Photo 1 of 2 : UCIP\_SP\_2018\_33346\_60364.jpg

WS slide gate showing soil plug

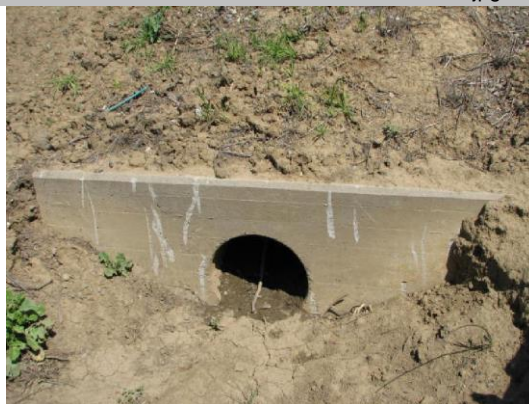
Photo 2 of 2 : UCIP\_SP\_2018\_33346\_60363.jpg

LS headwall showing soil plug

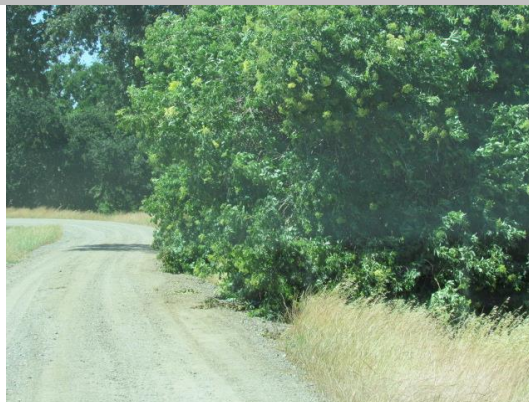
Photo 1 of 1 : SP\_2018\_ST0007\_283\_47\_20180305\_00013.jpg

Elderberry bushes blocking view of waterside shoulder at this location.
