**Flood Control Project Maintenance  
Levee Inspections**

## Maintenance Issue Types Only, Levee Inspection Report By Mile - Spring 2019

### Sacramento Maintenance Yard Putah Creek

Waterway	Bank	Unit Miles	Inspection Start/End	Inspector
Unit No. 01 Putah Creek or North Levee	Left	8.79	04/18/2019 04/18/2019	David Julian

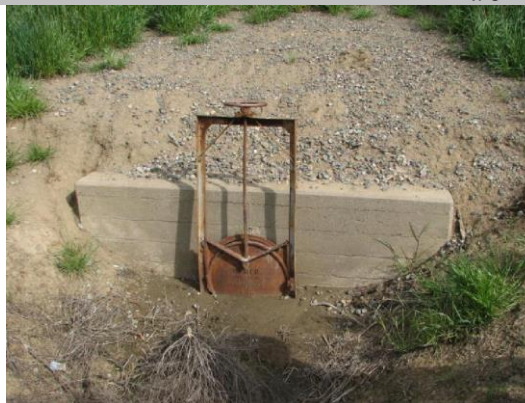
Photo 1 of 3 : UCIP\_SP\_2019\_33408\_60493.jpg

WS slide gate and headwall

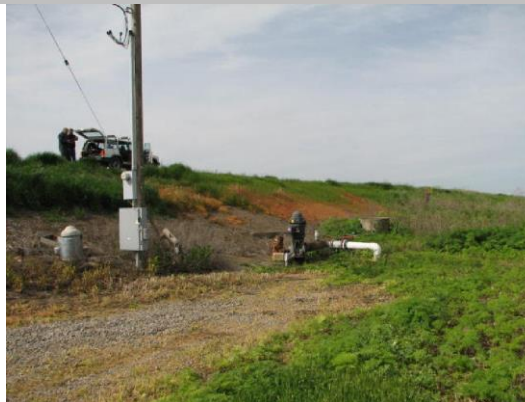
Photo 2 of 3 : UCIP\_SP\_2019\_33408\_60495.jpg

LS pump and appurtenances

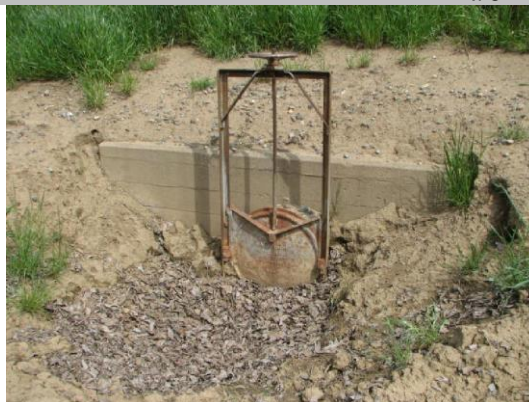
Photo 1 of 2 : UCIP\_SP\_2019\_33394\_60458.jpg

Comment Code					
Inspector Comment					
FS_ID:33394 DS_ID:492 EP_NO: 10262 Repair Type: No Action Needed Crossing Status: Found UCIP Comments: FIELD_STRUCT_DESC: 24-inch drainage pipe of unknown material through levee, 13 feet below crown. Slide gate is located on the waterside (WS) end. Concrete headwalls are located on both the waterside (WS) and landside (LS). (24-inch pipe [HLM 2.77] authorized under Automatic Board Order (ABO) issued as Permit No. 10262, 1974 - Wells Fargo Bank, Trustee for S.H. Cowell Foundation) [Additional Reference(s): DWR Levee Log, 1981 and 2005. USACE Sacramento O&M Manual Unit 119, December 1952, (Station XX+XX)] FS Date: 4/10/2014 2:43:44 PM

WS Slide gate

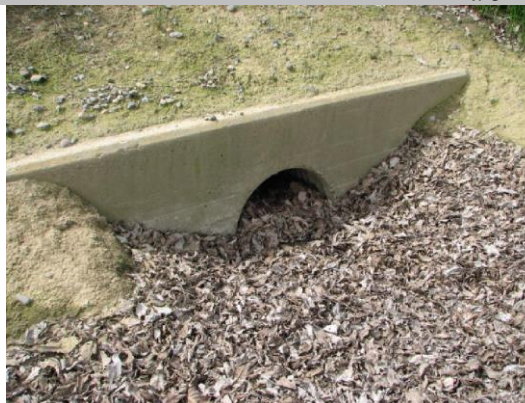
Photo 2 of 2 : UCIP\_SP\_2019\_33394\_60457.jpg

LS headwall

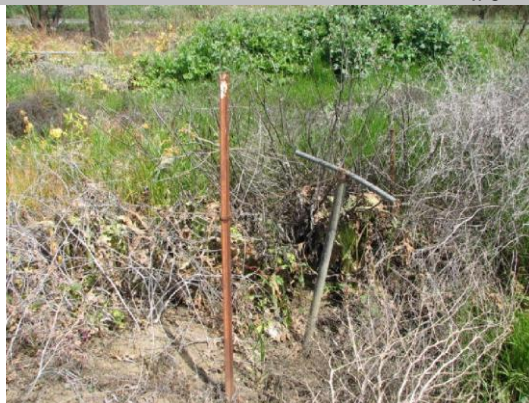
Photo 1 of 3 : UCIP\_SP\_2019\_53863\_60439.jpg

FS\_ID:53863  
DS\_ID:496  
EP\_NO: 10251  
Repair Type: Urgent  
Crossing Status: Found  
UCIP Comments: 4/10/2019 Major erosion through out pipe. Erosion on WS allows water to enter pipe and flood LS field. Erosion on farmers waterman valve. Field water drains into pipe and floods LS field. (J.McCabe DWR Sacramento Yard)  
FIELD\_STRUCT\_DESC: 24-inch corrugated metal drainage pipe through levee, 15 feet below the crown. Two metal cutoff walls were installed through the levee. A T-post and T-handle are located on the landside (LS) toe. The outfall structure and flap gate are located on the west side of bridge, waterside (WS). (24-inch pipe [HLM 3.87] authorized under Automatic Board Order (ABO) issued as Permit No. 10251, 1974 - F.M.C. Corp.) [Additional Reference(s): DWR Levee Log, 1981 and 2005. USACE Sacramento O&M Manual Unit 119, December 1952, (Station XX+XX)]  
FS Date: 4/9/2019 9:31:57 AM

WS toe at T handle. No access to pipe.

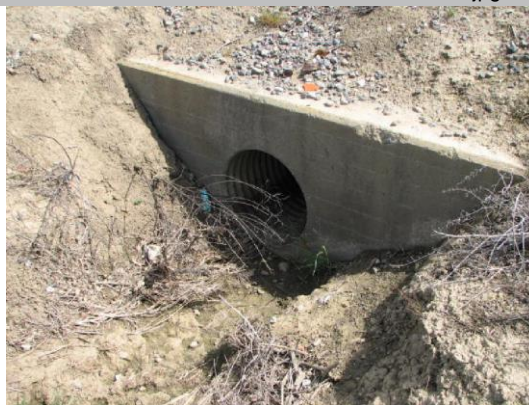
Photo 2 of 3 : UCIP\_SP\_2019\_53863\_60441.jpg

LS headwall and pipe

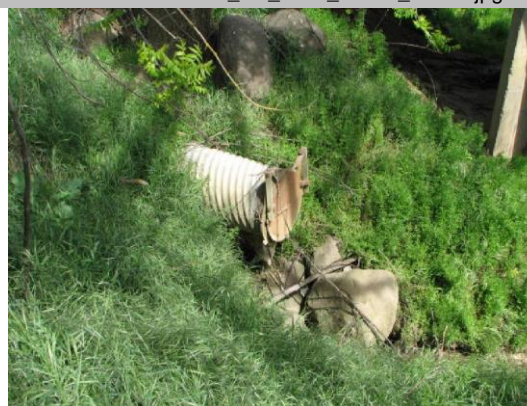
Photo 3 of 3 : UCIP\_SP\_2019\_53863\_60440.jpg

Outfall at creek with flap gate.

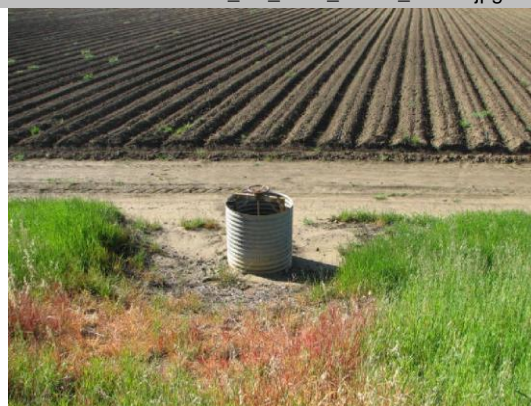
Photo 1 of 1 : UCIP\_SP\_2019\_33379\_60436.jpg

Slide gate in 36-inch Standpipe on WS toe.

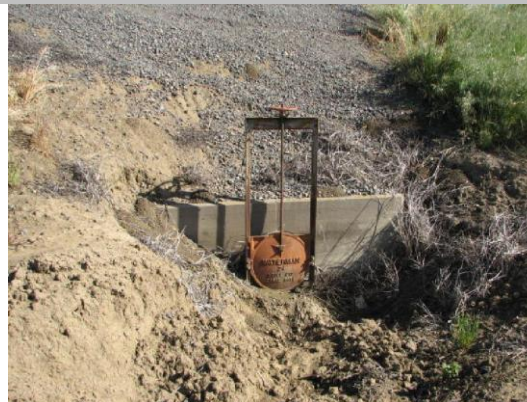
Photo 2 of 3 : UCIP\_SP\_2019\_33371\_60416.jpg

WS slide gate

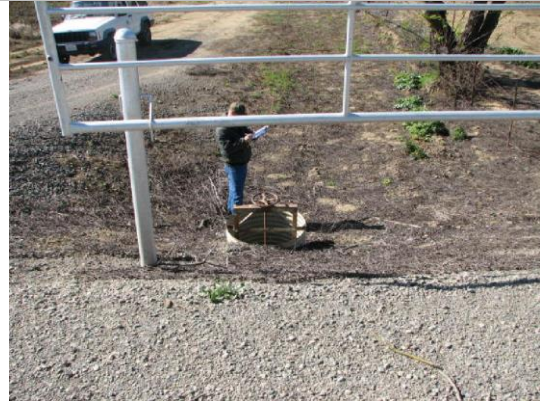
Photo 2 of 2 : UCIP\_SP\_2019\_33370\_60414.jpg

WS slide gate in 36-inch cmp standpipe

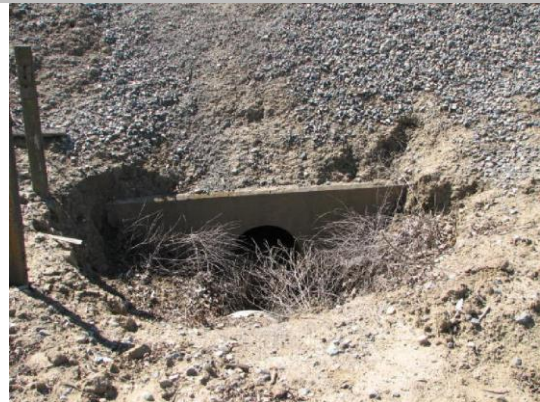
Photo 1 of 2 : UCIP\_SP\_2019\_33368\_60410.jpg

LS headwall

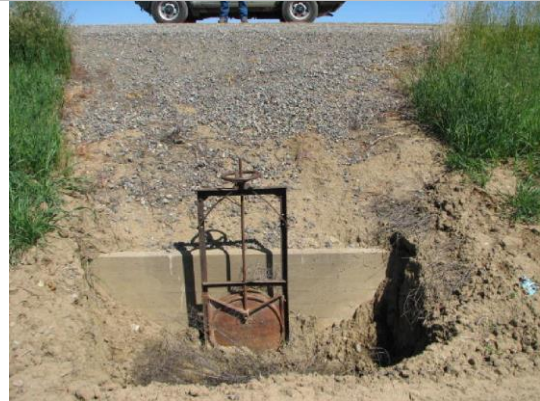
Photo 2 of 2 : UCIP\_SP\_2019\_33364\_60400.jpg

Comment Code						
Inspector Comment						
FS_ID:33364 DS_ID:503 EP_NO: 10252 Repair Type: No Action Needed Crossing Status: Found UCIP Comments: owner of pipe needs to clean out obstruction in pipe. FIELD_STRUCT_DESC: 24-inch corrugated metal drainage pipe through the levee, 12 feet below the crown. Slide gate on the waterside (WS) end. Concrete headwall on the landside (LS) end. (24-inch pipe [HLM 5.86] authorized under Automatic Board Order (ABO) issued as Permit No. 10252, 1974 - John F. Hamel). [Additional Reference(s): DWR Levee Log, 2005. USACE Sacramento O&M Manual 119, December 1952, (Station 108+00 PCT)]. FS Date: 4/10/2014 2:34:15 PM

WS headwall and slidegate

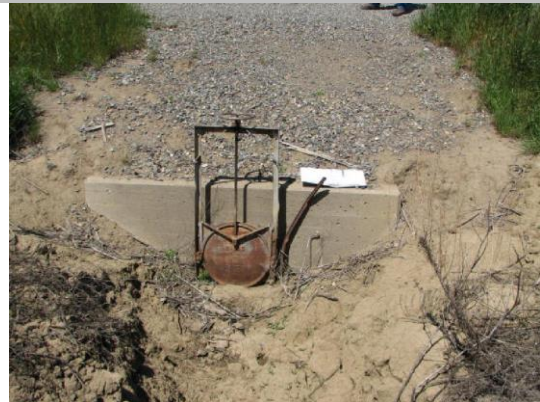
Photo 1 of 2 : UCIP\_SP\_2019\_33349\_60372.jpg

WS Slide Gate

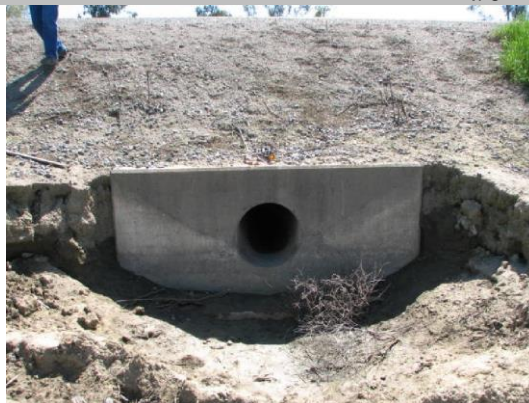
Photo 2 of 2 : UCIP\_SP\_2019\_33349\_60371.jpg

LS Headwall

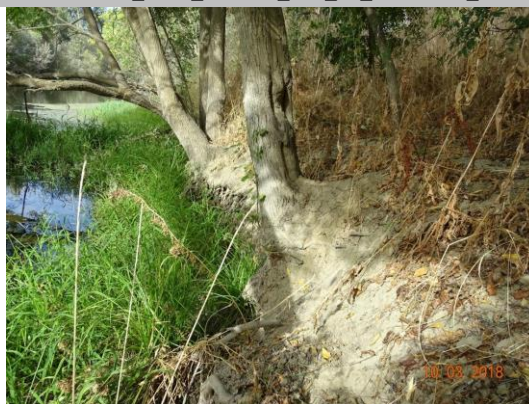
Photo 1 of 1 : SP\_2019\_ST0007\_282\_34\_20190311\_00007.jpg

LM Start	6.88	Rating **	M	Issue No.	34
LM End	6.93	Issue Type +	Ma	Location *	WS
Category	Supplemental			GPS Latitude/Longitude	
				Start	End
Item	2017 USACE Erosion Survey, DRAFT			38.517362 °	38.517355 °
				-121.751778 °	-121.752824 °
DWR ID	DWR_ST0007_01_f_2018_34				
Comment Code					
Inspector Comment					
2017 Site ID: PUC 7.2 L					
Status: Eroding					
2018 Field Notes: Erosion along lower bank with trees exposed. Erosion has not encroached on levee prism.					
2017 Field Notes: New erosion along lower bank.					
Site History: 2011 - The toe to mid-bank is slumping. Large tree pop-outs have furthered the erosion. Slope is slightly steeper than 1:1.

View looking upstream at erosion at the waterside toe. Tree roots are exposed (September 2018).

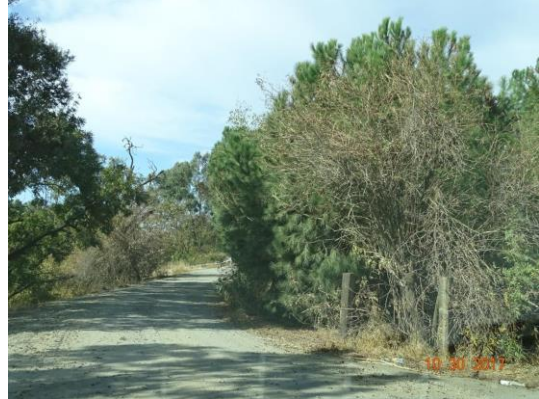
Photo 1 of 1 : SP\_2019\_ST0007\_282\_56\_20190311\_00016.jpg

Trees and bushes on landside block visibility and access. Includes elderberries.

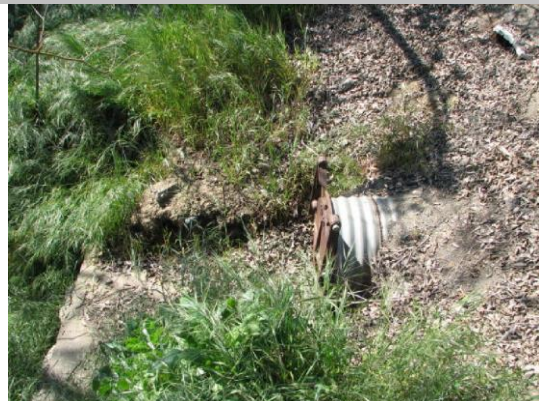
Photo 1 of 3 : UCIP\_SP\_2019\_33343\_60357.jpg

WS flap gate

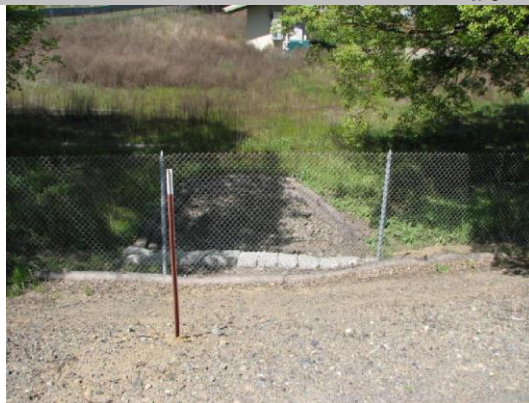
Photo 2 of 3 : UCIP\_SP\_2019\_33343\_60359.jpg

LS headwall

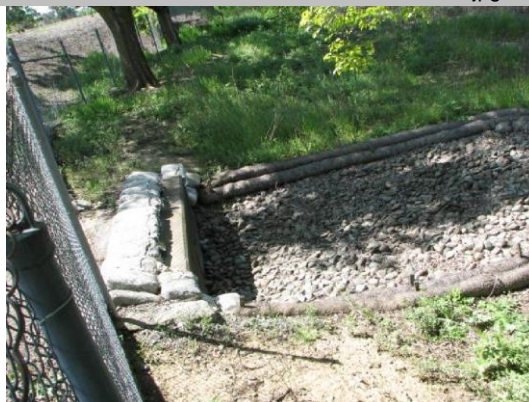
Photo 3 of 3 : UCIP\_SP\_2019\_33343\_60358.jpg

LS headwall

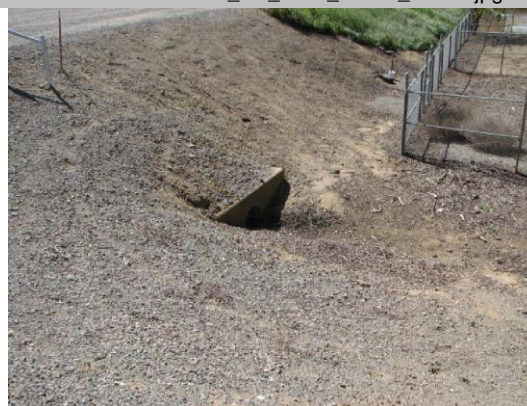
Photo 1 of 2 : UCIP\_SP\_2019\_42952\_60353.jpg

LS Headwall

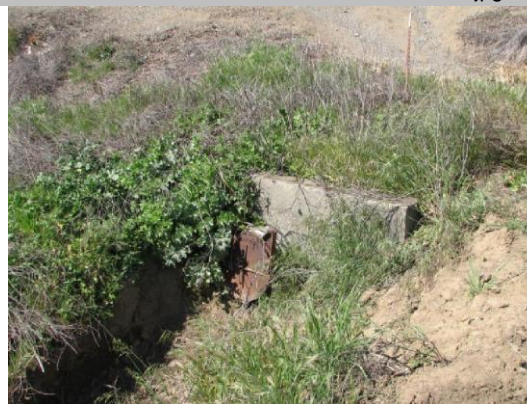
Photo 2 of 2 : UCIP\_SP\_2019\_42952\_60352.jpg

WS Flapgate

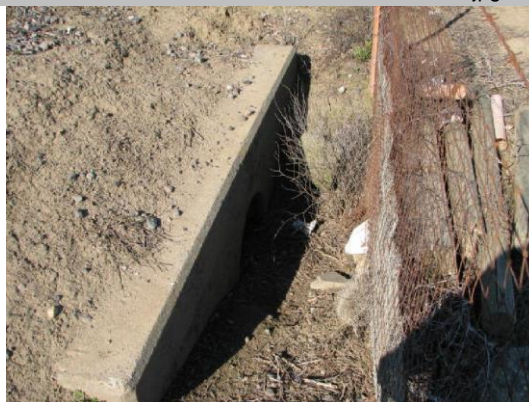
Photo 2 of 2 : UCIP\_SP\_2019\_33333\_60341.jpg

Comment Code					
Inspector Comment					
FS_ID:33333 DS_ID:518 EP_NO: 10247 Repair Type: No Action Needed Crossing Status: Found UCIP Comments: Fence blocking inlet. Owner of fence needs to move fence away from inlet. FIELD_STRUCT_DESC: 24-inch corrugated metal drainage pipe through the levee, 12 feet below the crown. Slide gate on the waterside (WS) slope, and headwalls on both sides. (24-inch pipe [HLM 7.75] authorized under Automatic Board Order (ABO) issued as Permit No. 10247, 1974 - University of California, Office of the Regents). [Additional Reference(s): DWR Levee Log, 2005. USACE Sacramento O&M Manual 119, December 1952, (Station 204+00 PCT)]. FS Date: 4/10/2014 2:24:52 PM

LS headwall showing fence and soil buildup.

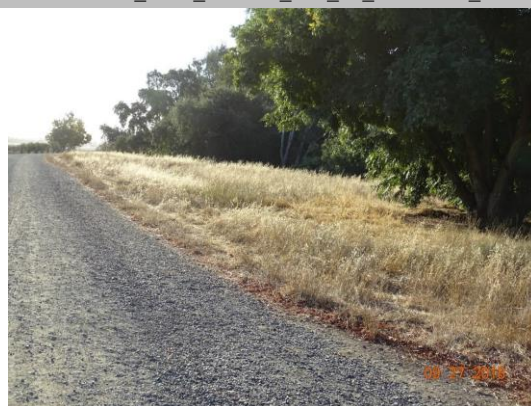
Photo 1 of 1 : SP\_2019\_ST0007\_282\_29\_20190311\_00006.jpg

View looking downstream at thick vegetation up to the crown (September 2018).

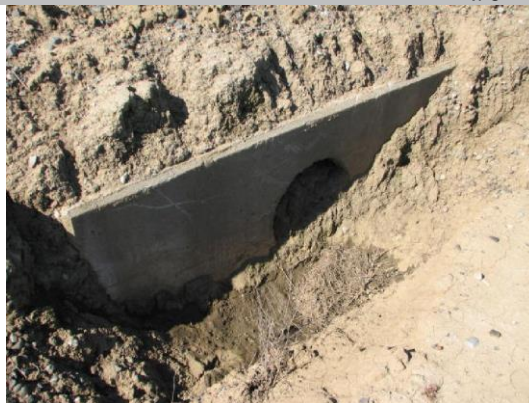
Photo 2 of 3 : UCIP\_SP\_2019\_33328\_60327.jpg

Comment Code						
Inspector Comment						
FS_ID:33328 DS_ID:520 EP_NO: 10247 Repair Type: No Action Needed Crossing Status: Found UCIP Comments: Cleaned inlet and outlets. Owner of pipe may need to clean pipe FIELD_STRUCT_DESC: 24-inch corrugated metal drainage pipe through the levee, 8 feet below the crown. Slide gate on the waterside (WS) end. (24-inch pipe [HLM 8.45] authorized under Automatic Board Order (ABO) issued as Permit No. 10247, 1974 - University of California, Office of the Regents). [Additional Reference(s): DWR Levee Log, 2005. USACE Sacramento O&M Manual 119, December 1952, (Station 241+50 PCT)]. FS Date: 4/10/2014 2:23:46 PM

LS headwall showing pipe plugged with soil

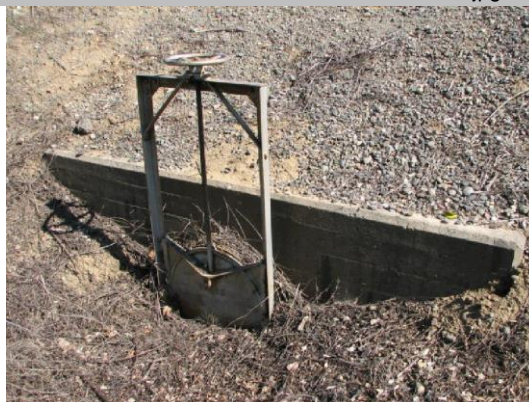
Photo 3 of 3 : UCIP\_SP\_2019\_33328\_60328.jpg

WS slide gate showing some blockage with soil.

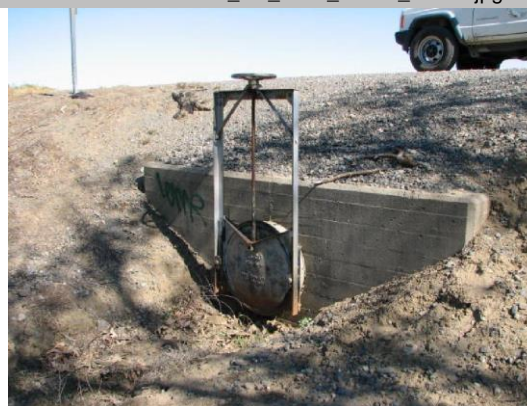
Photo 1 of 2 : UCIP\_SP\_2019\_33327\_60326.jpg

WS headwall and slidegate

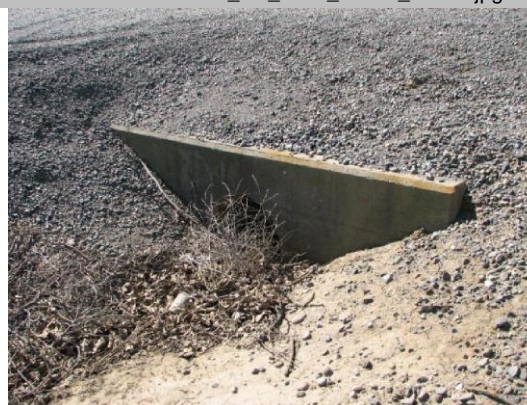
Photo 2 of 2 : UCIP\_SP\_2019\_33327\_60325.jpg

LS headwall showing partial blockage

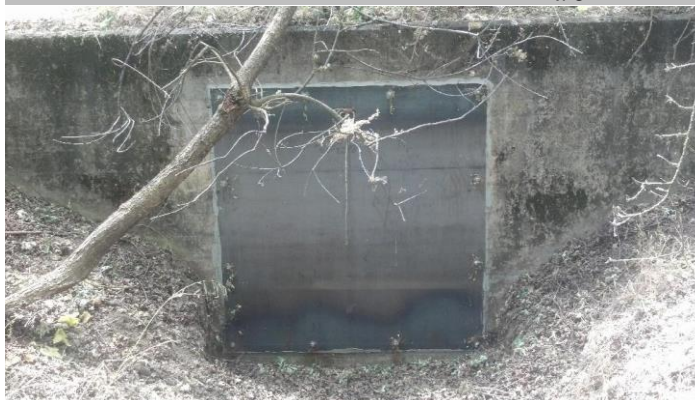
Photo 1 of 3 : UCIP\_SP\_2019\_41129\_60301.jpg

Steel plate installed over pipe off LS toe.

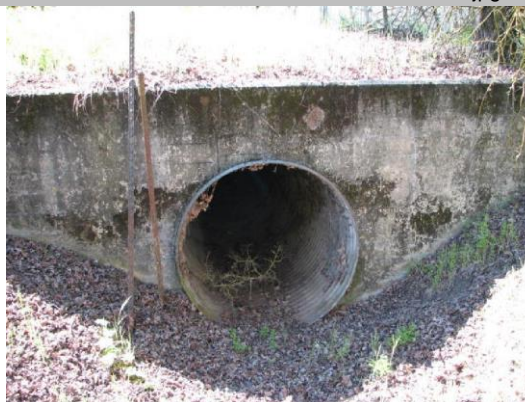
Photo 2 of 3 : UCIP\_SP\_2019\_41129\_60299.jpg

LS headwall and pipe before steel plate was installed over pipe to abandon it.

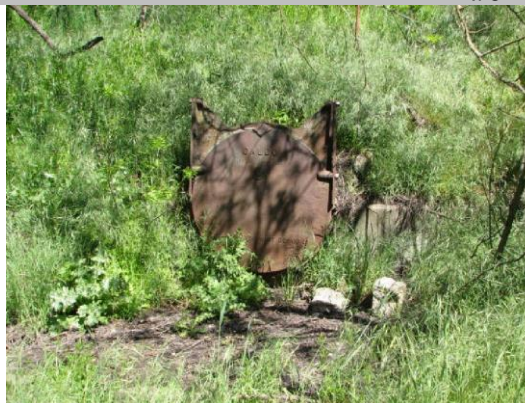
Photo 3 of 3 : UCIP\_SP\_2019\_41129\_60300.jpg

WS flap gate

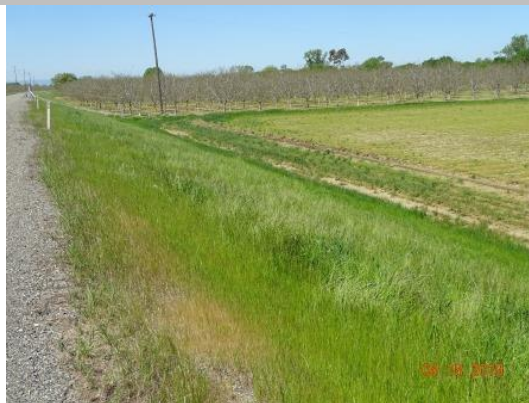
Photo 1 of 1 : SP\_2019\_ST0007\_283\_36\_20190418\_00062.jpg

View looking upstream at annual vegetation on the waterside slope (Spring 2019).

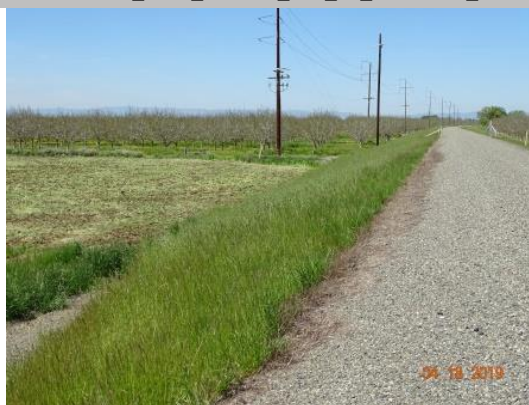
Photo 1 of 1 : SP\_2019\_ST0007\_283\_28\_20190418\_00061.jpg

View looking upstream at annual vegetation on the landside slope (Spring 2019).

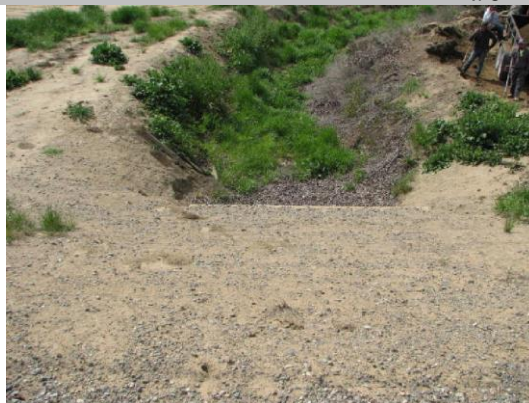
Photo 1 of 3 : UCIP\_SP\_2019\_33407\_60489.jpg

L/S inlet

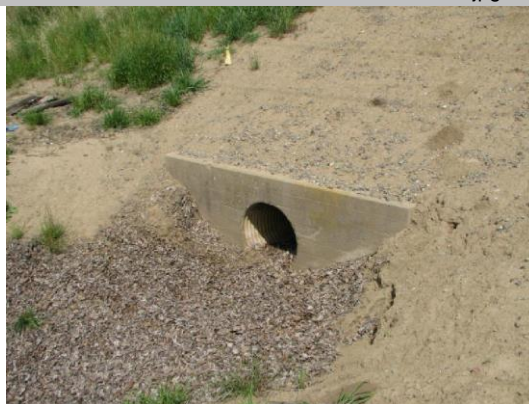
Photo 2 of 3 : UCIP\_SP\_2019\_33407\_60492.jpg

L/S headwall

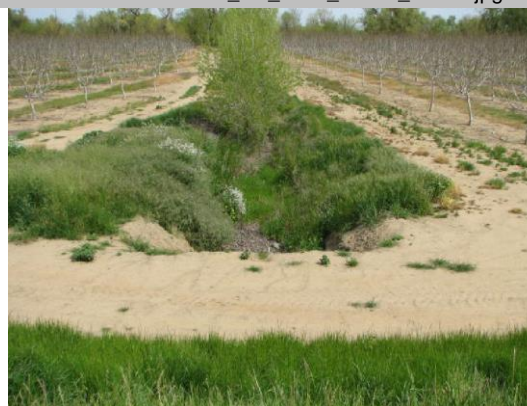
Photo 3 of 3 : UCIP\_SP\_2019\_33407\_60491.jpg

W/S Channel

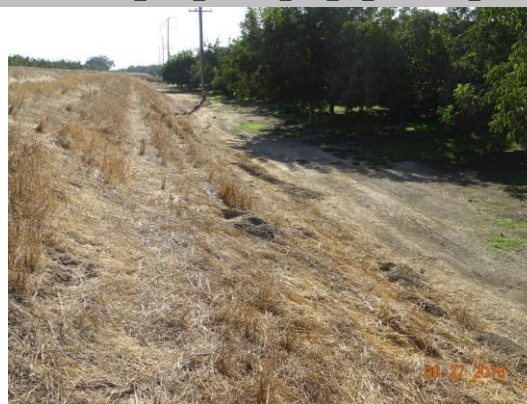
Photo 1 of 3 : SP\_2019\_ST0007\_283\_32\_20190311\_00010.jpg

View looking downstream at multiple animal holes on the levee slope (September 2018).

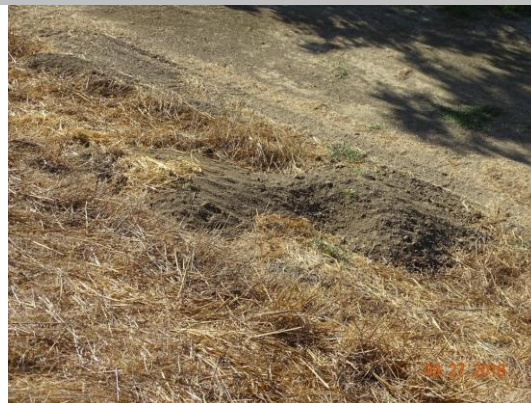
Photo 2 of 3 : SP\_2019\_ST0007\_283\_32\_20190311\_00011.jpg

View looking down slope at one of the animal holes on the levee slope with fresh dirt in front of the hole (September 2018).

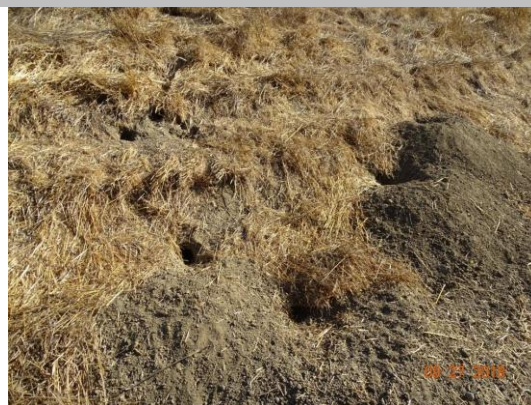
Photo 3 of 3 : SP\_2019\_ST0007\_283\_32\_20190311\_00012.jpg

View of multiple animal holes on the levee slope with fresh dirt in front of the holes (September 2018).

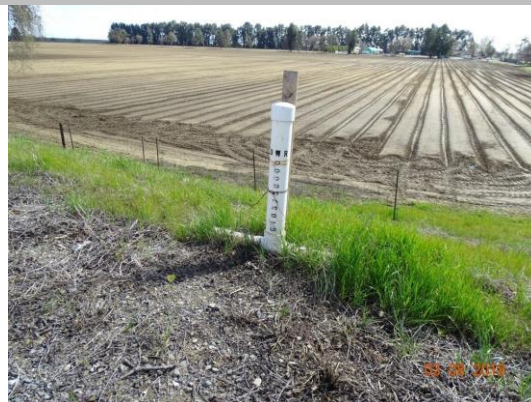
Photo 1 of 1 : SP\_2019\_ST0007\_283\_9\_20190311\_00002.jpg

Rodent bait station at LM 2.09.

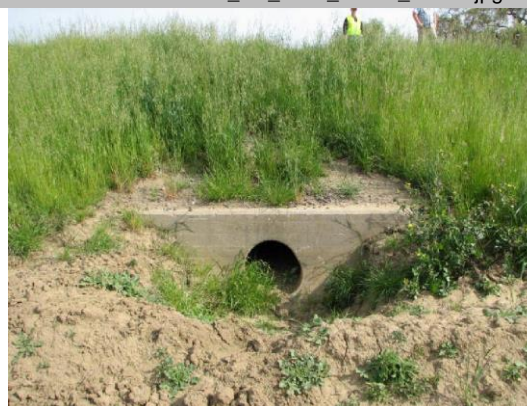
Photo 1 of 2 : UCIP\_SP\_2019\_33395\_60460.jpg

LS headwall

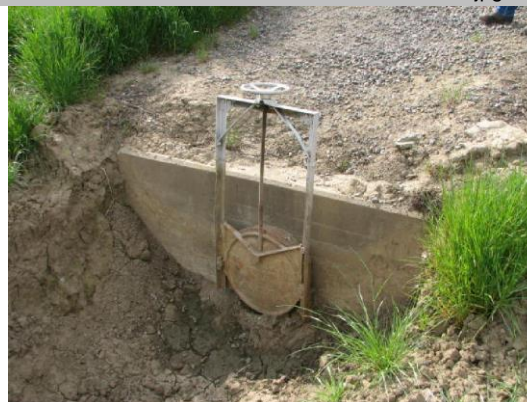
Photo 2 of 2 : UCIP\_SP\_2019\_33395\_60459.jpg

WS headwall and slidegate

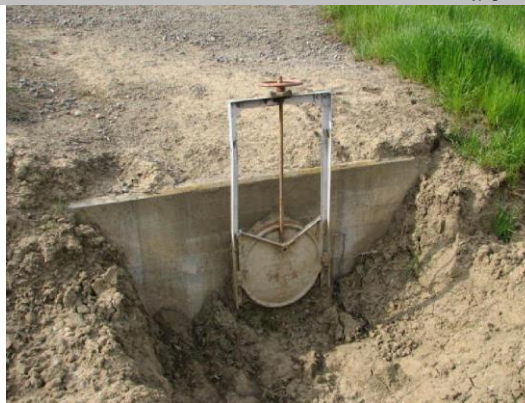
Photo 1 of 2 : UCIP\_SP\_2019\_33393\_60456.jpg

WS headwall and slide gate

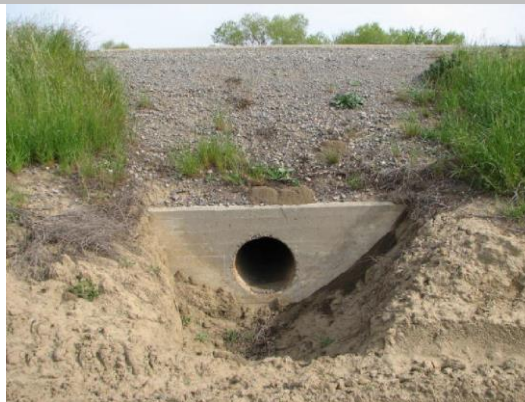
Photo 2 of 2 : UCIP\_SP\_2019\_33393\_60455.jpg

LS headwall and pipe

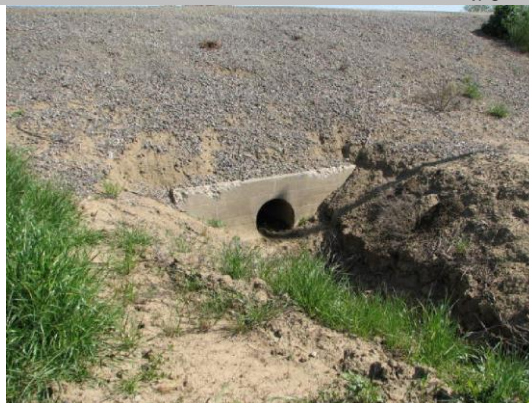
Photo 1 of 2 : UCIP\_SP\_2019\_33378\_60435.jpg

LS headwall

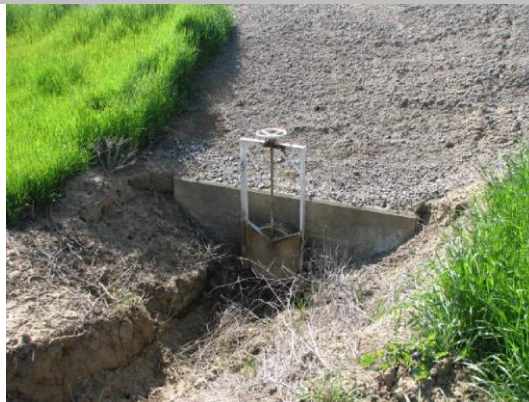
Photo 2 of 2 : UCIP\_SP\_2019\_33378\_60434.jpg

WS slide gate and headwall

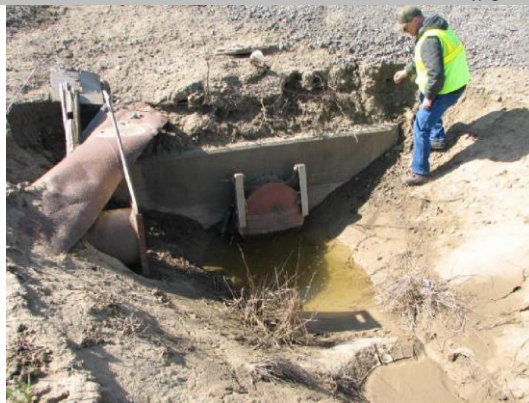
Photo 2 of 3 : UCIP\_SP\_2019\_33375\_60429.jpg

WS headwall and flapgate.

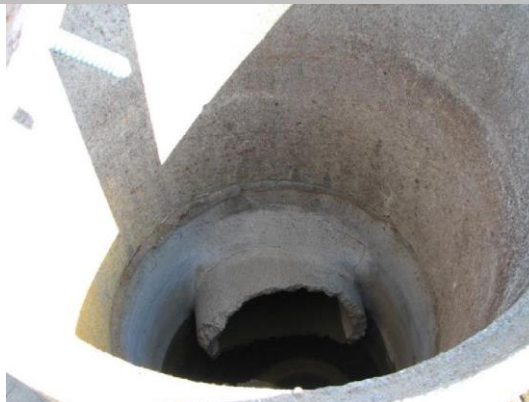
Photo 3 of 3 : UCIP\_SP\_2019\_33375\_60428.jpg

LS looking down standpipe at CC pipe

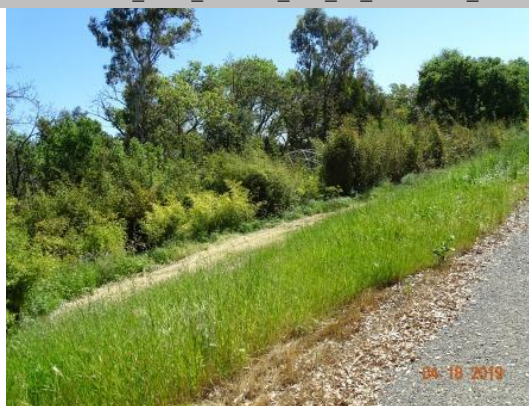
Photo 1 of 1 : SP\_2019\_ST0007\_283\_26\_20190418\_00059.jpg

View looking downstream at annual vegetation on the waterside slope (Spring 2019).

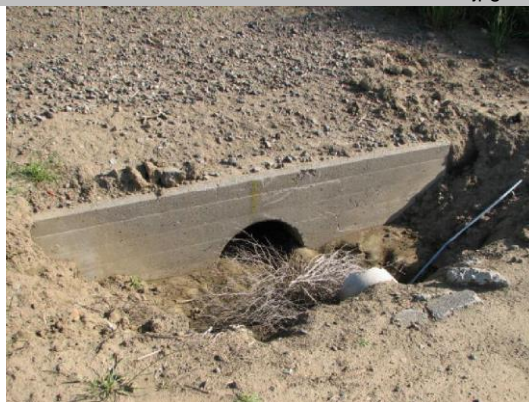
Photo 2 of 3 : UCIP\_SP\_2019\_33369\_60413.jpg

L/S Clogged

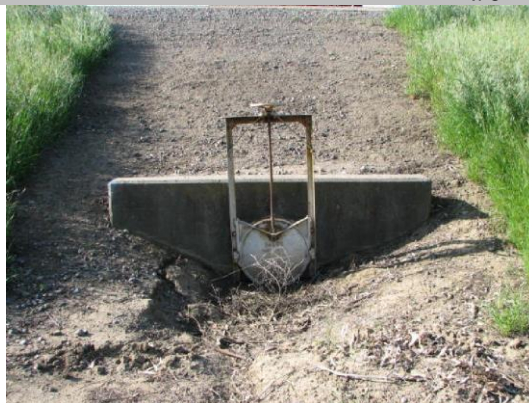
Photo 3 of 3 : UCIP\_SP\_2019\_33369\_60412.jpg

W/S positive closure device

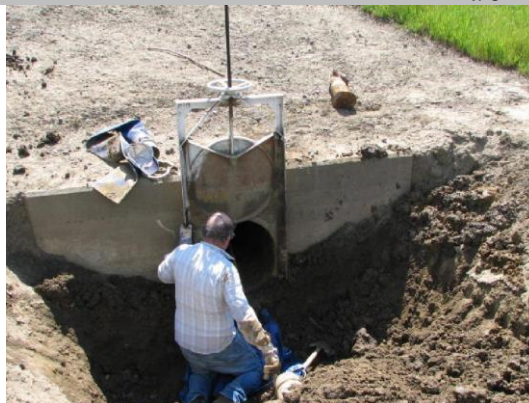
Photo 1 of 2 : UCIP\_SP\_2019\_33363\_60399.jpg

WS slide gate and headwall. 6-inch irrigation pipe just inside 24-inch pipe.

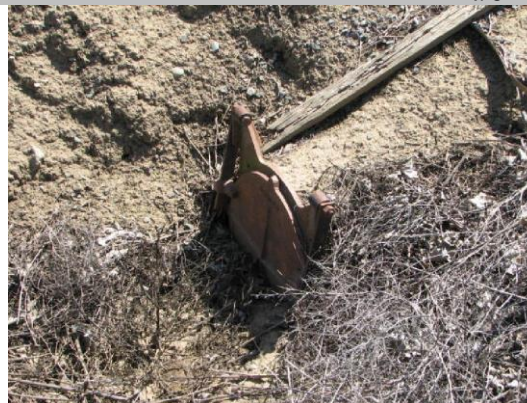
Photo 1 of 2 : UCIP\_SP\_2019\_42953\_60397.jpg

WS Flapgate blocked by sedimentation

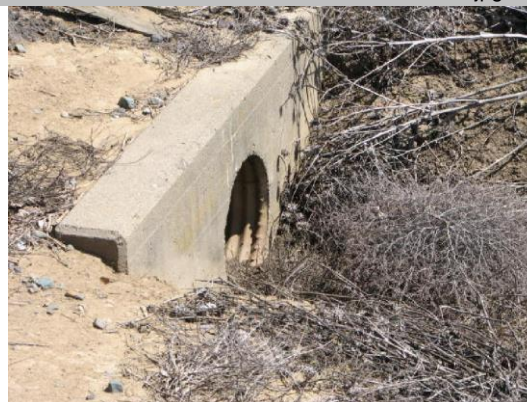
Photo 2 of 2 : UCIP\_SP\_2019\_42953\_60396.jpg

LS headwall

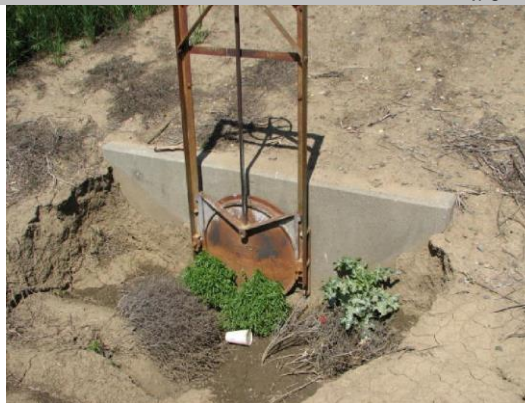
Photo 1 of 2 : UCIP\_SP\_2019\_53864\_60374.jpg

LS slide gate

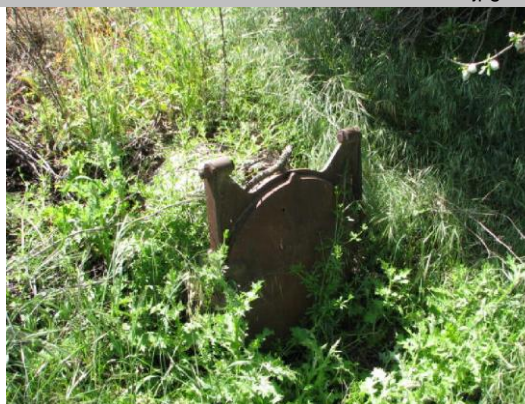
Photo 2 of 2 : UCIP\_SP\_2019\_53864\_60373.jpg

WS flap gate

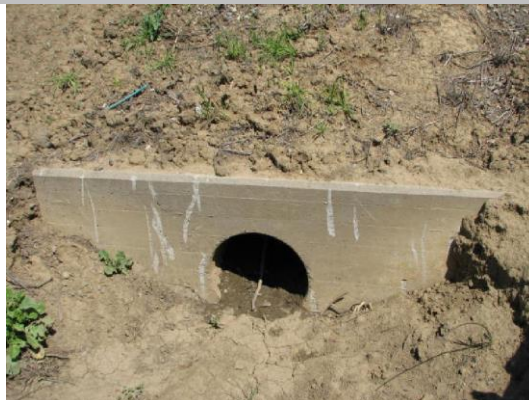
Photo 2 of 2 : UCIP\_SP\_2019\_33346\_60363.jpg

LS headwall showing soil plug
