**Flood Control Project Maintenance
Levee Inspections**

Maintenance Issue Types Only, Levee Inspection Report By Mile - Spring 2020

Sacramento Maintenance Yard Putah Creek

Waterway	Bank	Unit Miles	Inspection Start/End	Inspector
Unit No. 01 Putah Creek or North Levee	Left	8.79	04/23/2020 04/23/2020	David Julian

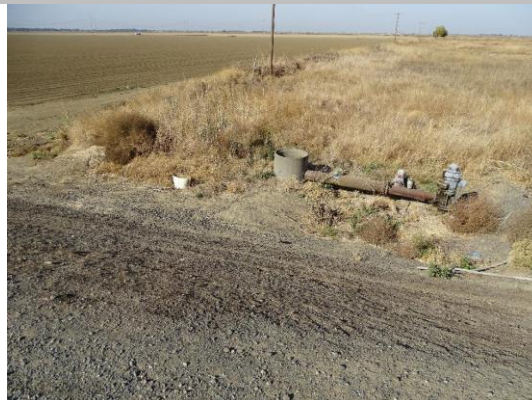
Photo 2 of 3 : UCIP_SP_2020_55584_82056.jpg

Comment Code					
Inspector Comment					
DS_ID:488 FS_ID:55584 EP_NO: 10261 Repair Type: Non-Urgent Crossing Status: Found UCIP Comments: 11/07/2019 Rating updated from No Action Needed to Non-Urgent. Crossing type has been updated from Drainage to Irrigation because current crossing design serves irrigation purposes. Need to have CVFPB review ABO and determine current owner. (O.Yakimov - DWR UCIP) FIELD_STRUCT_DESC: 24-inch drainage pipe of unknown material through the levee, 12.5 feet below the crown. Slide gate is located on the waterside (WS) end. Concrete standpipe and headwall are located on the LS. Water well is connected to the standpipe. (24-inch pipe [HLM 0.58] authorized under Automatic Board Order (ABO) issued as Permit No. 10261, 1974 - Tufts) [Additional Reference(s): DWR Levee Log, 1981 and 2005 (HLM 0.58). USACE Sacramento O&M Manual, Unit 119, December 1952, Revised 29 Dec 2016, (Station 31+00), listed as 24-inch pipe. USACE As-Built Drawing No. 50-04-2396, Revision 1, pdf page 19, Sheet 3, December 1947] FS Date: 11/7/2019 9:56:43 AM

View of LS looking from levee crown

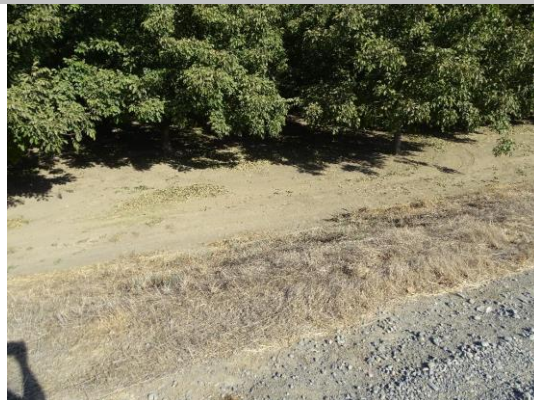
Photo 2 of 3 : UCIP_SP_2020_55597_82103.jpg

Comment Code					
Inspector Comment					
DS_ID:492 FS_ID:55597 EP_NO: 10262 Repair Type: Non-Urgent Crossing Status: Found UCIP Comments: 11/07/2019 Record updated from No Action Needed to Non-Urgent. Need to have CVFPB review ABO and determine current owner. (O.Yakimov - DWR UCIP) FIELD_STRUCT_DESC: 24-inch CIPP-lined drainage pipe of unknown material through levee, 13 feet below crown. Slide gate is located on the waterside (WS) end. Concrete headwalls are located on both the waterside (WS) and landside (LS). (24-inch pipe [HLM 2.77] authorized under Automatic Board Order (ABO) issued as Permit No. 10262, 1974 - Wells Fargo Bank, Trustee for S.H. Cowell Foundation) [Additional Reference(s): DWR Levee Log, 1981 and 2005 (HLM 2.77). USACE Sacramento O&M Manual, Unit 119, December 1952, Revised 29 Dec 2016, (Station P 213+00), listed as 24-inch pipe. USACE As-Built Drawing No. 50-04-2396, Revision 3, pdf page 22, Sheet 6, December 1947] FS Date: 11/7/2019 10:48:08 AM

View of LS looking from levee crown

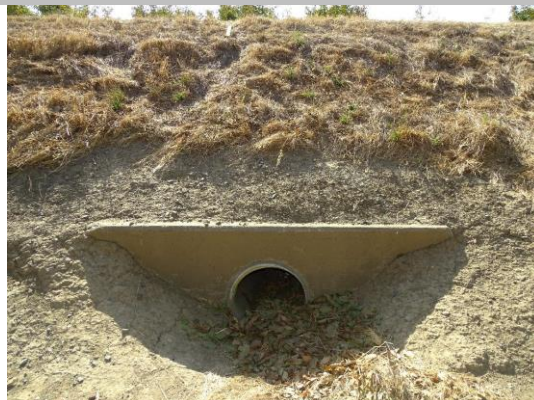
Photo 3 of 3 : UCIP_SP_2020_55597_82104.jpg

LS levee slope, headwall, and pipe end

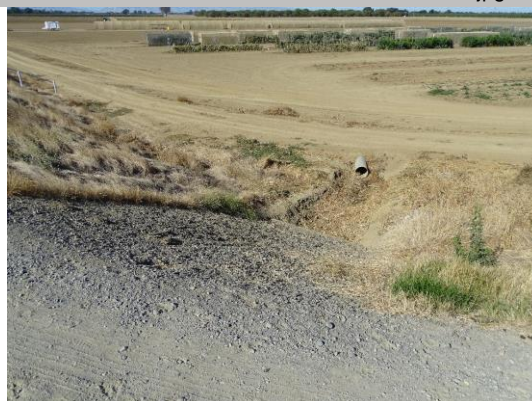
Photo 3 of 3 : UCIP_SP_2020_55455_81755.jpg

DS_ID:496
FS_ID:55455
EP_NO: 10251
Repair Type: Non-Urgent
Crossing Status: Found
UCIP Comments: 10/22/2019 Record updated from No Action Needed to Non-Urgent. Need to have CVFPB review ABO and determine current owner. Installed a new precast concrete box on the waterside. Pipe will be lined in November 2019 according to FMO staff. (O.Yakimov - DWR UCIP)4/10/2019 Major erosion through out pipe. Erosion on WS allows water to enter pipe and flood LS field. Erosion on farmers waterman valve. Field water drains into pipe and floods LS field. (J.McCabe - DWR Sacramento Yard)
FIELD_STRUCT_DESC: 24-inch corrugated metal drainage pipe through levee, 15 feet below the crown. Two metal cutoff walls were installed through the levee. A T-post and T-handle are located on the landside (LS) toe. The outfall structure and flap gate are located on the west side of bridge, waterside (WS). (24-inch pipe [HLM 3.87] authorized under Automatic Board Order (ABO) issued as Permit No. 10251, 1974 - F.M.C. Corp.) [Additional Reference(s): DWR Levee Log, 1981 and 2005 (HLM 3.87). USACE Sacramento O&M Manual, Unit 119, December 1952, Revised 29 Dec 2016, (Station 1+50 PCT), listed as 24-inch pipe. USACE As-Built Drawing No. 50-04-2396, Revision 4, pdf page 23, Sheet 7, December 1947]

View of LS looking from levee crown

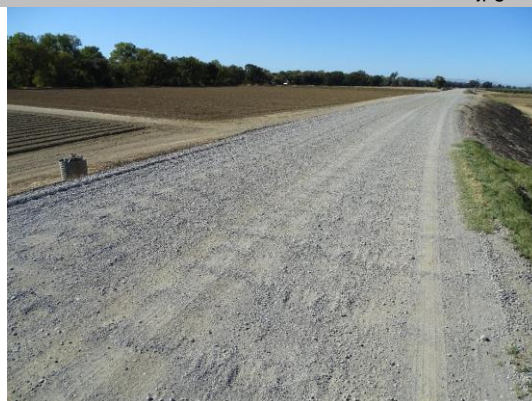
Photo 1 of 3 : UCIP_SP_2020_55456_81760.jpg

DS_ID:497
 FS_ID:55456
 EP_NO: 10251
 Repair Type: Non-Urgent
 Crossing Status: Found
 UCIP Comments: 10/22/2019 Record updated from No Action Needed to Non-Urgent. Geophysical study indicates possible presence of pipe through levee. Need to have CVFPB review ABO and determine current owner. Pipe inlet and headwall are not visible on LS. Slide gate in CMP riser is in closed position, crossing looks abandoned. Construction according to permit 10251-1 hasn't started yet. Field structure description is updated to match original pipe construction. (O.Yakimov - DWR UCIP)
 FIELD_STRUCT_DESC: 24-inch drainage pipe of unknown material through levee, 16 feet below the crown. 36-inch galvanized corrugated metal pipe (CMP) riser located on the waterside (WS) slope. (24-inch pipe [HLM 4.13] authorized under Automatic Board Order (ABO) issued as Permit No. 10251, 1974 - F.M.C. Corp.; assumed original 24-inch pipe was installed in 12/12/1952 per O&M manual) [Additional Reference(s): DWR Levee Log, 1981 and 2005 (HLM 4.13). USACE Sacramento O&M Manual, Unit 119, December 1952, Revised 29 Dec 2016, (Station 17+00 PCT), listed as 24-inch pipe. USACE As-Built Drawing No. 50-04-2396, Revision 4, pdf page 23, Sheet 7, December 1947]

View of levee crown at the crossing

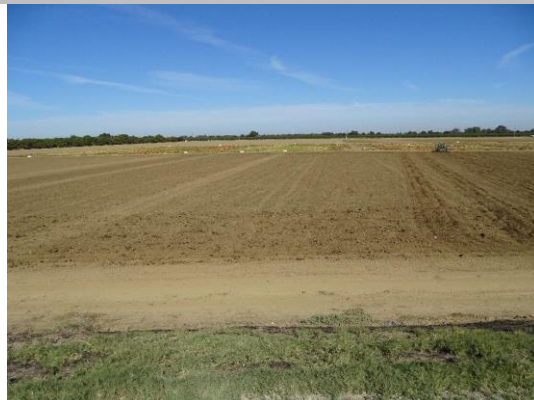
Photo 2 of 3 : UCIP_SP_2020_55456_81761.jpg

View of LS looking from levee crown

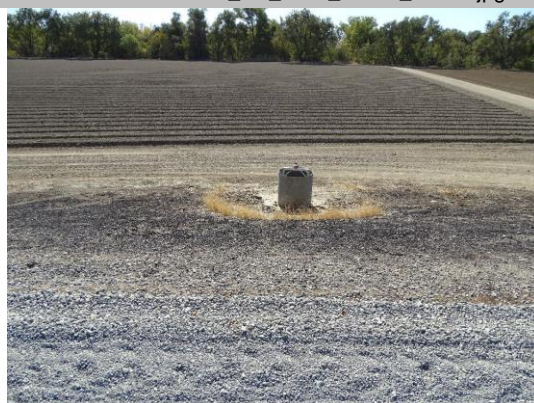
Photo 3 of 3 : UCIP_SP_2020_55456_81762.jpg

View of WS looking from levee crown

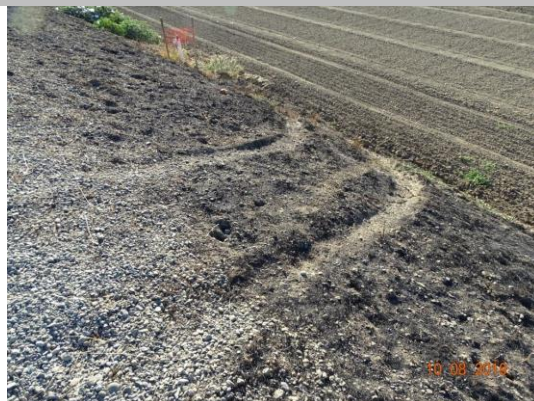
Photo 1 of 1 : SP_2020_ST0007_282_43_20200304_00012.jpg

LM Start	4.57	Rating **	M	Issue No.	43
LM End	4.57	Issue Type +	Ma	Location *	WS
Category	Earthen Levee			GPS Latitude/Longitude	
				Start	End
Item	Slope Stability			38.518175 °	38.518175 °
				-121.709270 °	-121.709270 °
DWR ID	DWR_ST0007_01_f_2019_43				
Comment Code					
S3 : Repair the levee slope damaged by vehicle traffic and prevent access where possible.					
Inspector Comment					
Vehicle tracks depressed into slope.

View of vehicle tracks on the waterside slope (Fall 2019).

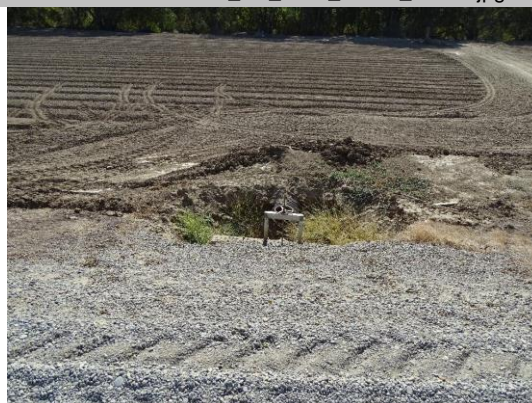
Photo 2 of 3 : UCIP_SP_2020_55459_81776.jpg

Comment Code						
Inspector Comment						
DS_ID:500 FS_ID:55459 EP_NO: 10256 Repair Type: Non-Urgent Crossing Status: Found UCIP Comments: 10/22/2019 Record updated from No Action Needed to Non-Urgent. Need to have CVFPB review ABO and determine current owner. (O.Yakimov - DWR UCIP) 05/06/2013 Debris removed. See picture (C. Lund - DWR Sacramento Yard) 04/04/2012 Some debris in pipe invert LS (W. Wylie - DWR UCIP) FIELD_STRUCT_DESC: 24-inch CIPP-lined corrugated metal drainage pipe through the levee, 15 feet below the crown. Slide gate on the waterside (WS) end. Concrete headwall on the landside (LS) end. (24-inch pipe [HLM 5.39] authorized under Automatic Board Order (ABO) issued as Permit No. 10256, 1974 - Albert H. Lederer). [Additional Reference(s): DWR Levee Log, 2005 (HLM 5.39). USACE Sacramento O&M Manual, Unit 119, December 1952, Revised 29 Dec 2016, (Station 83+70 PCT), listed as 24-inch pipe. USACE As-Built Drawing No. 50-04-2396, Revision 4, pdf page 24, Sheet 8, December 1947]. FS Date: 10/22/2019 3:11:16 PM

View of WS looking from levee crown

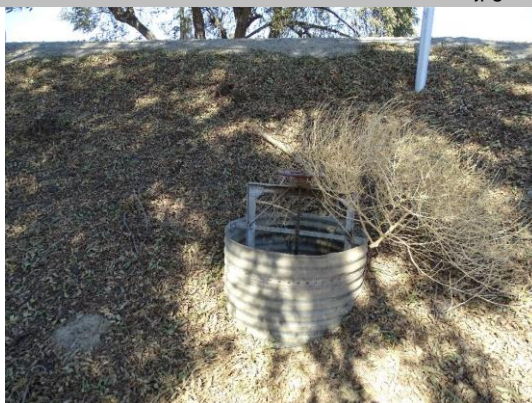
Photo 2 of 3 : UCIP_SP_2020_55460_81780.jpg

Comment Code					
Inspector Comment					
DS_ID:501 FS_ID:55460 EP_NO: 10256 Repair Type: Non-Urgent Crossing Status: Found UCIP Comments: 10/22/2019 Record updated from No Action Needed to Non-Urgent. Need to have CVFPB review ABO and determine current owner. Crossing has been modified to supply water from LS to WS. Should not be considered a storm drainage pipe. (O.Yakimov - DWR UCIP) FIELD_STRUCT_DESC: 24-inch corrugated metal drainage pipe through the levee, 12.5 feet below the crown. Slide gate on the waterside (WS) end in 36-inch standpipe. Concrete standpipe at LS toe with fill-in pipe. (24-inch pipe [HLM 5.40] authorized under Automatic Board Order (ABO) issued as Permit No. 10256, 1974 - Albert H. Lederer). [Additional Reference(s): DWR Levee Log, 2005 (HLM 5.40). USACE Sacramento O&M Manual, Unit 119, December 1952, Revised 29 Dec 2016, (Station 84+40 PCT), listed as 24-inch pipe. USACE As-Built Drawing No. 50-04-2396, Revision 4, pdf page 24, Sheet 8, December 1947]. FS Date: 10/22/2019 3:28:15 PM

36-inch CMP standpipe with slide gate at WS levee toe

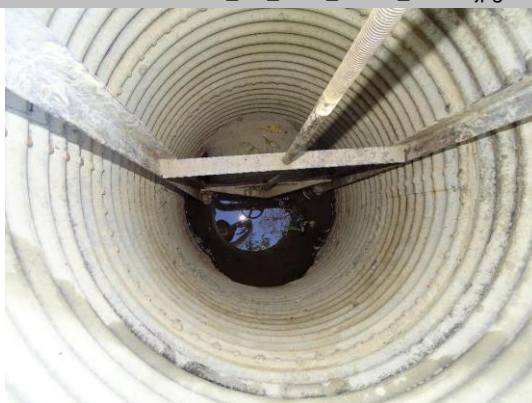
Photo 3 of 3 : UCIP_SP_2020_55460_81781.jpg

View inside of CMP standpipe on WS

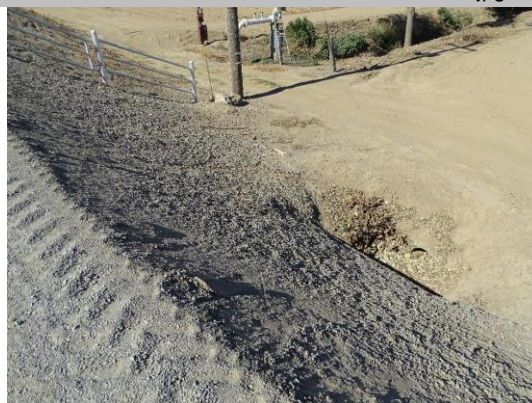
Photo 1 of 3 : UCIP_SP_2020_55461_81782.jpg

DS_ID:502
 FS_ID:55461
 EP_NO: 10255
 Repair Type: Non-Urgent
 Crossing Status: Found
 UCIP Comments: 10/22/2019 Record updated from No Action Needed to Non-Urgent. Need to have CVFPB review ABO and determine current owner. (O.Yakimov - DWR UCIP)
 FIELD_STRUCT_DESC: 24-inch CIPP-lined corrugated metal drainage pipe through the levee, 11 feet below the crown. Slide gate on the waterside (WS) end. Concrete headwall on the landside (LS) end. (24-inch pipe [HLM 5.67] authorized under Automatic Board Order (ABO) issued as Permit No. 10255, 1974 - Owen W. and Ray W. Hamel). [Additional Reference(s): DWR Levee Log, 2005 (HLM 5.67). USACE Sacramento O&M Manual, Unit 119, December 1952, Revised 29 Dec 2016, (Station 97+00 PCT), listed as 24-inch pipe. USACE As-Built Drawing No. 50-04-2396, Revision 4, pdf page 24, Sheet 8, December 1947].
 FS Date: 10/22/2019 4:03:27 PM

View of LS looking from levee crown

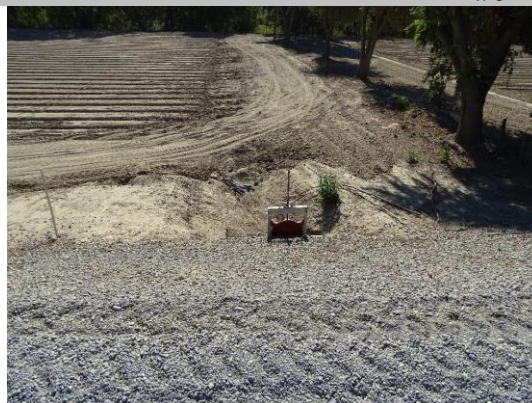
Photo 2 of 3 : UCIP_SP_2020_55461_81783.jpg

View of WS looking from levee crown

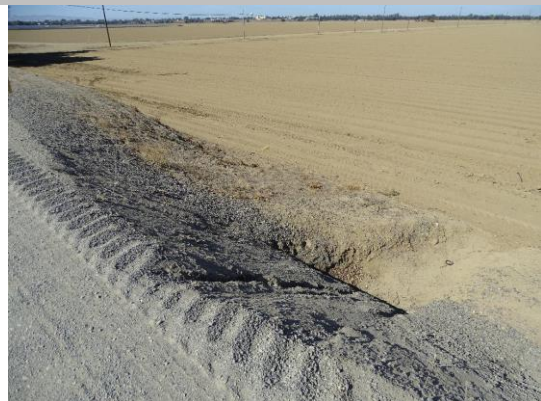
Photo 1 of 3 : UCIP_SP_2020_55644_82261.jpg

DS_ID:503
 FS_ID:55644
 EP_NO: 10252
 Repair Type: Non-Urgent
 Crossing Status: Found
 UCIP Comments: 10/22/2019 Record updated from No Action Needed to Non-Urgent. Need to have CVFPB review ABO and determine current owner. (O.Yakimov - DWR UCIP) 05/06/2013 owner of pipe needs to clean out obstruction in pipe. (C. Lund - DWR Sacramento Yard)
 04/04/2012 Partially obstructed with sedimentation throughout crossing. (W. Wylie - DWR UCIP)
 FIELD_STRUCT_DESC: 24-inch CIPP-lined corrugated metal drainage pipe through the levee, 12 feet below the crown. Slide gate on the waterside (WS) end. Concrete headwall on the landside (LS) end. (24-inch pipe [HLM 5.86] authorized under Automatic Board Order (ABO) issued as Permit No. 10252, 1974 - John F. Hamel). [Additional Reference(s): DWR Levee Log, 2005 (HLM 5.86). USACE Sacramento O&M Manual, Unit 119, December 1952, Revised 29 Dec 2016, (Station 108+00 PCT), listed as 24-inch pipe. USACE As-Built Drawing No. 50-04-2396, Revision 4, pdf page 24, Sheet 8, December 1947].

View of LS looking from levee crown

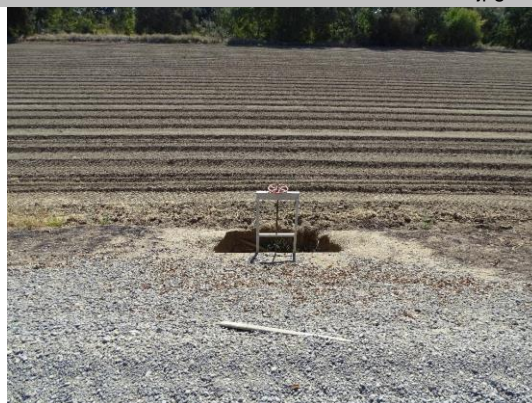
Photo 2 of 3 : UCIP_SP_2020_55644_82262.jpg

View of WS looking from levee crown

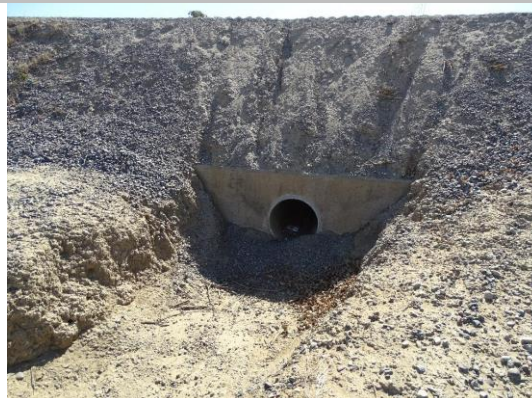
Photo 3 of 3 : UCIP_SP_2020_55644_82263.jpg

LS levee slope, headwall, and pipe end

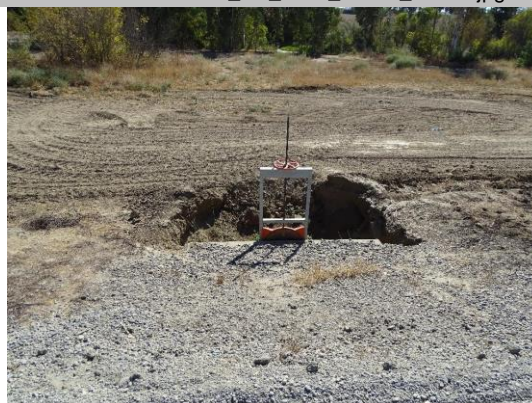
Photo 2 of 3 : UCIP_SP_2020_55647_82274.jpg

Comment Code						
Inspector Comment						
DS_ID:505 FS_ID:55647 EP_NO: 10253 Repair Type: Non-Urgent Crossing Status: Found UCIP Comments: 10/22/2019 Record updated from No Action Needed to Non-Urgent. Levee toe erosion on both sides of headwall on WS. Need to have CVFPB review ABO and determine current owner. (O.Yakimov - DWR UCIP) FIELD_STRUCT_DESC: 24-inch CIPP-lined corrugated metal drainage pipe through the levee, 10.4 feet below the crown. Slide gate on the waterside (WS), and concrete headwalls on both the WS and the landside (LS). (24-inch pipe [HLM 6.57] authorized under Automatic Board Order (ABO) issued as Permit No. 10253, 1974 - Lester J. Hamel). [Additional Reference(s): DWR Levee Log, 2005 (HLM 6.57. USACE Sacramento O&M Manual, Unit 119, December 1952, Revised 29 Dec 2016, (Station 145+50 PCT), listed as 24-inch pipe. USACE As-Built Drawing No. 50-04-2396, Revision 4, pdf page 24, Sheet 8, December 1947]. FS Date: 10/22/2019 11:07:35 AM

View of WS looking from levee crown

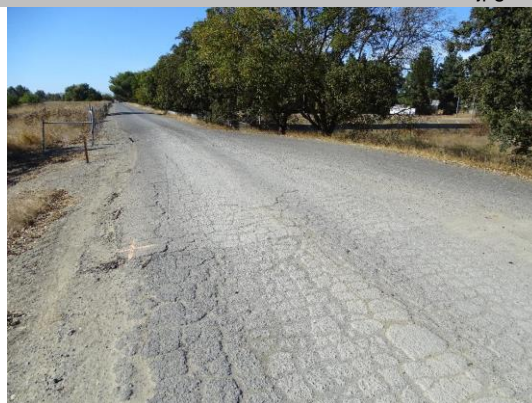
Photo 1 of 3 : UCIP_SP_2020_55664_82343.jpg

Comment Code						
Inspector Comment						
DS_ID:508 FS_ID:55664 EP_NO: 10247 Repair Type: Non-Urgent Crossing Status: Found UCIP Comments: 10/22/2019 Record updated from No Action Needed to Non-Urgent. Need to have CVFPB review ABO and determine current owner. (O.Yakimov - DWR UCIP) FIELD_STRUCT_DESC: 24-inch CIPP-lined corrugated metal drainage pipe through the levee, 11.0 feet below the crown. Flap gate on the waterside (WS) end. Concrete headwall on the landside (LS) end. Concrete Apron on the WS. (24-inch pipe [HLM 7.09] authorized under Automatic Board Order (ABO) issued as Permit No. 10247, 1974 - University of California, Office of the Regents). [Additional Reference(s): DWR Levee Log, 2005 (HLM 7.09). USACE Sacramento O&M Manual, Unit 119, December 1952, Revised 29 Dec 2016, (Station 172+00 PCT), listed as 24-inch pipe. USACE As-Built Drawing No. 50-04-2396, Revision 4, pdf page 25, Sheet 9, December 1947]. FS Date: 10/22/2019 1:55:30 PM

View of levee crown at the crossing

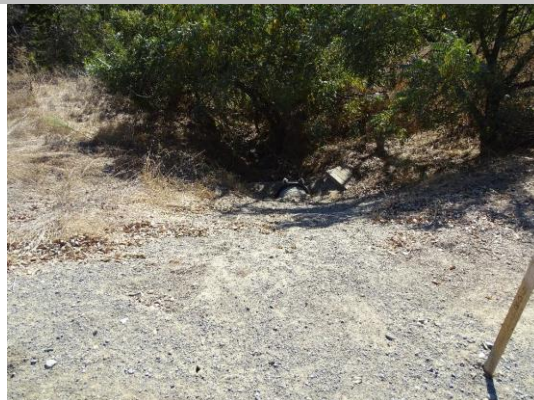
Photo 2 of 3 : UCIP_SP_2020_55664_82344.jpg

View of WS looking from levee crown

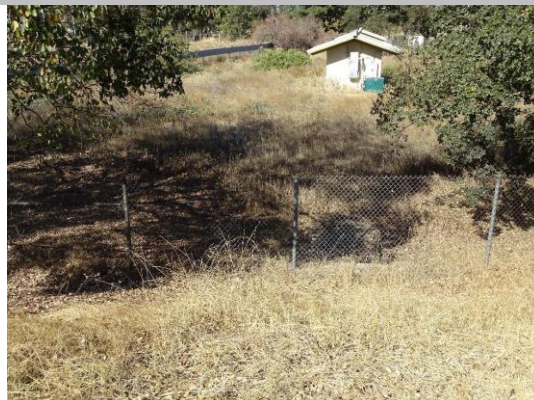
Photo 3 of 3 : UCIP_SP_2020_55664_82345.jpg

View of LS looking from levee crown

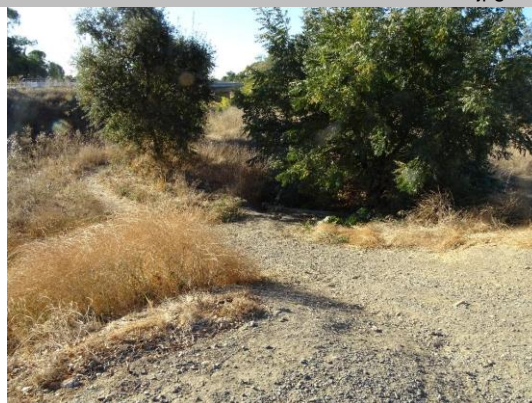
Photo 1 of 3 : UCIP_SP_2020_55667_82357.jpg

Comment Code					
Inspector Comment					
DS_ID:512 FS_ID:55667 EP_NO: 10247 Repair Type: Non-Urgent Crossing Status: Found UCIP Comments: 10/21/2019 Record updated from No Action Needed to Non-Urgent. Need to have CVFPB review ABO and determine current owner. (O.Yakimov - DWR UCIP) 05/07/2013 Debris removed from outlet (C. Lund - DWR Sacramento Yard) 04/04/2012 Some debris blocking outlet. (W. Wylie - DWR UCIP) FIELD_STRUCT_DESC: 24-inch CIPP-lined drainage pipe of an unknown material through the levee, 12 feet below the crown. Flap gate on the waterside (WS) end. Concrete headwall on the landside (LS) end. (24-inch [HLM 7.36] authorized under Automatic Board Order (ABO) issued as Permit No. 10247, 1974 - University of California, Office of the Regents). [Additional Reference(s): DWR Levee Log, 2005 (HLM 7.36). USACE Sacramento O&M Manual, Unit 119, December 1952, Revised 29 Dec 2016, (Station 183+97 PCT), listed as 24-inch pipe. USACE As-Built Drawing No. 50-04-2396, Revision 4, pdf page 25, Sheet 9, December 1947]. FS Date: 10/21/2019 2:33:12 PM

View of WS looking from levee crown

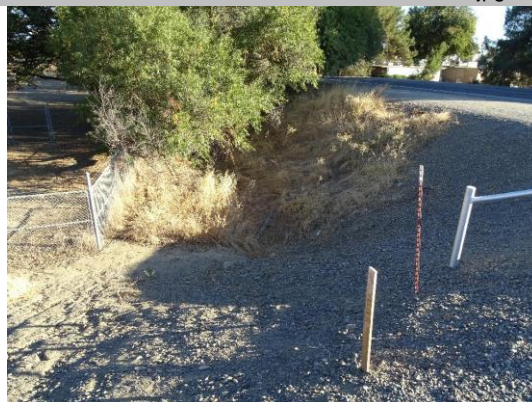
Photo 2 of 3 : UCIP_SP_2020_55667_82355.jpg

View of LS looking from levee crown

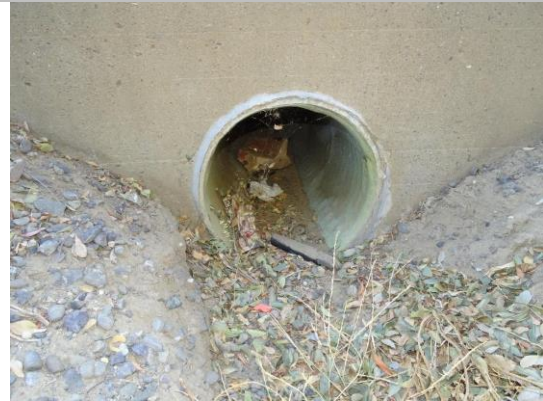
Photo 3 of 3 : UCIP_SP_2020_55667_82356.jpg

LS levee slope, headwall, and pipe end

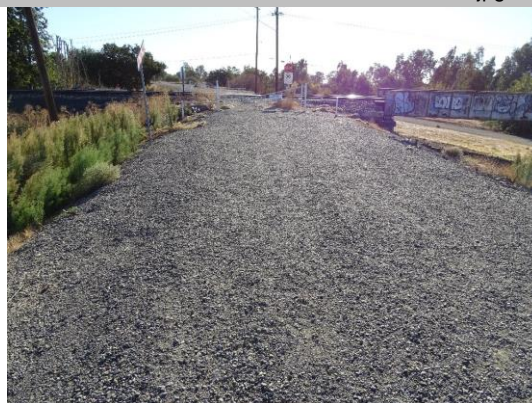
Photo 1 of 3 : UCIP_SP_2020_55673_82372.jpg

DS_ID:516
 FS_ID:55673
 EP_NO: 10260
 Repair Type: Non-Urgent
 Crossing Status: Found
 UCIP Comments: 10/21/2019 Record remains Non-Urgent. Need to have CVFPB review ABO and determine current owner. (O. Yakimov - DWR UCIP) 05/07/2013 Owner of pipe may have to clean sediment. (C. Lund - DWR Sacramento Yard)
 04/05/2012 Pipe is partially obstructed with sedimentation. (W. Wylie - DWR UCIP)
 FIELD_STRUCT_DESC: 24-inch corrugated metal drainage pipe through the levee, 12 feet below the crown. Flap gate on the waterside (WS) end. (24-inch pipe [HLM 7.52] authorized under Automatic Board Order (ABO) issued as Permit No. 10260, 1974 - Southern Pacific Transportation Company). [Additional Reference(s): DWR Levee Log, 2005 (HLM 7.52). USACE Sacramento O&M Manual, Unit 119, December 1952, Revised 29 Dec 2016, (Station 193+20 PCT), listed as 24-inch pipe. USACE As-Built Drawing No. 50-04-2396, Revision 4, pdf page 25, Sheet 9, December 1947].

View of levee crown at the crossing

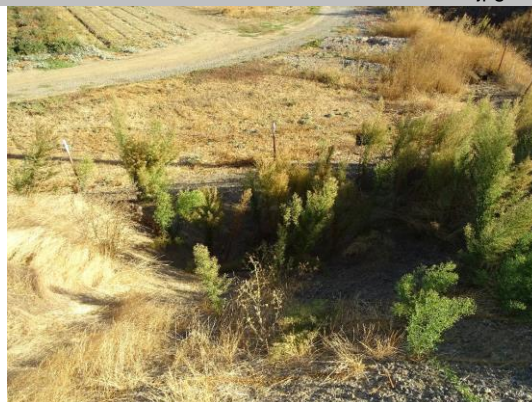
Photo 2 of 3 : UCIP_SP_2020_55673_82373.jpg

View of LS looking from levee crown

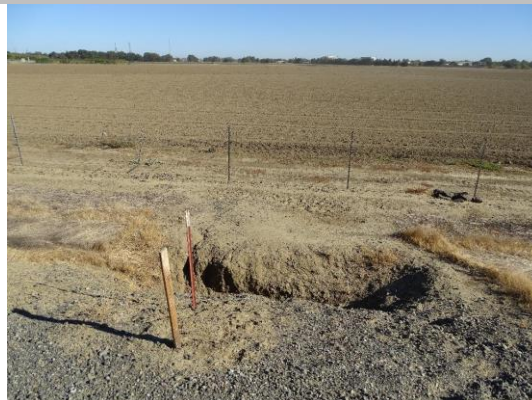
Photo 2 of 3 : UCIP_SP_2020_55679_82394.jpg

Comment Code					
Inspector Comment					
DS_ID:520 FS_ID:55679 EP_NO: 10247 Repair Type: Non-Urgent Crossing Status: Found UCIP Comments: 10/21/2019 Record updated from No Action Needed to Non-Urgent. Need to have CVFPB review ABO and determine current owner. (O.Yakimov - DWR UCIP) 05/07/2012 Cleaned inlet and outlets. Owner of pipe may need to clean pipe. (C. Lund - DWR Sacramento Yard) 04/05/2012 Pipe is plugged with soil on LS. (W. Wylie - DWR UCIP) FIELD_STRUCT_DESC: 24-inch CIPP-lined corrugated metal drainage pipe through the levee, 8 feet below the crown. Slide gate on the waterside (WS) end. (24-inch pipe [HLM 8.45] authorized under Automatic Board Order (ABO) issued as Permit No. 10247, 1974 - University of California, Office of the Regents). [Additional Reference(s): DWR Levee Log, 2005 (HLM 8.45). USACE Sacramento O&M Manual, Unit 119, December 1952, Revised 29 Dec 2016, (Station 241+50 PCT). USACE As-Built Drawing No. 50-04-2396, Revision 2, pdf page 26, Sheet 10, December 1947]. FS Date: 10/21/2019 10:02:10 AM

View of LS looking from levee crown

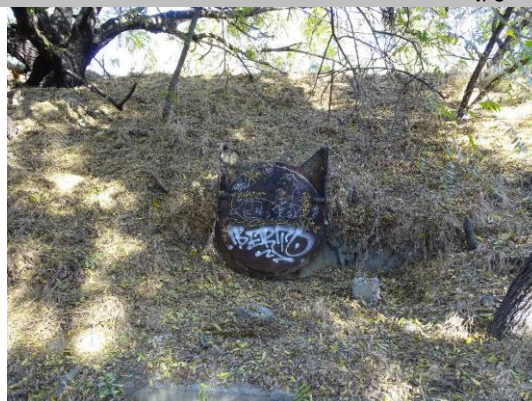
Photo 1 of 3 : UCIP_SP_2020_55684_82410.jpg

Comment Code						
Inspector Comment						
DS_ID:523 FS_ID:55684 EP_NO: 10247 Repair Type: Non-Urgent Crossing Status: Found UCIP Comments: 10/21/2019 Record remains Non-Urgent. Pipe inlet is closed with steel plate bolted to headwall in drainage canal on LS. (O.Yakimov - DWR UCIP) FIELD_STRUCT_DESC: *ABANDONED* 48-inch corrugated metal drainage pipe through the levee, 15.0 feet below the crown. Steel plate installed over inlet off the landside (LS) toe. Pipe not grouted. Flap gate on waterside (WS) end. Headwalls on both ends. (48-inch pipe [HLM 8.88] authorized under Automatic Board Order (ABO) issued as Permit No. 10247, 1974 - University of California, Office of the Regents). [Additional Reference(s): DWR Levee Log, 2005 (HLM 8.88). USACE Sacramento O&M Manual, Unit 119, December 1952, Revised 29 Dec 2016, (Station 262+30 PCT), 48-inch pipe referenced. USACE As-Built Drawing No. 50-04-2396, Revision 2, pdf page 26, Sheet 10, 24-inch pipe referenced on levee alignment, December 1947]. FS Date: 10/21/2019 1:46:45 PM

WS levee slope, headwall, and flap gate

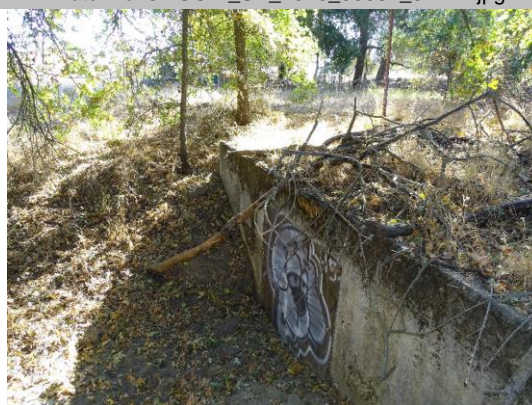
Photo 2 of 3 : UCIP_SP_2020_55684_82411.jpg

Steel plate installed over pipe off LS toe

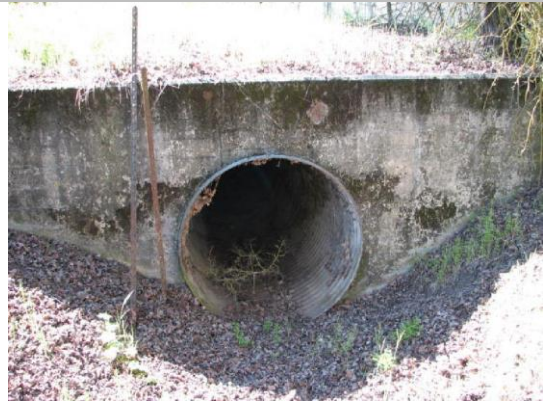
Photo 3 of 3 : UCIP_SP_2020_55684_60299.jpg

LS headwall and pipe before steel plate was installed over pipe to abandon it.

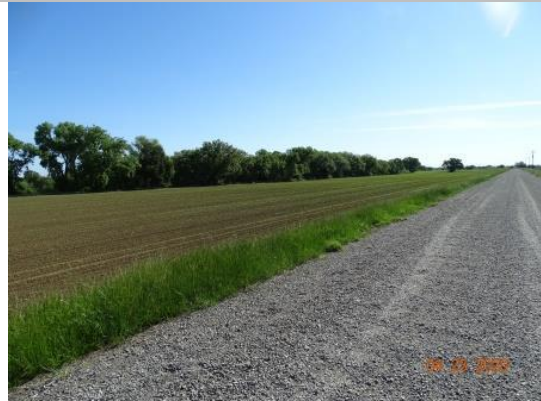
Photo 1 of 1 : SP_2020_ST0007_283_31_20200518_00098.jpg

View looking downstream at annual vegetation on the waterside slope (Spring 2020).

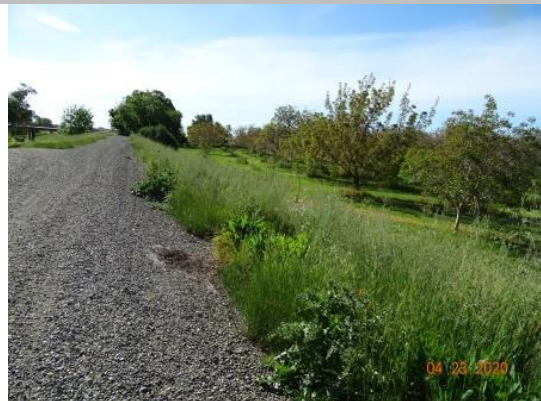
Photo 1 of 1 : SP_2020_ST0007_283_54_20200423_00096.jpg

View looking downstream at annual vegetation on the landside slope (Spring 2020).

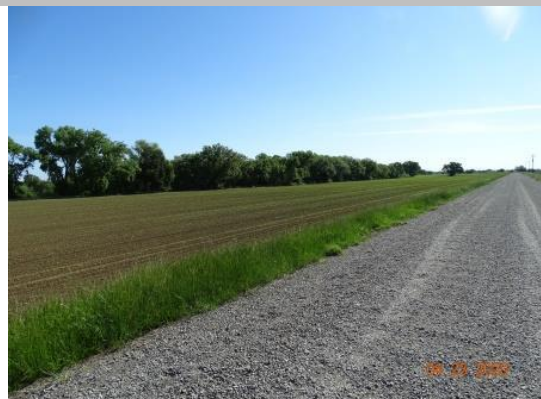
Photo 1 of 1 : SP_2020_ST0007_283_56_20200423_00097.jpg

View looking downstream at annual vegetation on the waterside slope (Spring 2020).

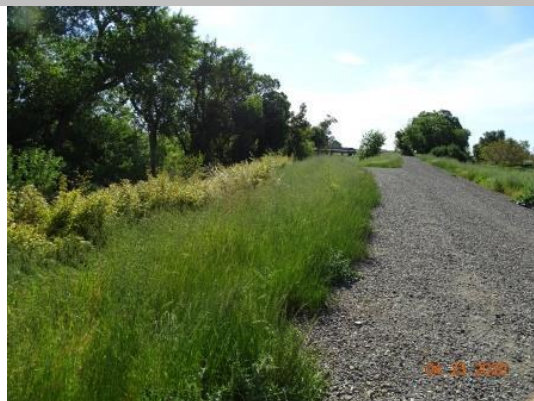
Photo 1 of 1 : SP_2020_ST0007_283_55_20200423_00094.jpg

View looking downstream at annual vegetation on the waterside slope (Spring 2020).
