**Flood Control Project Maintenance
Levee Inspections**

Maintenance Issue Types Only, Levee Inspection Report By Mile - Spring 2021

Sacramento Maintenance Yard Putah Creek

| Waterway | Bank | Unit Miles | Inspection Start/End | Inspector |
|--|---|---|---|---|
| Unit No. 01 Putah Creek or North Levee | Left | 8.79 | 03/18/2021 03/18/2021 | David Julian |

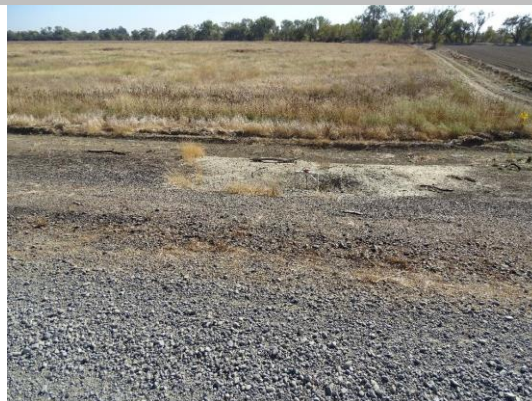
Photo 1 of 3 : UCIP_SP_2021_59851_82055.jpg

| FS_ID:59851 DS_ID:488 EP_NO: 10261 Repair Type: Non-Urgent Crossing Status: Found UCIP Comments: 11/07/2019 Rating updated from No Action Needed to Non-Urgent. Crossing type has been updated from Drainage to Irrigation because current crossing design serves irrigation purposes. Need to have CVFPB review ABO and determine current owner. (O.Yakimov - DWR UCIP) FIELD_STRUCT_DESC: 24-inch irrigation pipe of unknown material through the levee, 12.5 feet below the crown. Slide gate is located on the waterside (WS) end. Concrete standpipe and headwall are located on the LS. Water well is connected to the standpipe. (24-inch pipe [HLM 0.58] authorized under Automatic Board Order (ABO) issued as Permit No. 10261, 1974 - Tufts) [Additional Reference(s): DWR Levee Log, 1981 and 2005 (HLM 0.58). USACE Sacramento O&M Manual, Unit 119, December 1952, Revised 29 Dec 2016, (Station 31+00), listed as 24-inch pipe. USACE As-Built Drawing No. 50-04-2396, Revision 1, pdf page 19, Sheet 3, December 1947] FS Date: 11/7/2019 9:56:00 AM | | | | | | |

View of WS looking from levee crown

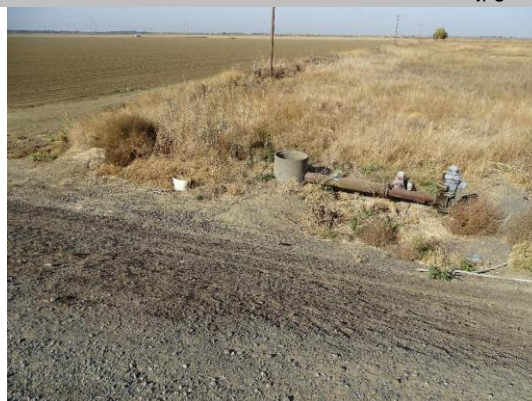
Photo 2 of 3 : UCIP_SP_2021_59851_82056.jpg

View of LS looking from levee crown

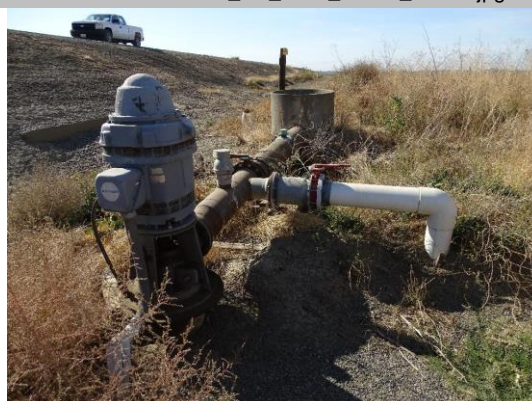
Photo 3 of 3 : UCIP_SP_2021_59851_82058.jpg

Water well connected to standpipe at LS toe. Top of headwall is visible

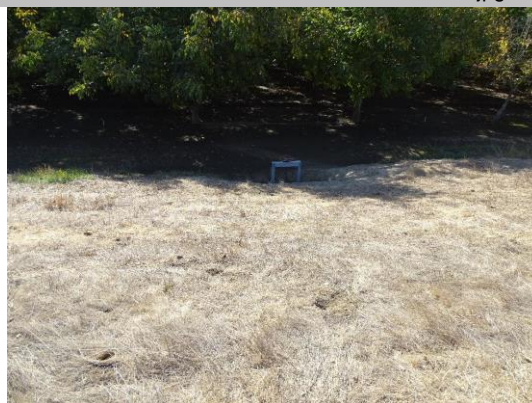
Photo 1 of 3 : UCIP_SP_2021_55597_82102.jpg

| FS_ID:55597 DS_ID:492 EP_NO: 10262 Repair Type: Non-Urgent Crossing Status: Found UCIP Comments: 11/07/2019 Record updated from No Action Needed to Non-Urgent. Need to have CVFPB review ABO and determine current owner. (O.Yakimov - DWR UCIP) FIELD_STRUCT_DESC: 24-inch CIPP-lined drainage pipe of unknown material through levee, 13 feet below crown. Slide gate is located on the waterside (WS) end. Concrete headwalls are located on both the waterside (WS) and landside (LS). (24-inch pipe [HLM 2.77] authorized under Automatic Board Order (ABO) issued as Permit No. 10262, 1974 - Wells Fargo Bank, Trustee for S.H. Cowell Foundation) [Additional Reference(s): DWR Levee Log, 1981 and 2005 (HLM 2.77). USACE Sacramento O&M Manual, Unit 119, December 1952, Revised 29 Dec 2016, (Station P 213+00), listed as 24-inch pipe. USACE As-Built Drawing No. 50-04-2396, Revision 3, pdf page 22, Sheet 6, December 1947] FS Date: 11/7/2019 10:48:08 AM | | | | | | |

View of WS looking from levee crown

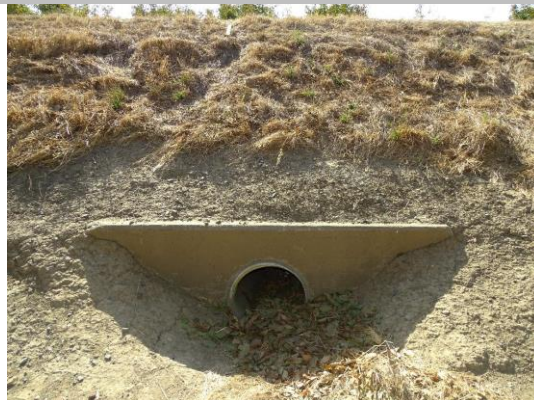
Photo 3 of 3 : UCIP_SP_2021_55597_82104.jpg

LS levee slope, headwall, and pipe end

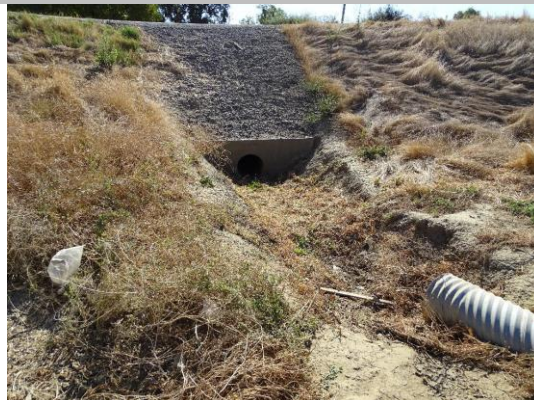
Photo 1 of 3 : UCIP_SP_2021_55455_81753.jpg

FS_ID:55455
DS_ID:496
EP_NO: 10251
Repair Type: Non-Urgent
Crossing Status: Found
UCIP Comments: 10/22/2019 Record updated from No Action Needed to Non-Urgent. Need to have CVFPB review ABO and determine current owner. Installed a new precast concrete box on the waterside. Pipe will be lined in November 2019 according to FMO staff. (O.Yakimov - DWR UCIP)4/10/2019 Major erosion through out pipe. Erosion on WS allows water to enter pipe and flood LS field. Erosion on farmers waterman valve. Field water drains into pipe and floods LS field. (J.McCabe - DWR Sacramento Yard)
FIELD_STRUCT_DESC: 24-inch corrugated metal drainage pipe through levee, 15 feet below the crown. Two metal cutoff walls were installed through the levee. A T-post and T-handle are located on the landside (LS) toe. The outfall structure and flap gate are located on the west side of bridge, waterside (WS). (24-inch pipe [HLM 3.87] authorized under Automatic Board Order (ABO) issued as Permit No. 10251, 1974 - F.M.C. Corp.) [Additional Reference(s): DWR Levee Log, 1981 and 2005 (HLM 3.87). USACE Sacramento O&M Manual, Unit 119, December 1952, Revised 29 Dec 2016, (Station 1+50 PCT), listed as 24-inch pipe. USACE As-Built Drawing No. 50-04-2396, Revision 4, pdf page 23, Sheet 7, December 1947]

LS levee slope, headwall, and pipe end

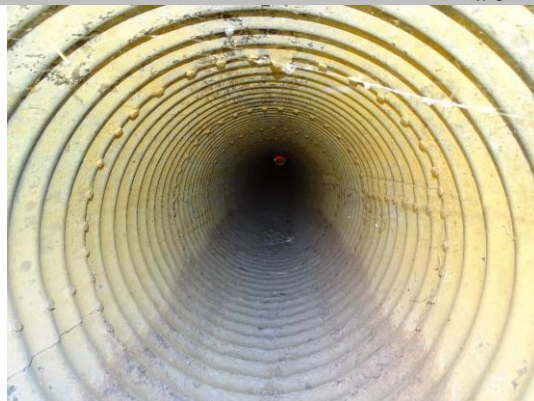
Photo 2 of 3 : UCIP_SP_2021_55455_81754.jpg

View inside of CMP drainage pipe

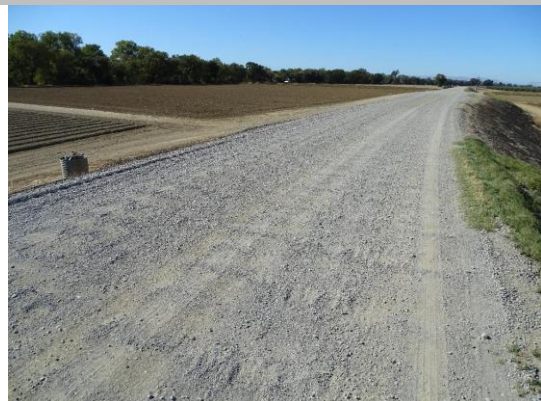
Photo 1 of 3 : UCIP_SP_2021_55456_81760.jpg

FS_ID:55456
DS_ID:497
EP_NO: 10251
Repair Type: Non-Urgent
Crossing Status: Found
UCIP Comments: 10/22/2019 Record updated from No Action Needed to Non-Urgent. Geophysical study indicates possible presence of pipe through levee. Need to have CVFPB review ABO and determine current owner. Pipe inlet and headwall are not visible on LS. Slide gate in CMP riser is in closed position, crossing looks abandoned. Construction according to permit 10251-1 hasn't started yet. Field structure description is updated to match original pipe construction. (O.Yakimov - DWR UCIP)
FIELD_STRUCT_DESC: 24-inch drainage pipe of unknown material through levee, 16 feet below the crown. 36-inch galvanized corrugated metal pipe (CMP) riser located on the waterside (WS) slope. (24-inch pipe [HLM 4.13] authorized under Automatic Board Order (ABO) issued as Permit No. 10251, 1974 - F.M.C. Corp.; assumed original 24-inch pipe was installed in 12/12/1952 per O&M manual) [Additional Reference(s): DWR Levee Log, 1981 and 2005 (HLM 4.13). USACE Sacramento O&M Manual, Unit 119, December 1952, Revised 29 Dec 2016, (Station 17+00 PCT), listed as 24-inch pipe. USACE As-Built Drawing No. 50-04-2396, Revision 4, pdf page 23, Sheet 7, December 1947]

View of levee crown at the crossing

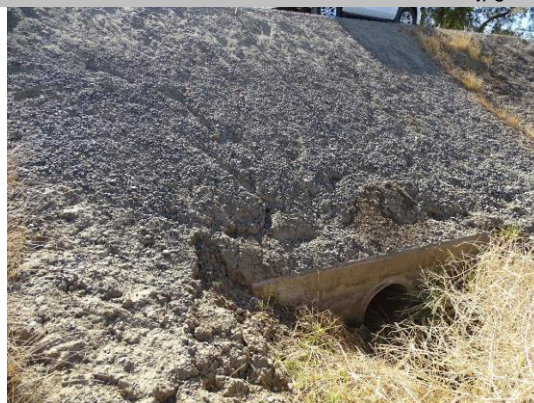
Photo 3 of 3 : UCIP_SP_2021_59861_81777.jpg

| FS_ID:59861 DS_ID:500 EP_NO: 10256 Repair Type: Non-Urgent Crossing Status: Found UCIP Comments: 10/22/2019 Record updated from No Action Needed to Non-Urgent. Need to have CVFPB review ABO and determine current owner. (O.Yakimov - DWR UCIP)05/06/2013 Debris removed. See picture (C. Lund - DWR Sacramento Yard) 04/04/2012 Some debris in pipe invert LS (W. Wylie - DWR UCIP) FIELD_STRUCT_DESC: 24-inch CIPP-lined corrugated metal drainage pipe through the levee, 15 feet below the crown. Slide gate on the waterside (WS) end. Concrete headwall on the landside (LS) end. (24-inch pipe [HLM 5.39] authorized under Automatic Board Order (ABO) issued as Permit No. 10256, 1974 - Albert H. Lederer). [Additional Reference(s): DWR Levee Log, 2005 (HLM 5.39). USACE Sacramento O&M Manual, Unit 119, December 1952, Revised 29 Dec 2016, (Station 83+70 PCT), listed as 24-inch pipe. USACE As-Built Drawing No. 50-04-2396, Revision 4, pdf page 24, Sheet 8, December 1947]. FS Date: 10/22/2019 3:11:00 PM | | | | | | |

LS levee slope, headwall, and pipe end

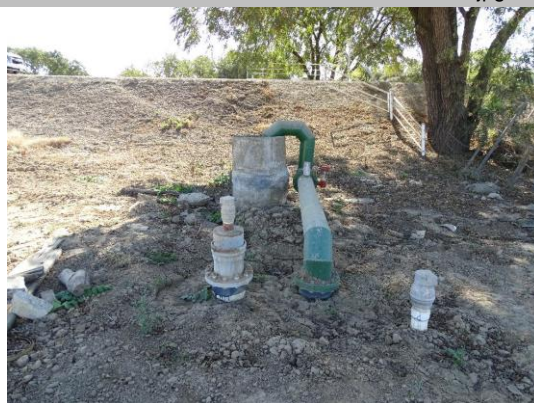
Photo 1 of 3 : UCIP_SP_2021_55460_81779.jpg

View of LS slope with concrete standpipe at levee toe

| FS_ID:55460 DS_ID:501 EP_NO: 10256 Repair Type: Non-Urgent Crossing Status: Found UCIP Comments: 10/22/2019 Record updated from No Action Needed to Non-Urgent. Need to have CVFPB review ABO and determine current owner. Crossing has been modified to supply water from LS to WS. Should not be considered a storm drainage pipe. (O.Yakimov - DWR UCIP) FIELD_STRUCT_DESC: 24-inch corrugated metal drainage pipe through the levee, 12.5 feet below the crown. Slide gate on the waterside (WS) end in 36-inch standpipe. Concrete standpipe at LS toe with fill-in pipe. (24-inch pipe [HLM 5.40] authorized under Automatic Board Order (ABO) issued as Permit No. 10256, 1974 - Albert H. Lederer). [Additional Reference(s): DWR Levee Log, 2005 (HLM 5.40). USACE Sacramento O&M Manual, Unit 119, December 1952, Revised 29 Dec 2016, (Station 84+40 PCT), listed as 24-inch pipe. USACE As-Built Drawing No. 50-04-2396, Revision 4, pdf page 24, Sheet 8, December 1947]. FS Date: 10/22/2019 3:28:15 PM | | | | | |

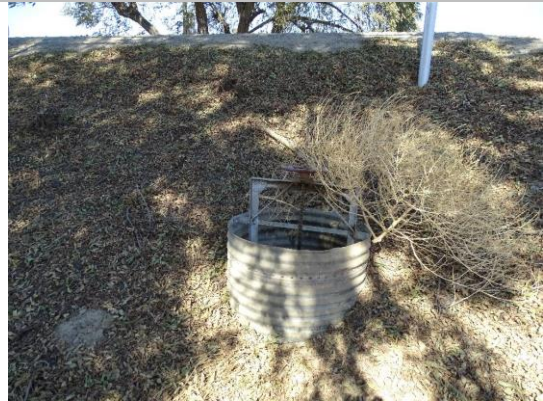
Photo 2 of 3 : UCIP_SP_2021_55460_81780.jpg

36-inch CMP standpipe with slide gate at WS levee toe

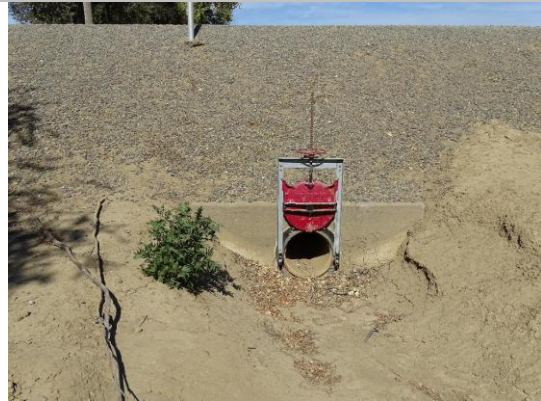
Photo 3 of 3 : UCIP_SP_2021_55461_81784.jpg

| FS_ID:55461 DS_ID:502 EP_NO: 10255 Repair Type: Non-Urgent Crossing Status: Found UCIP Comments: 10/22/2019 Record updated from No Action Needed to Non-Urgent. Need to have CVFPB review ABO and determine current owner. (O.Yakimov - DWR UCIP) FIELD_STRUCT_DESC: 24-inch CIPP-lined corrugated metal drainage pipe through the levee, 11 feet below the crown. Slide gate on the waterside (WS) end. Concrete headwall on the landside (LS) end. (24-inch pipe [HLM 5.67] authorized under Automatic Board Order (ABO) issued as Permit No. 10255, 1974 - Owen W. and Ray W. Hamel). [Additional Reference(s): DWR Levee Log, 2005 (HLM 5.67). USACE Sacramento O&M Manual, Unit 119, December 1952, Revised 29 Dec 2016, (Station 97+00 PCT), listed as 24-inch pipe. USACE As-Built Drawing No. 50-04-2396, Revision 4, pdf page 24, Sheet 8, December 1947]. FS Date: 10/22/2019 4:03:27 PM | | | | | |

WS levee slope, headwall, and slide gate

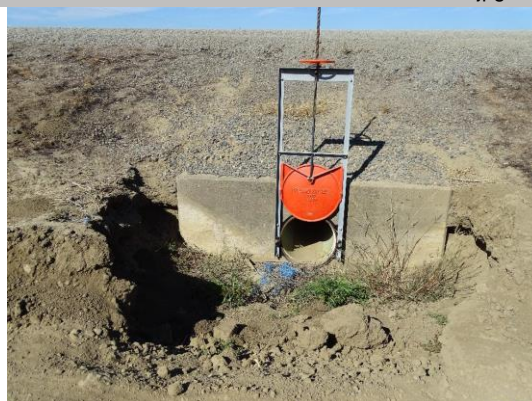
Photo 3 of 3 : UCIP_SP_2021_55647_82275.jpg

| FS_ID:55647 DS_ID:505 EP_NO: 10253 Repair Type: Non-Urgent Crossing Status: Found UCIP Comments: 10/22/2019 Record updated from No Action Needed to Non-Urgent. Levee toe erosion on both sides of headwall on WS. Need to have CVFPB review ABO and determine current owner. (O.Yakimov - DWR UCIP) FIELD_STRUCT_DESC: 24-inch CIPP-lined corrugated metal drainage pipe through the levee, 10.4 feet below the crown. Slide gate on the waterside (WS), and concrete headwalls on both the WS and the landside (LS). (24-inch pipe [HLM 6.57] authorized under Automatic Board Order (ABO) issued as Permit No. 10253, 1974 - Lester J. Hamel). [Additional Reference(s): DWR Levee Log, 2005 (HLM 6.57. USACE Sacramento O&M Manual, Unit 119, December 1952, Revised 29 Dec 2016, (Station 145+50 PCT), listed as 24-inch pipe. USACE As-Built Drawing No. 50-04-2396, Revision 4, pdf page 24, Sheet 8, December 1947]. FS Date: 10/22/2019 11:07:35 AM | | | | | | |

WS levee slope, headwall, and slide gate

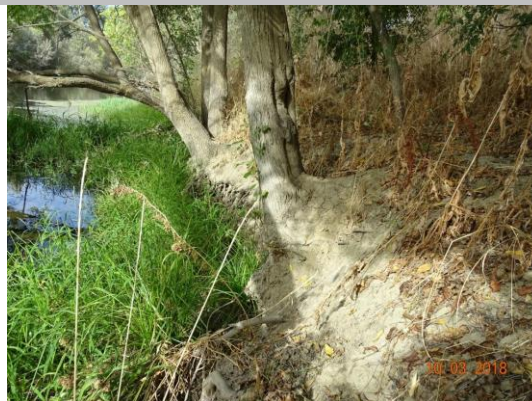
Photo 1 of 1 : SP_2021_ST0007_282_34_20210301_00005.jpg

View looking upstream at erosion at the waterside toe. Tree roots are exposed (September 2018).

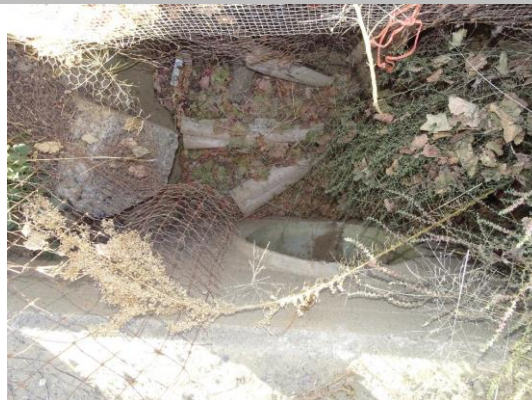
Photo 2 of 3 : UCIP_SP_2021_59875_82383.jpg

| FS_ID:59875 DS_ID:518 EP_NO: 10247 Repair Type: Non-Urgent Crossing Status: Found UCIP Comments: 10/21/2019 Difficult access to pipe inlet on LS due to a fence. (O.Yakimov - DWR UCIP)05/07/2013 Fence blocking inlet. Owner of fence needs to move fence away from inlet. (C. Lund - DWR Sacramento Yard) 04/05/2012 Clear debris from pipe. (W. Wylie - DWR UCIP) FIELD_STRUCT_DESC: 24-inch CIPP-lined corrugated metal drainage pipe through the levee, 12 feet below the crown. Slide gate on the waterside (WS) slope, and headwalls on both sides. (24-inch pipe [HLM 7.75] authorized under Automatic Board Order (ABO) issued as Permit No. 10247, 1974 - University of California, Office of the Regents). [Additional Reference(s): DWR Levee Log, 2005 (HLM 7.75). USACE Sacramento O&M Manual, Unit 119, December 1952, Revised 29 Dec 2016, (Station 204+00 PCT), listed as 24-inch pipe. USACE As-Built Drawing No. 50-04-2396, Revision 4, pdf page 25, Sheet 9, December 1947]. FS Date: 10/21/2019 8:27:00 AM | | | | | | |

LS: headwall and pipe end near a fence

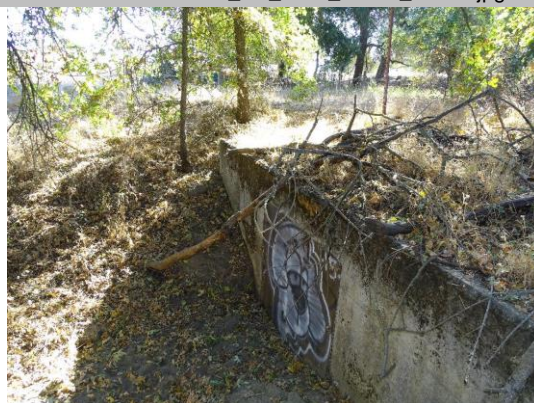
Photo 2 of 3 : UCIP_SP_2021_59884_82411.jpg

| FS_ID:59884 DS_ID:523 EP_NO: 10247 Repair Type: Non-Urgent Crossing Status: Found UCIP Comments: 10/21/2019 Record remains Non-Urgent. Pipe inlet is closed with steel plate bolted to headwall in drainage canal on LS. (O.Yakimov - DWR UCIP) FIELD_STRUCT_DESC: 48-inch corrugated metal drainage pipe through the levee, 15.0 feet below the crown. Steel plate installed over inlet off the landside (LS) toe. Pipe not grouted. Flap gate on waterside (WS) end. Headwalls on both ends. (48-inch pipe [HLM 8.88] authorized under Automatic Board Order (ABO) issued as Permit No. 10247, 1974 - University of California, Office of the Regents). [Additional Reference(s): DWR Levee Log, 2005 (HLM 8.88). USACE Sacramento O&M Manual, Unit 119, December 1952, Revised 29 Dec 2016, (Station 262+30 PCT), 48-inch pipe referenced. USACE As-Built Drawing No. 50-04-2396, Revision 2, pdf page 26, Sheet 10, 24-inch pipe referenced on levee alignment, December 1947]. FS Date: 10/21/2019 1:46:00 PM | | | | | | |

Steel plate installed over pipe off LS toe

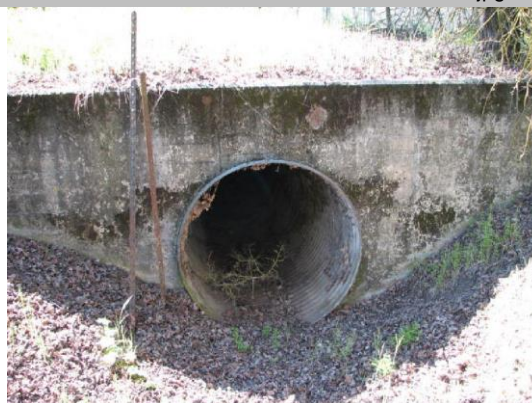
Photo 3 of 3 : UCIP_SP_2021_59884_60299.jpg

LS headwall and pipe before steel plate was installed over pipe to abandon it.

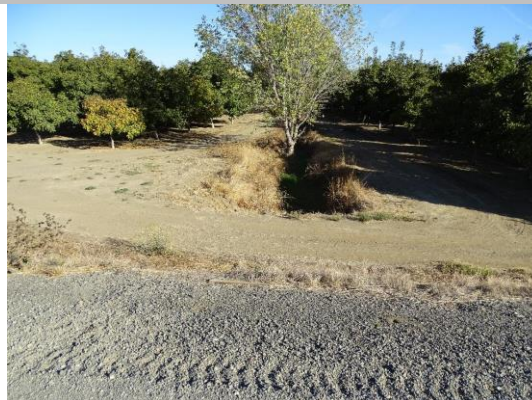
Photo 1 of 3 : UCIP_SP_2021_55424_81638.jpg

| FS_ID:55424 DS_ID:16621 EP_NO: 10270 Repair Type: Non-Urgent Crossing Status: Found UCIP Comments: 10/22/2019 Crossing visually is in good condition. 12-inch diameter through hole has developed due to soil instability on WS berm visible on the top of pipe outlet embankment. Need to have CVFPB review ABO and determine current owner. (O.Yakimov - DWR UCIP) FIELD_STRUCT_DESC: 36-inch corrugated metal drainage pipe through the levee, 14 feet below the crown. Flap gate on the waterside (WS) end. Concrete headwall on the landside (LS) end. (36-inch pipe [HLM 0.85] authorized under Automatic Board Order (ABO) issued as Permit No. 10270, 1974 - Hamel). [Additional Reference(s): DWR Levee Log, 2005 (HLM 0.85). USACE Sacramento O&M Manual, Unit 119, December 1952, Revised 29 Dec 2016, (Station T 1+45), listed as 36-inch pipe. USACE As-Built Drawing No. 50-04-2396, Revision 1, pdf page 21, Sheet 5, December 1947]. FS Date: 10/22/2019 9:59:31 AM | | | | | | |

View of WS looking from levee crown

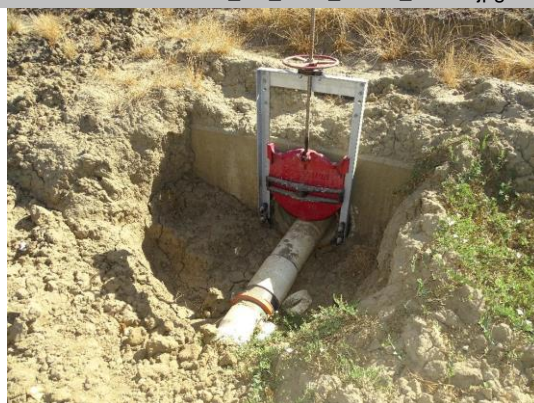
Photo 3 of 3 : UCIP_SP_2021_55411_81621.jpg

| FS_ID:55411 DS_ID:16625 EP_NO: 10277 Repair Type: Urgent Crossing Status: Found UCIP Comments: 10/21/2019 Record updated from No Action Needed to Urgent. A PVC pipe runs through a drainage pipe from LS to WS levee toe. Slide gate cannot be closed properly to prevent flooding on LS. Remove PVC pipe. Need to have CVFPB review ABO and determine current owner. (O.Yakimov - DWR UCIP) FIELD_STRUCT_DESC: 24-inch CIPP-lined corrugated metal drainage pipe through the levee, 9 feet below the crown. Slide gate on the waterside (WS) slope. Concrete headwalls on both ends. (24-inch pipe [HLM 2.71] authorized under Automatic Board Order (ABO) issued as Permit No. 10277, 1974 - Naomi Schoeningh). [Additional Reference(s): DWR Levee Log, 2005 (HLM 2.71). USACE Sacramento O&M Manual, Unit 119, December 1952, Revised 29 Dec 2016, (Station 30+15 PCT), listed as 24-inch pipe. USACE As-Built Drawing No. 50-04-2396, Revision 4, pdf page 23, Sheet 7, December 1947]. FS Date: 10/21/2019 11:18:53 AM | | | | | | |

Headwall and slidegate at WS toe with a PVC pipe running through

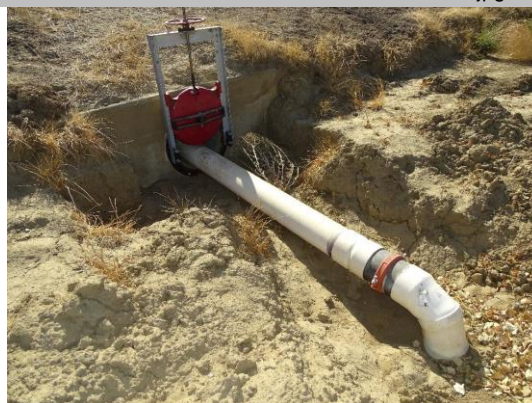
Photo 3 of 3 : UCIP_SP_2021_55412_81625.jpg

Headwall and slidegate at WS toe with a PVC pipe running through

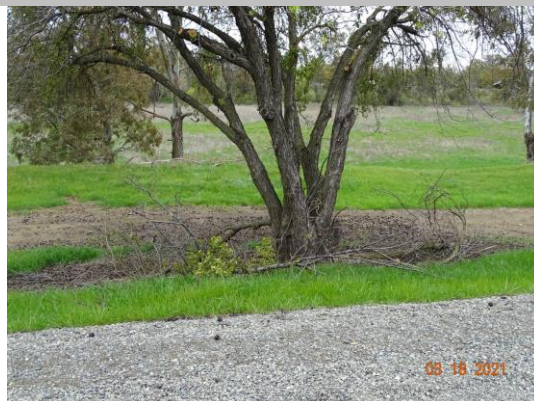
Photo 1 of 1 : SP_2021_ST0007_283_45_20210318_00089.jpg

View of pruned tree limbs on the waterside slope (Spring 2021).
