**Flood Control Project Maintenance
Levee Inspections**

Maintenance Issue Types Only, Levee Inspection Report By Mile - Spring 2022

Sacramento Maintenance Yard Putah Creek

Waterway	Bank	Unit Miles	Inspection Start/End	Inspector
Unit No. 01 Putah Creek or North Levee	Left	8.79	03/16/2022 03/16/2022	David Julian

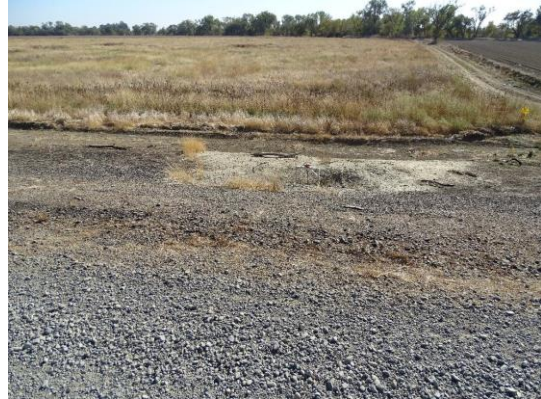
Photo 1 of 3 : UCIP_SP_2022_59851_82055.jpg

Comment Code						
Inspector Comment						
FS_ID:59851 DS_ID:488 EP_NO: 10261 Repair Type: Non-Urgent Crossing Status: Found UCIP Comments: 11/07/2019 Rating updated from No Action Needed to Non-Urgent. Crossing type has been updated from Drainage to Irrigation because current crossing design serves irrigation purposes. Need to have CVFPB review ABO and determine current owner. (O.Yakimov - DWR UCIP) FIELD_STRUCT_DESC: 24-inch irrigation pipe of unknown material through the levee, 12.5 feet below the crown. Slide gate is located on the waterside (WS) end. Concrete standpipe and headwall are located on the LS. Water well is connected to the standpipe. (24-inch pipe [HLM 0.58] authorized under Automatic Board Order (ABO) issued as Permit No. 10261, 1974 - Tufts) [Additional Reference(s): DWR Levee Log, 1981 and 2005 (HLM 0.58). USACE Sacramento O&M Manual, Unit 119, December 1952, Revised 29 Dec 2016, (Station 31+00), listed as 24-inch pipe. USACE As-Built Drawing No. 50-04-2396, Revision 1, pdf page 19, Sheet 3, December 1947] FS Date: 11/7/2019 9:56:00 AM

View of WS looking from levee crown

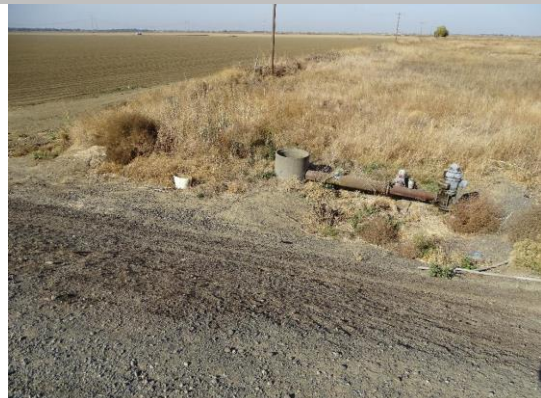
Photo 2 of 3 : UCIP_SP_2022_59851_82056.jpg

View of LS looking from levee crown

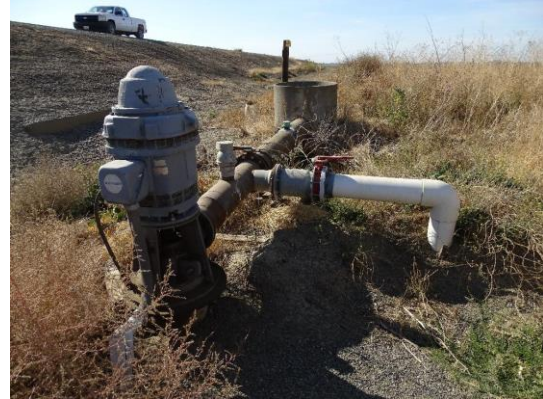
Photo 3 of 3 : UCIP_SP_2022_59851_82058.jpg

Water well connected to standpipe at LS toe. Top of headwall is visible

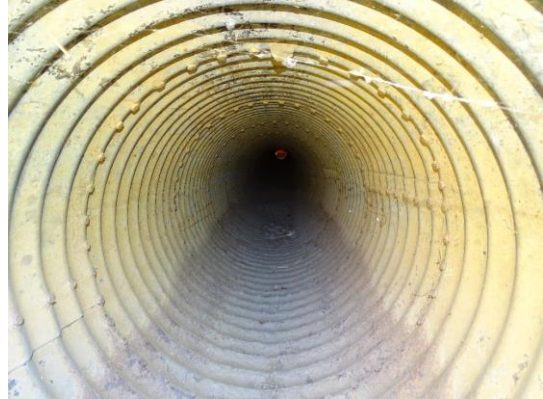
Photo 2 of 3 : UCIP_SP_2022_55455_81754.jpg

View inside of CMP drainage pipe

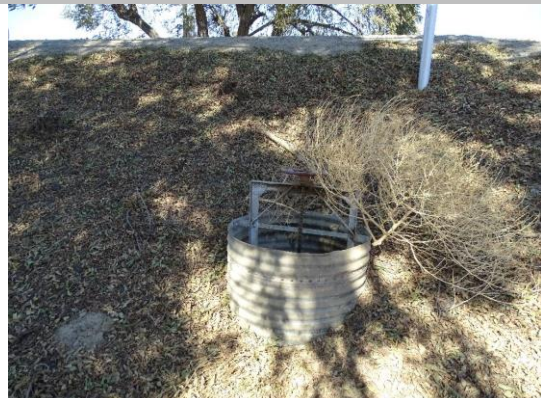
Photo 2 of 3 : UCIP_SP_2022_55460_81780.jpg

Comment Code						
Inspector Comment						
FS_ID:55460 DS_ID:501 EP_NO: 10256 Repair Type: Non-Urgent Crossing Status: Found UCIP Comments: 10/22/2019 Record updated from No Action Needed to Non-Urgent. Need to have CVFPB review ABO and determine current owner. Crossing has been modified to supply water from LS to WS. Should not be considered a storm drainage pipe. (O.Yakimov - DWR UCIP) FIELD_STRUCT_DESC: 24-inch corrugated metal drainage pipe through the levee, 12.5 feet below the crown. Slide gate on the waterside (WS) end in 36-inch standpipe. Concrete standpipe at LS toe with fill-in pipe. (24-inch pipe [HLM 5.40] authorized under Automatic Board Order (ABO) issued as Permit No. 10256, 1974 - Albert H. Lederer). [Additional Reference(s): DWR Levee Log, 2005 (HLM 5.40). USACE Sacramento O&M Manual, Unit 119, December 1952, Revised 29 Dec 2016, (Station 84+40 PCT), listed as 24-inch pipe. USACE As-Built Drawing No. 50-04-2396, Revision 4, pdf page 24, Sheet 8, December 1947]. FS Date: 10/22/2019 3:28:15 PM

36-inch CMP standpipe with slide gate at WS levee toe

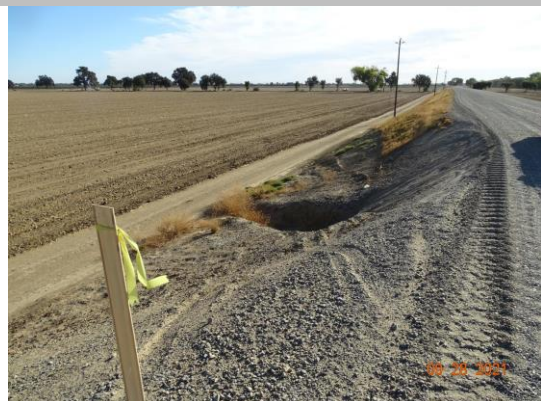
Photo 1 of 1 : SP_2022_ST0007_282_60_20220310_00012.jpg

LM Start	5.74	Rating **	U	Issue No.	60
LM End	5.74	Issue Type +	Ma	Location *	LS
Category	Earthen Levee			GPS Latitude/Longitude	
				Start	End
Item	Erosion / Bank Caving			38.518347 °	38.518347 °
				-121.730949 °	-121.730949 °
DWR ID	DWR_ST0007_01_f_2021_60				
Comment Code					
E2 : Schedule repair of erosion site prior to the next inspection.					
Inspector Comment					
Significant erosion at pipe location into the landside slope and edge of the roadway.

View of erosion around pipe on the landside slope is cutting into the edge of the crown (Fall 2021).

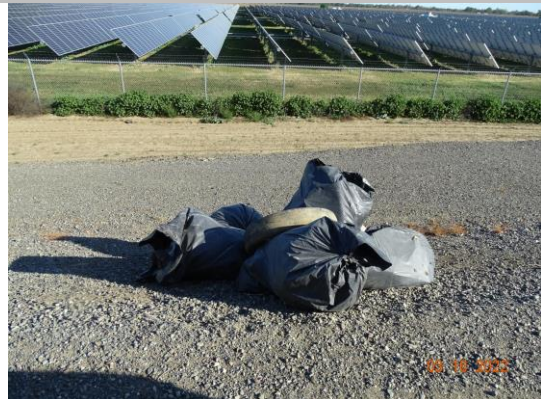
Photo 1 of 1 : SP_2022_ST0007_282_73_20220316_00118.jpg

View of garbage on the landside slope (Spring 2022).

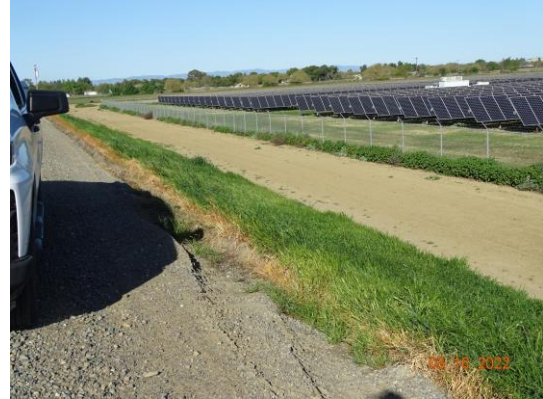
Photo 1 of 1 : SP_2022_ST0007_282_72_20220316_00119.jpg

LM Start	6.35	Rating **	M	Issue No.	72
LM End	6.35	Issue Type +	Ma	Location *	LS
Category	Earthen Levee			GPS Latitude/Longitude	
				Start	End
Item	Erosion / Vehicle Traffic			38.518273 °	38.518273 °
				-121.742212 °	-121.742212 °
DWR ID	DWR_ST0007_01_s_2022_72				
Comment Code					
E6 : Repair the levee slope damaged by vehicle traffic and prevent access where possible.					
Inspector Comment					
Erosion at top of landside slope.

View of erosion due to vehicles on the landside shoulder (Spring 2022).

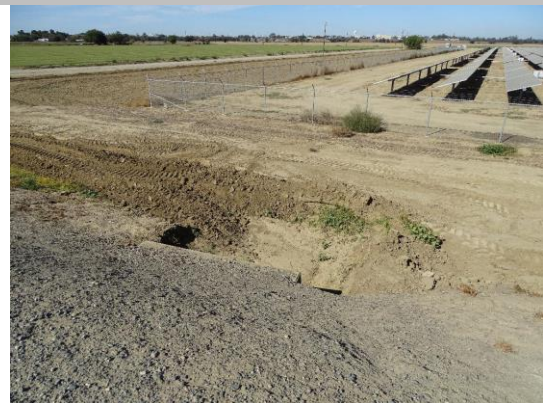
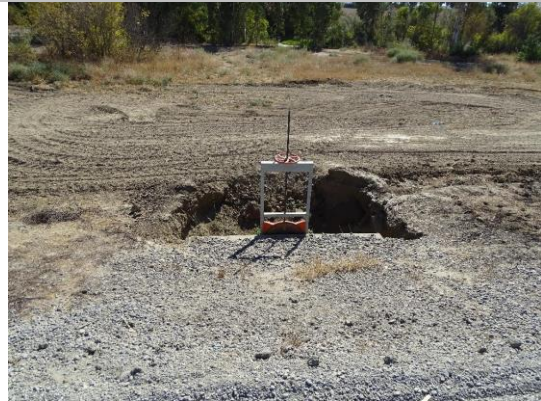
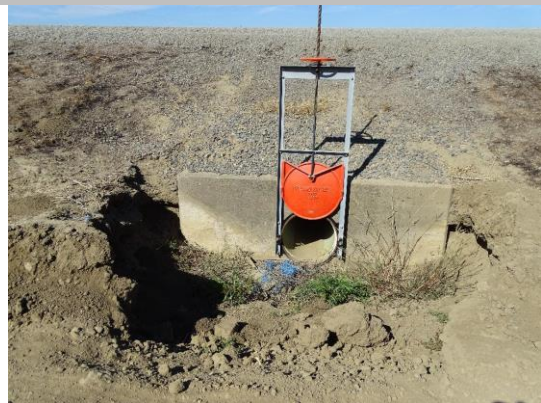
Comment Code						
Inspector Comment						
FS_ID:55647 DS_ID:505 EP_NO: 10253 Repair Type: Non-Urgent Crossing Status: Found UCIP Comments: 10/22/2019 Record updated from No Action Needed to Non-Urgent. Levee toe erosion on both sides of headwall on WS. Need to have CVFPB review ABO and determine current owner. (O.Yakimov - DWR UCIP) FIELD_STRUCT_DESC: 24-inch CIPP-lined corrugated metal drainage pipe through the levee, 10.4 feet below the crown. Slide gate on the waterside (WS), and concrete headwalls on both the WS and the landside (LS). (24-inch pipe [HLM 6.57] authorized under Automatic Board Order (ABO) issued as Permit No. 10253, 1974 - Lester J. Hamel). [Additional Reference(s): DWR Levee Log, 2005 (HLM 6.57. USACE Sacramento O&M Manual, Unit 119, December 1952, Revised 29 Dec 2016, (Station 145+50 PCT), listed as 24-inch pipe. USACE As-Built Drawing No. 50-04-2396, Revision 4, pdf page 24, Sheet 8, December 1947]. FS Date: 10/22/2019 11:07:35 AM

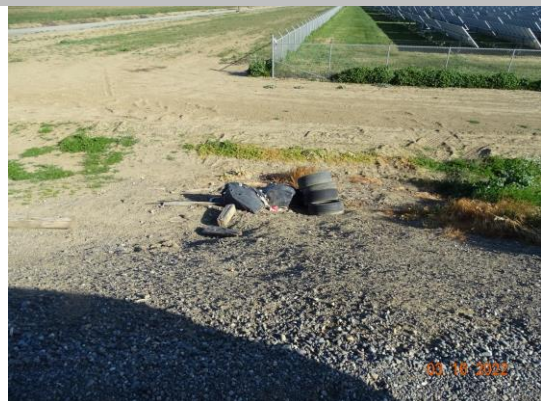
Photo 1 of 1 : SP_2022_ST0007_282_71_20220316_00120.jpg

View of garbage on the landside toe (Spring 2022).

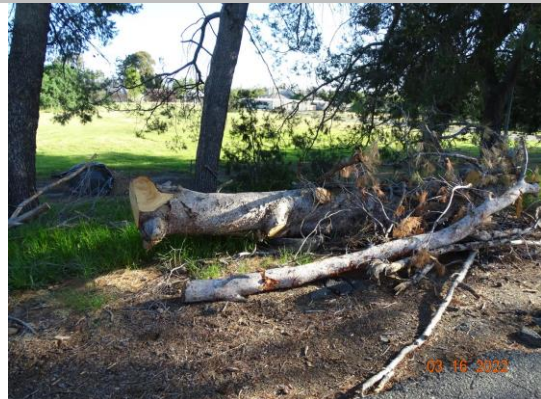
Photo 1 of 1 : SP_2022_ST0007_282_66_20220316_00122.jpg

View of cut up tree limbs on the landside shoulder (Spring 2022).

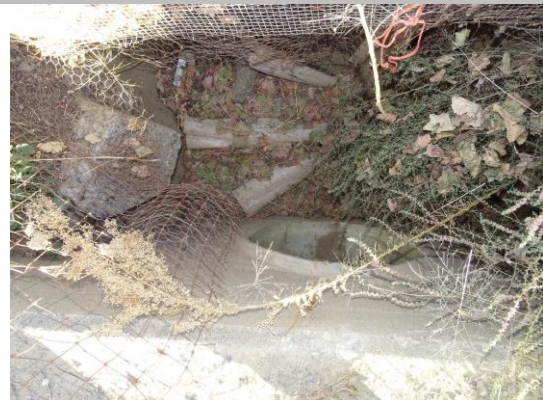
Photo 2 of 3 : UCIP_SP_2022_59875_82383.jpg

Comment Code						
Inspector Comment						
FS_ID:59875 DS_ID:518 EP_NO: 10247 Repair Type: Non-Urgent Crossing Status: Found UCIP Comments: 10/21/2019 Difficult access to pipe inlet on LS due to a fence. (O.Yakimov - DWR UCIP)05/07/2013 Fence blocking inlet. Owner of fence needs to move fence away from inlet. (C. Lund - DWR Sacramento Yard) 04/05/2012 Clear debris from pipe. (W. Wylie - DWR UCIP) FIELD_STRUCT_DESC: 24-inch CIPP-lined corrugated metal drainage pipe through the levee, 12 feet below the crown. Slide gate on the waterside (WS) slope, and headwalls on both sides. (24-inch pipe [HLM 7.75] authorized under Automatic Board Order (ABO) issued as Permit No. 10247, 1974 - University of California, Office of the Regents). [Additional Reference(s): DWR Levee Log, 2005 (HLM 7.75). USACE Sacramento O&M Manual, Unit 119, December 1952, Revised 29 Dec 2016, (Station 204+00 PCT), listed as 24-inch pipe. USACE As-Built Drawing No. 50-04-2396, Revision 4, pdf page 25, Sheet 9, December 1947]. FS Date: 10/21/2019 8:27:00 AM

LS: headwall and pipe end near a fence

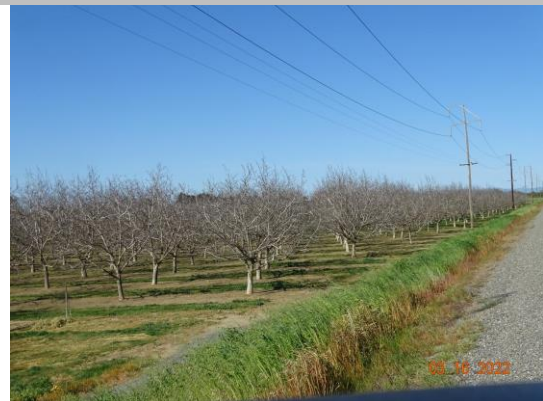
Photo 1 of 1 : SP_2022_ST0007_283_52_20220316_00094.jpg

View looking upstream at vegetation on the landside slope (Spring 2022).

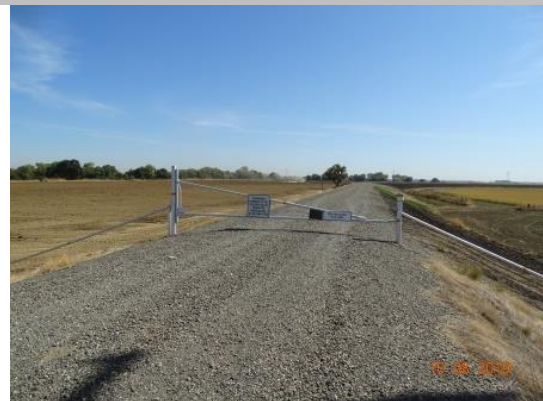
Photo 1 of 1 : SP_2022_ST0007_283_29_20220310_00005.jpg

View looking downstream at gate on the crown (Fall 2019).

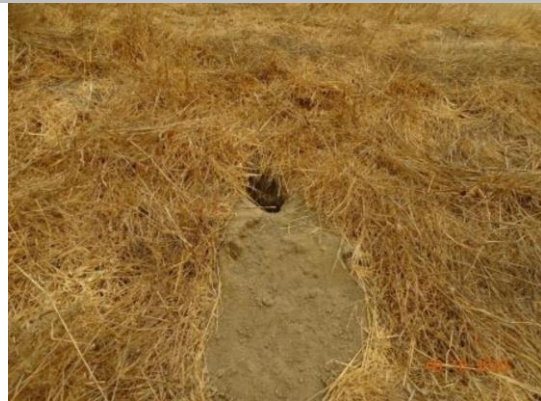
Photo 1 of 1 : SP_2022_ST0007_283_32_20220310_00007.jpg

View of large animal hole on the landside slope (Fall 2020).

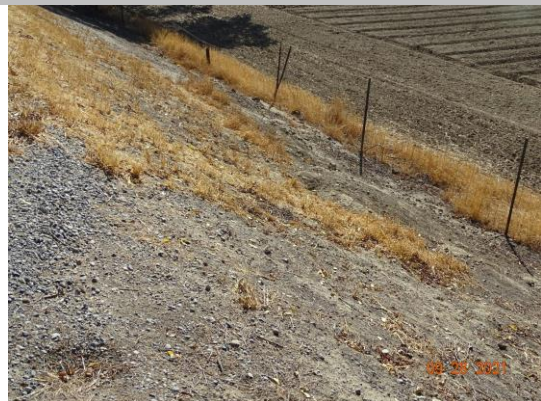
Photo 1 of 1 : SP_2022_ST0007_283_9_20220310_00001.jpg

View of multiple animal holes on the landside slope (Fall 2021).

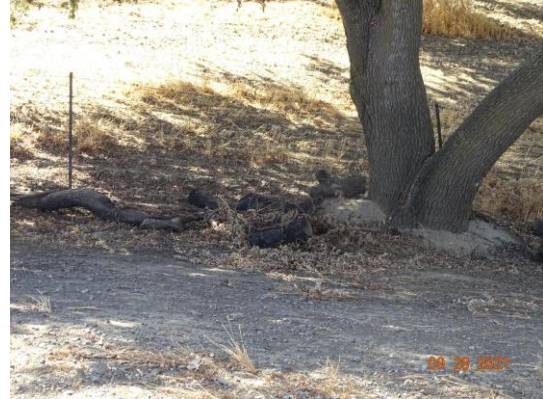
Photo 1 of 1 : SP_2022_ST0007_283_50_20220310_00021.jpg

View of tree limbs on the landside toe (Fall 2021).

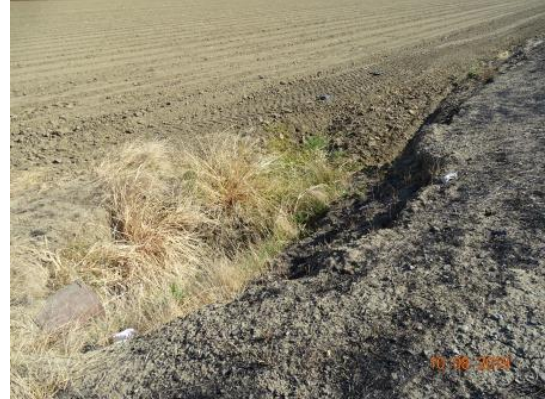
Photo 1 of 2 : SP_2022_ST0007_283_33_20220310_00008.jpg

View of erosion on the levee slope (Fall 2019).

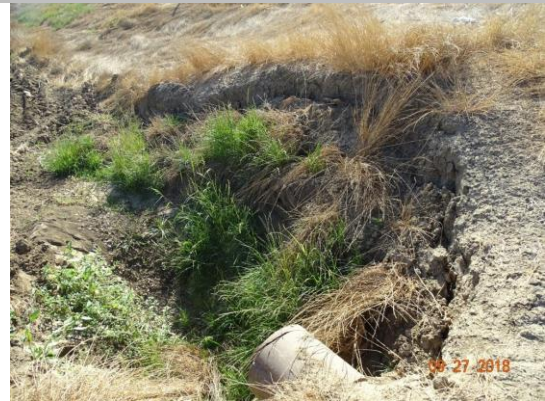
Photo 2 of 2 : SP_2022_ST0007_283_33_20220310_00009.jpg

View of erosion on the levee slope appears to be due to water from the pipe and trench (September 2018).

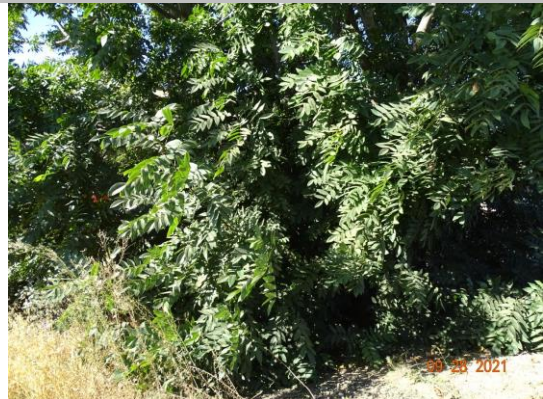
Photo 1 of 1 : SP_2022_ST0007_283_40_20220310_00013.jpg

View of thick tree on the landside slope (Fall 2021).
