**Flood Control Project Maintenance
Levee Inspections**

Maintenance Issue Types Only, Levee Inspection Report By Mile - Spring 2023

Sacramento Maintenance Yard Putah Creek

Waterway	Bank	Unit Miles	Inspection Start/End	Inspector
Unit No. 01 Putah Creek or North Levee	Left	8.79	05/15/2023 05/15/2023	Nate Hicks

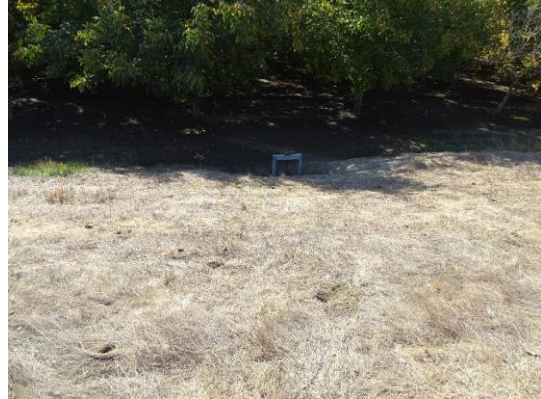
Photo 1 of 3 : UCIP_SP_2023_55597_82102.jpg

Comment Code						
Inspector Comment						
DS_ID:492 FS_ID:55597 EP_NO: 10262 Repair Type: Non-Urgent EVAL Issue: Crossing Status: Found UCIP Comments: 11/07/2019 Record updated from No Action Needed to Non-Urgent. Need to have CVFPB review ABO and determine current owner. (O.Yakimov - DWR UCIP) FIELD_STRUCT_DESC: 24-inch CIPP-lined drainage pipe of unknown material through levee, 13 feet below crown. Slide gate is located on the waterside (WS) end. Concrete headwalls are located on both the waterside (WS) and landside (LS). (24-inch pipe [HLM 2.77] authorized under Automatic Board Order (ABO) issued as Permit No. 10262, 1974 - Wells Fargo Bank, Trustee for S.H. Cowell Foundation) [Additional Reference(s): DWR Levee Log, 1981 and 2005 (HLM 2.77). USACE Sacramento O&M Manual, Unit 119, December 1952, Revised 29 Dec 2016, (Station P 213+00), listed as 24-inch pipe. USACE As-Built Drawing No. 50-04-2396, Revision 3, pdf page 22, Sheet 6, December 1947] FS Date: 11/7/2019 10:48:08 AM

View of WS looking from levee crown

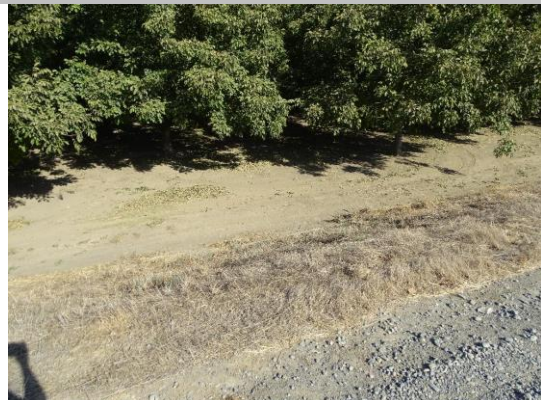
Photo 2 of 3 : UCIP_SP_2023_55597_82103.jpg

View of LS looking from levee crown

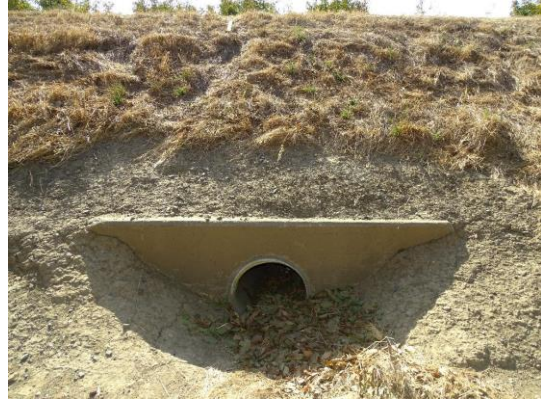
Photo 3 of 3 : UCIP_SP_2023_55597_82104.jpg

LS levee slope, headwall, and pipe end

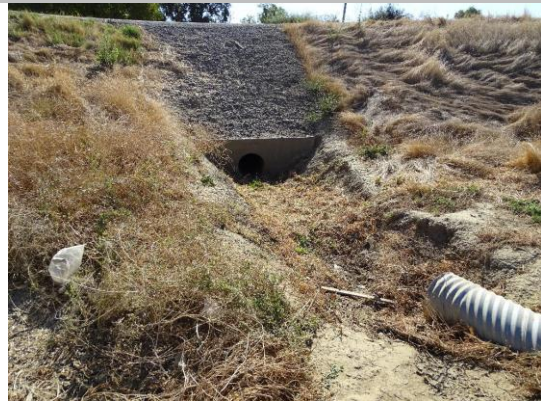
Photo 1 of 3 : UCIP_SP_2023_55455_81753.jpg

DS_ID:496
 FS_ID:55455
 EP_NO: 10251
 Repair Type: Non-Urgent
 EVAL Issue:
 Crossing Status: Found
 UCIP Comments: 10/22/2019 Record updated from No Action Needed to Non-Urgent. Need to have CVFPB review ABO and determine current owner. Installed a new precast concrete box on the waterside. Pipe will be lined in November 2019 according to FMO staff. (O.Yakimov - DWR UCIP)4/10/2019 Major erosion through out pipe. Erosion on WS allows water to enter pipe and flood LS field. Erosion on farmers waterman valve. Field water drains into pipe and floods LS field. (J.McCabe - DWR Sacramento Yard)
 FIELD_STRUCT_DESC: 24-inch corrugated metal drainage pipe through levee, 15 feet below the crown. Two metal cutoff walls were installed through the levee. A T-post and T-handle are located on the landside (LS) toe. The outfall structure and flap gate are located on the west side of bridge, waterside (WS). (24-inch pipe [HLM 3.87] authorized under Automatic Board Order (ABO) issued as Permit No. 10251, 1974 - F.M.C. Corp.) [Additional Reference(s): DWR Levee Log, 1981 and 2005 (HLM 3.87). USACE Sacramento O&M Manual, Unit 119, December 1952, Revised 29 Dec 2016, (Station 1+50 PCT), listed as 24-inch pipe. USACE As-Built Drawing No. 50-04-2396, Revision 4, pdf page 23, Sheet 7, December 1947]

LS levee slope, headwall, and pipe end

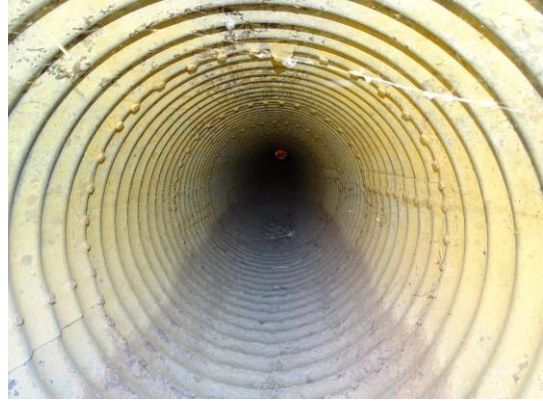
Photo 2 of 3 : UCIP_SP_2023_55455_81754.jpg

View inside of CMP drainage pipe

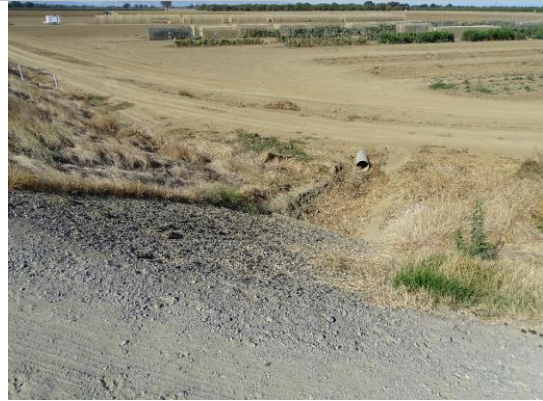
Photo 3 of 3 : UCIP_SP_2023_55455_81755.jpg

View of LS looking from levee crown

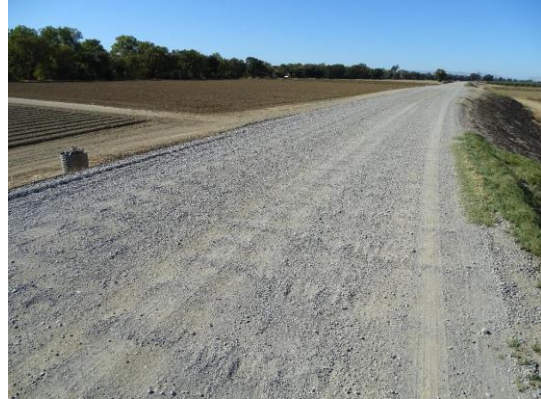
Photo 1 of 3 : UCIP_SP_2023_55456_81760.jpg

Comment Code						
Inspector Comment						
DS_ID:497 FS_ID:55456 EP_NO: 10251 Repair Type: Non-Urgent EVAL Issue: Crossing Status: Found UCIP Comments: 10/22/2019 Record updated from No Action Needed to Non-Urgent. Geophysical study indicates possible presence of pipe through levee. Need to have CVFPB review ABO and determine current owner. Pipe inlet and headwall are not visible on LS. Slide gate in CMP riser is in closed position, crossing looks abandoned. Construction according to permit 10251-1 hasn't started yet. Field structure description is updated to match original pipe construction. (O.Yakimov - DWR UCIP) FIELD_STRUCT_DESC: 24-inch drainage pipe of unknown material through levee, 16 feet below the crown. 36-inch galvanized corrugated metal pipe (CMP) riser located on the waterside (WS) slope. (24-inch pipe [HLM 4.13] authorized under Automatic Board Order (ABO) issued as Permit No. 10251, 1974 - F.M.C. Corp.; assumed original 24-inch pipe was installed in 12/12/1952 per O&M manual) [Additional Reference(s): DWR Levee Log, 1981 and 2005 (HLM 4.13). USACE Sacramento O&M Manual, Unit 119, December 1952, Revised 29 Dec 2016, (Station 17+00 PCT), listed as 24-inch pipe. USACE As-Built Drawing No. 50-04-2396, Revision 4, pdf page 23, Sheet 7, December 1947] FS Date: 10/22/2019 11:37:56 AM

View of levee crown at the crossing

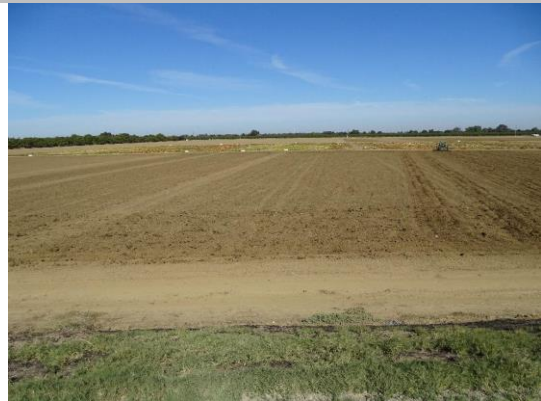
Photo 2 of 3 : UCIP_SP_2023_55456_81761.jpg

View of LS looking from levee crown

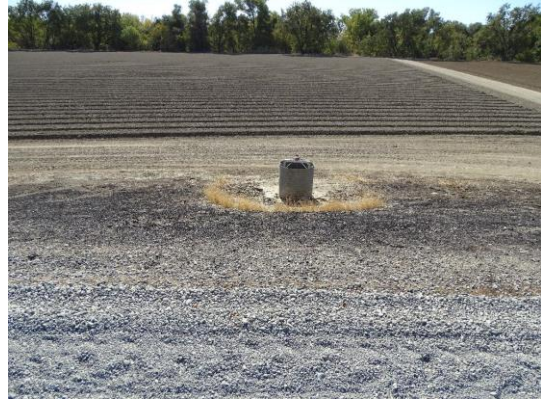
Photo 3 of 3 : UCIP_SP_2023_55456_81762.jpg

View of WS looking from levee crown

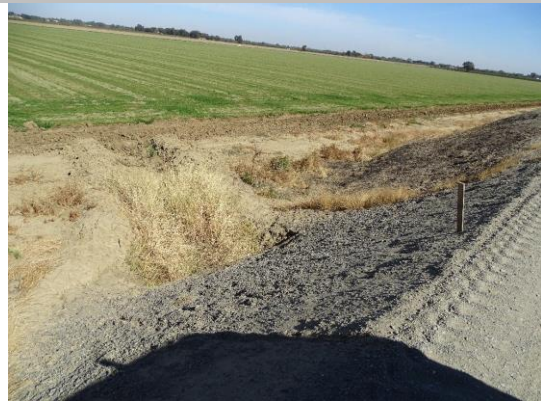
Photo 1 of 3 : UCIP_SP_2023_59861_81775.jpg

DS_ID:500
FS_ID:59861
EP_NO: 10256
Repair Type: Non-Urgent
EVAL Issue:
Crossing Status: Found
UCIP Comments: 10/22/2019 Record updated from No Action Needed to Non-Urgent. Need to have CVFPB review ABO and determine current owner. (O.Yakimov - DWR UCIP)05/06/2013 Debris removed. See picture (C. Lund - DWR Sacramento Yard)
04/04/2012 Some debris in pipe invert LS (W. Wylie - DWR UCIP)
FIELD_STRUCT_DESC: 24-inch CIPP-lined corrugated metal drainage pipe through the levee, 15 feet below the crown. Slide gate on the waterside (WS) end. Concrete headwall on the landside (LS) end. (24-inch pipe [HLM 5.39] authorized under Automatic Board Order (ABO) issued as Permit No. 10256, 1974 - Albert H. Lederer). [Additional Reference(s): DWR Levee Log, 2005 (HLM 5.39). USACE Sacramento O&M Manual, Unit 119, December 1952, Revised 29 Dec 2016, (Station 83+70 PCT), listed as 24-inch pipe. USACE As-Built Drawing No. 50-04-2396, Revision 4, pdf page 24, Sheet 8, December 1947].

View of LS looking from levee crown

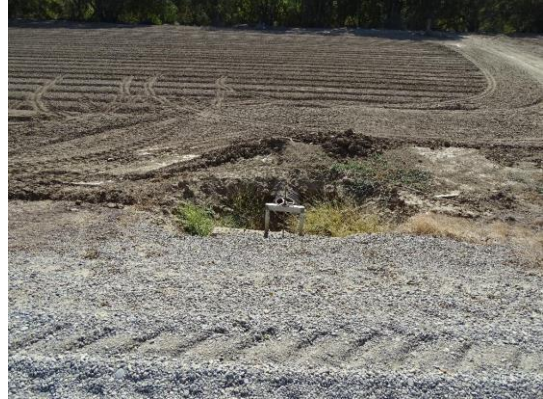
Photo 2 of 3 : UCIP_SP_2023_59861_81776.jpg

View of WS looking from levee crown

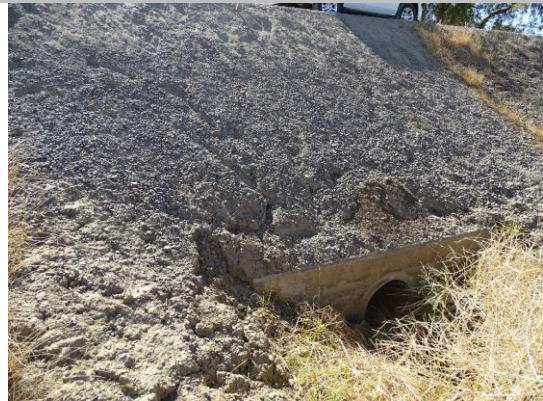
Photo 3 of 3 : UCIP_SP_2023_59861_81777.jpg

LS levee slope, headwall, and pipe end

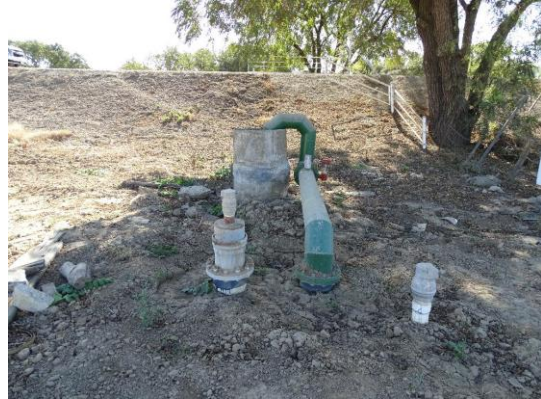
Photo 1 of 3 : UCIP_SP_2023_55460_81779.jpg

Comment Code						
Inspector Comment						
DS_ID:501 FS_ID:55460 EP_NO: 10256 Repair Type: Non-Urgent EVAL Issue: 10, Unauthorized Modification or Non-Compliant Permit Crossing Status: Found UCIP Comments: 10/22/2019 Record updated from No Action Needed to Non-Urgent. Need to have CVFPB review ABO and determine current owner. Crossing has been modified to supply water from LS to WS. Should not be considered a storm drainage pipe. (O.Yakimov - DWR UCIP) FIELD_STRUCT_DESC: 24-inch corrugated metal drainage pipe through the levee, 12.5 feet below the crown. Slide gate on the waterside (WS) end in 36-inch standpipe. Concrete standpipe at LS toe with fill-in pipe. (24-inch pipe [HLM 5.40] authorized under Automatic Board Order (ABO) issued as Permit No. 10256, 1974 - Albert H. Lederer). [Additional Reference(s): DWR Levee Log, 2005 (HLM 5.40). USACE Sacramento O&M Manual, Unit 119, December 1952, Revised 29 Dec 2016, (Station 84+40 PCT), listed as 24-inch pipe. USACE As-Built Drawing No. 50-04-2396, Revision 4, pdf page 24, Sheet 8, December 1947]. FS Date: 10/22/2019 3:28:15 PM

View of LS slope with concrete standpipe at levee toe

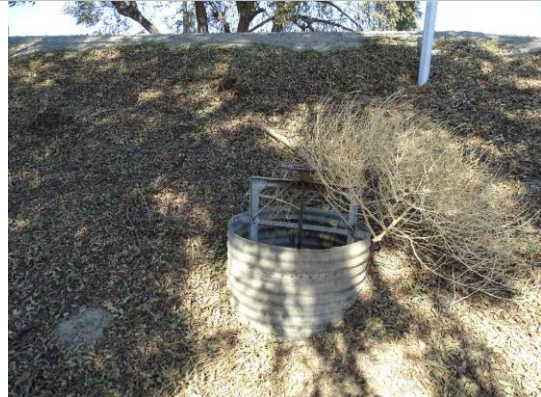
Photo 2 of 3 : UCIP_SP_2023_55460_81780.jpg

36-inch CMP standpipe with slide gate at WS levee toe

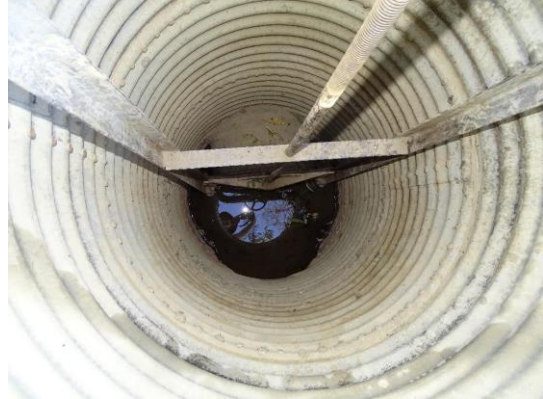
Photo 3 of 3 : UCIP_SP_2023_55460_81781.jpg

View inside of CMP standpipe on WS

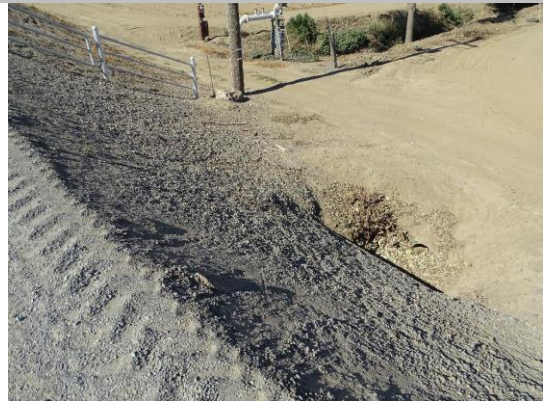
Photo 1 of 3 : UCIP_SP_2023_55461_81782.jpg

DS_ID:502
 FS_ID:55461
 EP_NO: 10255
 Repair Type: Non-Urgent
 EVAL Issue:
 Crossing Status: Found
 UCIP Comments: 10/22/2019 Record updated from No Action Needed to Non-Urgent. Need to have CVFPB review ABO and determine current owner. (O.Yakimov - DWR UCIP)
 FIELD_STRUCT_DESC: 24-inch CIPP-lined corrugated metal drainage pipe through the levee, 11 feet below the crown. Slide gate on the waterside (WS) end. Concrete headwall on the landside (LS) end. (24-inch pipe [HLM 5.67] authorized under Automatic Board Order (ABO) issued as Permit No. 10255, 1974 - Owen W. and Ray W. Hamel).
 [Additional Reference(s): DWR Levee Log, 2005 (HLM 5.67). USACE Sacramento O&M Manual, Unit 119, December 1952, Revised 29 Dec 2016, (Station 97+00 PCT), listed as 24-inch pipe. USACE As-Built Drawing No. 50-04-2396, Revision 4, pdf page 24, Sheet 8, December 1947].
 FS Date: 10/22/2019 4:03:27 PM

View of LS looking from levee crown

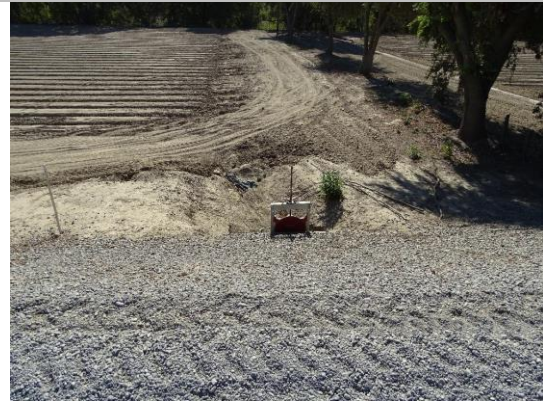
Photo 2 of 3 : UCIP_SP_2023_55461_81783.jpg

View of WS looking from levee crown

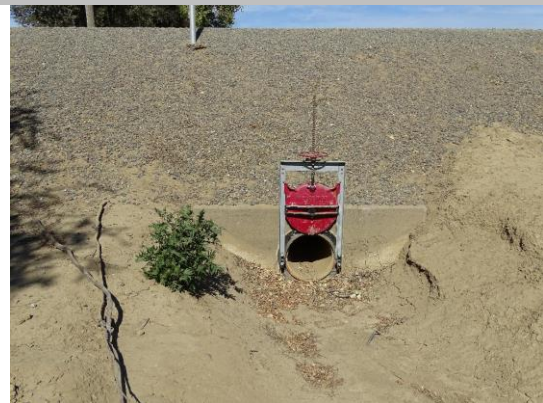
Photo 3 of 3 : UCIP_SP_2023_55461_81784.jpg

WS levee slope, headwall, and slide gate

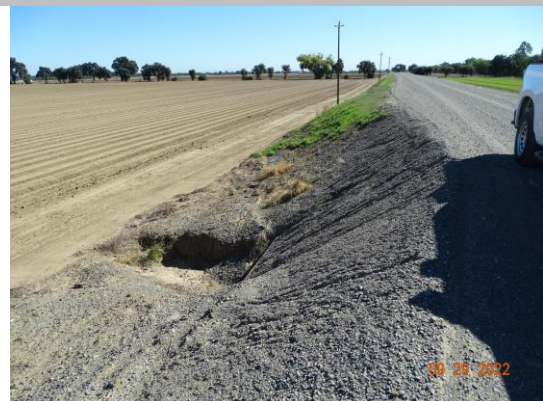
Photo 1 of 1 : SP_2023_ST0007_282_60_20230515_00013.jpg

LM Start	5.74	Rating **	U	Issue No.	60
LM End	5.74	Issue Type +	Ma	Location *	LS
Category	Earthen Levee			GPS Latitude/Longitude	
				Start	End
Item	Erosion / Bank Caving			38.518347°	38.518347°
				-121.730949°	-121.730949°
DWR ID	DWR_ST0007_01_f_2021_60				
Comment Code					
E2 : Schedule repair of erosion site prior to the next inspection.					
Inspector Comment					
There is significant erosion at the pipe location and into the landside slope and edge of the roadway.

View of the erosion around the pipe on the LS slope (Fall 2022).

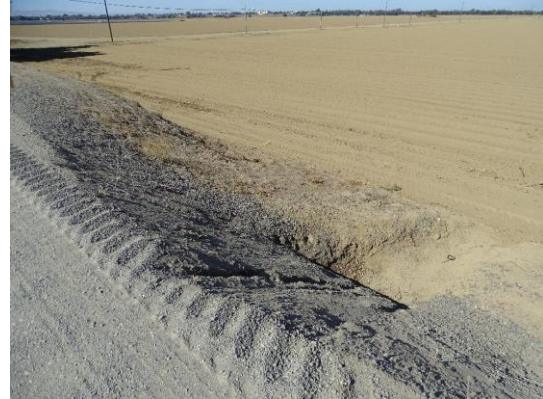
Photo 1 of 3 : UCIP_SP_2023_59863_82261.jpg

Comment Code					
Inspector Comment					
DS_ID:503 FS_ID:59863 EP_NO: 10252 Repair Type: Non-Urgent EVAL Issue: Crossing Status: Found UCIP Comments: 10/22/2019 Record updated from No Action Needed to Non-Urgent. Need to have CVFPB review ABO and determine current owner. (O.Yakimov - DWR UCIP) 05/06/2013 Owner of pipe needs to clean out obstruction in pipe. (C. Lund - DWR Sacramento Yard) 04/04/2012 Partially obstructed with sedimentation throughout crossing. (W. Wylie - DWR UCIP) FIELD_STRUCT_DESC: 24-inch CIPP-lined corrugated metal drainage pipe through the levee, 12 feet below the crown. Slide gate on the waterside (WS) end. Concrete headwall on the landside (LS) end. (24-inch pipe [HLM 5.86] authorized under Automatic Board Order (ABO) issued as Permit No. 10252, 1974 - John F. Hamel). [Additional Reference(s): DWR Levee Log, 2005 (HLM 5.86). USACE Sacramento O&M Manual, Unit 119, December 1952, Revised 29 Dec 2016, (Station 108+00 PCT), listed as 24-inch pipe. USACE As-Built Drawing No. 50-04-2396, Revision 4, pdf page 24, Sheet 8, December 1947]. FS Date: 10/22/2019 10:55:00 AM

View of LS looking from levee crown

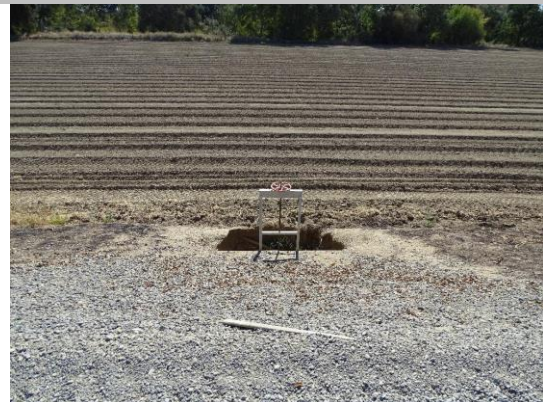
Photo 2 of 3 : UCIP_SP_2023_59863_82262.jpg

View of WS looking from levee crown

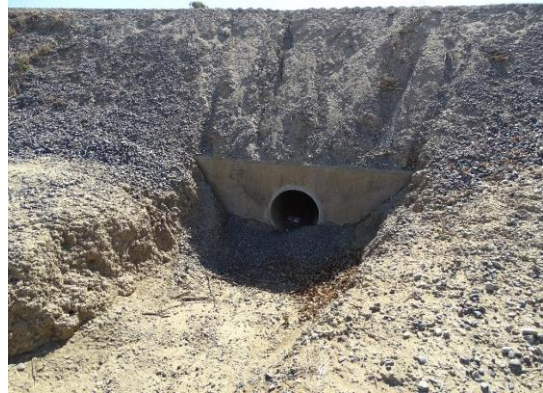
Photo 3 of 3 : UCIP_SP_2023_59863_82263.jpg

LS levee slope, headwall, and pipe end

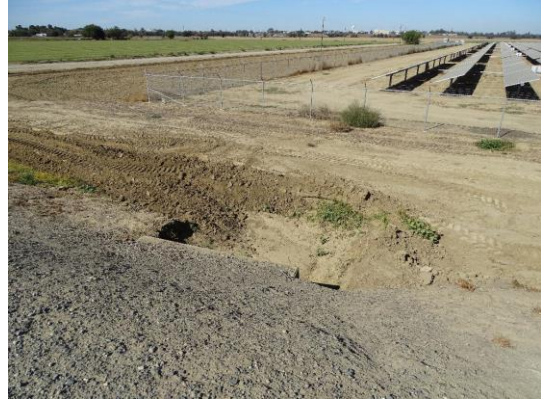
Photo 1 of 3 : UCIP_SP_2023_55647_82273.jpg

Comment Code						
Inspector Comment						
DS_ID:505 FS_ID:55647 EP_NO: 10253 Repair Type: Non-Urgent EVAL Issue: 6, Levee Damage or Threat for Levee Damage Crossing Status: Found UCIP Comments: 10/22/2019 Record updated from No Action Needed to Non-Urgent. Levee toe erosion on both sides of headwall on WS. Need to have CVFPB review ABO and determine current owner. (O.Yakimov - DWR UCIP) FIELD_STRUCT_DESC: 24-inch CIPP-lined corrugated metal drainage pipe through the levee, 10.4 feet below the crown. Slide gate on the waterside (WS), and concrete headwalls on both the WS and the landside (LS). (24-inch pipe [HLM 6.57] authorized under Automatic Board Order (ABO) issued as Permit No. 10253, 1974 - Lester J. Hamel). [Additional Reference(s): DWR Levee Log, 2005 (HLM 6.57. USACE Sacramento O&M Manual, Unit 119, December 1952, Revised 29 Dec 2016, (Station 145+50 PCT), listed as 24-inch pipe. USACE As-Built Drawing No. 50-04-2396, Revision 4, pdf page 24, Sheet 8, December 1947]. FS Date: 10/22/2019 11:07:35 AM

View of LS looking from levee crown

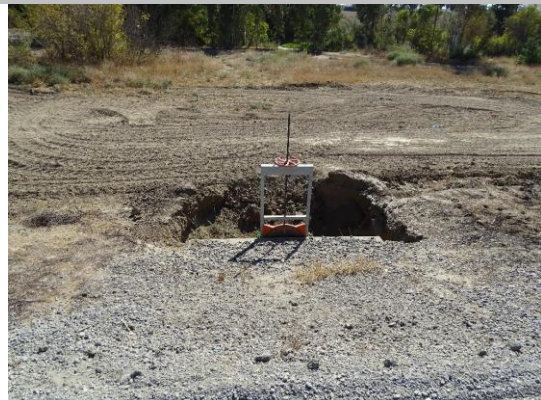
Photo 2 of 3 : UCIP_SP_2023_55647_82274.jpg

View of WS looking from levee crown

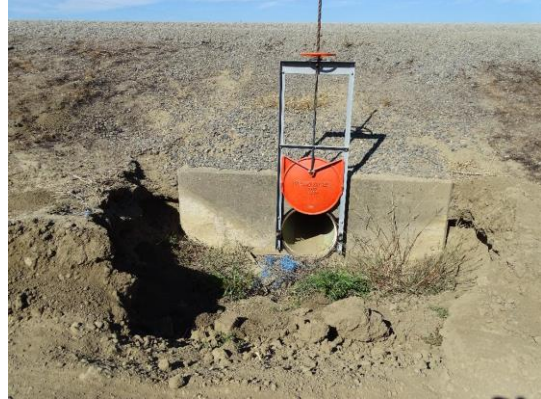
Photo 3 of 3 : UCIP_SP_2023_55647_82275.jpg

WS levee slope, headwall, and slide gate

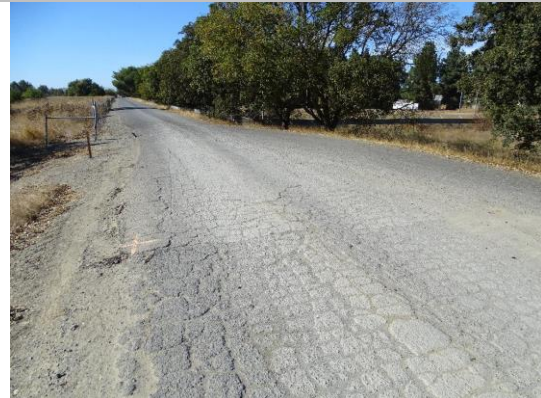
Photo 1 of 3 : UCIP_SP_2023_55664_82343.jpg

Comment Code					
Inspector Comment					
DS_ID:508 FS_ID:55664 EP_NO: 10247 Repair Type: Non-Urgent EVAL Issue: Crossing Status: Found UCIP Comments: 10/22/2019 Record updated from No Action Needed to Non-Urgent. Need to have CVFPB review ABO and determine current owner. (O.Yakimov - DWR UCIP) FIELD_STRUCT_DESC: 24-inch CIPP-lined corrugated metal drainage pipe through the levee, 11.0 feet below the crown. Flap gate on the waterside (WS) end. Concrete headwall on the landside (LS) end. Concrete Apron on the WS. (24-inch pipe [HLM 7.09] authorized under Automatic Board Order (ABO) issued as Permit No. 10247, 1974 - University of California, Office of the Regents). [Additional Reference(s): DWR Levee Log, 2005 (HLM 7.09). USACE Sacramento O&M Manual, Unit 119, December 1952, Revised 29 Dec 2016, (Station 172+00 PCT), listed as 24-inch pipe. USACE As-Built Drawing No. 50-04-2396, Revision 4, pdf page 25, Sheet 9, December 1947]. FS Date: 10/22/2019 1:55:30 PM

View of levee crown at the crossing

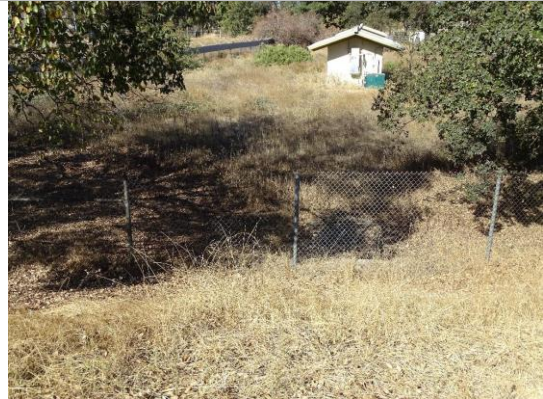
Photo 3 of 3 : UCIP_SP_2023_55664_82345.jpg

View of LS looking from levee crown

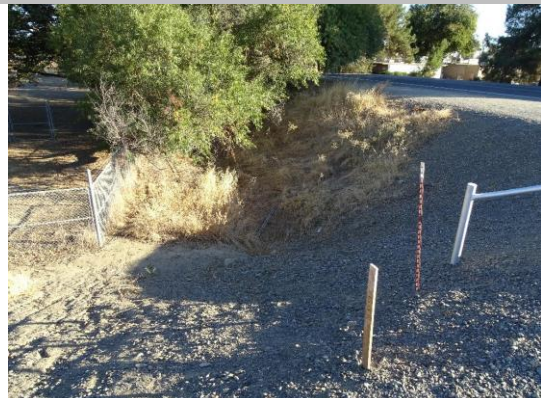
Photo 2 of 3 : UCIP_SP_2023_59869_82355.jpg

Comment Code						
Inspector Comment						
DS_ID:512						
FS_ID:59869						
EP_NO: 10247						
Repair Type: Non-Urgent						
EVAL Issue:						
Crossing Status: Found						
UCIP Comments: 10/21/2019 Record updated from No Action Needed to Non-Urgent. Need to have CVFPB review ABO and determine current owner. (O.Yakimov - DWR UCIP) 05/07/2013 Debris removed from outlet. (C. Lund - DWR Sacramento Yard)						
04/04/2012 Some debris blocking outlet. (W. Wylie - DWR UCIP)						
FIELD_STRUCT_DESC: 24-inch CIPP-lined drainage pipe of an unknown material through the levee, 12 feet below the crown. Flap gate on the waterside (WS) end. Concrete headwall on the landside (LS) end. (24-inch [HLM 7.36] authorized under Automatic Board Order (ABO) issued as Permit No. 10247, 1974 - University of California, Office of the Regents). [Additional Reference(s): DWR Levee Log, 2005 (HLM 7.36). USACE Sacramento O&M Manual, Unit 119, December 1952, Revised 29 Dec 2016, (Station 183+97 PCT), listed as 24-inch pipe. USACE As-Built Drawing No. 50-04-2396, Revision 4, pdf page 25, Sheet 9, December 1947].

View of LS looking from levee crown

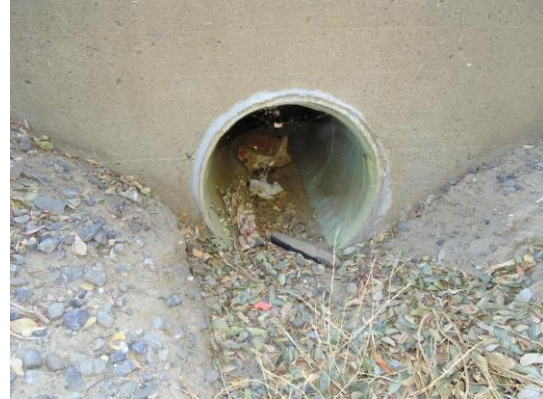
Photo 3 of 3 : UCIP_SP_2023_59869_82356.jpg

LS levee slope, headwall, and pipe end

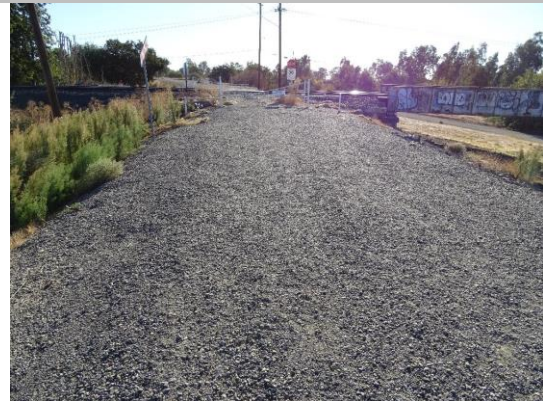
Photo 1 of 3 : UCIP_SP_2023_59874_82372.jpg

DS_ID:516
 FS_ID:59874
 EP_NO: 10260
 Repair Type: Non-Urgent
 EVAL Issue:
 Crossing Status: Found
 UCIP Comments: 10/21/2019 Record remains Non-Urgent. Need to have CVFPB review ABO and determine current owner. (O.Yakimov - DWR UCIP) 05/07/2013 Owner of pipe may have to clean sediment. (C. Lund - DWR Sacramento Yard)
 04/05/2012 Pipe is partially obstructed with sedimentation. (W. Wylie - DWR UCIP)
 FIELD_STRUCT_DESC: 24-inch corrugated metal drainage pipe through the levee, 12 feet below the crown. Flap gate on the waterside (WS) end. (24-inch pipe [HLM 7.52] authorized under Automatic Board Order (ABO) issued as Permit No. 10260, 1974 - Southern Pacific Transportation Company). [Additional Reference(s): DWR Levee Log, 2005 (HLM 7.52). USACE Sacramento O&M Manual, Unit 119, December 1952, Revised 29 Dec 2016, (Station 193+20 PCT), listed as 24-inch pipe. USACE As-Built Drawing No. 50-04-2396, Revision 4, pdf page 25, Sheet 9, December 1947].

View of levee crown at the crossing

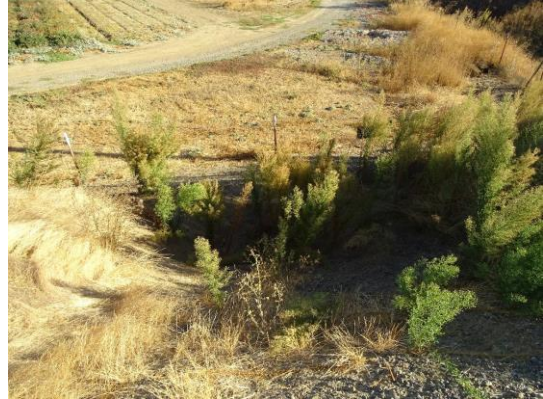
Photo 2 of 3 : UCIP_SP_2023_59874_82373.jpg

View of LS looking from levee crown

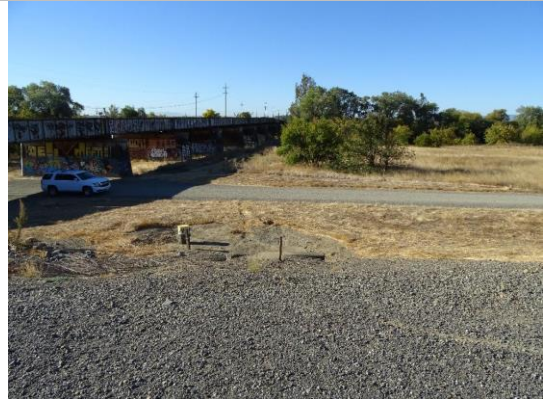
Photo 3 of 3 : UCIP_SP_2023_59874_82374.jpg

View of WS looking from levee crown

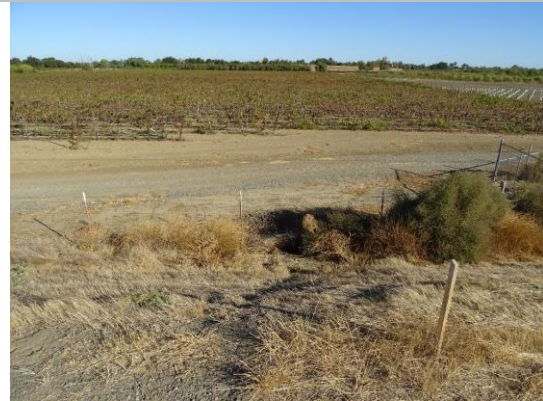
Photo 1 of 3 : UCIP_SP_2023_59875_82382.jpg

Comment Code						
Inspector Comment						
DS_ID:518 FS_ID:59875 EP_NO: 10247 Repair Type: Non-Urgent EVAL Issue: Crossing Status: Found UCIP Comments: 10/21/2019 Difficult access to pipe inlet on LS due to a fence. (O.Yakimov - DWR UCIP)05/07/2013 Fence blocking inlet. Owner of fence needs to move fence away from inlet. (C. Lund - DWR Sacramento Yard) 04/05/2012 Clear debris from pipe. (W. Wylie - DWR UCIP) FIELD_STRUCT_DESC: 24-inch CIPP-lined corrugated metal drainage pipe through the levee, 12 feet below the crown. Slide gate on the waterside (WS) slope, and headwalls on both sides. (24-inch pipe [HLM 7.75] authorized under Automatic Board Order (ABO) issued as Permit No. 10247, 1974 - University of California, Office of the Regents). [Additional Reference(s): DWR Levee Log, 2005 (HLM 7.75). USACE Sacramento O&M Manual, Unit 119, December 1952, Revised 29 Dec 2016, (Station 204+00 PCT), listed as 24-inch pipe. USACE As-Built Drawing No. 50-04-2396, Revision 4, pdf page 25, Sheet 9, December 1947]. FS Date: 10/21/2019 8:27:00 AM

View of LS looking from levee crown

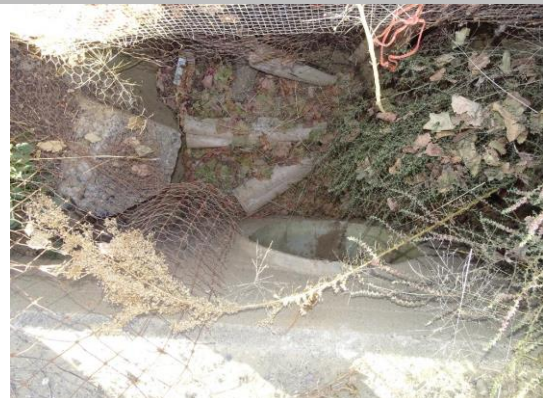
Photo 2 of 3 : UCIP_SP_2023_59875_82383.jpg

LS: headwall and pipe end near a fence

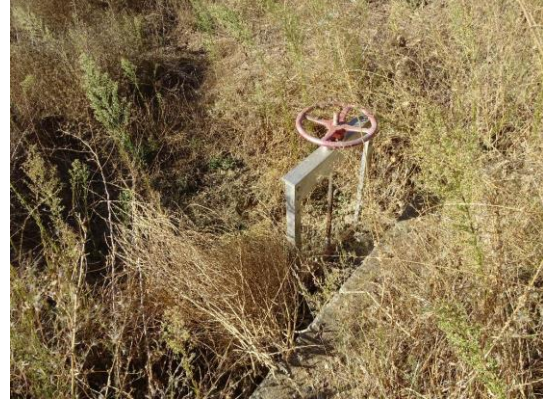
Photo 3 of 3 : UCIP_SP_2023_59875_82385.jpg

WS: headwall and slide gate

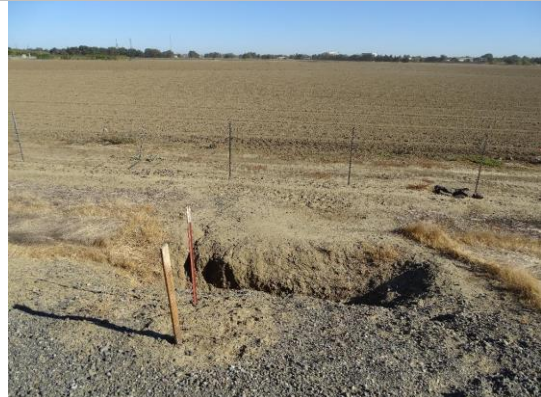
Photo 2 of 3 : UCIP_SP_2023_59879_82394.jpg

Comment Code						
Inspector Comment						
DS_ID:520 FS_ID:59879 EP_NO: 10247 Repair Type: Non-Urgent EVAL Issue: Crossing Status: Found UCIP Comments: 10/21/2019 Record updated from No Action Needed to Non-Urgent. Need to have CVFPB review ABO and determine current owner. (O.Yakimov - DWR UCIP) 05/07/2012 Cleaned inlet and outlets. Owner of pipe may need to clean pipe. (C. Lund - DWR Sacramento Yard) 04/05/2012 Pipe is plugged with soil on LS. (W. Wylie - DWR UCIP) FIELD_STRUCT_DESC: 24-inch CIPP-lined corrugated metal drainage pipe through the levee, 8 feet below the crown. Slide gate on the waterside (WS) end. (24-inch pipe [HLM 8.45] authorized under Automatic Board Order (ABO) issued as Permit No. 10247, 1974 - University of California, Office of the Regents). [Additional Reference(s): DWR Levee Log, 2005 (HLM 8.45). USACE Sacramento O&M Manual, Unit 119, December 1952, Revised 29 Dec 2016, (Station 241+50 PCT), listed as 24-inch pipe. USACE As-Built Drawing No. 50-04-2396, Revision 2, pdf page 26, Sheet 10, December 1947]. FS Date: 10/21/2019 10:02:00 AM

View of LS looking from levee crown

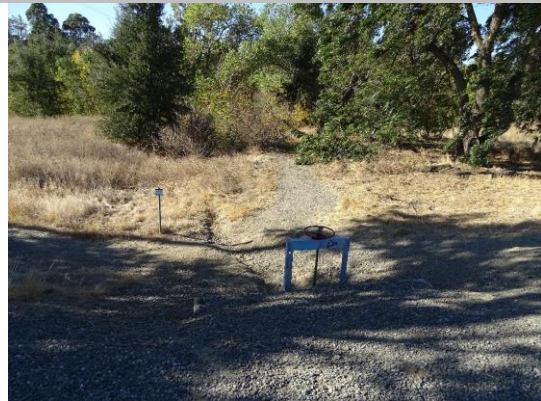
Photo 1 of 3 : UCIP_SP_2023_59880_82398.jpg

DS_ID:521
FS_ID:59880
EP_NO: 10247
Repair Type: Non-Urgent
EVAL Issue:
Crossing Status: Found
UCIP Comments: 10/21/2019 Record updated from No Action Needed to Non-Urgent. Need to have CVFPB review ABO and determine current owner. (O.Yakimov - DWR UCIP) 05/07/2013 Removed material at slidegate and inlet. (C. Lund - DWR Sacramento Yard) 04/05/2012 Pipe is partially blocked by sedimentation and slide gate will not open. (W. Wylie - DWR UCIP)
FIELD_STRUCT_DESC: 24-inch CIPP-lined corrugated metal drainage pipe through the levee, 7 feet below the crown. Slide gate on the waterside (WS) end. Headwalls on both ends. (24-inch pipe [HLM 8.50] authorized under Automatic Board Order (ABO) issued as Permit No. 10247, 1974 - University of California, Office of the Regents. Also mentioned in Permit No. 5896, 1967 - The Regents of the University of California, Office of Architects and Engineers, University of California, Davis Campus). [Additional Reference(s): DWR Levee Log, 2005 (HLM 8.50). USACE Sacramento O&M Manual, Unit 119, December 1952, Revised 29 Dec 2016, (Station 244+20 PCT), listed as 24-inch pipe. USACE As-Built Drawing No. 50-04-2396, Revision 2, pdf page 26, Sheet 10, December 1947].

View of WS looking from levee crown

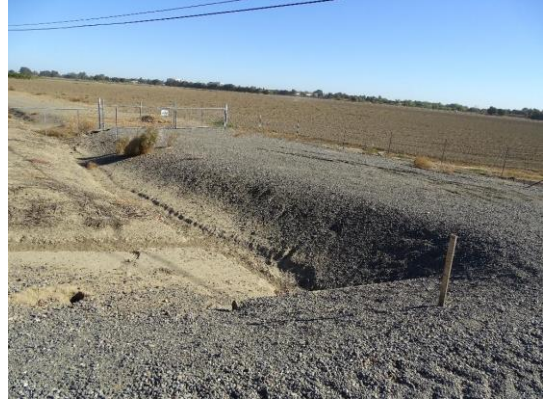
Photo 2 of 3 : UCIP_SP_2023_59880_82399.jpg

View of LS looking from levee crown

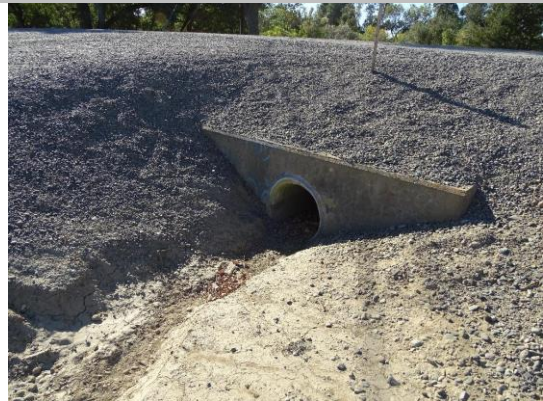
Photo 3 of 3 : UCIP_SP_2023_59880_82400.jpg

LS levee slope, headwall, and pipe end

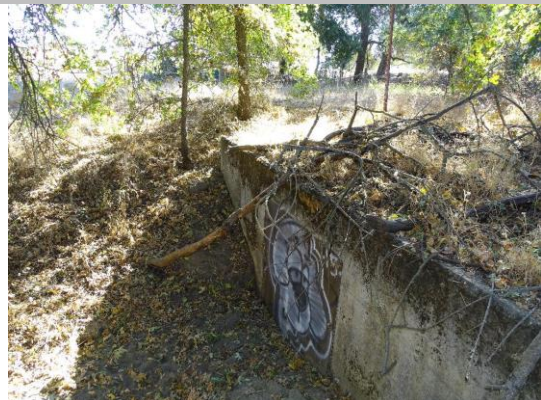
Photo 2 of 3 : UCIP_SP_2023_59884_82411.jpg

Steel plate installed over pipe off LS toe

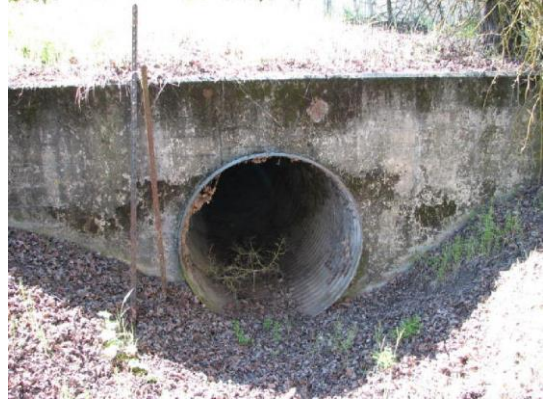
Photo 3 of 3 : UCIP_SP_2023_59884_60299.jpg

LS headwall and pipe before steel plate was installed over pipe to abandon it.

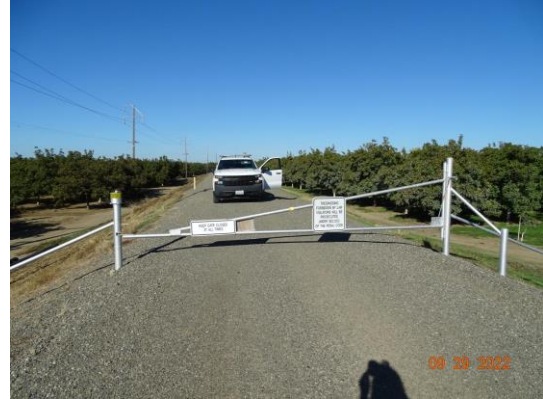
Photo 1 of 1 : SP_2023_ST0007_283_29_20230515_00004.jpg

View looking upstream at gate across the crown (Fall 2022).

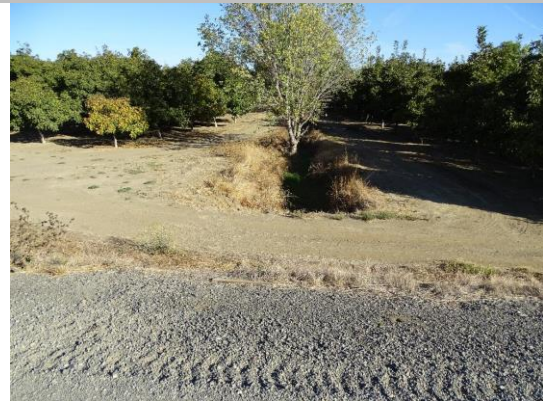
Photo 1 of 3 : UCIP_SP_2023_55424_81638.jpg

View of WS looking from levee crown

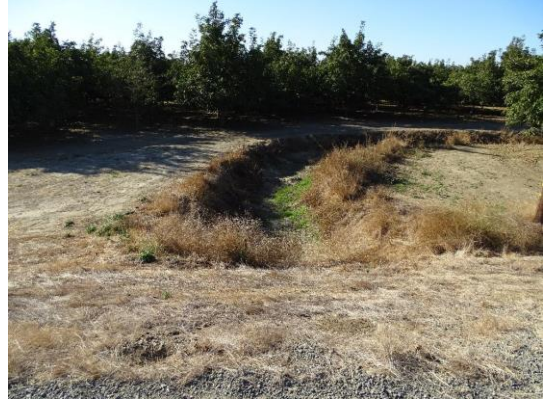
Photo 2 of 3 : UCIP_SP_2023_55424_81639.jpg

View of LS looking from levee crown

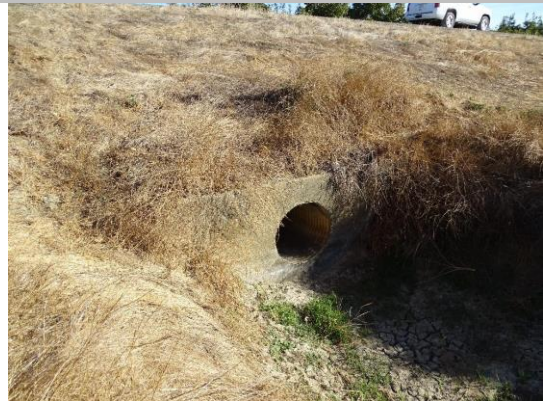
Photo 3 of 3 : UCIP_SP_2023_55424_81640.jpg

Headwall and pipe at LS toe

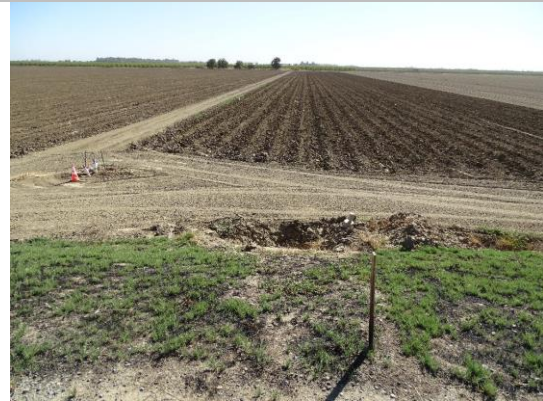
Photo 1 of 3 : UCIP_SP_2023_79825_81619.jpg

View of LS from levee crown

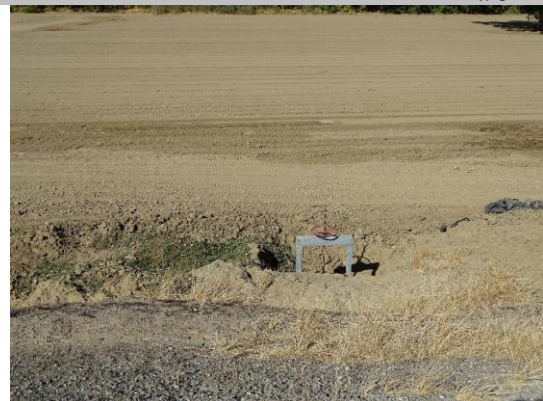
Photo 2 of 3 : UCIP_SP_2023_79825_81620.jpg

View of WS from levee crown

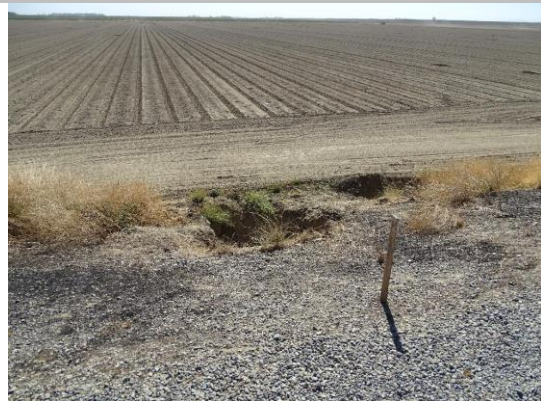
Photo 1 of 3 : UCIP_SP_2023_79826_81623.jpg

View of LS from levee crown

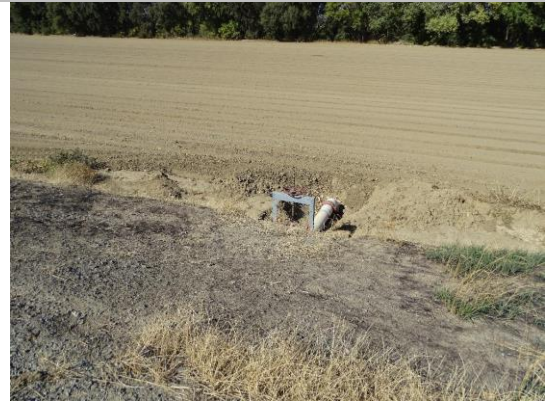
Photo 2 of 3 : UCIP_SP_2023_79826_81624.jpg

View of WS from levee crown

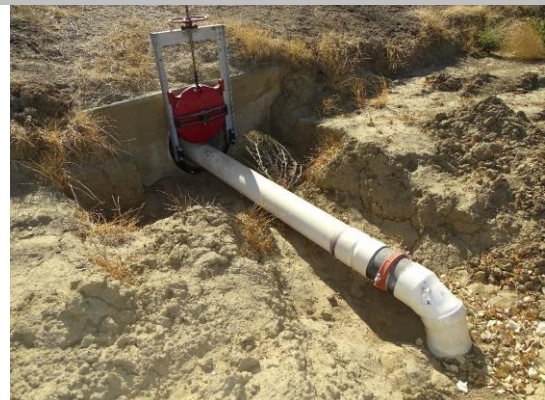
Photo 3 of 3 : UCIP_SP_2023_79826_81625.jpg

Headwall and slidegate at WS toe with a PVC pipe running through

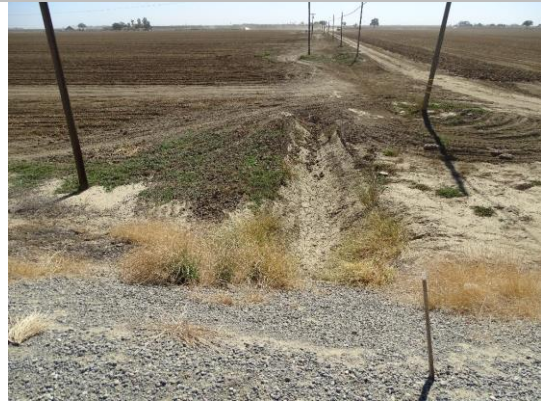
Photo 1 of 3 : UCIP_SP_2023_55434_81690.jpg

View of LS looking from levee crown

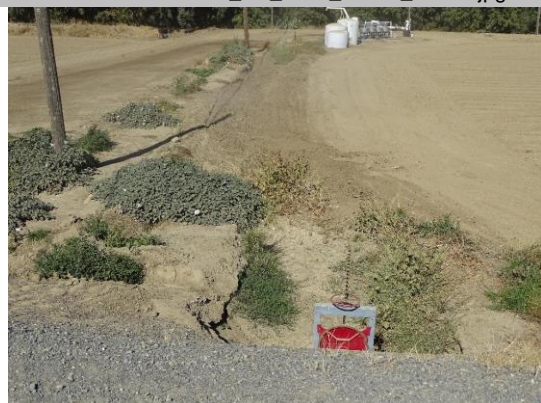
Photo 2 of 3 : UCIP_SP_2023_55434_81691.jpg

View of WS looking from levee crown

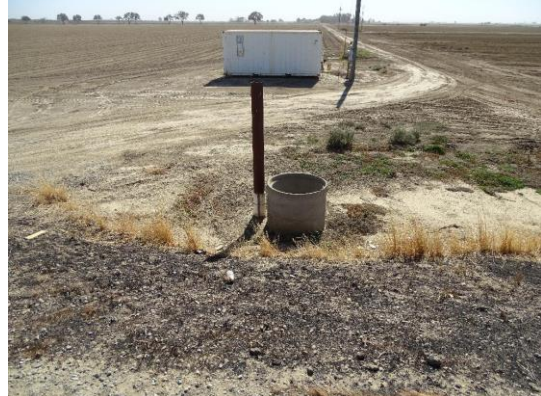
Photo 1 of 3 : UCIP_SP_2023_55436_81697.jpg

View of LS looking from levee crown. 36-inch standpipe near levee toe

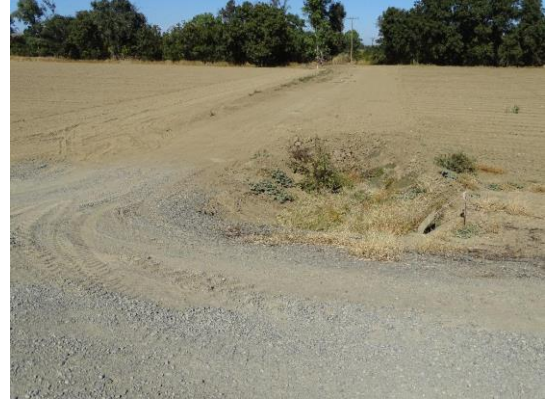
Photo 2 of 3 : UCIP_SP_2023_55436_81698.jpg

View of WS looking from levee crown

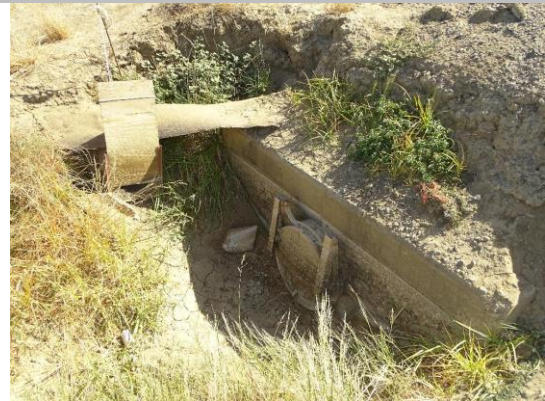
Photo 3 of 3 : UCIP_SP_2023_55436_81699.jpg

Headwall and flap gate at WS levee toe

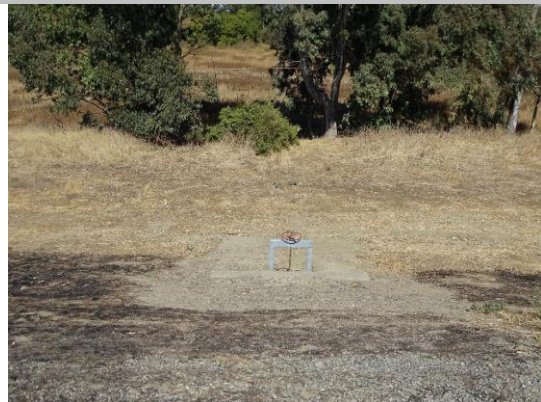
Photo 2 of 3 : UCIP_SP_2023_59897_81708.jpg

View of WS looking from levee crown

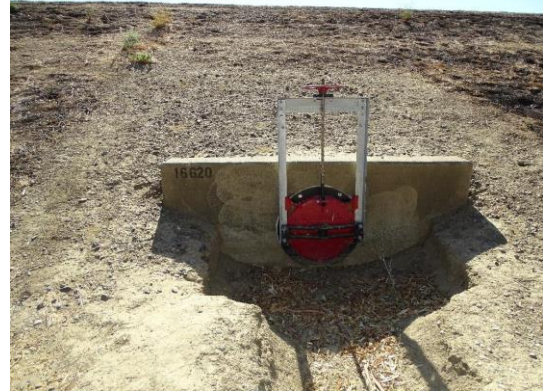
Photo 3 of 3 : UCIP_SP_2023_59897_81709.jpg

WS levee slope, headwall and slide gate

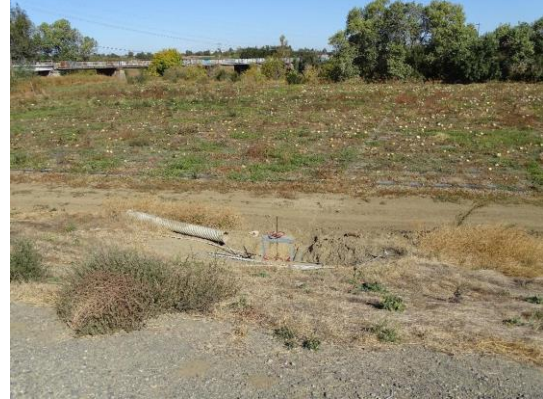
Photo 1 of 3 : UCIP_SP_2023_77888_81628.jpg

View of WS from levee crown

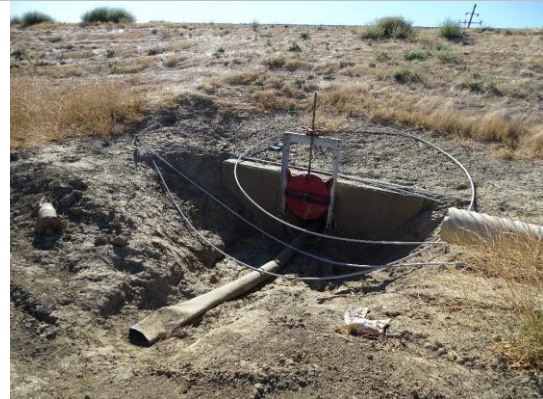
Photo 3 of 3 : UCIP_SP_2023_77888_81630.jpg

WS slope with headwall and slide gate

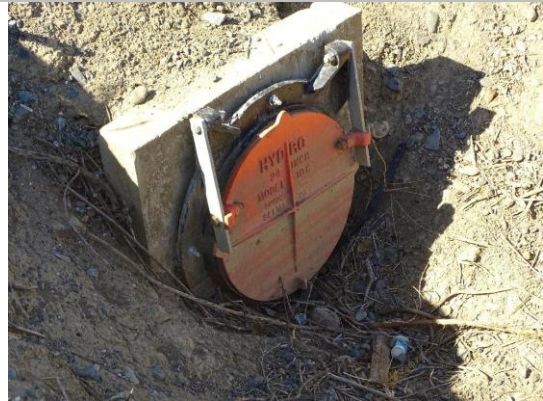
Photo 1 of 3 : UCIP_SP_2023_59903_81718.jpg

Headwall and flap gate

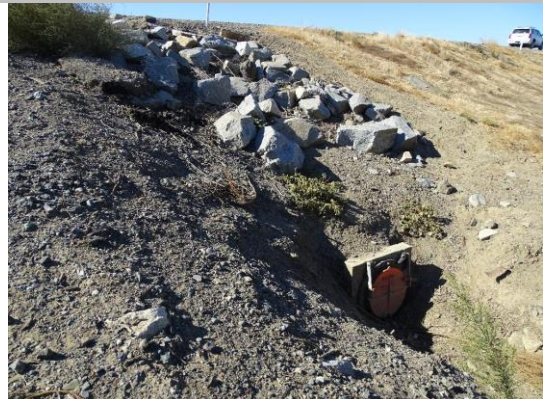
Photo 2 of 3 : UCIP_SP_2023_59903_81719.jpg

View of WS slope and flap gate at levee toe

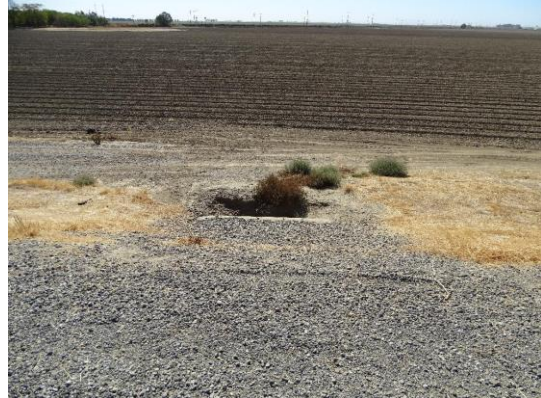
Photo 1 of 3 : UCIP_SP_2023_59905_81724.jpg

View of LS looking from levee crown

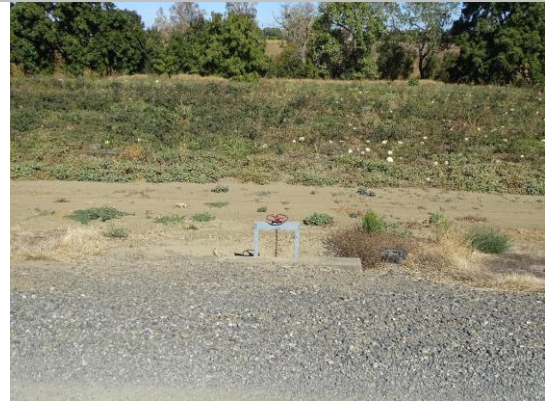
Photo 2 of 3 : UCIP_SP_2023_59905_81725.jpg

View of WS looking from levee crown

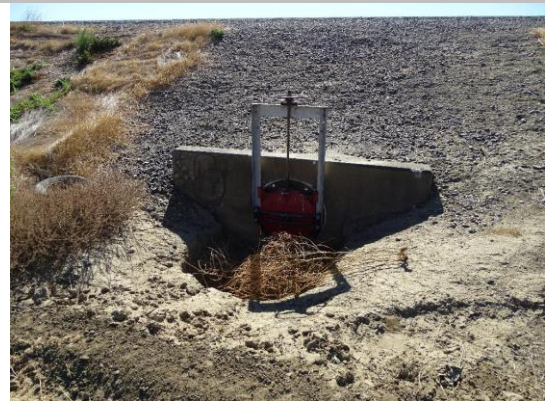
Photo 3 of 3 : UCIP_SP_2023_59905_81726.jpg

WS levee slope, headwall, and slide gate

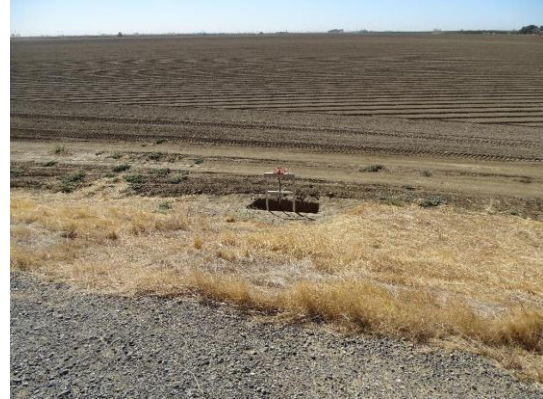
Photo 1 of 3 : UCIP_SP_2023_59906_81729.jpg

View of LS looking from levee crown

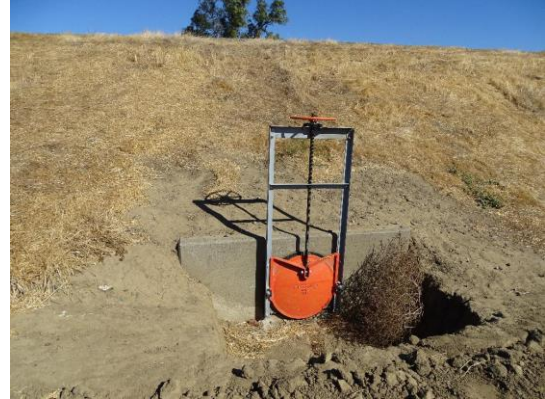
Photo 2 of 3 : UCIP_SP_2023_59906_81730.jpg

LS slope, headwall, and slide gate

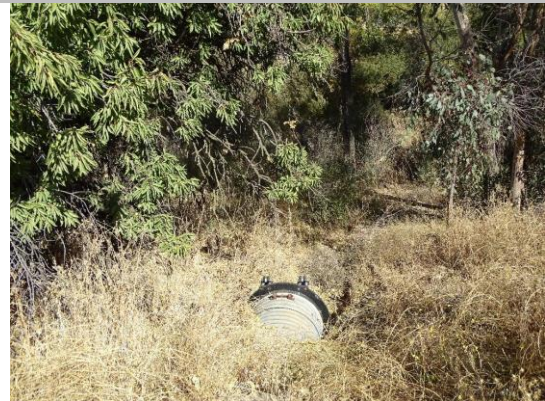
Photo 3 of 3 : UCIP_SP_2023_59906_81731.jpg

Pipe end on WS

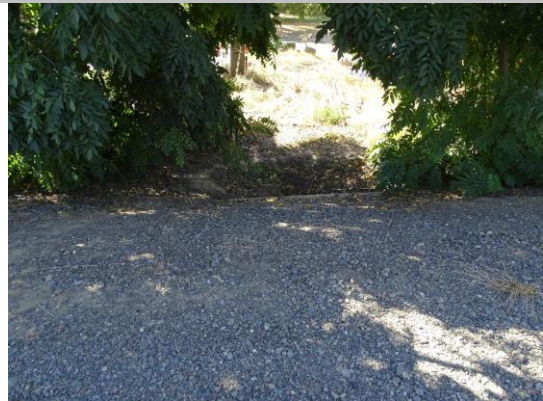
Photo 1 of 3 : UCIP_SP_2023_59908_81739.jpg

View of LS looking from levee crown

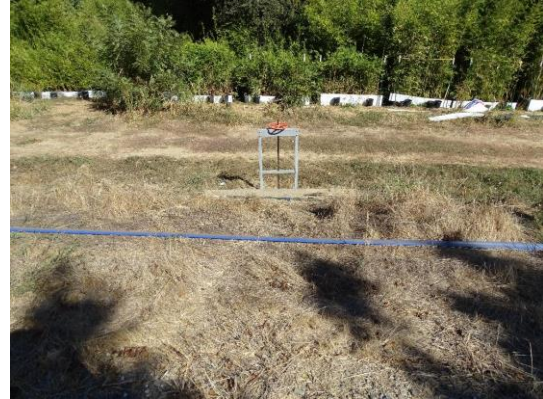
Photo 2 of 3 : UCIP_SP_2023_59908_81740.jpg

View of WS looking from levee crown

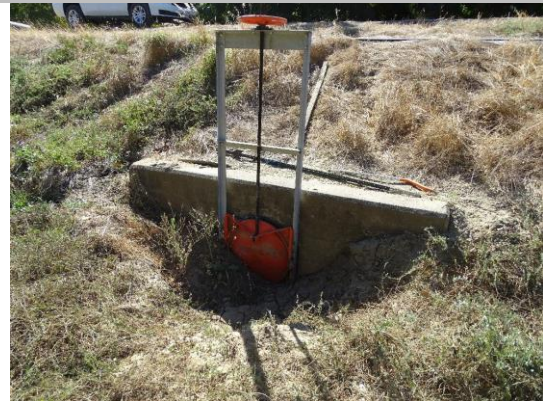
Photo 3 of 3 : UCIP_SP_2023_59908_81741.jpg

WS levee slope, headwall, and slide gate
