**Flood Control Project Maintenance
Levee Inspections**

Maintenance Issue Types Only, Levee Inspection Report By Mile - Spring 2024

Sacramento Maintenance Yard Putah Creek

Waterway	Bank	Unit Miles	Inspection Start/End	Inspector
Unit No. 01 Putah Creek or North Levee	Left	8.79	03/12/2024 03/12/2024	Nate Hicks

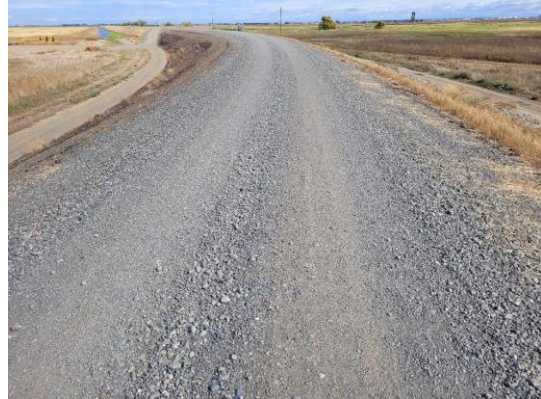
Photo 1 of 3 : UCIP_SP_2024_81288_117162.jpg

Comment Code						
Inspector Comment						
DS_ID:594 FS_ID:81288 EP_NO: N/A Repair Type: Non-Urgent EVAL Issue: Crossing Status: Not Found UCIP Comments: 10/10/2023 Record remains Non-Urgent. Crossing not found. Geophysical results did not confirm presence of pipe through levee. Record will remain in UCIP's inspection records until future Levee Improvement Project can confirm no crossing was found through the levee. (O. Yakimov - DWR UCIP) 11/07/2019 Record updated from No Action Needed to Non-Urgent. Crossing not found. (O.Yakimov - DWR UCIP) FIELD_STRUCT_DESC: 48-inch corrugated metal drainage pipe through the levee at an unknown depth below the crown. Reinforced concrete headwalls on both waterside (WS) and landside (LS). Concrete apron with cobble paving is located on the channel side. [Additional Reference(s): USACE Sacramento O&M Manual, Unit 119, December 1952, Revised 29 Dec 2016, (Station 0+62), listed as 48-inch pipe. USACE As-Built Drawing No. 50-04-2396, Revision 1, pdf page 18, Sheet 2, December 1947]. FS Date: 10/10/2023 7:32:40 AM

Top of Levee: View of levee crown looking upstream

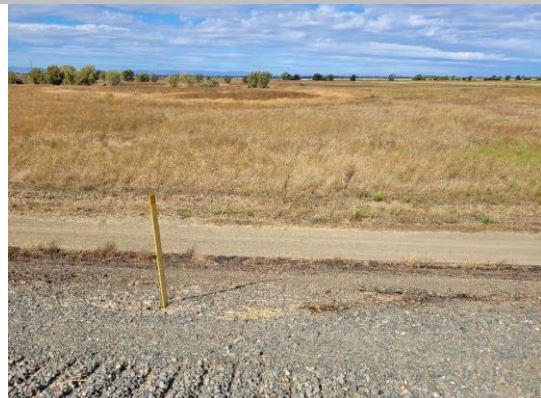
Photo 2 of 3 : UCIP_SP_2024_81288_117161.jpg

Land-Side: View of levee slope looking from crown

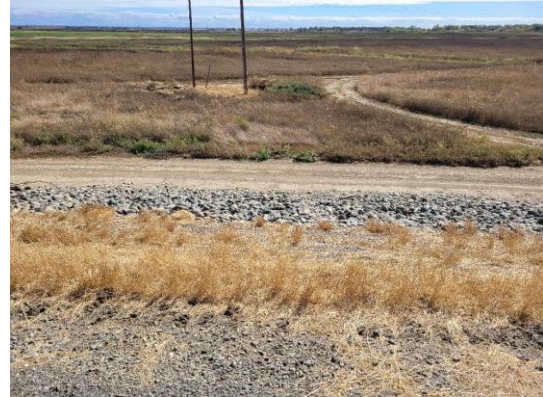
Photo 3 of 3 : UCIP_SP_2024_81288_117163.jpg

Water-Side: View of levee slope looking from crown

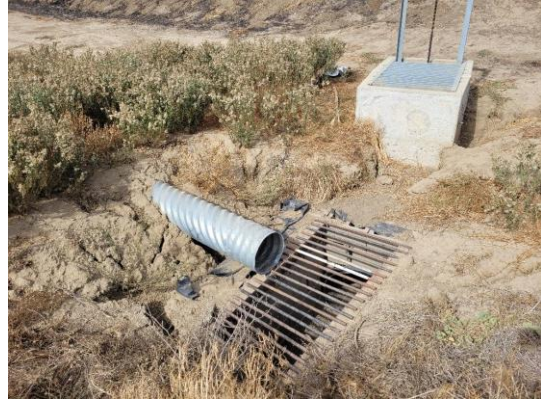
Photo 1 of 3 : UCIP_SP_2024_81307_117240.jpg

Comment Code					
Inspector Comment					
DS_ID:496					
FS_ID:81307					
EP_NO: 10251					
Repair Type: Non-Urgent					
EVAL Issue: 10, Unauthorized Modification or Non-Compliant Permit					
Crossing Status: Found					
UCIP Comments: 10/10/2023 Record updated from No Action Needed					
to Non-Urgent. Concrete drainage box and concrete drainage pit were					
installed on waterside berm, unable to find a permit for modifications.					
DMP internal video inspection has found none or minor pipe defects.

(O. Yakimov - DWR UCIP)					
10/22/2019 Record updated from No Action Needed to Non-Urgent.					
Need to have CVFPB review ABO and determine current owner.					
Installed a new precast concrete box on the waterside. Pipe will be lined					
in November 2019 according to FMO staff. (O.Yakimov - DWR					
UCIP)4/10/2019 Major erosion through out pipe. Erosion on WS					
allows water to enter pipe and flood LS field. Erosion on farmers					
waterman valve. Field water drains into pipe and floods LS field.					
(J.McCabe - DWR Sacramento Yard)					
FIELD_STRUCT_DESC: 24-inch CIPP-lined corrugated metal drainage					
pipe through levee, 15 feet below the crown. Two metal cutoff walls					
were installed through the levee. A T-post and T-handle are located on					
the landside (LS) toe. The outfall structure and flap gate are located on					
the west side of bridge, waterside (WS). (24-inch pipe [HLM 3.87]

Water-Side: New concrete drainage box and concrete drainage pit were installed on levee berm

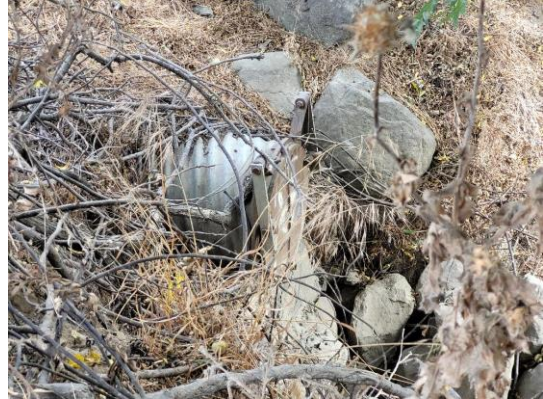
Photo 2 of 3 : UCIP_SP_2024_81307_117242.jpg

Water-Side: Closeup view of pipe with flap gate at the channel

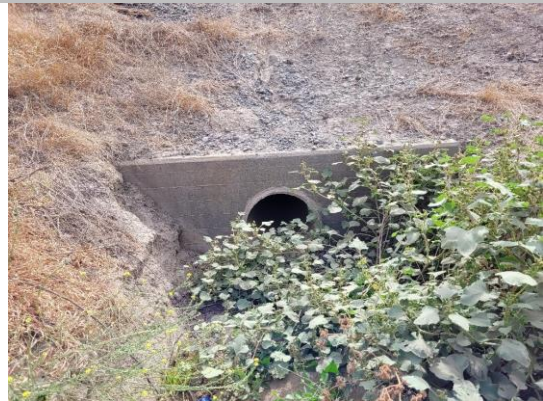
Photo 3 of 3 : UCIP_SP_2024_81307_117239.jpg

Land-Side: Concrete headwall and pipe inlet at levee toe

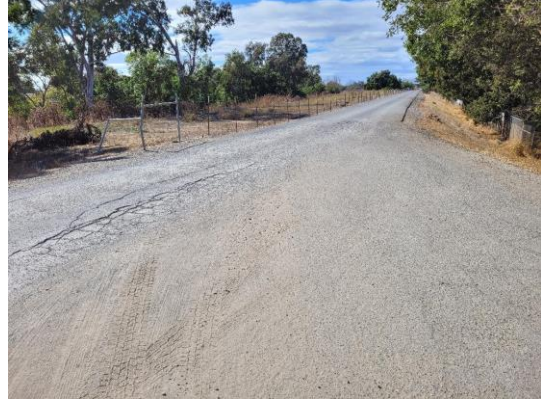
Photo 1 of 3 : UCIP_SP_2024_81344_117343.jpg

Comment Code					
Inspector Comment					
DS_ID:508 FS_ID:81344 EP_NO: 10247 Repair Type: No Action Needed EVAL Issue: Crossing Status: Found UCIP Comments: 10/10/2023 Record remains No Action Needed. DMP internal video inspection has found none or minor pipe defects. No other issues observed during inspection. (O. Yakimov - DWR UCIP) 10/22/2019 Record updated from No Action Needed to Non-Urgent. Need to have CVFPB review ABO and determine current owner. (O.Yakimov - DWR UCIP) FIELD_STRUCT_DESC: 24-inch CIPP-lined corrugated metal drainage pipe through the levee, 11.0 feet below the crown. Flap gate on the waterside (WS) end. Concrete headwall on the landside (LS) end. Concrete Apron on the WS. (24-inch pipe [HLM 7.09] authorized under Automatic Board Order (ABO) issued as Permit No. 10247, 1974 - University of California, Office of the Regents). [Additional Reference(s): DWR Levee Log, 2005 (HLM 7.09). USACE Sacramento O&M Manual, Unit 119, December 1952, Revised 29 Dec 2016, (Station 172+00 PCT), listed as 24-inch pipe. USACE As-Built Drawing No. 50-04-2396, Revision 4, pdf page 25, Sheet 9, December 1947]. FS Date: 10/10/2023 8:06:54 AM

Top of Levee: View of levee crown looking upstream

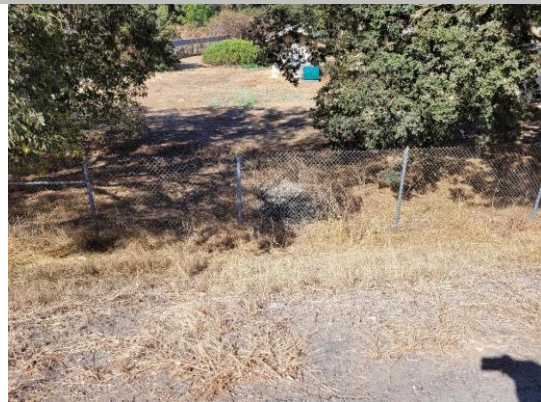
Photo 2 of 3 : UCIP_SP_2024_81344_117344.jpg

Land-Side: View of levee slope looking from crown. Pipe inlet behind the fence

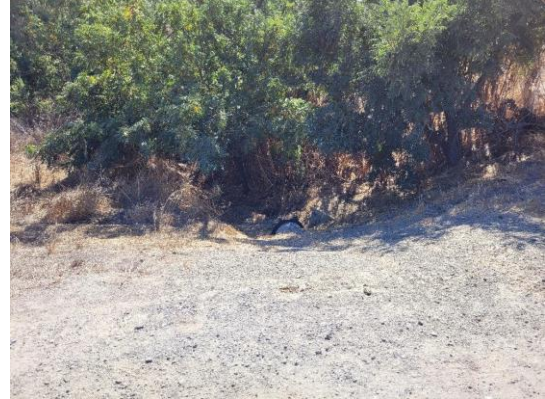
Photo 3 of 3 : UCIP_SP_2024_81344_117341.jpg

Water-Side: View of levee slope looking from crown

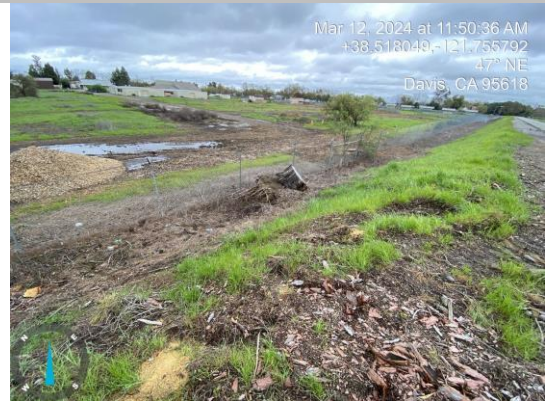
Photo 1 of 1 : SP_2024_ST0007_282_28_20240313_00069.jpg

LM Start	7.10	Rating **	N	Issue No.	28
LM End	7.10	Issue Type +	Ma	Location *	LS
Category	Earthen Levee			GPS Latitude/Longitude	
				Start	End
Item	Trim / Thin Trees			38.517988°	38.517988°
				-121.755850°	-121.755850°
DWR ID	DWR_ST0007_01_s_2024_28				
Comment Code					
T5 : Tree stumps.					
Inspector Comment					
There are three tree stumps within the area and one has an exposed root ball.

View of stump with exposed root ball on the landside toe (Spring 2024).

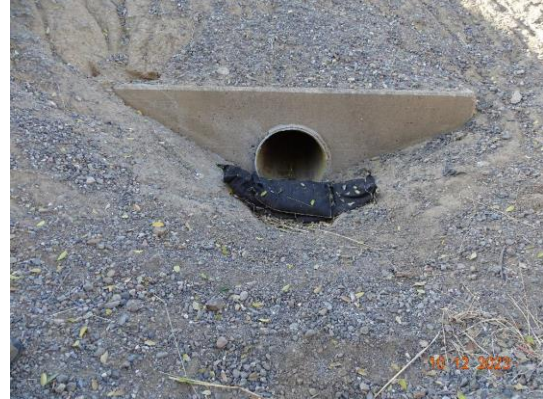
Photo 1 of 3 : UCIP_SP_2024_81347_117354.jpg

DS_ID:512
FS_ID:81347
EP_NO: 10247
Repair Type: Non-Urgent
EVAL Issue: 6, Levee Damage or Threat for Levee Damage
Crossing Status: Found
UCIP Comments: 10/12/2023 Record updated from No Action Needed to Non-Urgent. Erosion around headwall on waterside was observed. DMP internal video inspection has found none or minor pipe defects. (O. Yakimov - DWR UCIP)
10/21/2019 Record updated from No Action Needed to Non-Urgent. Need to have CVFPB review ABO and determine current owner. (O.Yakimov - DWR UCIP) 05/07/2013 Debris removed from outlet. (C. Lund - DWR Sacramento Yard)04/04/2012 Some debris blocking outlet. (W. Wylie - DWR UCIP)
FIELD_STRUCT_DESC: 24-inch CIPP-lined drainage pipe of an unknown material through the levee, 12 feet below the crown. Flap gate on the waterside (WS) end. Concrete headwall on the landside (LS) end. (24-inch [HLM 7.36] authorized under Automatic Board Order (ABO) issued as Permit No. 10247, 1974 - University of California, Office of the Regents). [Additional Reference(s): DWR Levee Log, 2005 (HLM 7.36). USACE Sacramento O&M Manual, Unit 119, December 1952, Revised 29 Dec 2016, (Station 183+97 PCT), listed as 24-inch pipe. USACE As-Built Drawing No. 50-04-2396, Revision 4, pdf page 25, Sheet 9, December 1947].

Land-Side: View of pipe inlet in drainage ditch

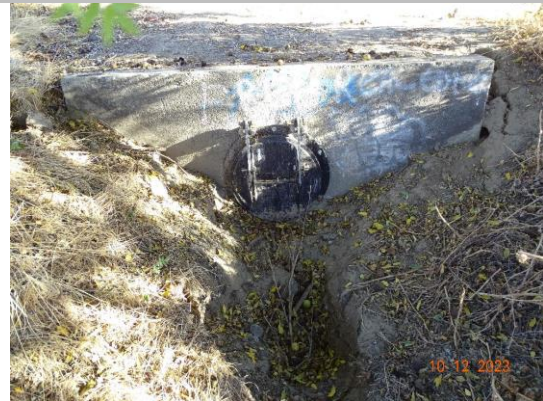
Photo 2 of 3 : UCIP_SP_2024_81347_117355.jpg

Water-Side: Headwall and flap gate in drainage ditch

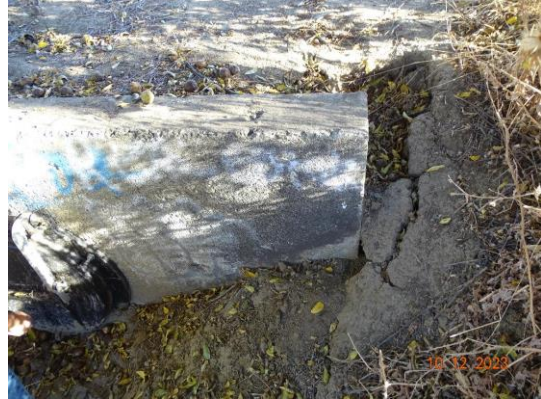
Photo 3 of 3 : UCIP_SP_2024_81347_117356.jpg

Water-Side: Erosion at downstream side of headwall

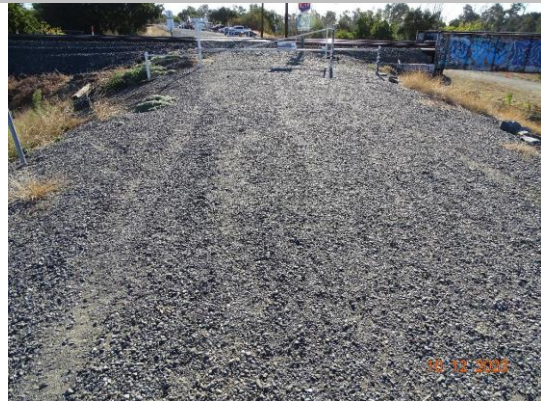
Photo 1 of 3 : UCIP_SP_2024_81353_117380.jpg

DS_ID:516
FS_ID:81353
EP_NO: 10260
Repair Type: No Action Needed
EVAL Issue:
Crossing Status: Found
UCIP Comments: 10/12/2023 Record updated from Non-Urgent to No Action Needed. DMP internal video inspection has found none or minor pipe defects. No issues observed during inspection. (O. Yakimov - DWR UCIP)
10/21/2019 Record remains Non-Urgent. Need to have CVFPB review ABO and determine current owner. (O.Yakimov - DWR UCIP)

Top of Levee: View of levee crown looking downstream

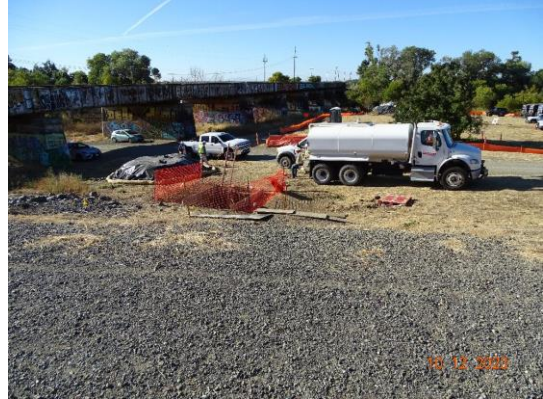
Photo 2 of 3 : UCIP_SP_2024_81353_117383.jpg

Water-Side: View of levee slope looking from crown

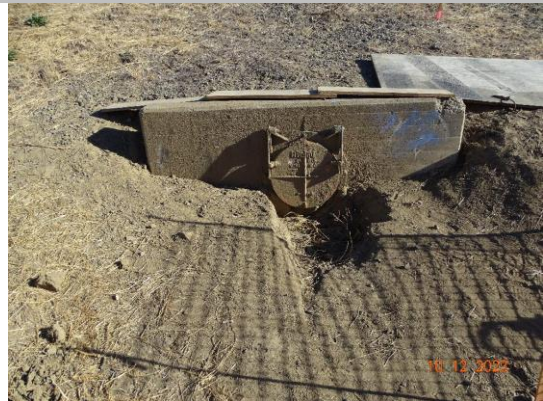
Photo 3 of 3 : UCIP_SP_2024_81353_117381.jpg

Water-Side: Headwall and flap gate at levee toe

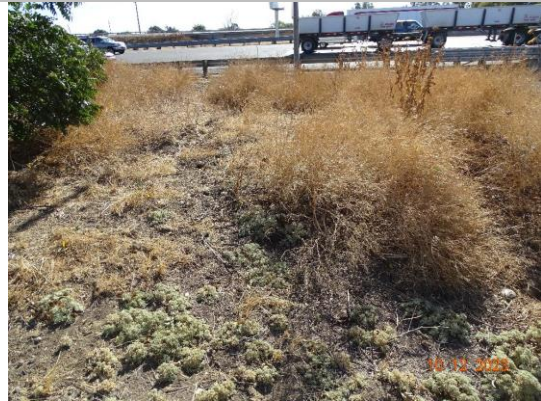
Photo 1 of 3 : UCIP_SP_2024_81359_117408.jpg

Comment Code					
Inspector Comment					
DS_ID:599 FS_ID:81359 EP_NO: N/A Repair Type: Non-Urgent EVAL Issue: Crossing Status: Not Found UCIP Comments: 10/12/2023 Record remains Non-Urgent. Crossing not found during inspection. (O. Yakimov - DWR UCIP) 10/21/2019 Record updated from No Action Needed to Non-Urgent. Crossing not found. (O.Yakimov - DWR UCIP)04/05/2012 Likely removed as part of I-80 construction as no evidence remains of pipe. (W. Wylie - DWR UCIP) FIELD_STRUCT_DESC: 24-inch corrugated metal drainage pipe through the levee, at an unknown depth. Two corrugated metal cutoff walls, two reinforced concrete headwalls, and one saddle and apron. [Additional Reference(s): USACE Sacramento O&M Manual, Unit 119, December 1952, Revised 29 Dec 2016, (Station 225+15 PCT), listed as 24-inch pipe. USACE As-Built Drawing No. 50-04-2396, Revision 2, pdf page 26, Sheet 10, December 1947]. FS Date: 10/12/2023 10:59:37 AM

Top of Levee: View of levee crown looking downstream

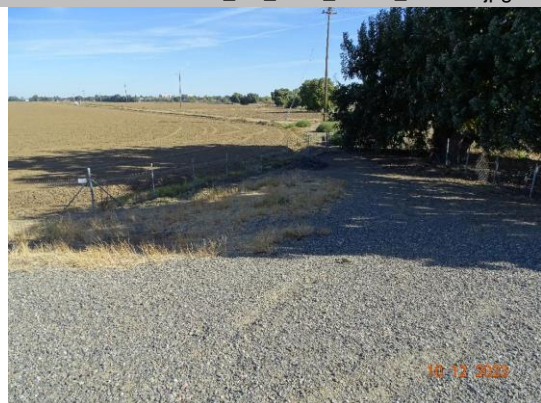
Photo 2 of 3 : UCIP_SP_2024_81359_117407.jpg

Land-Side: View of levee slope looking from crown

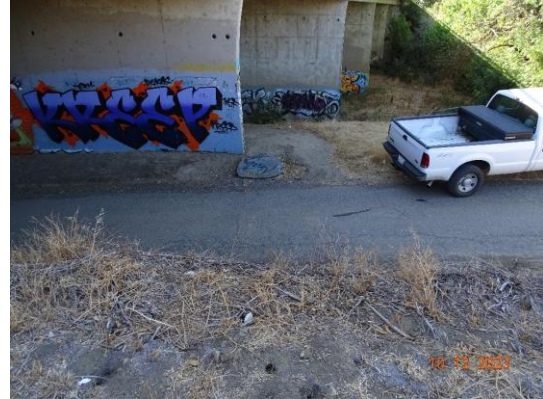
Photo 3 of 3 : UCIP_SP_2024_81359_117402.jpg

Water-Side: View of levee slope looking from crown

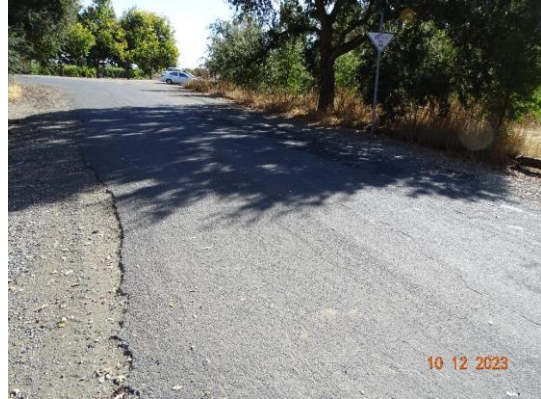
Photo 1 of 3 : UCIP_SP_2024_81368_117435.jpg

Comment Code					
Inspector Comment					
DS_ID:523 FS_ID:81368 EP_NO: 10247 Repair Type: Non-Urgent EVAL Issue: Crossing Status: Found UCIP Comments: 10/12/2023 Record remains Non-Urgent. Crossing appears abandoned. Unable to locate a permit and confirm proper pipe abandonment. (O. Yakimov - DWR UCIP) 10/21/2019 Record remains Non-Urgent. Pipe inlet is closed with steel plate bolted to headwall in drainage canal on LS. (O.Yakimov - DWR UCIP) FIELD_STRUCT_DESC: 48-inch corrugated metal drainage pipe through the levee, 15.0 feet below the crown. Steel plate installed over inlet off the landside (LS) toe. Pipe not grouted. Flap gate on waterside (WS) end. Headwalls on both ends. (48-inch pipe [HLM 8.88] authorized under Automatic Board Order (ABO) issued as Permit No. 10247, 1974 - University of California, Office of the Regents). [Additional Reference(s): DWR Levee Log, 2005 (HLM 8.88). USACE Sacramento O&M Manual, Unit 119, December 1952, Revised 29 Dec 2016, (Station 262+30 PCT), 48-inch pipe referenced. USACE As-Built Drawing No. 50-04-2396, Revision 2, pdf page 26, Sheet 10, 24-inch pipe referenced on levee alignment, December 1947]. FS Date: 10/12/2023 11:45:37 AM

Top of Levee: View of levee crown looking upstream

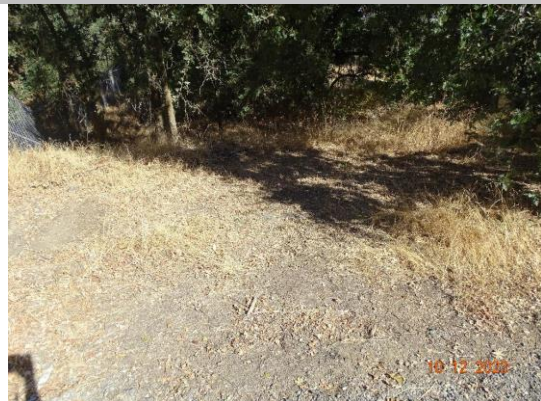
Photo 2 of 3 : UCIP_SP_2024_81368_117430.jpg

Water-Side: View of levee slope looking from crown

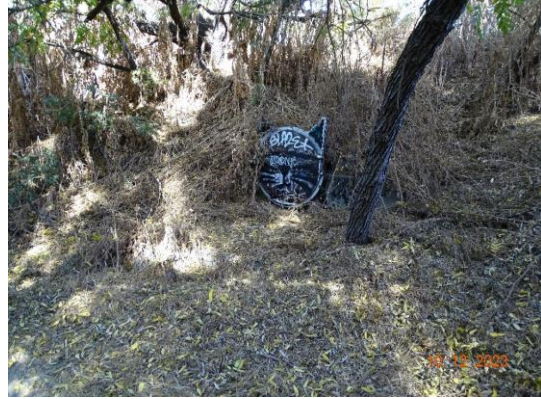
Photo 3 of 3 : UCIP_SP_2024_81368_117431.jpg

Water-Side: Pipe at the headwall

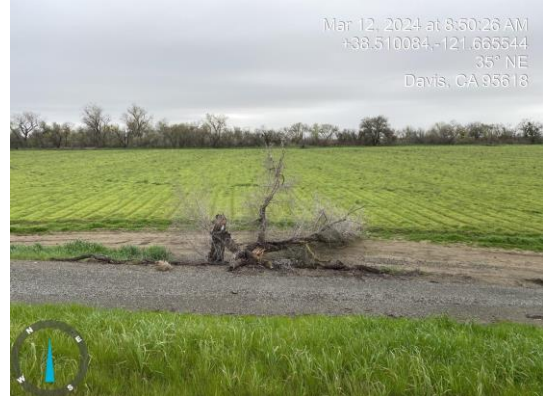
Photo 1 of 1 : SP_2024_ST0007_283_19_20240313_00039.jpg

View of fallen tree on the waterside toe road (Spring 2024).

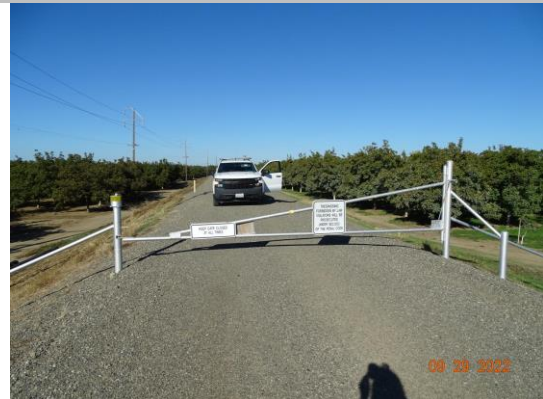
Photo 1 of 1 : SP_2024_ST0007_283_29_20240308_00010.jpg

LM Start	0.55	Rating **	A/W	Issue No.	29
LM End	0.55	Issue Type +	Ma	Location *	LS
Category	Earthen Levee			GPS Latitude/Longitude	
				Start	End
Item	Access Gates			38.510249°	38.510249°
				-121.667551°	-121.667551°
DWR ID	DWR_ST0007_02_s_2013_29				
Comment Code					
AG : Access Gates					
Inspector Comment					
There is no CVFPB Permit for this gate. DWR - Sac Maintenance Yard installed this gate a few years ago. The gate and locks are operable and in good condition.

View looking upstream at gate across the crown (Fall 2022).

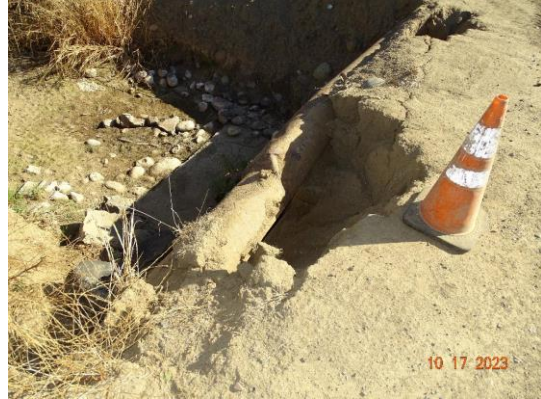
Photo 1 of 3 : UCIP_SP_2024_81380_117446.jpg

Comment Code					
Inspector Comment					
DS_ID:16621 FS_ID:81380 EP_NO: 10270 Repair Type: Non-Urgent EVAL Issue: 6, Levee Damage or Threat for Levee Damage Crossing Status: Found UCIP Comments: 10/17/2023 Record remains Non-Urgent. Erosion at the edge of drainage ditch on waterside has progressed starting 13 feet from levee toe. Recommend LMA taking actions to stabilize erosion site. DMP internal video inspection has found none or minor pipe defects. (O. Yakimov - DWR UCIP) 10/22/2019 Crossing visually is in good condition. 12-inch diameter through hole has developed due to soil instability on WS berm visible on the top of pipe outlet embankment. (O.Yakimov - DWR UCIP) FIELD_STRUCT_DESC: 36-inch CIPP-lined corrugated metal drainage pipe through the levee, 14 feet below the crown. Flap gate on the waterside (WS) end. Concrete headwall on the landside (LS) end. (36-inch pipe [HLM 0.85] authorized under Automatic Board Order (ABO) issued as Permit No. 10270, 1974 - Hamel). [Additional Reference(s): DWR Levee Log, 2005 (HLM 0.85). USACE Sacramento O&M Manual, Unit 119, December 1952, Revised 29 Dec 2016, (Station T 1+45), listed as 36-inch pipe. USACE As-Built Drawing No. 50-04-2396, Revision 1, pdf page 21, Sheet 5, December 1947]. FS Date: 10/17/2023 8:13:48 AM

Water-Side: View of erosion site at drainage ditch located 13 feet from levee toe

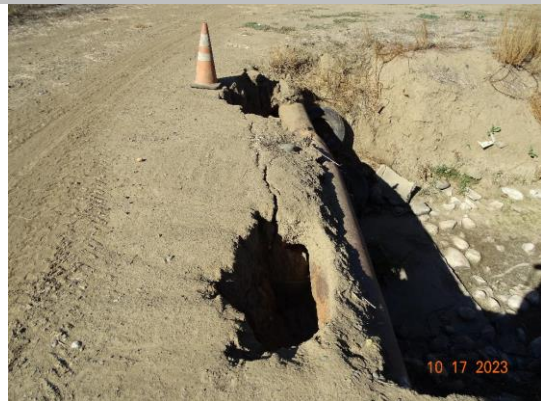
Photo 2 of 3 : UCIP_SP_2024_81380_117441.jpg

Water-Side: Erosion, soil instability at the edge of drainage ditch

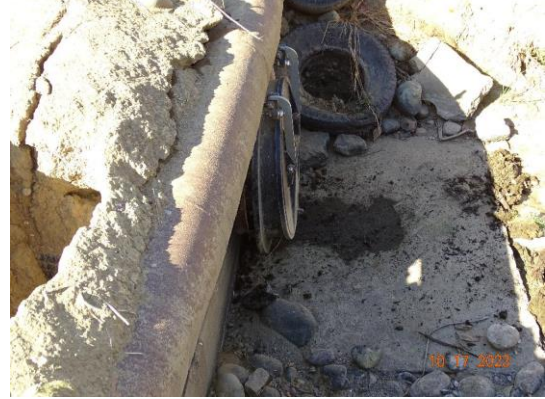
Photo 3 of 3 : UCIP_SP_2024_81380_117442.jpg

Water-Side: View of flap gate in drainage ditch

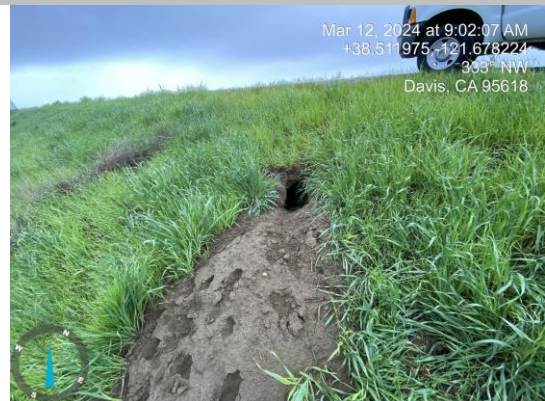
Photo 1 of 1 : SP_2024_ST0007_283_22_20240313_00040.jpg

View of animal burrow on the landside slope (Spring 2024).

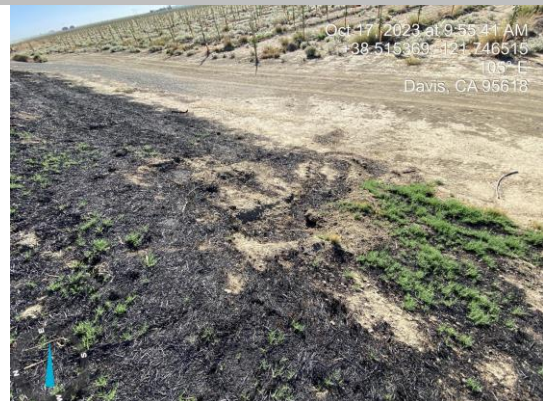
Photo 1 of 1 : SP_2024_ST0007_283_7_20240308_00002.jpg

LM Start	4.96	Rating **	M	Issue No.	7							
LM End	4.96	Issue Type +	Ma	Location *	LS							
Category	Earthen Levee		GPS Latitude/Longitude									
			Start	End								
Item	Erosion / Vehicle Traffic		38.515442°	38.515442°								
			-121.746517°	-121.746517°								
DWR ID	DWR_ST0007_02_f_2023_7											
Comment Code												
E6 : Repair the levee slope damaged by vehicle traffic and prevent access where possible.												
Inspector Comment												
Vehicle ruts on the landside slope.

View of vehicle ruts on the landside slope (Fall 2023).

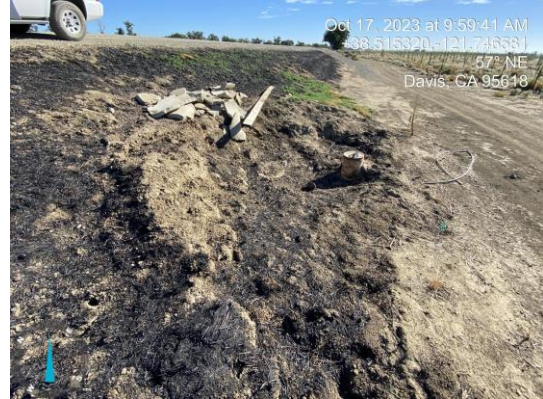
Photo 1 of 1 : SP_2024_ST0007_283_9_20240308_00004.jpg

LM Start	4.97	Rating **	M	Issue No.	9
LM End	4.97	Issue Type +	Ma	Location *	LS
Category	Earthen Levee			GPS Latitude/Longitude	
				Start	End
Item	Erosion / Bank Caving			38.515428°	38.515428°
				-121.746640°	-121.746640°
DWR ID	DWR_ST0007_02_f_2023_9				
Comment Code					
E2 : Schedule repair of erosion site prior to the next inspection.					
Inspector Comment					
Soil has been excavated from the levee prism.

View of soil that has been excavated from levee prism (Fall 2023).

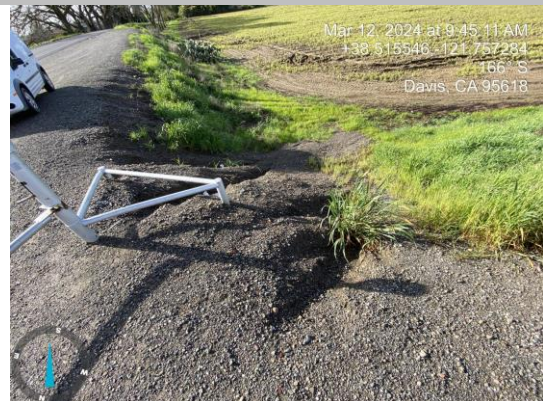
Photo 1 of 1 : SP_2024_ST0007_283_27_20240313_00041.jpg

LM Start	5.57	Rating **	M	Issue No.	27
LM End	5.57	Issue Type +	Ma	Location *	LS
Category	Earthen Levee			GPS Latitude/Longitude	
				Start	End
Item	Erosion / Rills			38.515587°	38.515587°
				-121.757400°	-121.757400°
DWR ID	DWR_ST0007_02_s_2024_27				
Comment Code					
E5 : Schedule repair of rills prior to the next inspection.					
Inspector Comment					
Rills along the landside slope near the gate need repair.

View of erosion/rills forming on the landside slope (Spring 2024).

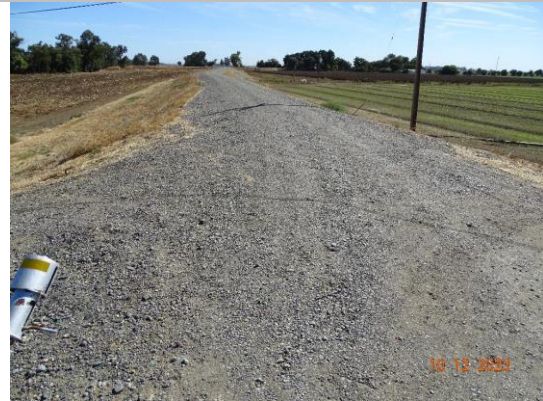
Photo 1 of 3 : UCIP_SP_2024_81406_117558.jpg

Comment Code					
Inspector Comment					
DS_ID:16657 FS_ID:81406 EP_NO: N/A Repair Type: Non-Urgent EVAL Issue: Crossing Status: Not Found UCIP Comments: 10/12/2023 Record remains Non-Urgent. Crossing not found. Geophysical results did not confirm presence of pipe through levee. Record will remain in UCIP's inspection records until future Levee Improvement Project can confirm no crossing was found through the levee. No permit has been identified authorizing pipe. (O. Yakimov - DWR UCIP) 10/21/2019 Rating updated from No Action Needed to Non-Urgent. Also, no permit has been issued for this pipe through the period of historical records. Crossing not found. DMP geophysics didn't confirm evidence of pipe through levee at this location. (O.Yakimov - DWR UCIP)04/05/2012 No indication in field that pipe remains. May need electromagnetic survey to locate pipe. (W. Wylie - DWR UCIP) FIELD_STRUCT_DESC: 24-inch corrugated metal drainage pipe through the levee, at an unknown depth. Two corrugated metal cutoff walls, one reinforced concrete headwall, and one saddle and apron with cobble paving on the waterside (WS). [Additional Reference(s): USACE Sacramento O&M Manual, Unit 119, December 1952, Revised 29 Dec 2016, (Station 197+60 PCT), listed as 24-inch pipe. USACE As-Built Drawing No. 50-04-2396, Revision 4, pdf page 25, Sheet 9, December 1947]. FS Date: 10/12/2023 4:10:28 PM

Top of Levee: View of levee crown looking downstream

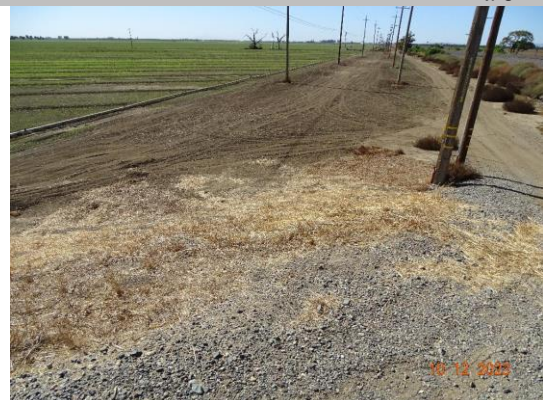
Photo 2 of 3 : UCIP_SP_2024_81406_117557.jpg

Land-Side: View of levee slope looking from crown

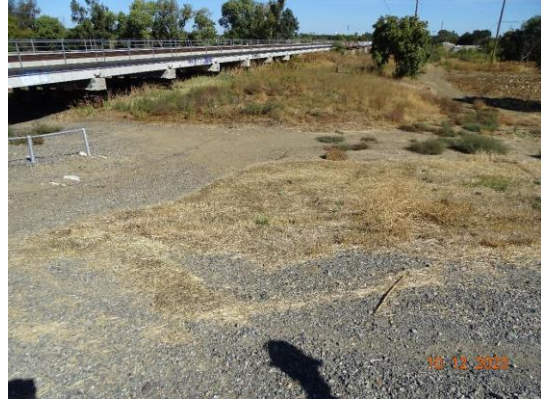
Photo 3 of 3 : UCIP_SP_2024_81406_117556.jpg

Water-Side: View of levee slope looking from crown
