**Flood Control Project Maintenance
Levee Inspections**

Fall 2014 Levee Maintenance Deficiency Summary Report

Sacramento Maintenance Yard Sacramento Bypass

Levee Inspection Report By Mile - Fall 2014

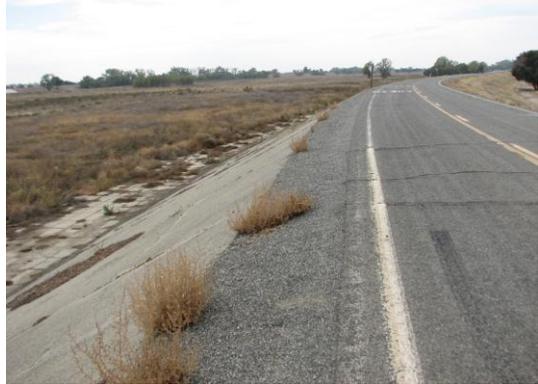
Photo 1 of 2 : FA_2014_ST0008_284_6_20141106_00002.jpg

LM Start	0.00	Rating **	A	Issue No.	6
LM End	1.73	Issue Type +	Ma	Location *	LS
Category	Earthen Levee		GPS Latitude/Longitude		
			Start	End	
Item	Vegetation		°	°	
DWR ID	DWR_ST0008_01_f_2014_6				
Action/Comments					
Control annual grass and weeds on the levee slopes and easements.

Levee mile 0.05, vegetation on the water side levee slope. Fall 2014.

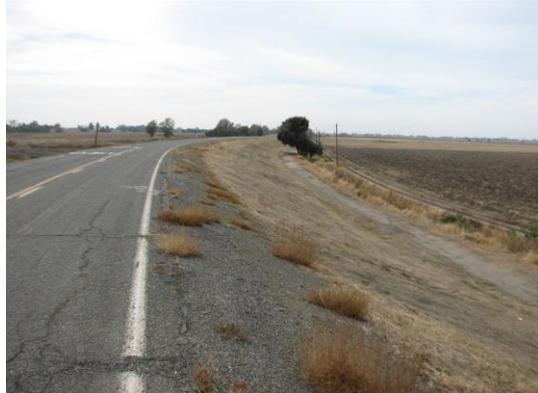
Photo 2 of 2 : FA_2014_ST0008_284_6_20141106_00003.jpg

Levee mile 0.05, vegetation on the land side levee slope. Fall 2014.

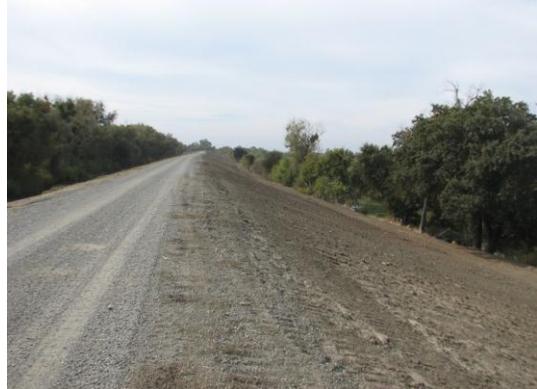
Photo 1 of 2 : FA_2014_ST0008_285_2_20141106_00003.jpg

LM Start	0.00	Rating **	A	Issue No.	2
LM End	1.78	Issue Type +	Ma	Location *	LS
Category	Earthen Levee		GPS Latitude/Longitude		
			Start	End	
Item	Vegetation			°	°
				°	°
DWR ID	DWR_ST0008_02_f_2014_2				
Action/Comments					
Control annual grass and weeds on the levee slopes and easements.

Levee mile 1.00, vegetation controlled on land side levee slope. Fall 2014.

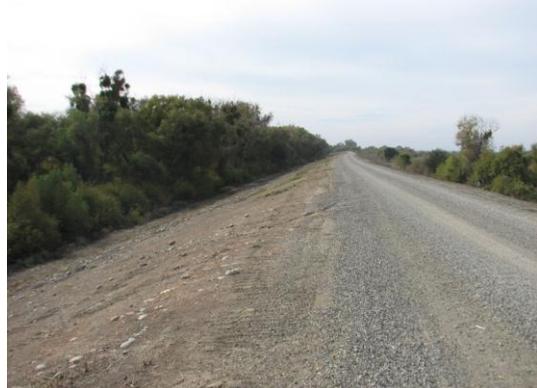
Photo 2 of 2 : FA_2014_ST0008_285_2_20141106_00004.jpg

Levee mile 1.00, vegetation controlled on water side levee slope. Fall 2014.

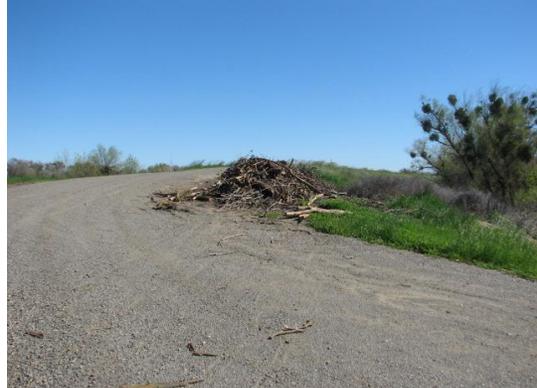
Photo 1 of 2 : FA_2014_ST0008_285_5_20141014_00001.jpg

LM Start	1.76	Rating **	M	Issue No.	5
LM End	1.76	Issue Type +	En	Location *	LS
Category	Earthen Levee		GPS Latitude/Longitude		
			Start	End	
Item	Encroachments		38.594777	°	38.594777
			-121.586525	°	-121.586525
DWR ID	DWR_ST0008_02_f_2013_5				
Action/Comments					
Prunings Inspector Comments: This is a seasonal pile but gets burned by the maintenance division each year.

This is this years pile of brush and will be burned by the maintenance yard. Spring 2014
