**Flood Control Project Maintenance  
Levee Inspections  
LMA District Cover Sheet  
Spring 2013 Levee Inspection Results**

**Sacramento Maintenance Yard Sacramento Bypass**

**Spring 2013 Levee Inspection Results**

**Levee Inspection Report By Mile - Spring 2013**

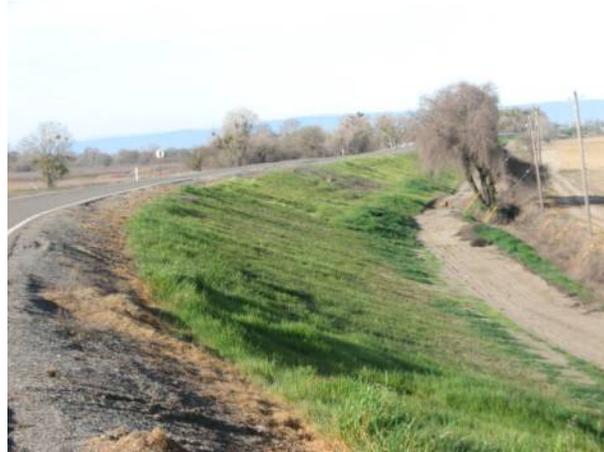
Levee Mile Report Line	4
Start Levee Mile	0.04
End Levee Mile	1.72
Location	Land Side
Category	
Item	Vegetation
The levee has no unwanted vegetation. Spring 2013	
johngw_s_20130307_800.JPG

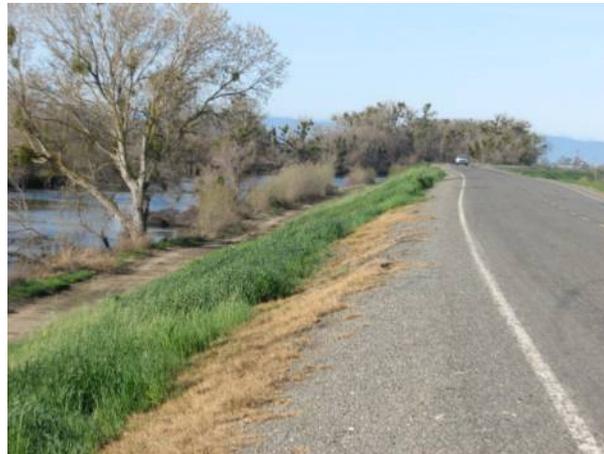
Levee Mile Report Line	5
Start Levee Mile	0.43
End Levee Mile	1.72
Location	Water Side
Category	
Item	Vegetation
The levee has no unwanted vegetation. Spring 2013	
johngw_s_20130307_801.JPG

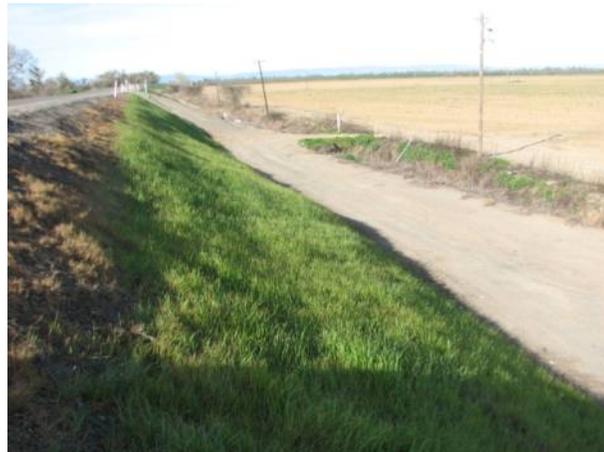
Levee Mile Report Line	6
Start Levee Mile	0.46
End Levee Mile	0.46
Location	Land Side
Category	
Item	Slope Stability
Bulge at toe of the levee. This was in the USACE report. Spring 2013	
johngw_s_20130307_802.JPG

LMIR No.	Levee Mile		Category	Item	* Location	+ Rating	Action/Comment	GPS Latitude/Longitude		Issue No. Photo
	Start	End						Start	End	
1				Operations & Maintenance Manuals	LS	A Ma		°	°	3
								DWR ID: DWR_ST0008_01_s_2013_3		
2				Emergency Supplies & Equipment	LS	A Ma		°	°	4
								DWR ID: DWR_ST0008_01_s_2013_4		
3				Flood Preparedness & Training	LS	A Ma		°	°	5
								DWR ID: DWR_ST0008_01_s_2013_5		
4	0.04	1.72		Vegetation	LS	A Ob	V1 : Control annual grass and weeds on the levee slopes and easements.	38.607009 ° -121.560528 °	38.599448 ° -121.590030 °	1 Y
								DWR ID: DWR_ST0008_01_s_2012_1		
5	0.43	1.72		Vegetation	WS	A Ob	V1 : Control annual grass and weeds on the levee slopes and easements.	38.604856 ° -121.567293 °	38.599444 ° -121.589943 °	2 Y
								DWR ID: DWR_ST0008_01_s_2012_2		
6	0.46	0.46		Slope Stability	LS	M Ma	S1 : Repair slope instability.	38.604712 ° -121.567738 °	38.604712 ° -121.567738 °	12 Y

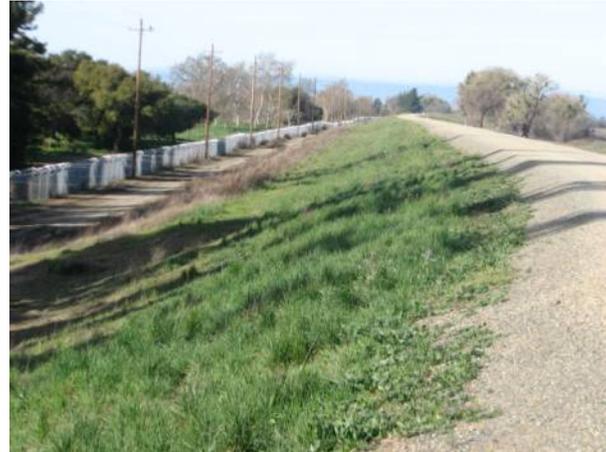
Levee Mile Report Line	1
Start Levee Mile	0.03
End Levee Mile	1.76
Location	Land Side
Category	
Item	Vegetation
The levee has no unwanted vegetation. Spring 2013	
johngw_s_20130307_803.JPG

LMIR No.	Levee Mile		Category	Item	* Location	** Rating	Action/Comment	GPS Latitude/Longitude		Issue No. Photo
	Start	End						Start	End	
1	0.03	1.76		Vegetation	LS	A	V1 : Control annual grass and weeds on the levee slopes and easements.	38.602612 °	38.594724 °	1
						Ob		-121.556050 °	-121.586563 °	Y
								DWR ID: DWR_ST0008_02_s_2012_1		
2	0.51	1.76		Vegetation	WS	A	V1 : Control annual grass and weeds on the levee slopes and easements.	38.600315 °	38.594763 °	2
						Ob		-121.564472 °	-121.586508 °	Y
								DWR ID: DWR_ST0008_02_s_2012_2

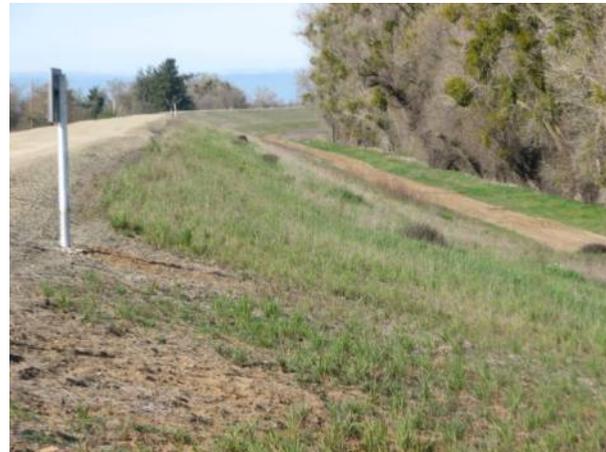
Levee Mile Report Line	2
Start Levee Mile	0.51
End Levee Mile	1.76
Location	Water Side
Category	
Item	Vegetation
The levee has no unwanted vegetation. Spring 2013	
johngw_s_20130307_804.JPG
