**Flood Control Project Maintenance
Levee Inspections**

Maintenance Issue Types Only, Levee Inspection Report By Mile - Spring 2015

Sacramento Maintenance Yard Sacramento Bypass

Waterway	Bank	Unit Miles	Inspection Start/End	Inspector
Unit No. 01 Sacramento Bypass or North Levee	Right	1.74	04/14/2015 04/14/2015	Jai Lor

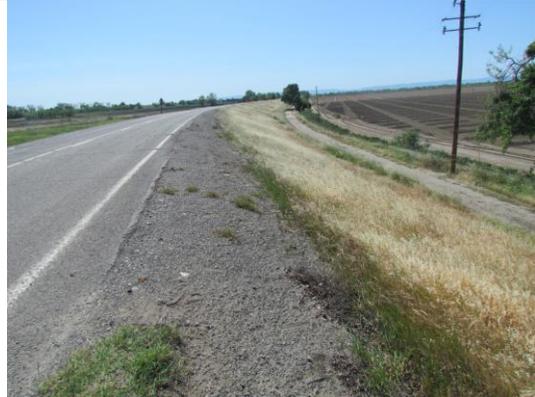
Photo 1 of 1 : SP_2015_ST0008_284_156_20150417_00002.jpg

LM Start	0.04	Rating **	M	Issue No.	156
LM End	1.73	Issue Type +	Ma	Location *	LS
Category	Earthen Levee			GPS Latitude/Longitude	
				Start	End
Item	Vegetation			38.606933 °	38.599515 °
				-121.560655 °	-121.590107 °
DWR ID	DWR_ST0008_01_s_2015_156				
Action/Comments					
Control annual grass and weeds on the levee slopes and easements.

View of the vegetation on the landward side of the levee looking downstream. Spring 2015.

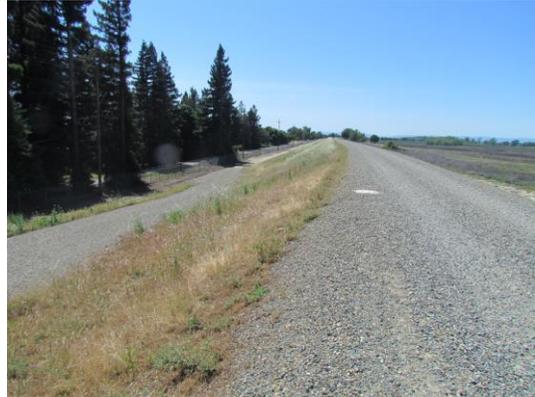
Photo 1 of 1 : SP_2015_ST0008_285_2_20150417_00003.jpg

LM Start	0.08	Rating **	M	Issue No.	2
LM End	1.78	Issue Type +	Ma	Location *	LS
Category	Earthen Levee		GPS Latitude/Longitude		
			Start	End	
Item	Vegetation		38.602432 °	38.594620 °	
			-121.556945 °	-121.586702 °	
DWR ID	DWR_ST0008_02_s_2015_2				
Action/Comments					
Control annual grass and weeds on the levee slopes and easements.

View of the vegetation on the landward side of the levee looking downstream. Spring 2015.
