**Flood Control Project Maintenance
Levee Inspections
LMA District Cover Sheet
Spring 2012 Levee Inspection Results**

Sacramento Maintenance Yard Sacramento Bypass

Levee Inspection Report By Mile - Spring 2012

Waterway			Bank	Unit Miles	Inspection Start/End	Inspector
Unit No. 01 Sacramento Bypass or North Levee			Right	1.73	03/23/2012 03/23/2012	John Williamson

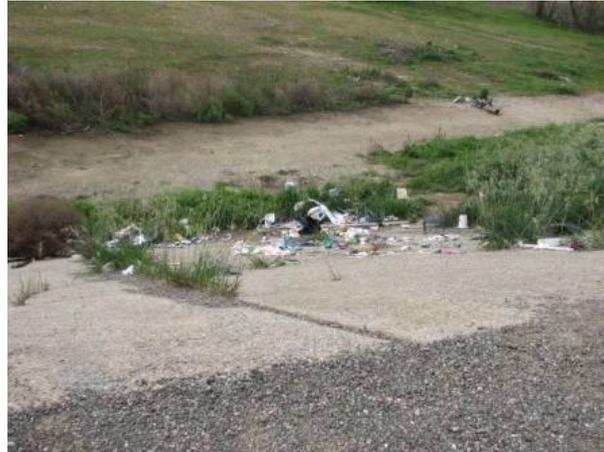
Levee Mile Report Line	1
Start Levee Mile	0.38
End Levee Mile	0.38
Location	Water Side
Category	Earthen Levee
Item	Encroachments
Photo taken spring 2012, trash and debris at toe of waterside levee.	
johngw_s_20120326_615.jpg

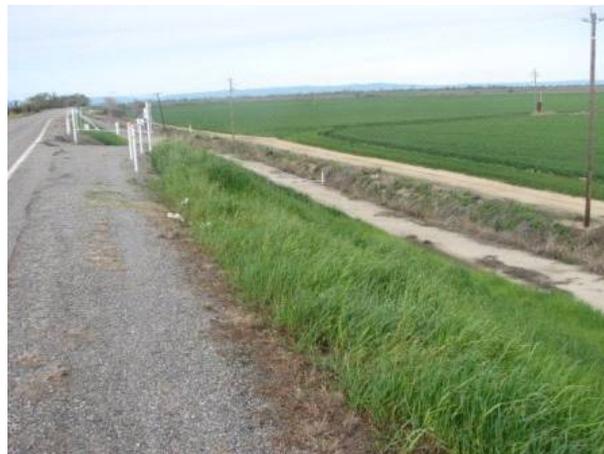
Levee Mile Report Line	2
Start Levee Mile	0.40
End Levee Mile	1.36
Location	Land Side
Category	Earthen Levee
Item	Vegetation
Photo taken spring 2012, grasses are taller than 12".	
johngw_s_20120326_617.jpg

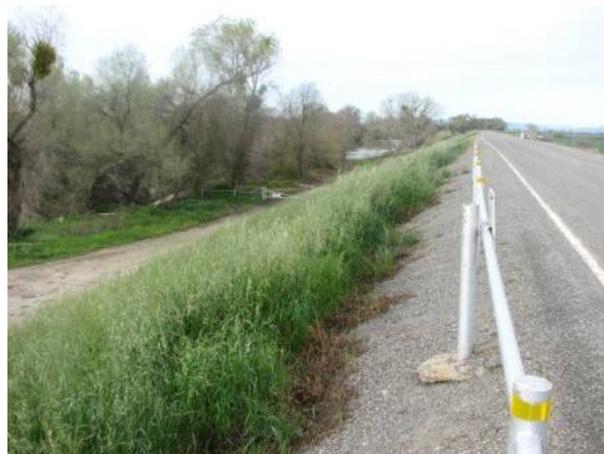
Levee Mile Report Line	3
Start Levee Mile	0.40
End Levee Mile	1.43
Location	Water Side
Category	Earthen Levee
Item	Vegetation
Photo taken spring 2012, grasses are taller than 12".	
johngw_s_20120326_616.jpg

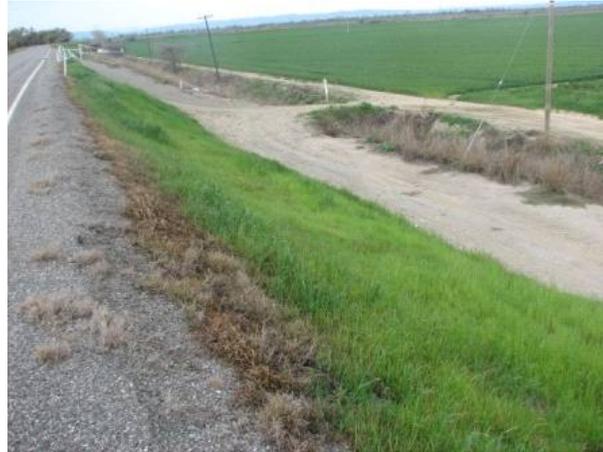
Levee Mile Report Line	4
Start Levee Mile	0.46
End Levee Mile	0.46
Location	Land Side
Category	Earthen Levee
Item	Slope Stability

Photo taken spring 2012, a bulge near the toe of the levee slope.

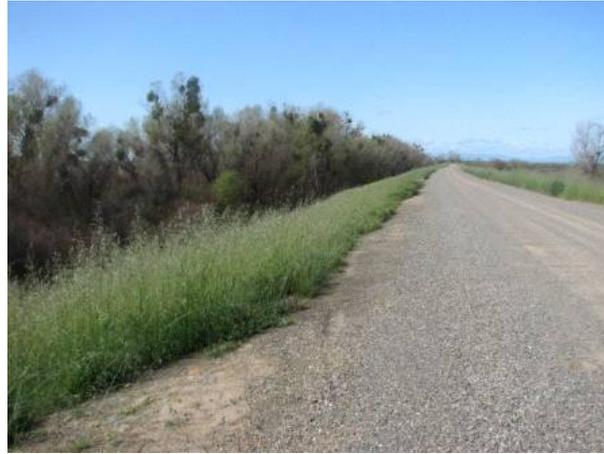
Levee Mile Report Line	5
Start Levee Mile	1.13
End Levee Mile	1.76
Location	Land Side
Category	Earthen Levee
Item	Vegetation
Photo taken spring 2012, grasses are taller than 12".	
johngw_s_20120326_611.jpg

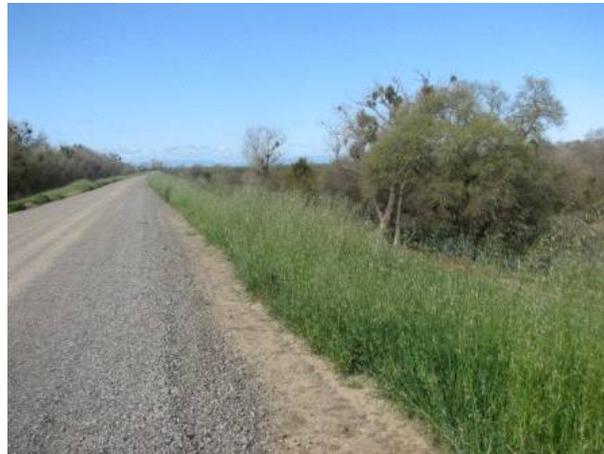
Levee Mile Report Line	6
Start Levee Mile	1.24
End Levee Mile	1.76
Location	Water Side
Category	Earthen Levee
Item	Vegetation
Photo taken spring 2012, grasses are taller than 12".	
johngw_s_20120326_612.jpg
