**Flood Control Project Maintenance
Levee Inspections**

Fall 2011 Levee Maintenance Deficiency Summary Report

Sutter Maintenance Yard Tisdale Bypass

Waterway		Bank	Unit Miles
Unit No. 01 Tisdale Bypass		Left	4.50

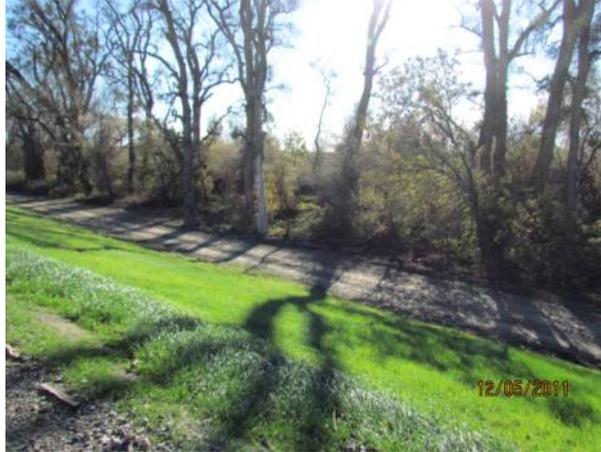
Levee Mile Report Line	2
Start Levee Mile	1.05
End Levee Mile	1.05
Location	Water Side
Category	Earthen Levee
Item	Encroachments
The downed trees has been removed from this location.	
rduffey_f_20111206_557.jpg

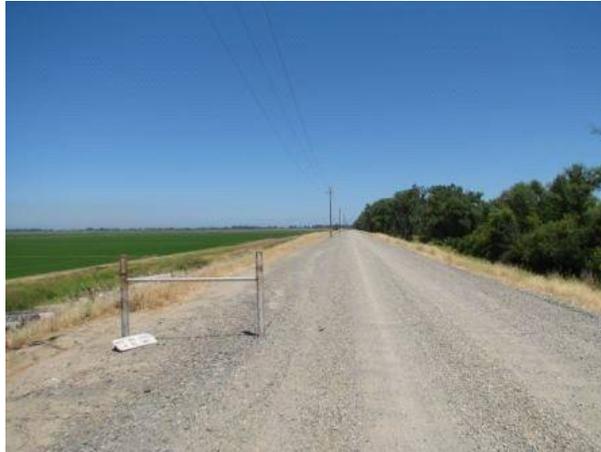
Levee Mile Report Line	3
Start Levee Mile	2.18
End Levee Mile	4.10
Location	Land Side
Category	Earthen Levee
Item	Encroachments
View of the PG&E poles along the landside crown of the levee.	
rduffey_f_20110927_229.jpg

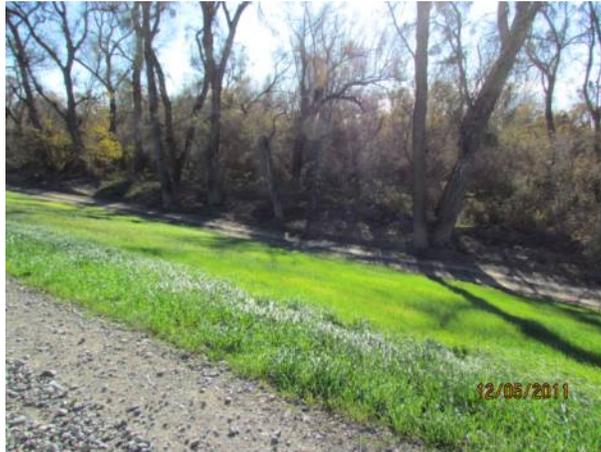
Levee Mile Report Line	4
Start Levee Mile	3.69
End Levee Mile	3.69
Location	Water Side
Category	Earthen Levee
Item	Encroachments
The downed trees has been removed from this location.	
rduffey_f_20111206_558.jpg

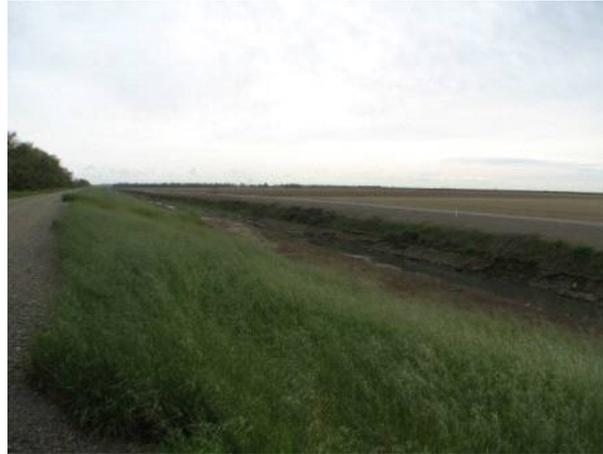
Levee Mile Report Line	1
Start Levee Mile	0.11
End Levee Mile	0.25
Location	Land Side
Category	Earthen Levee
Item	Encroachments

View of the agriculture ditch and erosion along the landside toe of the Levee.

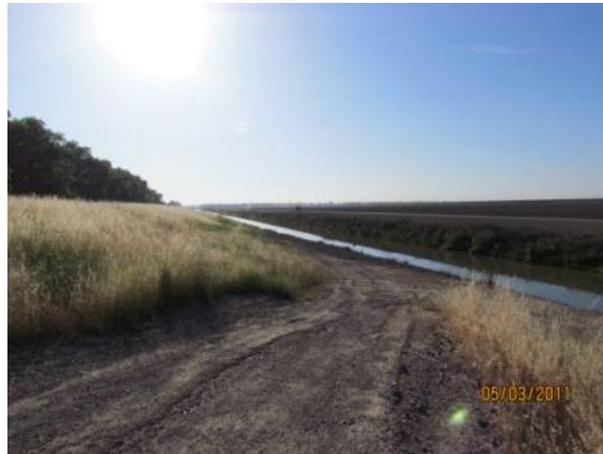
Levee Mile Report Line	2
Start Levee Mile	0.52
End Levee Mile	1.74
Location	Land Side
Category	Earthen Levee
Item	Encroachments

View of the AG ditch next to the L/S toe.

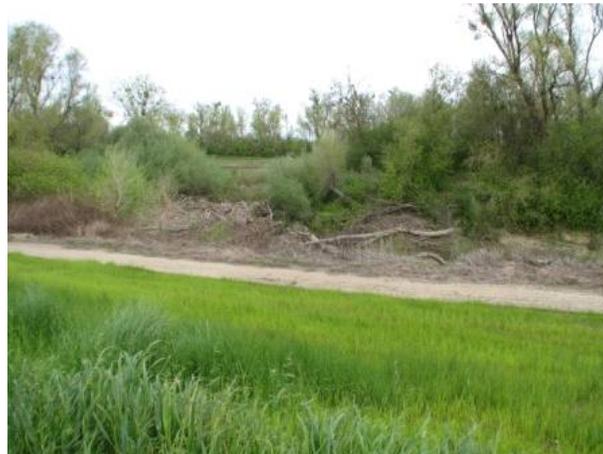
Levee Mile Report Line	3
Start Levee Mile	1.01
End Levee Mile	1.01
Location	Water Side
Category	Earthen Levee
Item	Erosion / Bank Caving

View of the erosion along the waterside toe of the levee.
