**Flood Control Project Maintenance  
Levee Inspections**

**Fall 2014 Levee Maintenance Deficiency Summary Report  
Overall LMA & Unit Ratings, including USACE Erosion Survey**

**Sutter Maintenance Yard Tisdale Bypass**

**Levee Inspection Report By Mile - Fall 2014**

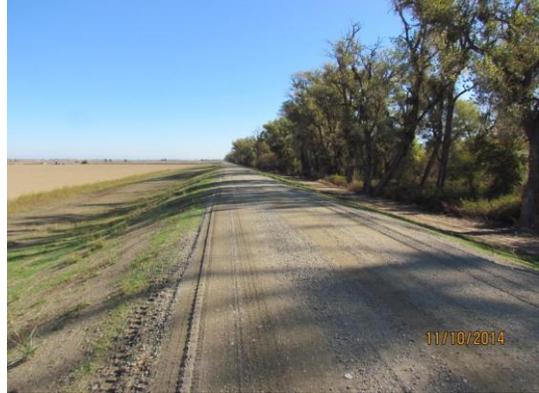
Photo 1 of 1 : FA\_2014\_ST0009\_286\_6\_20141112\_00002.jpg

LM Start	<b>0.71</b>	Rating **	A	Issue No.	<b>6</b>
LM End	<b>0.71</b>	Issue Type +	Ma	Location *	LS
Category	Earthen Levee		GPS Latitude/Longitude		
			Start	End	
Item	Vegetation		39.028345 °	39.028345 °	
			-121.808753 °	-121.808753 °	
DWR ID	DWR_ST0009_01_f_2014_6				
Action/Comments					
Control annual grass and weeds on the levee slopes and easements. Inspector Comments: Sutter Yard has burned and dragged both slopes.

View of the levee with no vegetation on both slopes.

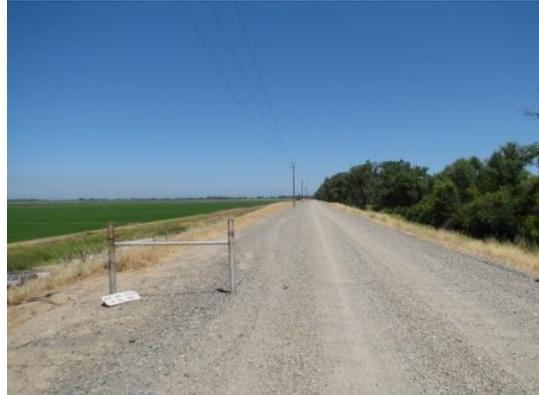
Photo 1 of 1 : FA\_2014\_ST0009\_286\_3\_20141013\_00001.jpg

LM Start	<b>2.18</b>	Rating **	M	Issue No.	<b>3</b>
LM End	<b>4.10</b>	Issue Type +	En	Location *	LS
Category	Earthen Levee		GPS Latitude/Longitude		
			Start	End	
Item	Encroachments		39.028173 °	39.028012 °	
			-121.781475 °	-121.745665 °	
DWR ID	DWR_ST0009_01_s_2012_3				
Action/Comments					
Pole

View of the PG&E poles along the landside crown of the levee.

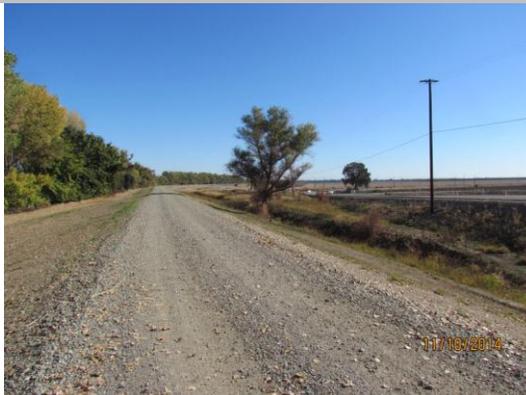
Photo 1 of 1 : FA\_2014\_ST0009\_287\_1\_20141112\_00006.jpg

LM Start	<b>0.11</b>	Rating **	M	Issue No.	<b>1</b>
LM End	<b>0.25</b>	Issue Type +	En	Location *	LS
Category	Earthen Levee		GPS Latitude/Longitude		
			Start	End	
Item	Encroachments		39.023760 °	39.024559 °	
			-121.818875 °	-121.816344 °	
DWR ID	DWR_ST0009_02_s_2012_1				
Action/Comments					
Ditch

View of the agricultural ditch and erosion along the land side toe.

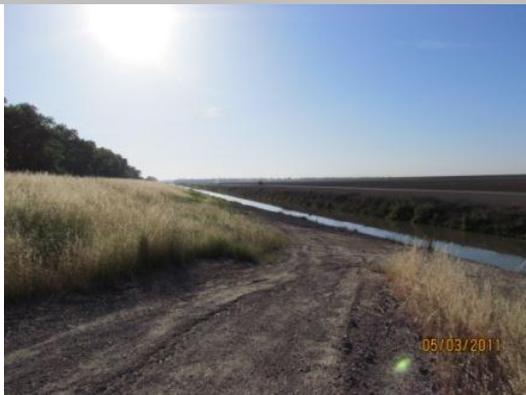
Photo 1 of 1 : FA\_2014\_ST0009\_287\_2\_20141013\_00002.jpg

LM Start	<b>0.52</b>	Rating **	M	Issue No.	<b>2</b>
LM End	<b>1.74</b>	Issue Type +	En	Location *	LS
Category	Earthen Levee		GPS Latitude/Longitude		
			Start	End	
Item	Encroachments		39.025539 °	39.025398 °	
			-121.811540 °	-121.789006 °	
DWR ID	DWR_ST0009_02_s_2012_2				
Action/Comments					
Ditch

View of the ag ditch next to the L/S toe.

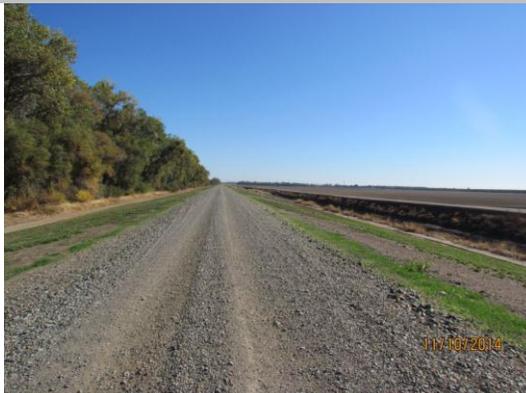
Photo 1 of 1 : FA\_2014\_ST0009\_287\_8\_20141112\_00007.jpg

LM Start	<b>0.66</b>	Rating **	A	Issue No.	<b>8</b>
LM End	<b>0.66</b>	Issue Type +	Ma	Location *	LS
Category	Earthen Levee		GPS Latitude/Longitude		
			Start	End	
Item	Vegetation		39.025625 °	39.025625 °	
			-121.808913 °	-121.808913 °	
DWR ID	DWR_ST0009_02_f_2014_8				
Action/Comments					
Control annual grass and weeds on the levee slopes and easements. Inspector Comments: Sutter Yard has burned and dragged both slopes.

View of the levee with no vegetation on both slopes.

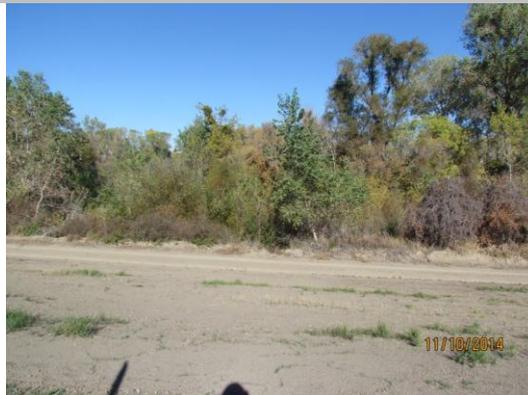
Photo 1 of 1 : FA\_2014\_ST0009\_287\_3\_20141112\_00008.jpg

LM Start	<b>1.01</b>	Rating **	M	Issue No.	<b>3</b>
LM End	<b>1.01</b>	Issue Type +	Ma	Location *	WS
Category	Earthen Levee		GPS Latitude/Longitude		
			Start	End	
Item	Erosion / Bank Caving		39.025542 °	39.025542 °	
			-121.802468 °	-121.802468 °	
DWR ID	DWR_ST0009_02_s_2012_3				
Action/Comments					
Note and monitor erosion site. Inspector Comments: Sutter Yard needs to monitor the erosion.

View of the erosion along the waterside berm.

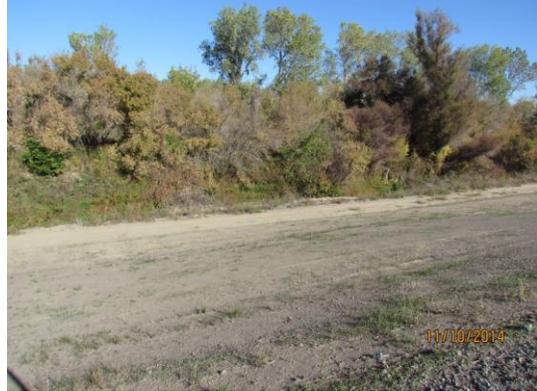
Photo 1 of 1 : FA\_2014\_ST0009\_287\_4\_20141112\_00009.jpg

LM Start	<b>1.29</b>	Rating **	M	Issue No.	<b>4</b>
LM End	<b>1.29</b>	Issue Type +	Ma	Location *	WS
Category	Earthen Levee		GPS Latitude/Longitude		
			Start	End	
Item	Erosion / Bank Caving		39.025478 °	39.025478 °	
			-121.797232 °	-121.797232 °	
DWR ID	DWR_ST0009_02_s_ 2013_4				
Action/Comments					
Schedule repair of erosion site prior to the next inspection. Inspector Comments: Sutter Yard needs to monitor the erosion.

View of the erosion along the waterside berm.

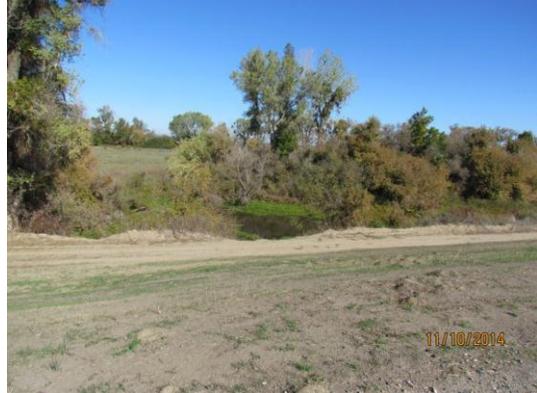
Photo 1 of 1 : FA\_2014\_ST0009\_287\_5\_20141112\_00010.jpg

LM Start	<b>1.50</b>	Rating **	M	Issue No.	<b>5</b>
LM End	<b>1.50</b>	Issue Type +	Ma	Location *	WS
Category	Earthen Levee		GPS Latitude/Longitude		
			Start	End	
Item	Erosion / Bank Caving		39.025446 °	39.025446 °	
			-121.793347 °	-121.793347 °	
DWR ID	DWR_ST0009_02_s_ 2013_5				
Action/Comments					
Schedule repair of erosion site prior to the next inspection. Inspector Comments: Sutter Yard needs to monitor the erosion.

View of the erosion along the waterside berm.
