**Flood Control Project Maintenance
Levee Inspections
LMA District Cover Sheet
Spring 2012 Levee Inspection Results**

Sutter Maintenance Yard Tisdale Bypass

Levee Inspection Report By Mile - Spring 2012

Waterway	Bank	Unit Miles	Inspection Start/End	Inspector
Unit No. 01 Tisdale Bypass	Left	4.50	03/29/2012 03/29/2012	Bob Duffey

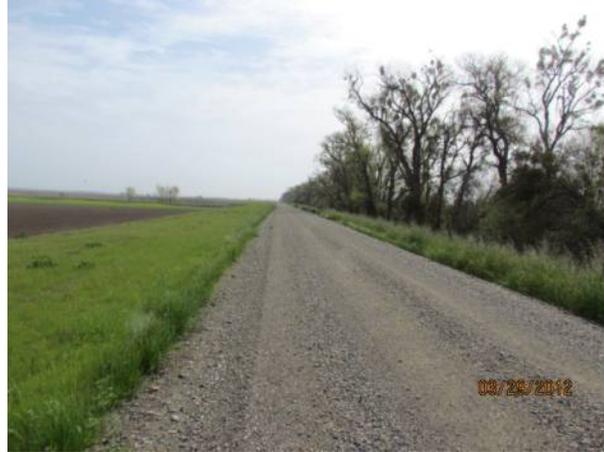
Levee Mile Report Line	4
Start Levee Mile	0.95
End Levee Mile	0.95
Location	Land Side
Category	Earthen Levee
Item	Vegetation
Both slope of the levee are covered with grasses.	
rduffey_s_20120430_575.jpg

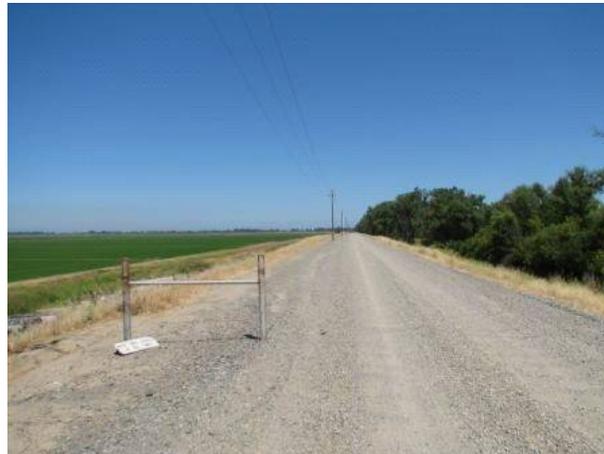
Levee Mile Report Line	5
Start Levee Mile	2.18
End Levee Mile	4.10
Location	Land Side
Category	Earthen Levee
Item	Encroachments
View of the PG&E poles along the landside crown of the levee.	
rduffey_s_20120312_509.jpg

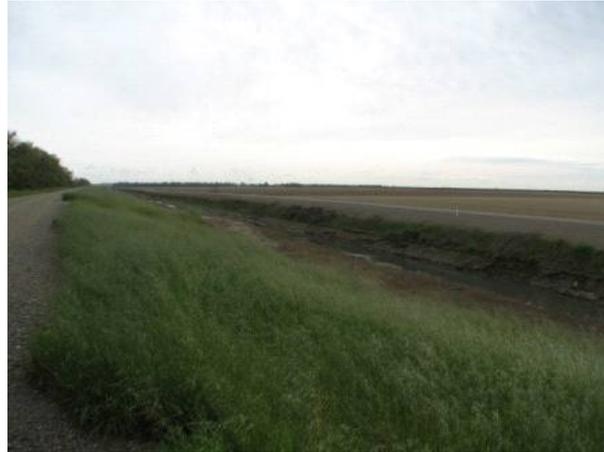
Levee Mile Report Line	1
Start Levee Mile	0.11
End Levee Mile	0.25
Location	Land Side
Category	Earthen Levee
Item	Encroachments

View of the agriculture ditch and erosion along the landside toe of the Levee.

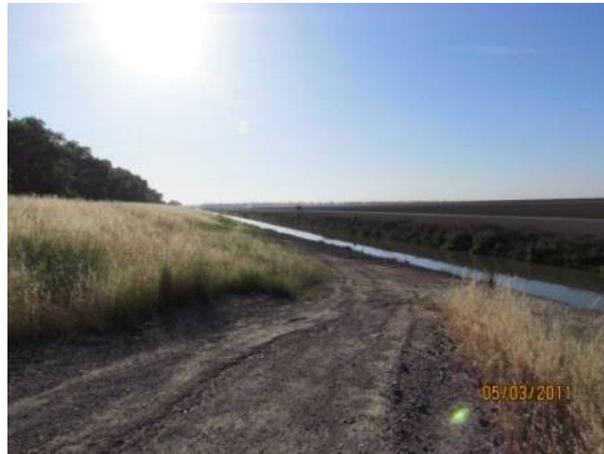
Levee Mile Report Line	2
Start Levee Mile	0.52
End Levee Mile	1.74
Location	Land Side
Category	Earthen Levee
Item	Encroachments

View of the ag ditch next to the L/S toe.

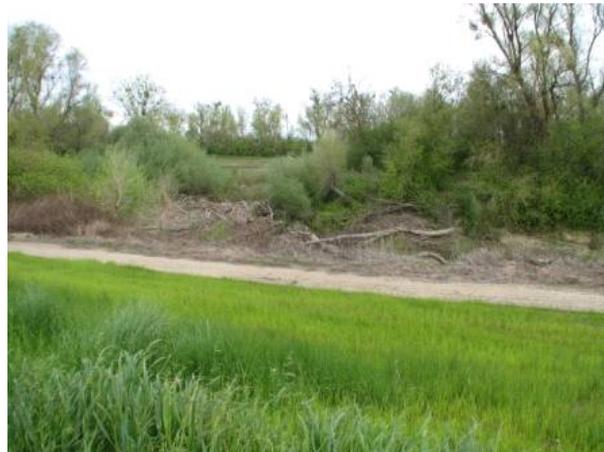
Levee Mile Report Line	3
Start Levee Mile	1.01
End Levee Mile	1.01
Location	Water Side
Category	Earthen Levee
Item	Erosion / Bank Caving

View of the erosion along the waterside toe of the levee.

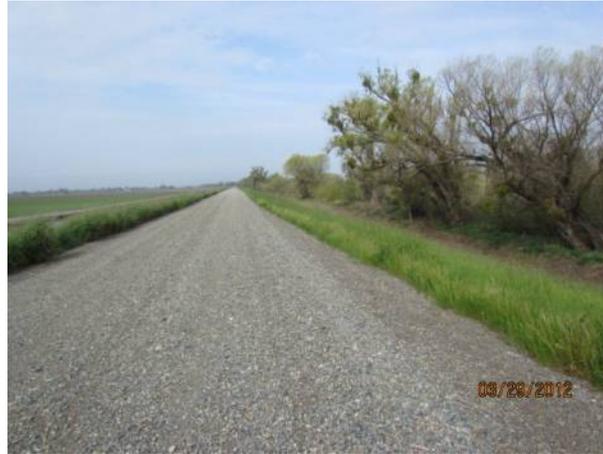
Levee Mile Report Line	4
Start Levee Mile	1.82
End Levee Mile	1.82
Location	Land Side
Category	Earthen Levee
Item	Vegetation
Both slopes of the levee are covered with native grasses.	
rduffey_s_20120416_573.jpg
