**Flood Control Project Maintenance  
Levee Inspections**  
**LMA District Cover Sheet**  
**Spring 2014 Levee Inspection Results**

**Sutter Maintenance Yard Tisdale Bypass**

**Levee Inspection Report By Mile - Spring 2014**

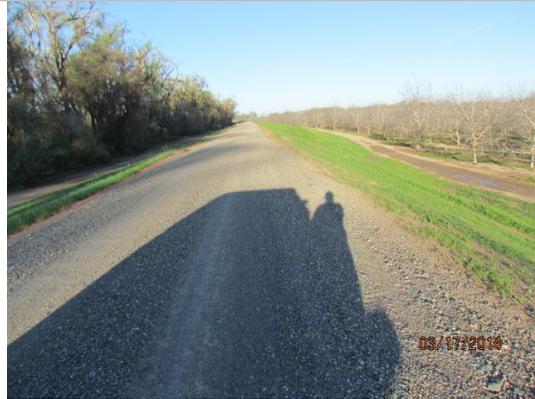
Photo 1 of 1 : rduffey\_s\_20140317\_110.jpg

LM Start	<b>0.60</b>	Rating **	A	Issue No.	<b>159</b>
LM End	<b>0.60</b>	Issue Type +	Ma	Location *	LS
Category	Earthen Levee		GPS Latitude/Longitude		
			Start	End	
Item	Vegetation		39.028367 °	39.028367 °	
			-121.810786 °	-121.810786 °	
DWR ID	DWR_ST0009_01_s_2014_159				
Action/Comments					
Control annual grass and weeds on the levee slopes and easements.

View of the native grasses on both slopes.

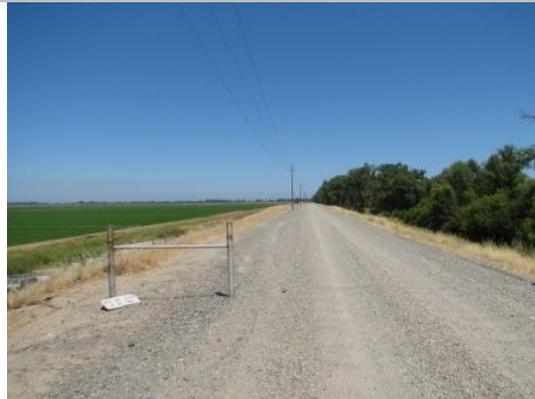
Photo 1 of 1 : rduffey\_s\_20140304\_673.jpg

LM Start	<b>2.18</b>	Rating **	M	Issue No.	<b>3</b>
LM End	<b>4.10</b>	Issue Type +	En	Location *	LS
Category	Earthen Levee		GPS Latitude/Longitude		
			Start	End	
Item	Encroachments		39.028173 °	39.028012 °	
			-121.781475 °	-121.745665 °	
DWR ID	DWR_ST0009_01_s_2012_3				
Action/Comments					
Pole

View of the PG&E poles along the landside crown of the levee.

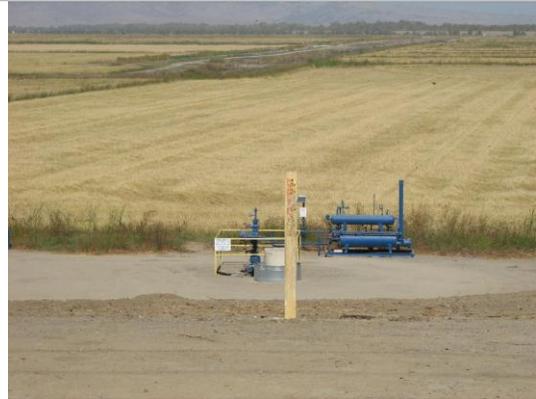
Photo 1 of 1 : UCIP\_3602.jpg

LM Start	<b>3.64</b>	Rating **	M	Issue No.	<b>158</b>
LM End	<b>3.64</b>	Issue Type +	En	Location *	LS
Category	Supplemental			GPS Latitude/Longitude	
				Start	End
Item	DWR UCIP Field Study			39.027911 °	39.027911 °
				-121.754224 °	-121.754224 °
DWR ID	DWR_ST0009_01_s_2014_158				
Action/Comments					
Inspector Comments: FS_ID:23689					
EP_NO: 14740					
Repair Type:					
Crossing Status:					
UCIP Comments: 5/20/2013 Carsonite marker on WS shoulder missing and should be replaced 10/30/2013 Same as last inspection.					
FIELD_STRUCT_DESC: 4-inch pipe through levee and under channel 2.5 feet below crown. Carsonite signs on both LS and WS shoulder.					
Gas Wells 200-feet off of LS toe. (Permit No. 14740 - Nahama and Weagant Energy Co.) Drawings available.					
FS Date: 11/6/2013 7:22:38 AM

Carsonite sign on LS shoulder with view of gas well in background.

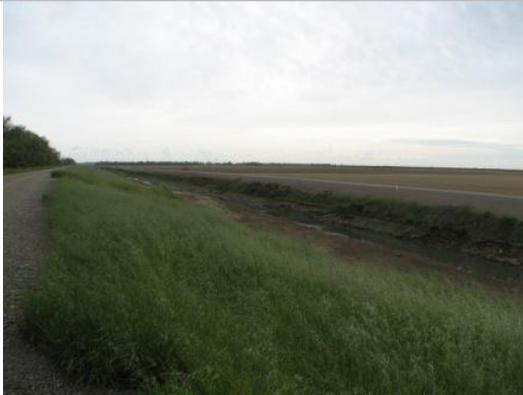
Photo 1 of 1 : rduffey\_s\_20140304\_823.jpg

LM Start	<b>0.11</b>	Rating **	M	Issue No.	<b>1</b>
LM End	<b>0.25</b>	Issue Type +	En	Location *	LS
Category	Earthen Levee		GPS Latitude/Longitude		
			Start	End	
Item	Encroachments		39.023760 °	39.024559 °	
			-121.818875 °	-121.816344 °	
DWR ID	DWR_ST0009_02_s_2012_1				
Action/Comments					
Ditch

View of the agricultural ditch and erosion along the landside toe of the levee.

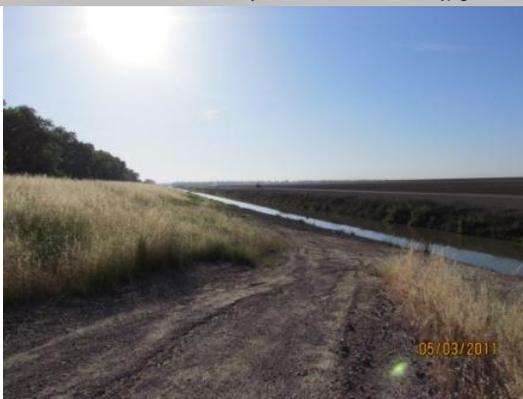
Photo 1 of 1 : rduffey\_s\_20140304\_824.jpg

LM Start	<b>0.52</b>	Rating **	M	Issue No.	<b>2</b>
LM End	<b>1.74</b>	Issue Type +	En	Location *	LS
Category	Earthen Levee		GPS Latitude/Longitude		
			Start	End	
Item	Encroachments		39.025539 °	39.025398 °	
			-121.811540 °	-121.789006 °	
DWR ID	DWR_ST0009_02_s_2012_2				
Action/Comments					
Ditch

View of the ag ditch next to the L/S toe.

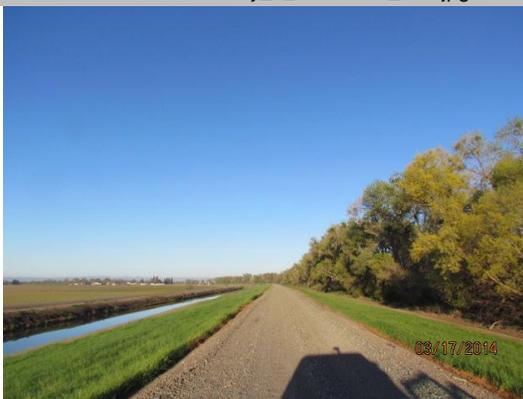
Photo 1 of 1 : rduffey\_s\_20140317\_109.jpg

LM Start	<b>0.94</b>	Rating **	A	Issue No.	<b>149</b>
LM End	<b>0.94</b>	Issue Type +	Ma	Location *	LS
Category	Earthen Levee		GPS Latitude/Longitude		
			Start	End	
Item	Vegetation		39.025544 °	39.025544 °	
			-121.803835 °	-121.803835 °	
DWR ID	DWR_ST0009_02_s_2014_149				
Action/Comments					
Control annual grass and weeds on the levee slopes and easements.

View of the native grasses on those slopes.

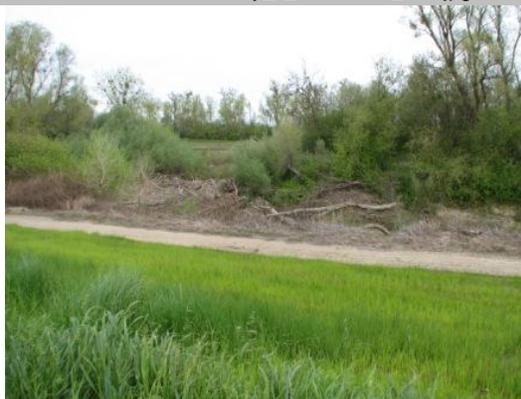
Photo 1 of 1 : rduffey\_s\_20140304\_825.jpg

LM Start	<b>1.01</b>	Rating **	M	Issue No.	<b>3</b>
LM End	<b>1.01</b>	Issue Type +	Ma	Location *	WS
Category	Earthen Levee			GPS Latitude/Longitude	
				Start	End
Item	Erosion / Bank Caving			39.025542 °	39.025542 °
				-121.802468 °	-121.802468 °
DWR ID	DWR_ST0009_02_s_2012_3				
Action/Comments					
Note and monitor erosion site.

View of the erosion along the waterside toe of the levee.

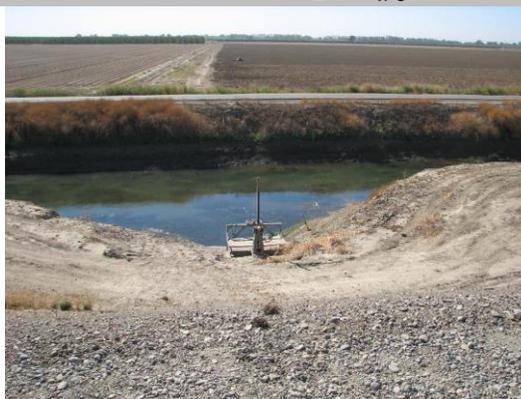
Photo 1 of 1 : UCIP\_3599.jpg

LM Start	<b>1.14</b>	Rating **	M	Issue No.	<b>147</b>
LM End	<b>1.14</b>	Issue Type +	En	Location *	WS
Category	Supplemental			GPS Latitude/Longitude	
				Start	End
Item	DWR UCIP Field Study			39.025503 °	39.025503 °
				-121.800053 °	-121.800053 °
DWR ID	DWR_ST0009_02_s_2014_147				
Action/Comments					
Inspector Comments: FS_ID:23684 EP_NO: 267 Repair Type: Crossing Status: UCIP Comments: Burrowing along downstream side of concrete vault on WS Toe. May need to be grouted 5/20/2013 Same as last inspection 10/30/2013 Same as last inspection. FIELD_STRUCT_DESC: 54-inch concrete pipe through levee, 29.5 feet below the crown. Slide gates on both ends. Waterward end gate in 5-foot by 6-foot concrete box. Landward end gate in concrete "U" headwall. Siphon pipe under and across bypass, steel concrete encased. (Permit No. 267 & 290 - Sutter Basin Water Co.) FS Date: 11/6/2013 7:12:40 AM

Slide gate at concrete outlet on LS toe.

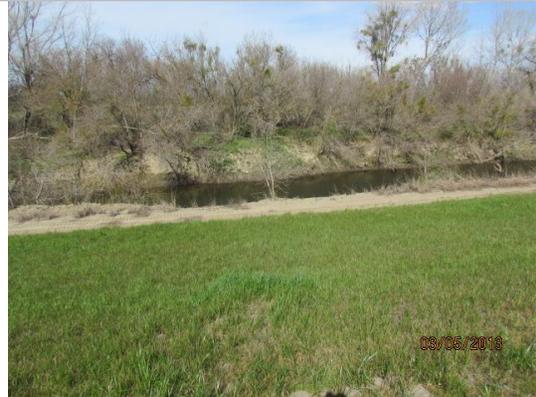
Photo 1 of 1 : rduffey\_s\_20140304\_826.jpg

LM Start	<b>1.29</b>	Rating **	M	Issue No.	<b>4</b>
LM End	<b>1.29</b>	Issue Type +	Ma	Location *	WS
Category	Earthen Levee		GPS Latitude/Longitude		
			Start	End	
Item	Erosion / Bank Caving		39.025478 °	39.025478 °	
			-121.797232 °	-121.797232 °	
DWR ID	DWR_ST0009_02_s_2013_4				
Action/Comments

View of the erosion along the waterside berm.

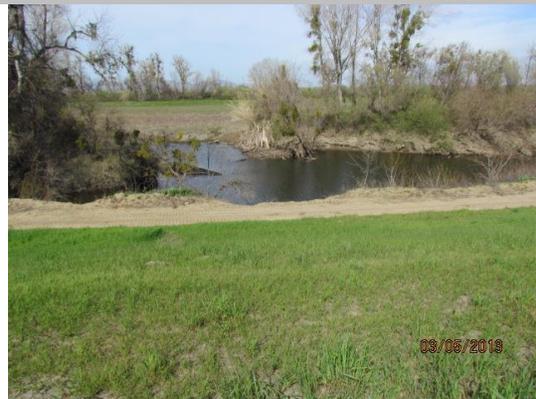
Photo 1 of 1 : rduffey\_s\_20140304\_827.jpg

LM Start	<b>1.50</b>	Rating **	M	Issue No.	<b>5</b>
LM End	<b>1.50</b>	Issue Type +	Ma	Location *	WS
Category	Earthen Levee		GPS Latitude/Longitude		
			Start	End	
Item	Erosion / Bank Caving		39.025446 °	39.025446 °	
			-121.793347 °	-121.793347 °	
DWR ID	DWR_ST0009_02_s_2013_5				
Action/Comments

View of the erosion along the waterside berm

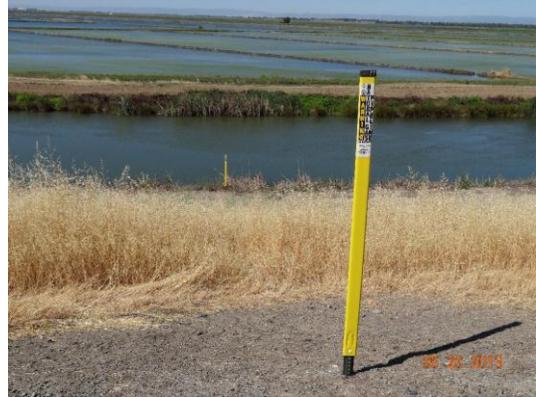
Photo 1 of 1 : UCIP\_3605.jpg

LM Start	<b>4.21</b>	Rating **	M	Issue No.	<b>148</b>
LM End	<b>4.21</b>	Issue Type +	En	Location *	WS
Category	Supplemental			GPS Latitude/Longitude	
				Start	End
Item	DWR UCIP Field Study			39.024079 °	39.024079 °
				-121.743420 °	-121.743420 °
DWR ID	DWR_ST0009_02_s_2014_148				
Action/Comments					
Inspector Comments: FS_ID:23690					
EP_NO: N/A					
Repair Type:					
Crossing Status:					
UCIP Comments: Need to identify permit for crossing 0/30/2013					
Same as last inspection.					
FIELD_STRUCT_DESC: Natural gas pipeline markers on LS shoulder and toe and WS shoulder and toe. No photos available.					
FS Date: 11/6/2013 7:24:41 AM

Marker on LS shoulder and toe
