**Flood Control Project Maintenance
Levee Inspections**

Maintenance Issue Types Only, Levee Inspection Report By Mile - Fall 2015

Sutter Maintenance Yard Tisdale Bypass

Waterway	Bank	Unit Miles	Inspection Start/End	Inspector
Unit No. 01 Tisdale Bypass	Left	4.51	09/17/2015 09/17/2015	Bob Duffey

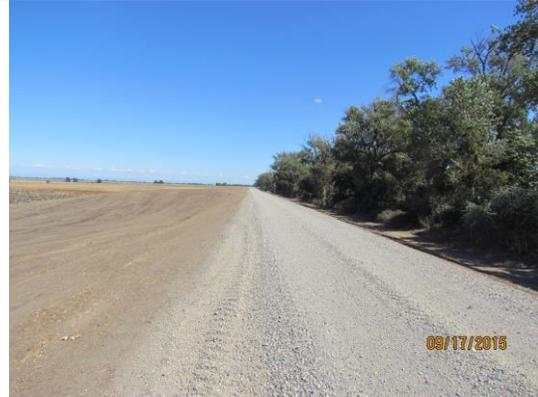
Photo 1 of 1 : FA_2015_ST0009_286_7_20151013_00004.jpg

LM Start	1.27	Rating **	A	Issue No.	7
LM End	1.27	Issue Type +	Ma	Location *	LS
Category	Earthen Levee		GPS Latitude/Longitude		
			Start	End	
Item	Vegetation		39.028268 °	39.028268 °	
			-121.798585 °	-121.798585 °	
DWR ID	DWR_ST0009_01_f_2015_7				
Action/Comments					
Control annual grass and weeds on the levee slopes and easements. Inspector Comments: Sutter Yard Burned and dragged both slopes.

View of the levee slope with no vegetation.

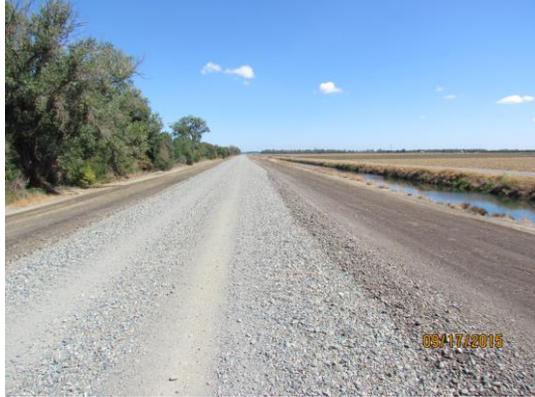
Photo 1 of 1 : FA_2015_ST0009_287_8_20151013_00007.jpg

LM Start	0.91	Rating **	A	Issue No.	8
LM End	0.91	Issue Type +	Ma	Location *	LS
Category	Earthen Levee		GPS Latitude/Longitude		
			Start	End	
Item	Vegetation		39.025587 °	39.025587 °	
			-121.804295 °	-121.804295 °	
DWR ID	DWR_ST0009_02_f_2015_8				
Action/Comments					
Control annual grass and weeds on the levee slopes and easements. Inspector Comments: Sutter Yard burned and dragged both slopes.

View of the levee slopes with no vegetation.

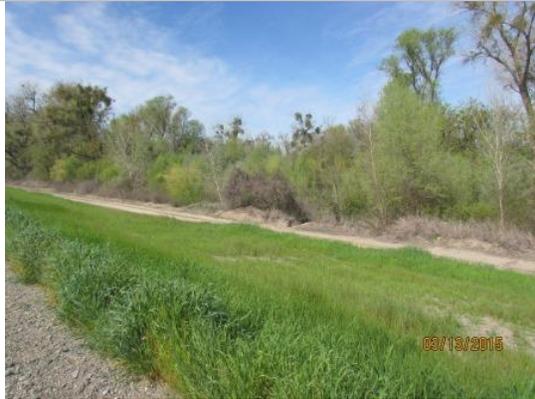
Photo 1 of 1 : FA_2015_ST0009_287_3_20150910_00003.jpg

LM Start	1.01	Rating **	M	Issue No.	3
LM End	1.01	Issue Type +	Ma	Location *	WS
Category	Earthen Levee		GPS Latitude/Longitude		
			Start	End	
Item	Erosion / Bank Caving		39.025542 °	39.025542 °	
			-121.802468 °	-121.802468 °	
DWR ID	DWR_ST0009_02_s_2012_3				
Action/Comments					
Note and monitor erosion site. Inspector Comments: Sutter Yard needs to monitor the erosion.

View of the erosion along the waterside berm.

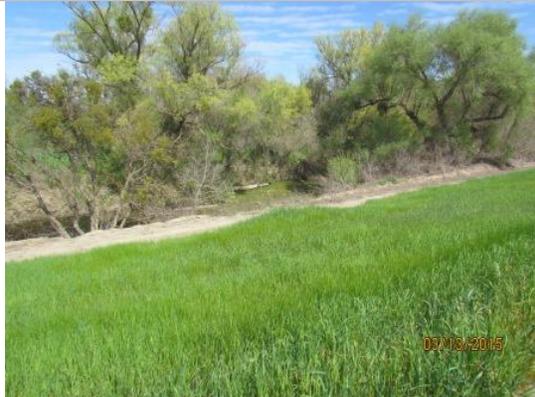
Photo 1 of 1 : FA_2015_ST0009_287_290_20150910_00006.jpg

LM Start	1.19	Rating **	M	Issue No.	290
LM End	1.19	Issue Type +	Ma	Location *	WS
Category	Earthen Levee		GPS Latitude/Longitude		
			Start	End	
Item	Erosion / Bank Caving		39.025490 °	39.025490 °	
			-121.799240 °	-121.799240 °	
DWR ID	DWR_ST0009_02_s_2015_290				
Action/Comments					
Note and monitor erosion site. Inspector Comments: Sutter Yard needs to monitor the erosion along the berm.

View of the erosion along the waterside berm.

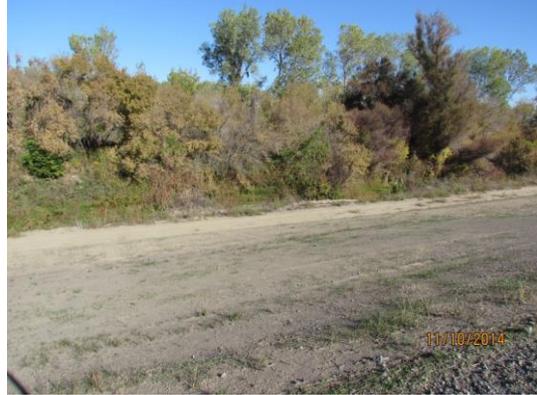
Photo 1 of 1 : FA_2015_ST0009_287_4_20150910_00004.jpg

LM Start	1.29	Rating **	M	Issue No.	4
LM End	1.29	Issue Type +	Ma	Location *	WS
Category	Earthen Levee		GPS Latitude/Longitude		
			Start	End	
Item	Erosion / Bank Caving		39.025478 °	39.025478 °	
			-121.797232 °	-121.797232 °	
DWR ID	DWR_ST0009_02_s_2013_4				
Action/Comments					
Schedule repair of erosion site prior to the next inspection. Inspector Comments: Sutter Yard needs to monitor the erosion.

View of the erosion along the waterside berm.

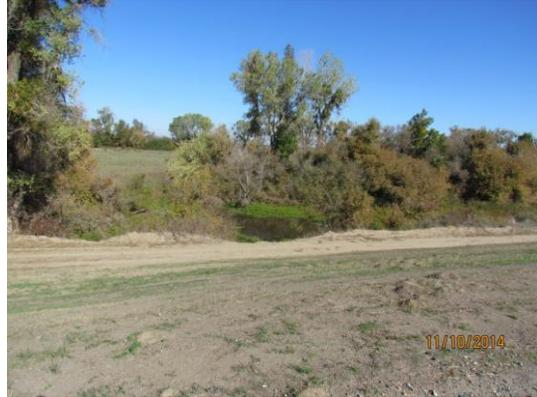
Photo 1 of 1 : FA_2015_ST0009_287_5_20150910_00005.jpg

LM Start	1.50	Rating **	M	Issue No.	5
LM End	1.50	Issue Type +	Ma	Location *	WS
Category	Earthen Levee		GPS Latitude/Longitude		
			Start	End	
Item	Erosion / Bank Caving		39.025446 °	39.025446 °	
			-121.793347 °	-121.793347 °	
DWR ID	DWR_ST0009_02_s_2013_5				
Action/Comments					
Schedule repair of erosion site prior to the next inspection. Inspector Comments: Sutter Yard needs to monitor the erosion.

View of the erosion along the waterside berm.
