**Flood Control Project Maintenance
Levee Inspections**

Maintenance Issue Types Only, Levee Inspection Report By Mile - Spring 2015

Sutter Maintenance Yard Tisdale Bypass

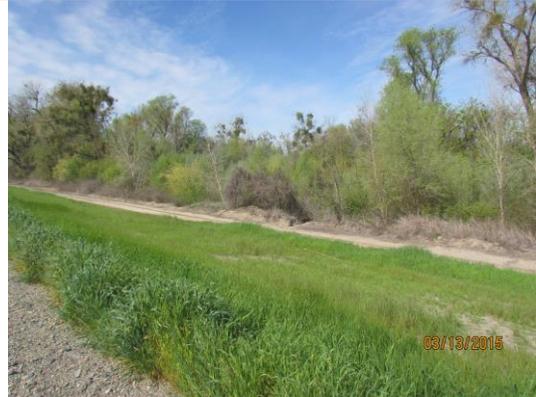
Photo 1 of 1 : SP_2015_ST0009_287_3_20150406_00410.jpg

LM Start	1.01	Rating **	M	Issue No.	3
LM End	1.01	Issue Type +	Ma	Location *	WS
Category	Earthen Levee		GPS Latitude/Longitude		
			Start	End	
Item	Erosion / Bank Caving		39.025542 °	39.025542 °	
			-121.802468 °	-121.802468 °	
DWR ID	DWR_ST0009_02_s_2012_3				
Action/Comments					
Note and monitor erosion site. Inspector Comments: Sutter Yard needs to monitor the erosion.

View of the erosion along the waterside berm.

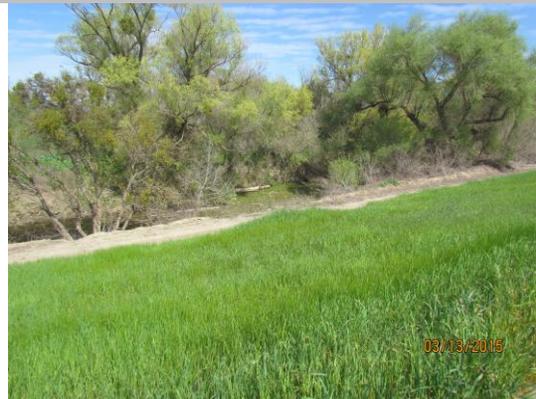
Photo 1 of 1 : SP_2015_ST0009_287_290_20150406_00411.jpg

LM Start	1.19	Rating **	M	Issue No.	290
LM End	1.19	Issue Type +	Ma	Location *	WS
Category	Earthen Levee		GPS Latitude/Longitude		
			Start	End	
Item	Erosion / Bank Caving		39.025490 °	39.025490 °	
			-121.799240 °	-121.799240 °	
DWR ID	DWR_ST0009_02_s_2015_290				
Action/Comments					
Note and monitor erosion site. Inspector Comments: Sutter Yard needs to monitor the erosion along the berm.

View of the erosion along the waterside berm.

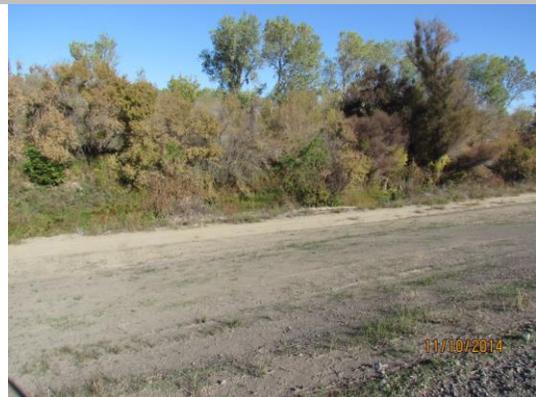
Photo 1 of 1 : SP_2015_ST0009_287_4_20150310_00004.jpg

LM Start	1.29	Rating **	M	Issue No.	4
LM End	1.29	Issue Type +	Ma	Location *	WS
Category	Earthen Levee		GPS Latitude/Longitude		
			Start	End	
Item	Erosion / Bank Caving		39.025478 °	39.025478 °	
			-121.797232 °	-121.797232 °	
DWR ID	DWR_ST0009_02_s_2013_4				
Action/Comments					
Schedule repair of erosion site prior to the next inspection. Inspector Comments: Sutter Yard needs to monitor the erosion.

View of the erosion along the waterside berm.

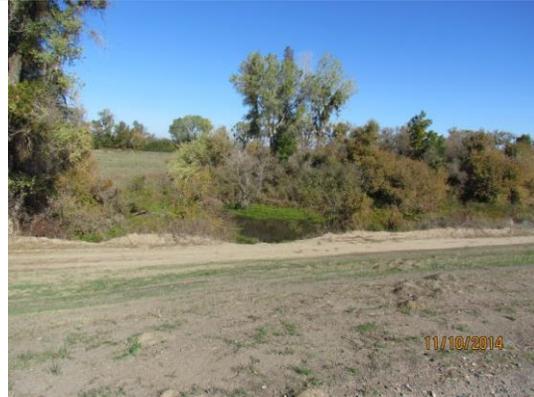
Photo 1 of 1 : SP_2015_ST0009_287_5_20150310_00005.jpg

LM Start	1.50	Rating **	M	Issue No.	5
LM End	1.50	Issue Type +	Ma	Location *	WS
Category	Earthen Levee		GPS Latitude/Longitude		
			Start	End	
Item	Erosion / Bank Caving		39.025446 °	39.025446 °	
			-121.793347 °	-121.793347 °	
DWR ID	DWR_ST0009_02_s_2013_5				
Action/Comments					
Schedule repair of erosion site prior to the next inspection. Inspector Comments: Sutter Yard needs to monitor the erosion.

View of the erosion along the waterside berm.
