**Flood Control Project Maintenance
Levee Inspections**

Fall 2015 Levee Maintenance Deficiency Summary Report

Sacramento River Basin

Sutter Maintenance Yard Wadsworth Canal

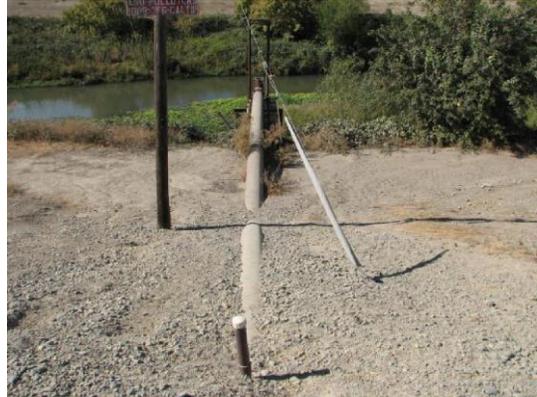
Photo 1 of 3 : UCIP_FA_2015_5177.jpg

LM Start	1.21	Rating **	M	Issue No.	109
LM End	1.21	Issue Type +	En	Location *	N/A
Category	Supplemental			GPS Latitude/Longitude	
				Start	End
Item	DWR UCIP Field Study			39.127566 °	39.127566 °
				-121.755282 °	-121.755282 °
DWR ID					
Action/Comments					
Inspector Comments: FS_ID:45174 DS_ID:17059 EP_NO: 1605 FS_HLM: 1.197 Repair Type: Non-Urgent Crossing Status: Found UCIP Comments: 5/12/2015 Abandoned crossing. Needs to be properly abandoned. No pump on Pier and power lines cut. Apparently abandoned-should be abandoned properly. 5/16/2013 Same as last inspection. 10/29/2013 Same as last inspection. 5/13/2014 Same as last inspection. 11/18/2014 Same as last inspection. FIELD_STRUCT_DESC: 18-inch steel irrigation pipe through the levee, 3.7 feet below the crown. Siphon breaker on the waterward slope. Pump on channel bank on steel structure. (App. 1605 - Schnable) Service pole at the waterward toe. Anchor in waterward slope. (App 1631-Schnable). FS Date: 05/14/2015

Pipe on WS slope with siphon breaker at WS shoulder.

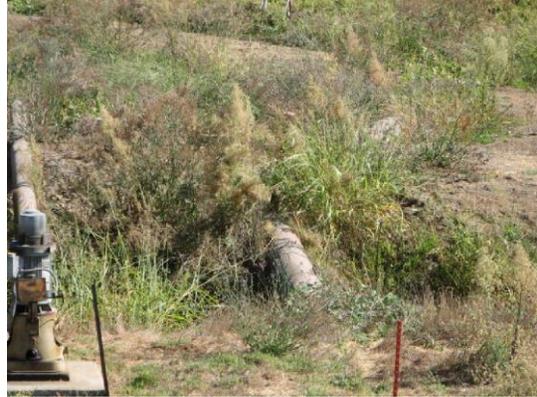
Photo 2 of 3 : UCIP_FA_2015_5178.jpg

LM Start	1.21	Rating **	M	Issue No.	109 (cont)
LM End	1.21	Issue Type +	En	Location *	N/A
Category	Supplemental			GPS Latitude/Longitude	
				Start	End
Item	DWR UCIP Field Study			39.127566 °	39.127566 °
				-121.755282 °	-121.755282 °
DWR ID					
Action/Comments					
Inspector Comments: FS_ID:45174 DS_ID:17059 EP_NO: 1605 FS_HLM: 1.197 Repair Type: Non-Urgent Crossing Status: Found UCIP Comments: 5/12/2015 Abandoned crossing. Needs to be properly abandoned.No pump on Pier and power lines cut. Apparently abandoned-should be abandoned properly.5/16/2013 Same as last inspection.10/29/2013 Same as last inspection.5/13/2014 Same as last inspection.11/18/2014 Same as last inspection. FIELD_STRUCT_DESC: 18-inch steel irrigation pipe through the levee, 3.7 feet below the crown. Siphon breaker on the waterward slope. Pump on channel bank on steel structure. (App. 1605 - Schnable) Service pole at the waterward toe. Anchor in waterward slope. (App 1631-Schnable). FS Date: 05/14/2015

Pipe on LS toe.

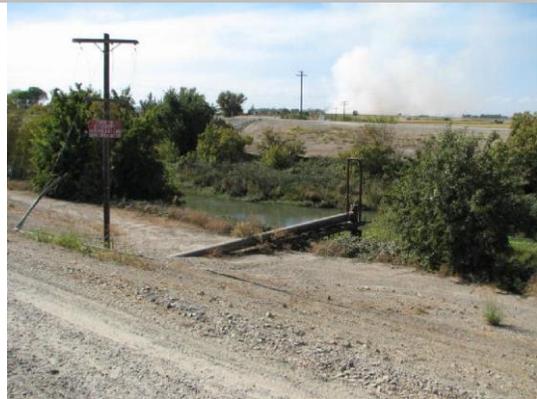
Photo 3 of 3 : UCIP_FA_2015_5179.jpg

Power pole with cut powerlines, pump missing from steel pier.

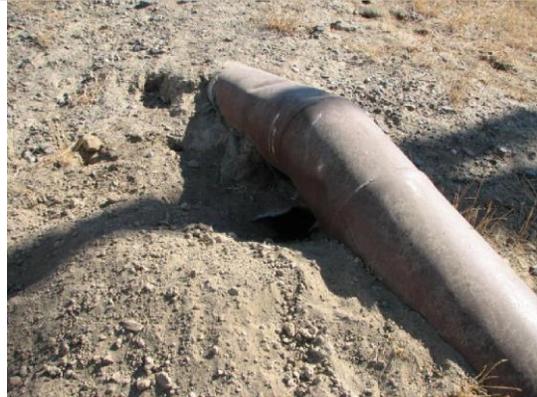
Photo 1 of 3 : UCIP_FA_2015_5199.jpg

LM Start	1.85	Rating **	M	Issue No.	110
LM End	1.85	Issue Type +	En	Location *	WS
Category	Supplemental			GPS Latitude/Longitude	
				Start	End
Item	DWR UCIP Field Study			39.135091 °	39.135091 °
				-121.748196 °	-121.748196 °
DWR ID					
Action/Comments					
Inspector Comments: FS_ID:45179 DS_ID:17063 EP_NO: N/A FS_HLM: 1.85 Repair Type: Non-Urgent Crossing Status: Found UCIP Comments: 5/12/2015 Abandoned crossing. Cap was made and installed on WS open end of pipe. Pipe abandoned. Pipe open and not plugged. Pipe should be removed or abandoned properly. Extensive animal burrowing occurring along pipe alignment. 5/16/2013 Same as last inspection. Steve Beckley is looking into finding pipe owner to properly abandon pipe. 10/29/2013 Same as last inspection. 5/13/2014 Cap was made and bolted on to WS open end of pipe. 11/18/2014 Same as last inspection. FIELD_STRUCT_DESC: 14-inch steel irrigation pipe through the levee, 5.7 feet below the crown. Siphon breaker on landward side. Vertical pump on waterward side. Meter pole on berm. Originally in O+M manual, asbuilt available (Permit No. 572, 1932). FS Date: 05/14/2015

Extensive burrowing along pipe alignment on WS slope.

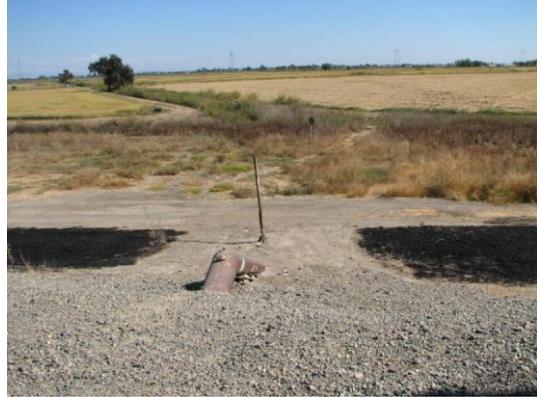
Photo 2 of 3 : UCIP_FA_2015_5200.jpg

Pipe with siphon breaker plugged on LS shoulder.

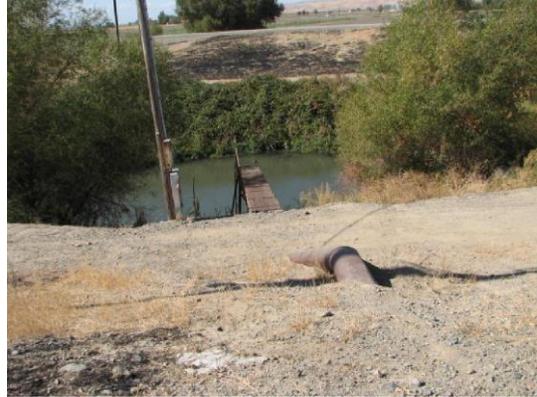
Photo 3 of 3 : UCIP_FA_2015_5201.jpg

Pump missing from steel pier on WS toe.

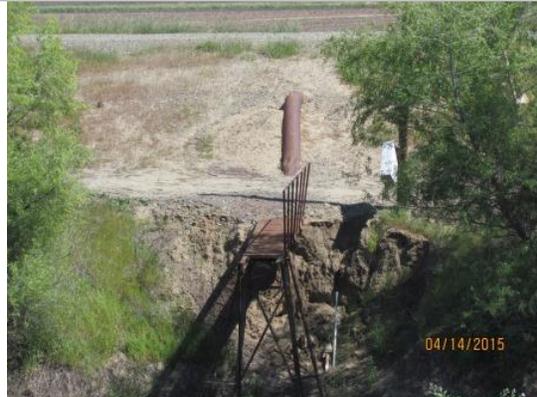
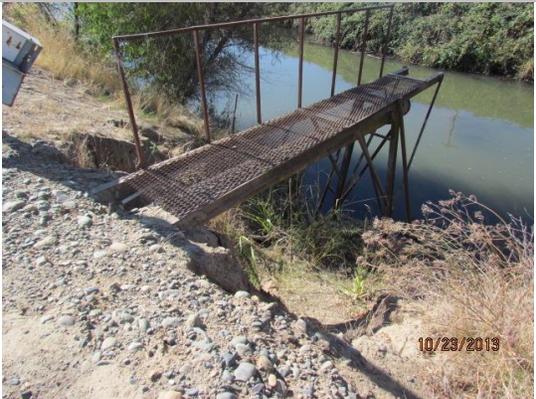
LM Start	1.85	Rating **	U	Issue No.	107
LM End	1.85	Issue Type +	Ma	Location *	WS
Category	Earthen Levee			GPS Latitude/Longitude	
				Start	End
Item	Erosion / Bank Caving			39.135110 °	39.135110 °
				-121.748230 °	-121.748230 °
DWR ID	DWR_ST0010_01_f_2013_107				
Action/Comments					
Schedule repair of erosion site prior to the next inspection. Inspector Comments: Repair the erosion under the abandoned pump.

View of the erosion along both sides of the abandoned pump.

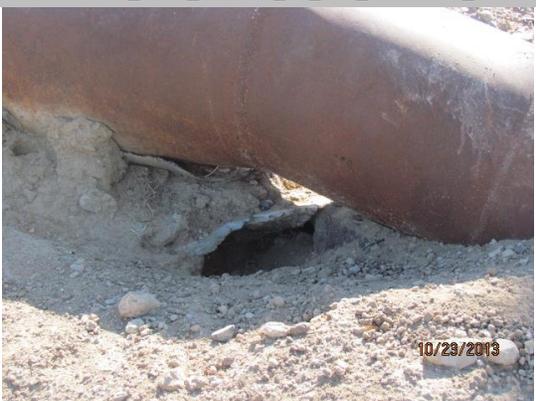
Photo 1 of 1 : FA_2015_ST0010_42_106_20150910_00007.jpg

LM Start	1.85	Rating **	M	Issue No.	106
LM End	1.85	Issue Type +	Ma	Location *	WS
Category	Earthen Levee			GPS Latitude/Longitude	
				Start	End
Item	Animal Control			39.135110 °	39.135110 °
				-121.748229 °	-121.748229 °
DWR ID	DWR_ST0010_01_f_2013_106				
Action/Comments					
No rodents visible, but rodent burrows visible; need to backfill and compact or grout burrows.

View of the rodent holes under the irrigation pipe.

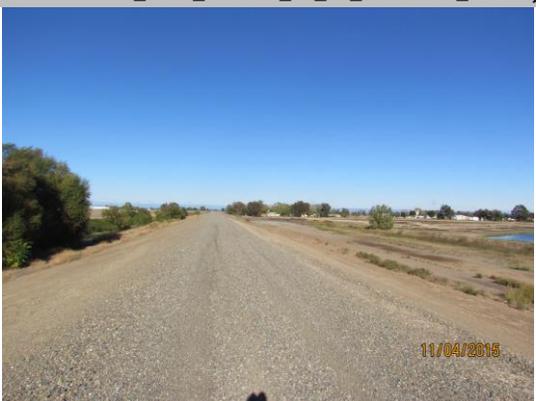
Photo 1 of 1 : FA_2015_ST0010_42_20_20151109_00010.jpg

LM Start	2.14	Rating **	A	Issue No.	20
LM End	2.14	Issue Type +	Ma	Location *	LS
Category	Earthen Levee			GPS Latitude/Longitude	
				Start	End
Item	Vegetation			39.138568 °	39.138568 °
				-121.745360 °	-121.745360 °
DWR ID	DWR_ST0010_01_f_2015_20				
Action/Comments					
Control annual grass and weeds on the levee slopes and easements. Inspector Comments: Sutter Yard burned and dragged both slopes.

View of no vegetation on both slopes.

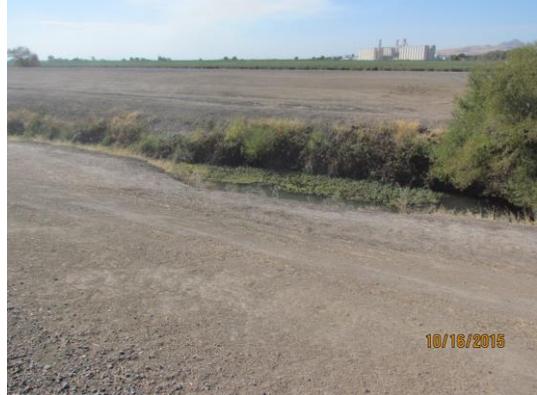
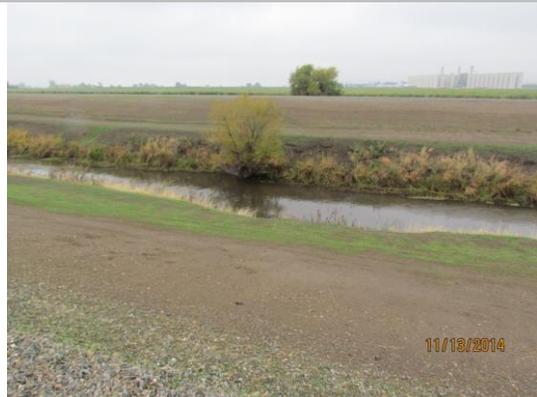
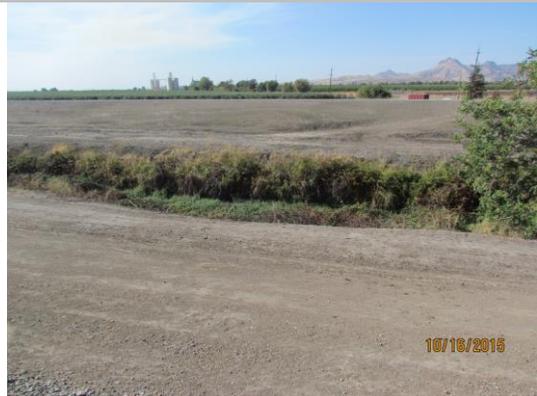
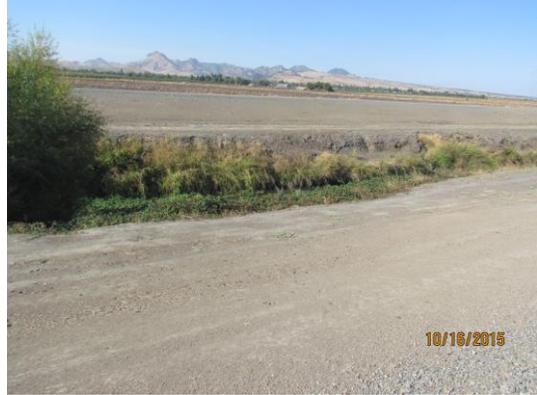
View of the erosion along the waterside toe.

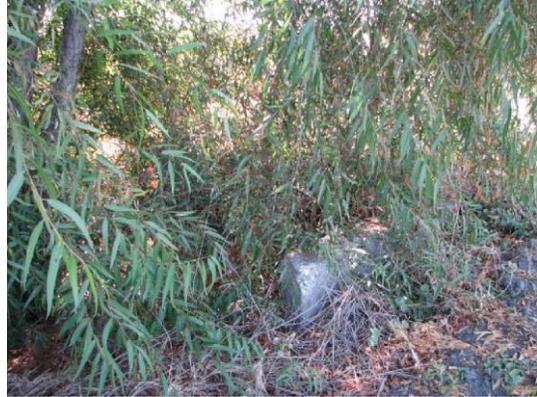
Photo 1 of 3 : UCIP_FA_2015_5202.jpg

Inspector Comments: FS_ID:45183
 DS_ID:17066
 EP_NO: N/A
 FS_HLM: 3.522
 Repair Type: Non-Urgent
 Crossing Status: Found
 UCIP Comments: 5/12/2015 Concrete headwall on LS is completely silted in. LS pipe end is located near the edge of rice field. No issues seen on WS.5/16/2013 Same as last inspection.10/29/2013 Concrete headwall is silted in and appears to be abandoned. Discharge end of pipe is approx. 100ft. from LS toe on the edge of the rice field.5/13/2014 Same as last inspection.11/18/2014 Same as last inspection.
 FIELD_STRUCT_DESC: 24-inch steel irrigation pipe through the levee, 11.0 feet below the crown. Vertical pump mounted on a steel structure in channel. Service pole on the berm with 18-inch standpipe on WS toe. Concrete U shaped headwall on LS toe. Originally shown in O+M manual, asbuilt available
 FS Date: 05/14/2015

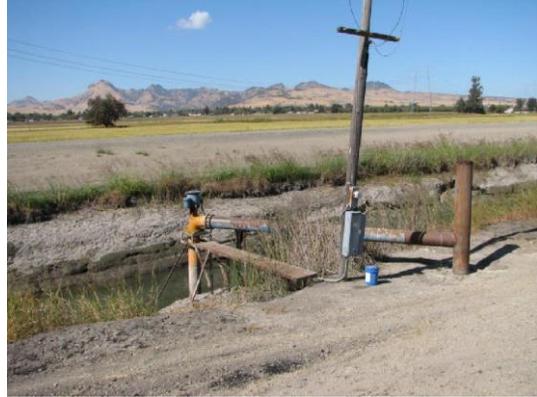
Photo 2 of 3 : UCIP_FA_2015_5203.jpg

Pump, Pipe, walkway, power pole, and standpipe on WS toe.

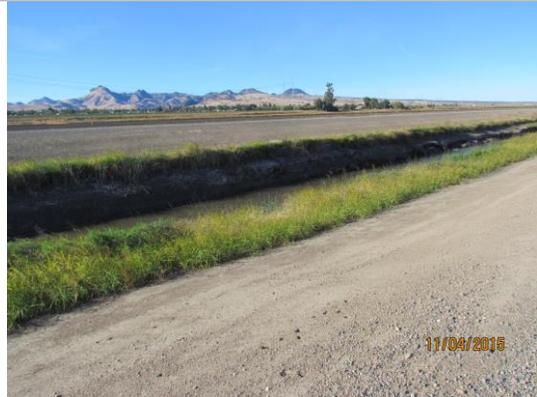
Photo 1 of 1 : FA_2015_ST0010_42_3_20151109_00011.jpg

LM Start	3.53	Rating **	M	Issue No.	3
LM End	3.56	Issue Type +	Ma	Location *	WS
Category	Earthen Levee			GPS Latitude/Longitude	
			Start	End	
Item	Erosion / Bank Caving			39.156225 °	39.156639 °
				-121.732930 °	-121.732755 °
DWR ID	DWR_ST0010_01_s_2012_3				
Action/Comments					
Note and monitor erosion site. Inspector Comments: Monitor the erosion along the waterside toe.

View of the erosion along the waterside toe.

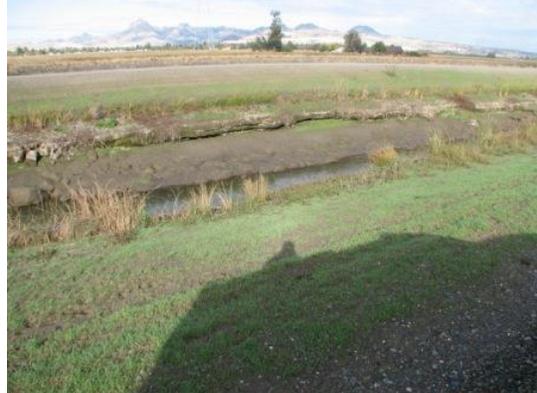
Photo 1 of 2 : FA_2015_ST0010_42_4_20150910_00003.jpg

View of the erosion along the waterside toe of the levee.

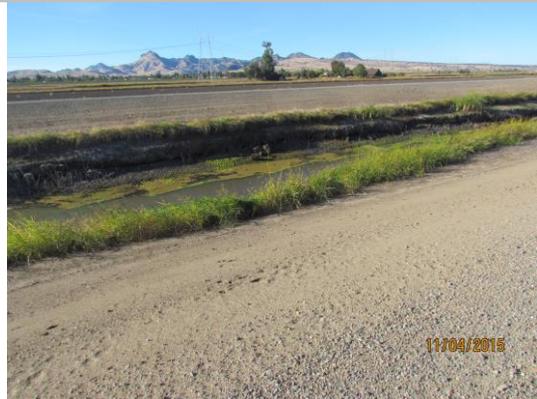
Photo 2 of 2 : FA_2015_ST0010_42_4_20151109_00012.jpg

View of the erosion along the waterside toe.

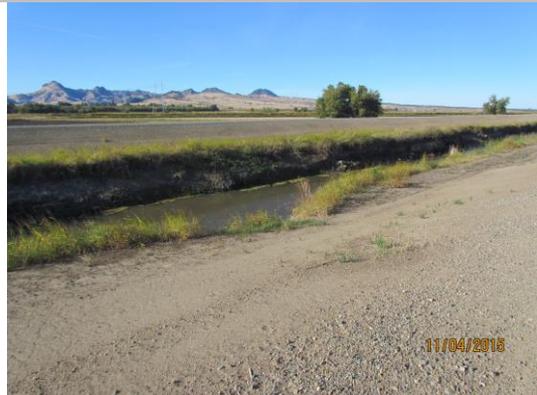
Photo 1 of 1 : FA_2015_ST0010_42_17_20151109_00013.jpg

LM Start	3.84	Rating **	M	Issue No.	17
LM End	3.84	Issue Type +	Ma	Location *	WS
Category	Earthen Levee		GPS Latitude/Longitude		
			Start	End	
Item	Erosion / Bank Caving		39.160442 °	39.160442 °	
			-121.731067 °	-121.731067 °	
DWR ID	DWR_ST0010_01_f_2014_17				
Action/Comments					
Note and monitor erosion site. Inspector Comments: Monitor the erosion along the waterside toe.

View of the erosion along the waterside toe.

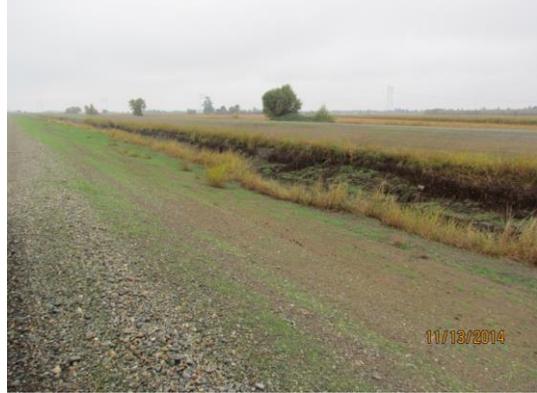
Photo 1 of 2 : FA_2015_ST0010_42_5_20150910_00004.jpg

View of the erosion along the waterside toe.

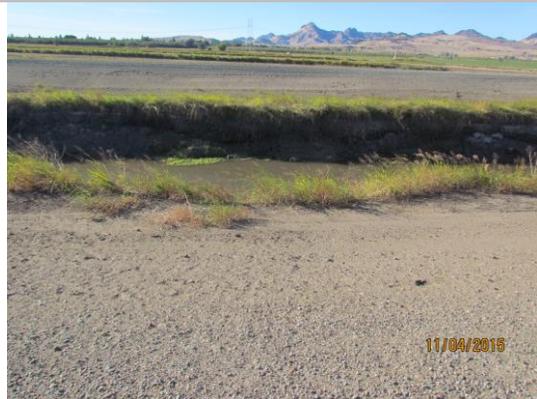
Photo 2 of 2 : FA_2015_ST0010_42_5_20151109_00014.jpg

View of the erosion along the waterside toe.

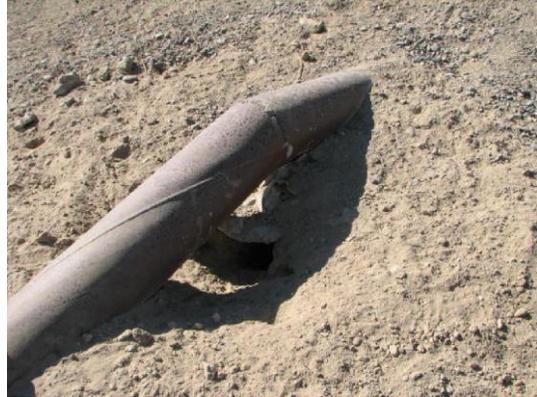
Photo 1 of 3 : UCIP_FA_2015_4731.jpg

LM Start	1.16	Rating **	M	Issue No.	24
LM End	1.16	Issue Type +	En	Location *	WS
Category	Supplemental			GPS Latitude/Longitude	
				Start	End
Item	DWR UCIP Field Study			39.127487 °	39.127487 °
				-121.756485 °	-121.756485 °
DWR ID					
Action/Comments					
Inspector Comments: FS_ID:45187 DS_ID:17069 EP_NO: N/A FS_HLM: 1.154 Repair Type: Non-Urgent Crossing Status: Found UCIP Comments: 5/12/2015 Abandoned crossing. Signs of rodent activity on both sides of levee.Pipe appears improperly abandoned. No motor present, electrical equipment is stripped. Heavy rodent activity along pipe WS and LS. Pipe needs to be removed or properly abandoned.5/16/2013 Same as last inspection.10/29/2013 Same as last inspection.5/13/2014 Same as last inspection.11/18/2014 Same as last inspection. FIELD_STRUCT_DESC: 10-inch steel irrigation pipe through the levee, 4.8-feet below the crown. Pump mounted on concrete pad near canal bank. Service pole on berm. 30-inch diameter concrete standpipe at landward toe. Originally in O+M manual, asbuilt available. (Permit No. 945, 1944). FS Date: 05/14/2015

Heavy rodent activity along pipe, both sides.

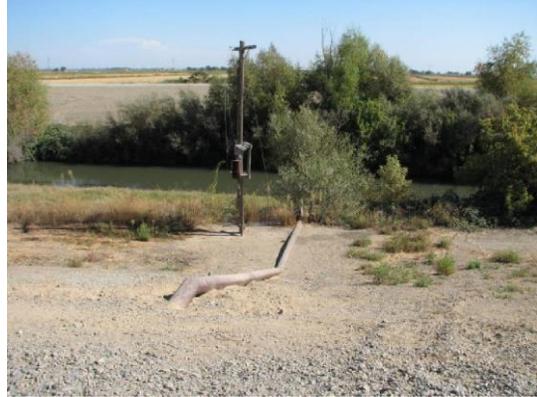
Photo 2 of 3 : UCIP_FA_2015_4732.jpg

Action/Comments
 Inspector Comments: FS_ID:45187
 DS_ID:17069
 EP_NO: N/A
 FS_HLM: 1.154
 Repair Type: Non-Urgent
 Crossing Status: Found
 UCIP Comments: 5/12/2015 Abandoned crossing. Signs of rodent activity on both sides of levee. Pipe appears improperly abandoned. No motor present, electrical equipment is stripped. Heavy rodent activity along pipe WS and LS. Pipe needs to be removed or properly abandoned. 5/16/2013 Same as last inspection. 10/29/2013 Same as last inspection. 5/13/2014 Same as last inspection. 11/18/2014 Same as last inspection.
 FIELD_STRUCT_DESC: 10-inch steel irrigation pipe through the levee, 4.8-feet below the crown. Pump mounted on concrete pad near canal bank. Service pole on berm. 30-inch diameter concrete standpipe at landward toe. Originally in O+M manual, asbuilt available. (Permit No. 945, 1944).
 FS Date: 05/14/2015

Pipe and pump facilities on WS slope.

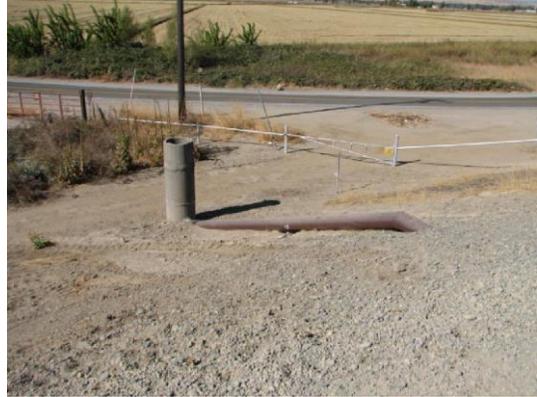
Photo 3 of 3 : UCIP_FA_2015_4733.jpg

Pipe and Standpipe on LS toe.

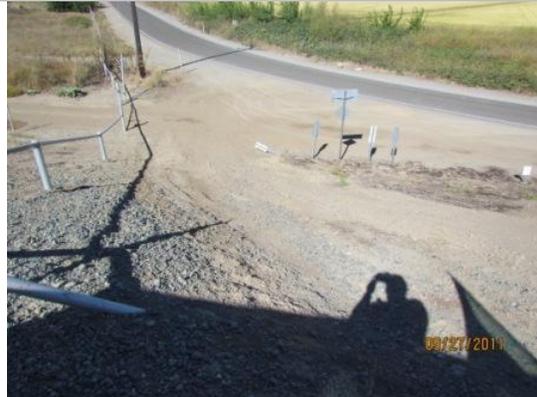
Photo 1 of 1 : FA_2015_ST0010_43_3_20150910_00001.jpg

LM Start	1.17	Rating **	M	Issue No.	3
LM End	1.17	Issue Type +	Ma	Location *	LS
Category	Earthen Levee			GPS Latitude/Longitude	
				Start	End
Item	Slope Stability			39.127648 °	39.127648 °
				-121.756345 °	-121.756345 °
DWR ID	DWR_ST0010_02_s_2012_3				
Action/Comments					
Repair the levee slope damaged by vehicle traffic and prevent access where possible.

View of vehicle erosion along L/S slope.

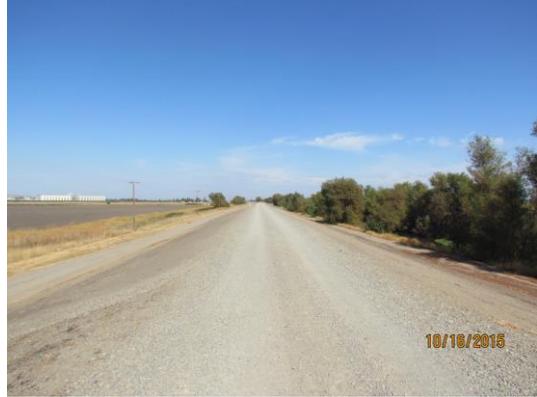
Photo 1 of 1 : FA_2015_ST0010_43_20_20151109_00012.jpg

LM Start	1.38	Rating **	A	Issue No.	20
LM End	1.38	Issue Type +	Ma	Location *	LS
Category	Earthen Levee		GPS Latitude/Longitude		
			Start	End	
Item	Vegetation		39.130125 °	39.130125 °	
			-121.753912 °	-121.753912 °	
DWR ID	DWR_ST0010_02_f_2015_20				
Action/Comments					
Control annual grass and weeds on the levee slopes and easements. Inspector Comments: Sutter Yard burned and dragged both slopes.

View of no vegetation on both slopes.

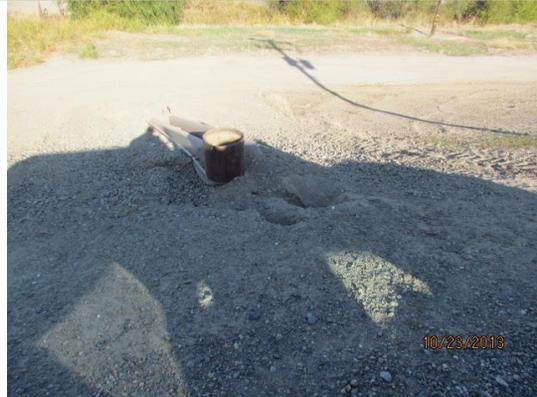
Photo 1 of 2 : FA_2015_ST0010_43_11_20150910_00006.jpg

LM Start	1.76	Rating **	A/W	Issue No.	11
LM End	1.76	Issue Type +	Ma	Location *	LS
Category	Earthen Levee		GPS Latitude/Longitude		
			Start	End	
Item	Animal Control		39.134490 °	39.134490 °	
			-121.749716 °	-121.749716 °	
DWR ID	DWR_ST0010_02_f_2012_11				
Action/Comments					
No rodents visible, but rodent burrows visible; need to backfill and compact or grout burrows. Inspector Comments: Repair the rodent hole.

View of the rodent holes above the irrigation pipe.

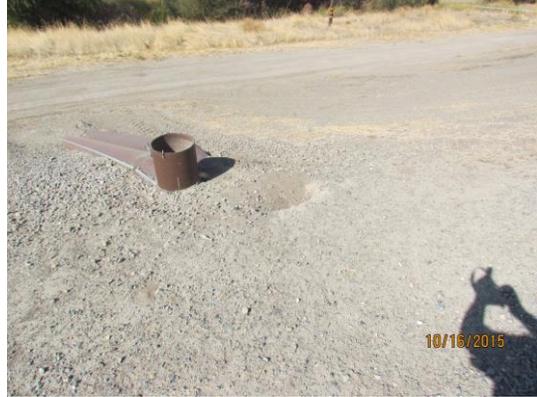
Photo 2 of 2 : FA_2015_ST0010_43_11_20151109_00013.jpg

View of the rodent hole above the irrigation pipe.

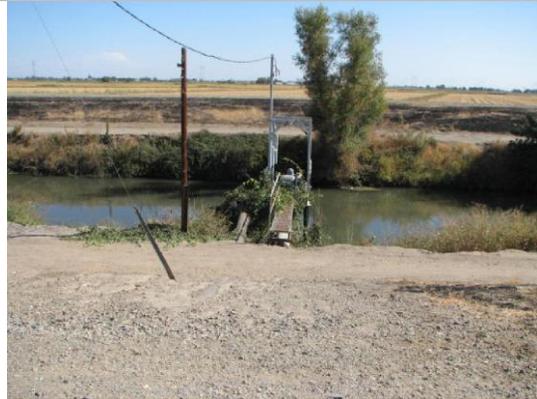
Photo 1 of 3 : UCIP_FA_2015_4875.jpg

LM Start	1.76	Rating **	M	Issue No.	25
LM End	1.76	Issue Type +	En	Location *	LS
Category	Supplemental			GPS Latitude/Longitude	
				Start	End
Item	DWR UCIP Field Study			39.134497 °	39.134497 °
				-121.749716 °	-121.749716 °
DWR ID					
Action/Comments					
Inspector Comments: FS_ID:45192 DS_ID:17074 EP_NO: 1096 FS_HLM: 1.769 Repair Type: Non-Urgent Crossing Status: Found UCIP Comments: 5/12/2015 Rodent activity near pipe on LS.Heavy rodent activity on LS slope along pipe alignment.5/16/2013 Same as last inspection.10/29/2013 Same as last inspection.5/13/2014 Air vent on LS shoulder leaks and is causing minor erosion to the LS slope.11/18/2014 Levee inspection is aware of problem and repairs seem to have been made. Slope has also been rocked to prevent erosion. FIELD_STRUCT_DESC: 16-inch steel irrigation pipe through the levee, 4.4-feet below the crown. Pump mounted on a steel structure on the bank. Siphon breaker on the landward slope. unable to locate 48-inch concrete standpipe on the landward berm that was listed in permit. (Permit No. 1096 - Brown and PN: 1479). Asbuilt available. FS Date: 05/14/2015

Pump platform and power pole on WS berm.

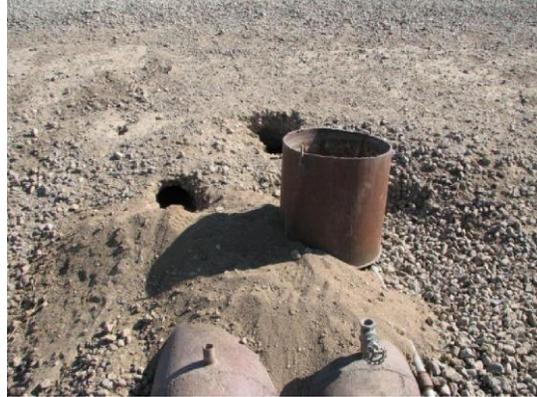
Photo 2 of 3 : UCIP_FA_2015_4876.jpg

Pipe on LS with rodent activity shown.

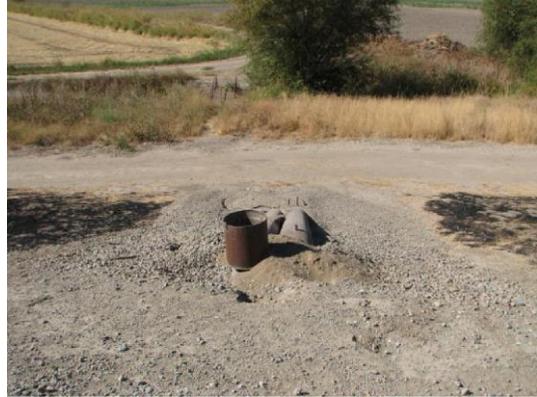
Photo 3 of 3 : UCIP_FA_2015_4877.jpg

Pipe on LS with rodent activity shown.

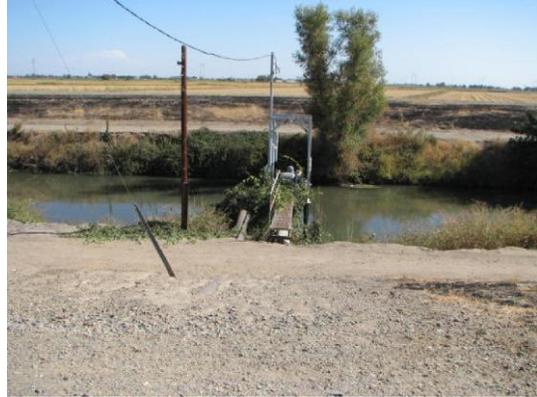
Photo 1 of 3 : UCIP_FA_2015_4734.jpg

Pipe on left without pump.

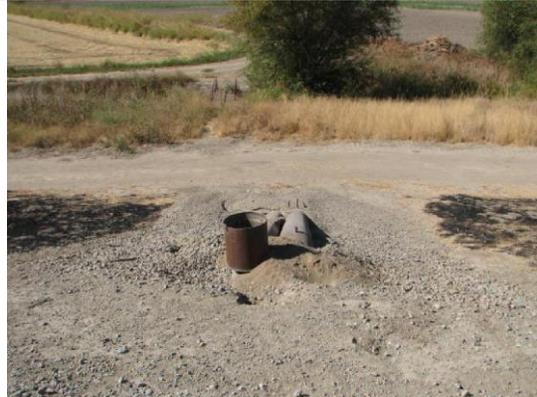
Photo 3 of 3 : UCIP_FA_2015_4736.jpg

Pipe on LS showing rodent activity.

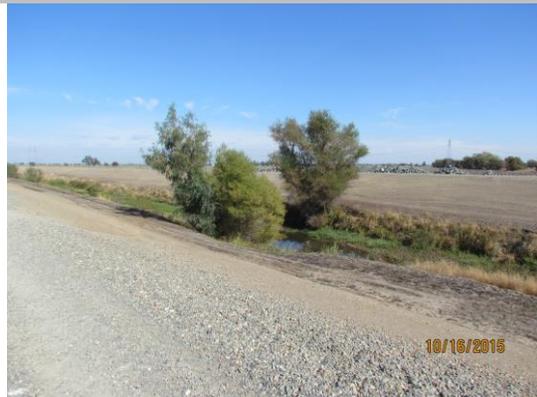
Photo 1 of 2 : FA_2015_ST0010_43_8_20151210_00016.jpg

View of the erosion along the landside toe.

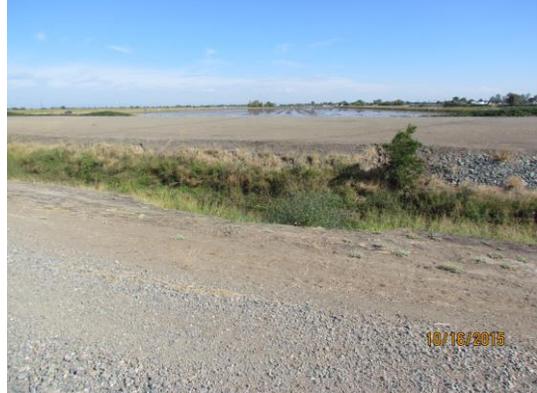
Photo 2 of 2 : FA_2015_ST0010_43_8_20151210_00017.jpg

View of erosion along the waterside toe.

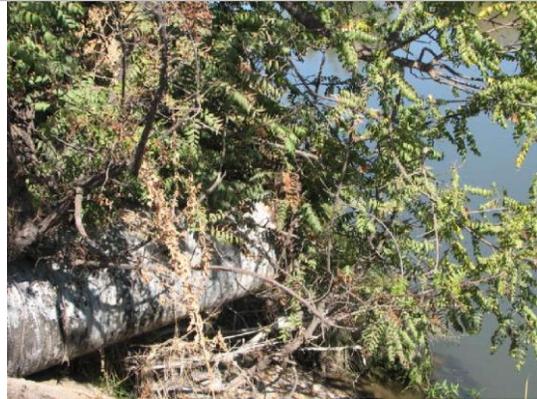
Photo 1 of 3 : UCIP_FA_2015_4737.jpg

Pipe and flap gate at WS outlet.

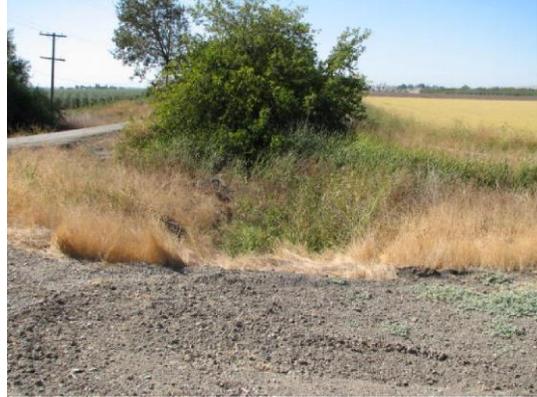
Photo 2 of 3 : UCIP_FA_2015_4738.jpg

Heavy vegetation at LS inlet at channel.

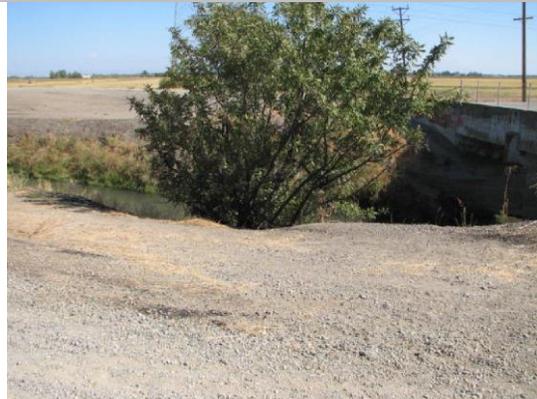
Photo 3 of 3 : UCIP_FA_2015_4739.jpg

Bush camouflaging outlet of pipe on WS slope.

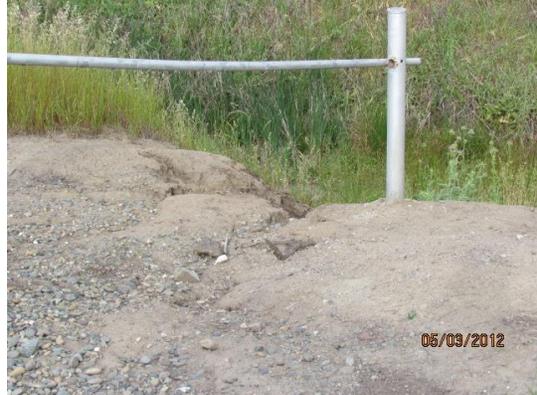
Photo 1 of 1 : FA_2015_ST0010_43_14_20150910_00007.jpg

View of the erosion along the W/S toe.

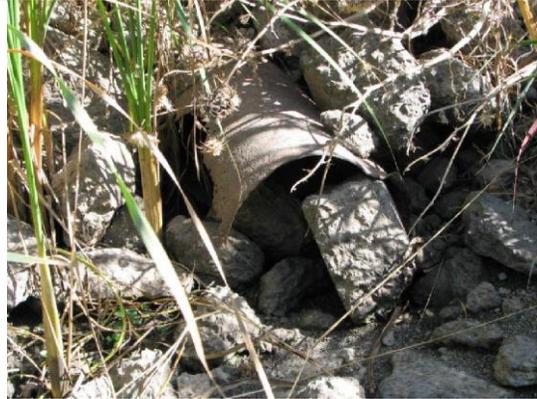
Photo 1 of 2 : UCIP_FA_2015_4759.jpg

Rusted outlet at LS channel. Unclear if this is same pipe as one under investigation.

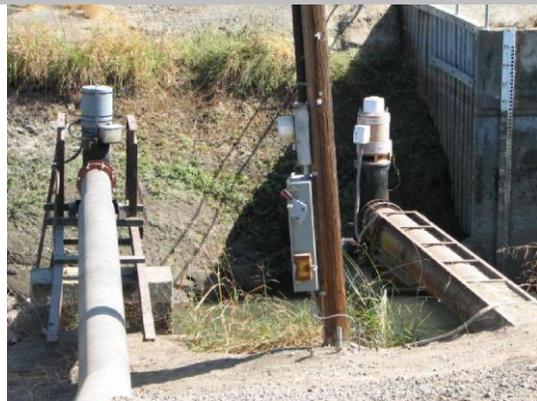
Photo 2 of 2 : UCIP_FA_2015_4760.jpg

Pump on steel pier at WS toe.

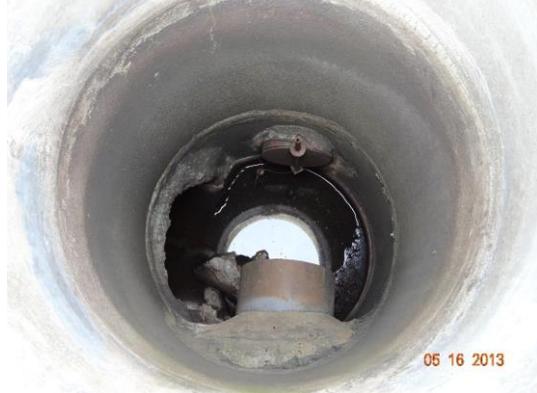
Photo 1 of 3 : UCIP_FA_2015_4761.jpg

Inside of 36in. concrete riser

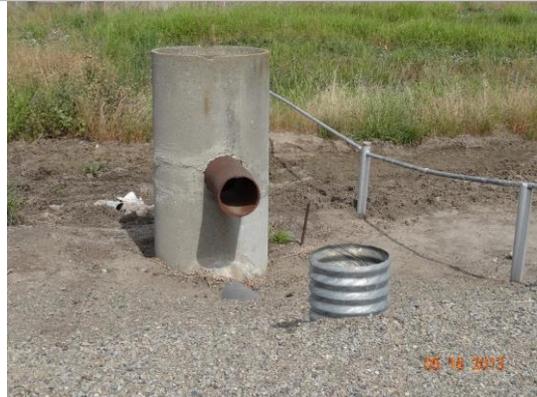
Photo 2 of 3 : UCIP_FA_2015_4762.jpg

36in. concrete standpipe and 12in. cm riser on LS.

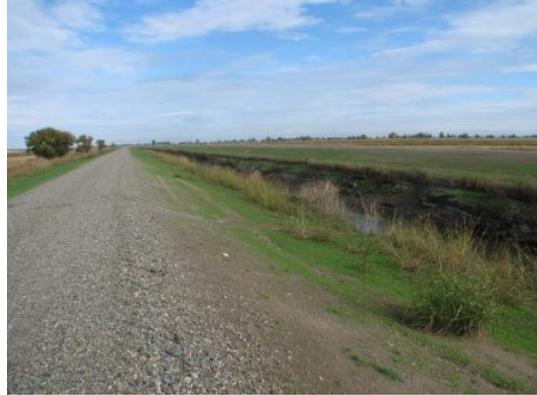
Photo 1 of 2 : FA_2015_ST0010_43_5_20150910_00003.jpg

View of the erosion along the waterside toe.

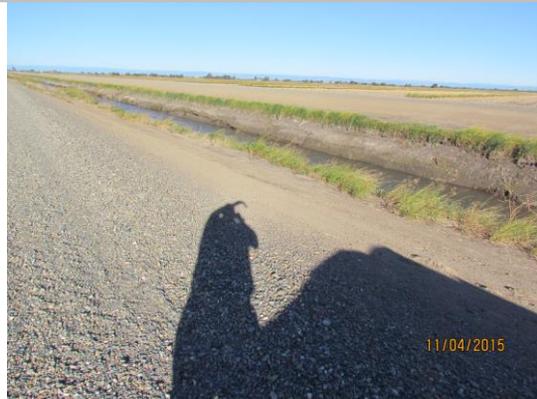
Photo 2 of 2 : FA_2015_ST0010_43_5_20151109_00009.jpg

View of erosion at the waterside toe

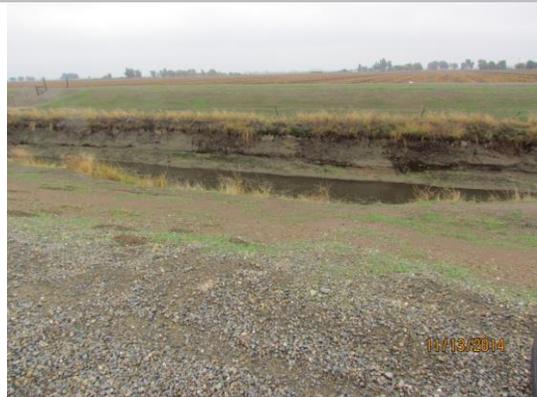
Photo 1 of 2 : FA_2015_ST0010_43_9_20151210_00018.jpg

View of the erosion along the waterside toe.

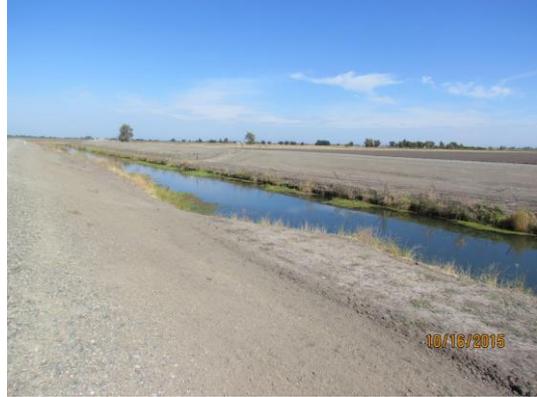
Photo 2 of 2 : FA_2015_ST0010_43_9_20151210_00019.jpg

View of the erosion along the waterside toe.

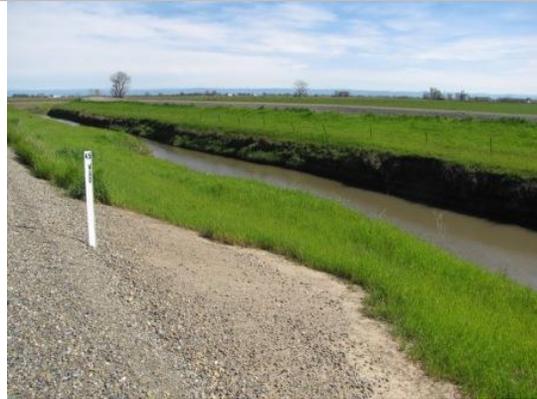
Photo 1 of 2 : FA_2015_ST0010_43_7_20150910_00005.jpg

View of the erosion along the W/S toe.

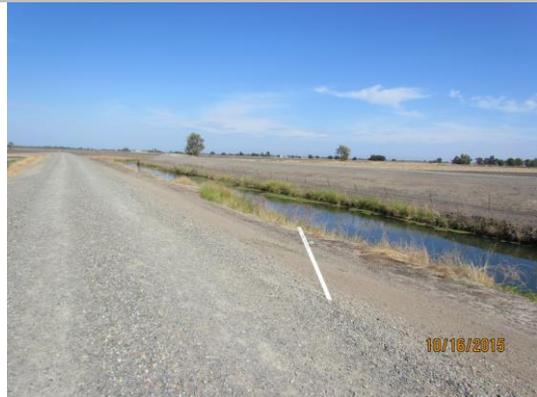
Photo 2 of 2 : FA_2015_ST0010_43_7_20151109_00011.jpg

View of the erosion along the waterside toe.
