**Flood Control Project Maintenance
Levee Inspections**
LMA District Cover Sheet
Spring 2010 Levee Inspection Results

Sutter Maintenance Yard Wadsworth Canal

Spring 2010 Levee Inspection Results

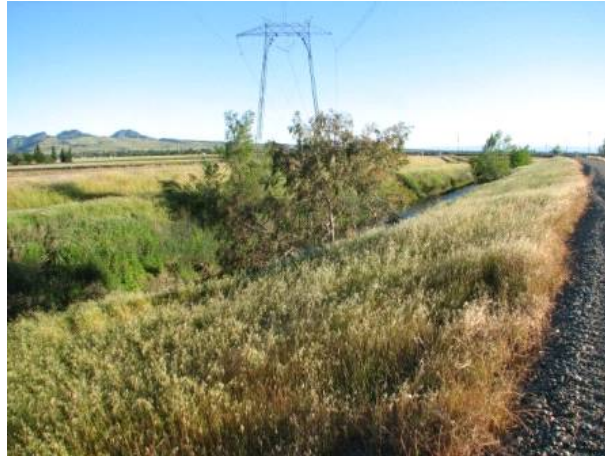
rduffey_s_20100607_019.jpg

Levee Mile Report Line	1
Start Levee Mile	3.18
End Levee Mile	3.25
Location	Water Side
Category	Earthen Levee
Item	Erosion / Bank Caving

View of the erosion at the waterside toe of the levee

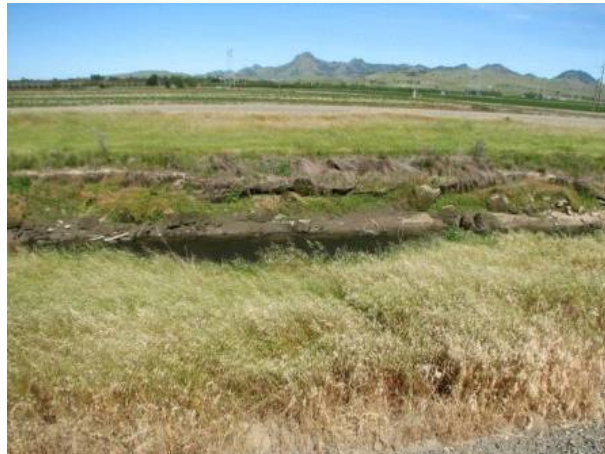
rduffey_s_20100607_020.jpg

Levee Mile Report Line	2
Start Levee Mile	3.56
End Levee Mile	3.59
Location	Water Side
Category	Earthen Levee
Item	Erosion / Bank Caving

View of the erosion along the waterside toe of the levee.

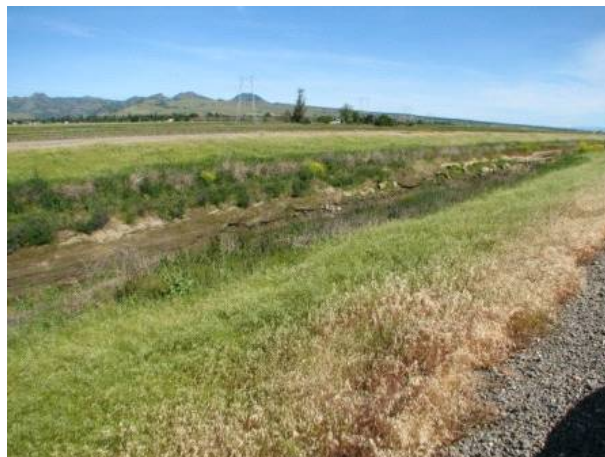
rduffey_s_20100607_021.jpg

Levee Mile Report Line	3
Start Levee Mile	3.68
End Levee Mile	3.68
Location	Water Side
Category	Earthen Levee
Item	Erosion / Bank Caving

View of the erosion along the waterside toe of the levee.

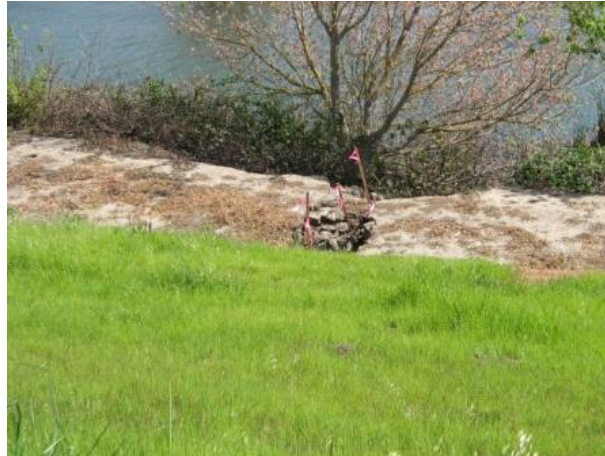
rduffey_s_20100607_016.jpg

Levee Mile Report Line	1
Start Levee Mile	0.82
End Levee Mile	0.82
Location	Water Side
Category	Earthen Levee
Item	Erosion / Bank Caving

View of the erosion along the waterside toe of the levee.

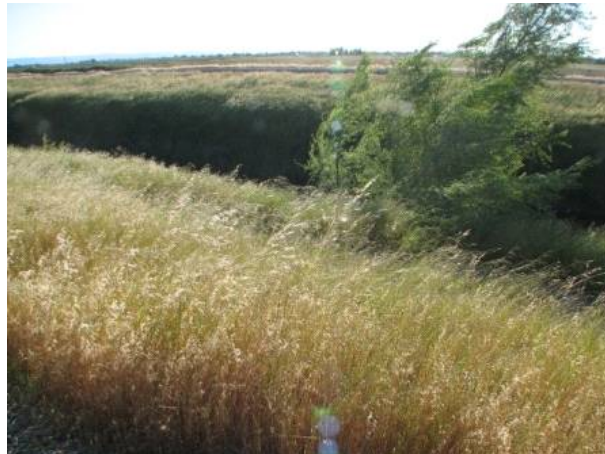
rduffey_s_20100607_017.jpg

Levee Mile Report Line	2
Start Levee Mile	3.21
End Levee Mile	3.21
Location	Water Side
Category	Earthen Levee
Item	Erosion / Bank Caving

View of the erosion at the waterside toe of the levee.

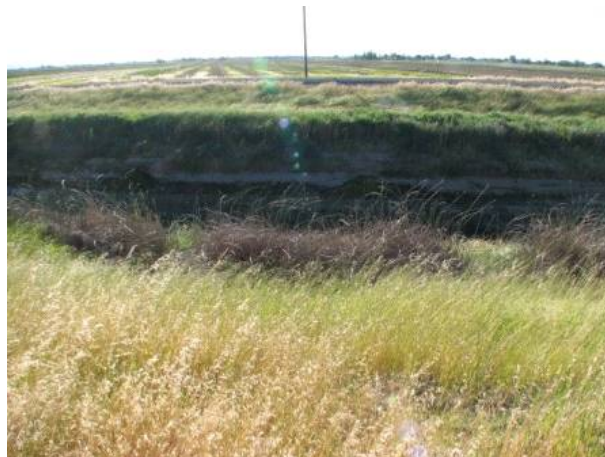
rduffey_s_20100607_018.jpg

Levee Mile Report Line	3
Start Levee Mile	3.46
End Levee Mile	3.46
Location	Water Side
Category	Earthen Levee
Item	Erosion / Bank Caving

View of the erosion at the waterside toe of the levee.
