**Flood Control Project Maintenance
Levee Inspections**
LMA District Cover Sheet
Spring 2011 Levee Inspection Results

Sutter Maintenance Yard Wadsworth Canal

Spring 2011 Levee Inspection Results

Levee Inspection Report By Mile - Spring 2011

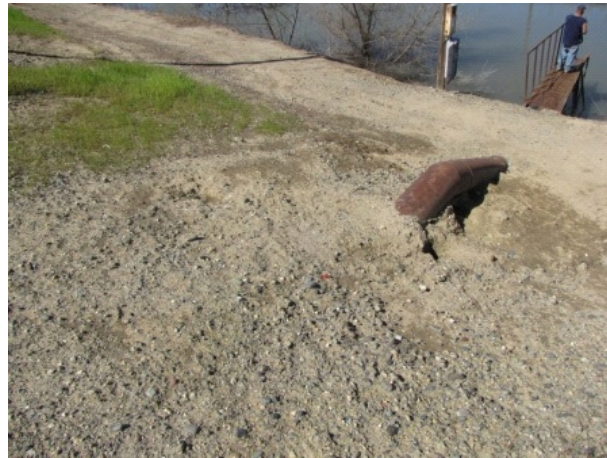
rduffey_s_20110427_316.jpg

Levee Mile Report Line	1
Start Levee Mile	1.85
End Levee Mile	1.85
Location	Water Side
Category	Earthen Levee
Item	Animal Control

View of rodents burrows along the slope & next to a pipe.

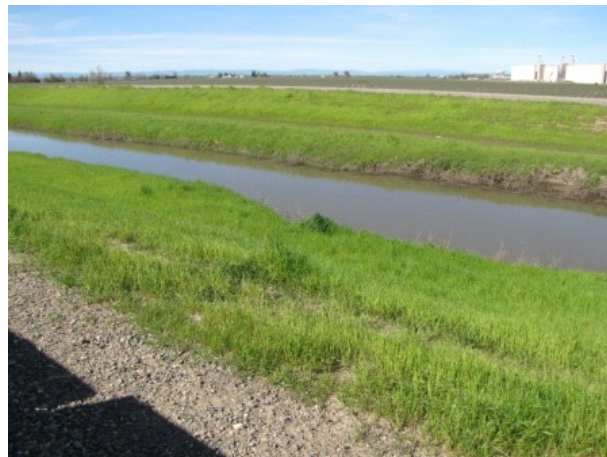
rduffey_s_20110427_317.jpg

Levee Mile Report Line	2
Start Levee Mile	2.76
End Levee Mile	2.76
Location	Water Side
Category	Earthen Levee
Item	Erosion / Bank Caving

View of erosion along W/S toe.

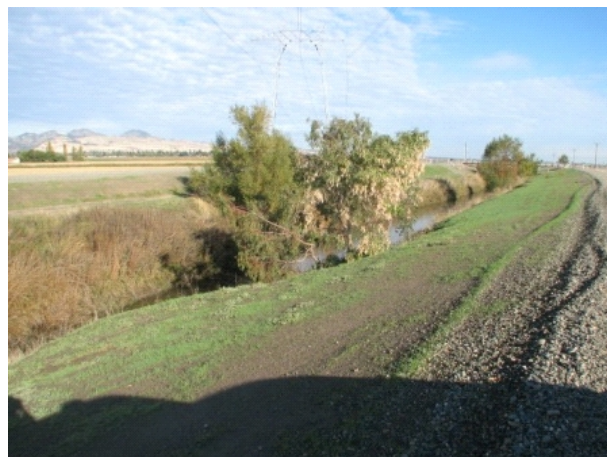
rduffey_s_20110228_223.jpg

Levee Mile Report Line	3
Start Levee Mile	3.18
End Levee Mile	3.25
Location	Water Side
Category	Earthen Levee
Item	Erosion / Bank Caving

View of the erosion at the waterside toe of the levee.

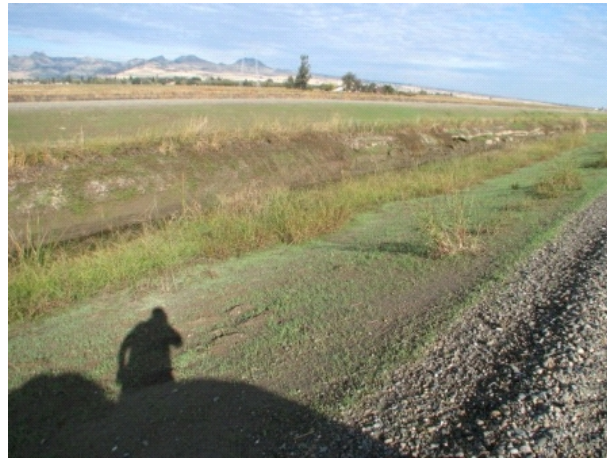
rduffey_s_20110228_224.jpg

Levee Mile Report Line	4
Start Levee Mile	3.56
End Levee Mile	3.59
Location	Water Side
Category	Earthen Levee
Item	Erosion / Bank Caving

View of the erosion along the waterside toe of the levee.

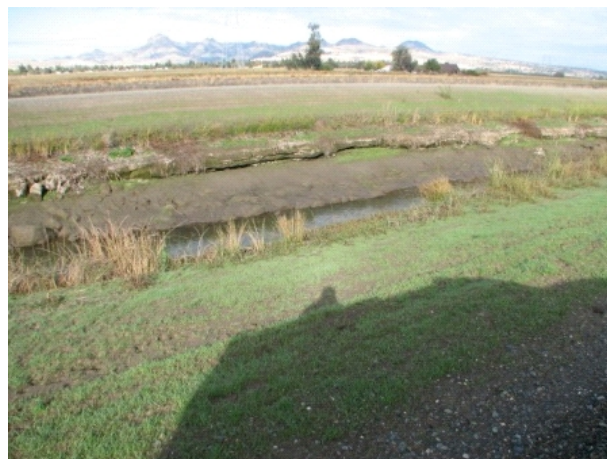
rduffey_s_20110228_225.jpg

Levee Mile Report Line	5
Start Levee Mile	3.68
End Levee Mile	3.68
Location	Water Side
Category	Earthen Levee
Item	Erosion / Bank Caving

View of the erosion along the waterside toe of the levee.

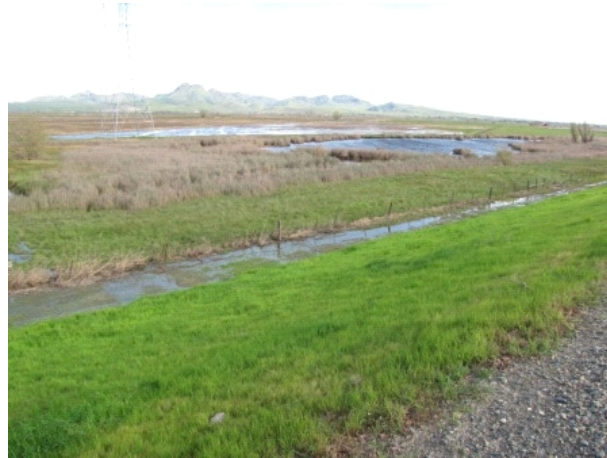
rduffey_s_20110427_313.jpg

Levee Mile Report Line	1
Start Levee Mile	0.02
End Levee Mile	0.18
Location	Land Side
Category	Earthen Levee
Item	Seepage / Sandboils

View of seepage along the toe.

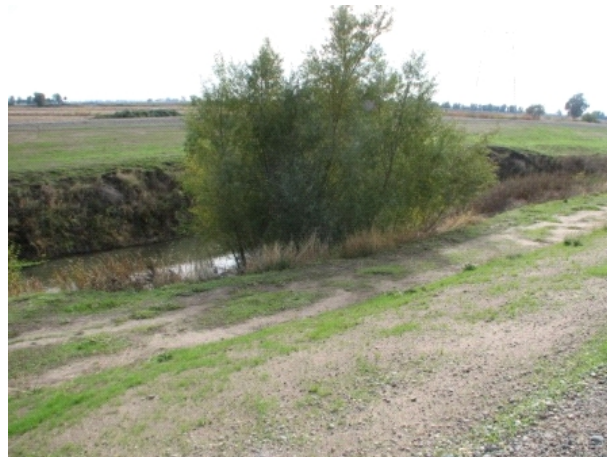
rduffey_s_20110228_226.jpg

Levee Mile Report Line	5
Start Levee Mile	3.21
End Levee Mile	3.21
Location	Water Side
Category	Earthen Levee
Item	Erosion / Bank Caving

View of the erosion at the waterside toe of the levee.

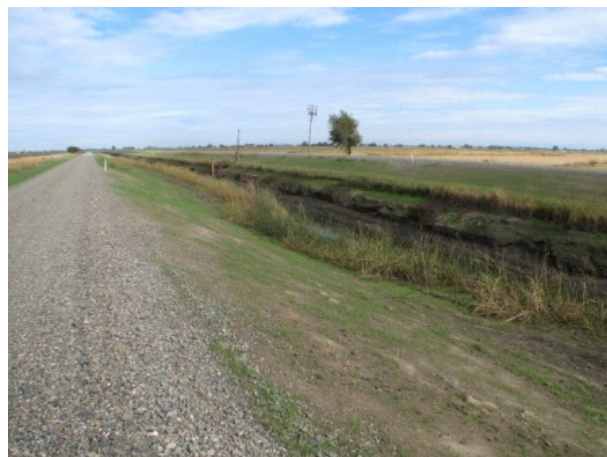
rduffey_s_20110228_228.jpg

Levee Mile Report Line	6
Start Levee Mile	3.46
End Levee Mile	3.46
Location	Water Side
Category	Earthen Levee
Item	Erosion / Bank Caving

View of the erosion at the waterside toe of the levee.

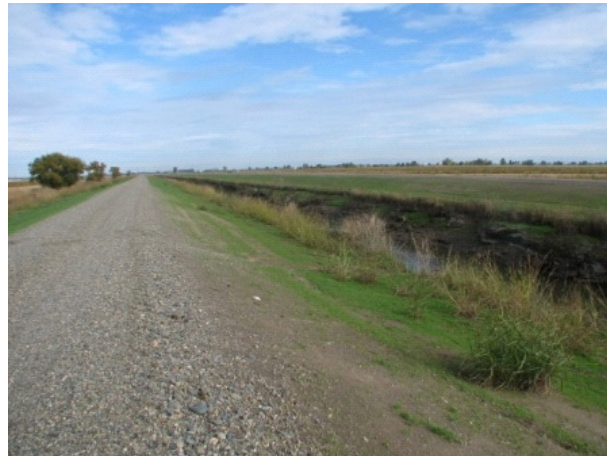
Levee Mile Report Line	7
Start Levee Mile	3.59
End Levee Mile	3.99
Location	Water Side
Category	Earthen Levee
Item	Erosion / Bank Caving
View of the erosion along the waterside toe.	
rduffey_s_20110228_229.jpg

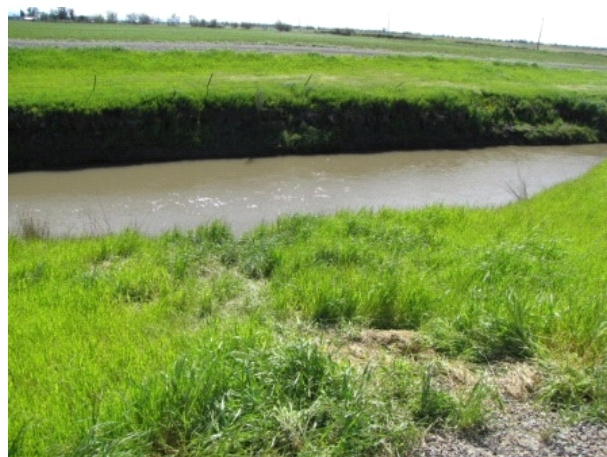
Levee Mile Report Line	8
Start Levee Mile	4.49
End Levee Mile	4.49
Location	Water Side
Category	Earthen Levee
Item	Erosion / Bank Caving
View of erosion along the W/S toe.	
rduffey_s_20110427_314.jpg

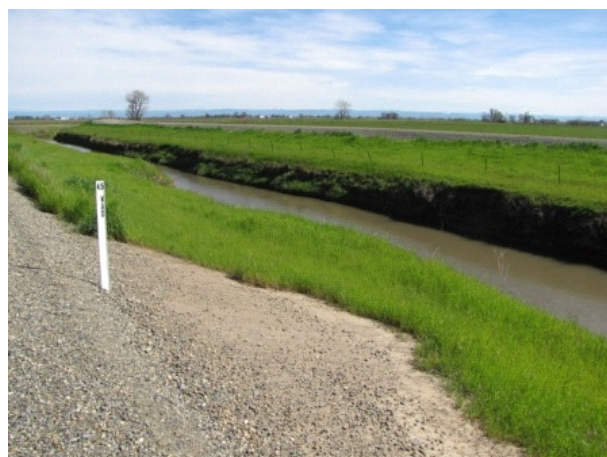
Levee Mile Report Line	9
Start Levee Mile	4.55
End Levee Mile	4.55
Location	Water Side
Category	Earthen Levee
Item	Erosion / Bank Caving
View of the erosion along the W/S toe.	
rduffey_s_20110427_318.jpg
