**Flood Control Project Maintenance
Levee Inspections****LMA District Cover Sheet****Spring 2012 Levee Inspection Results****Sutter Maintenance Yard Wadsworth Canal**

Spring 2012 Levee Inspection Results

Sutter Maintenance Yard Wadsworth Canal

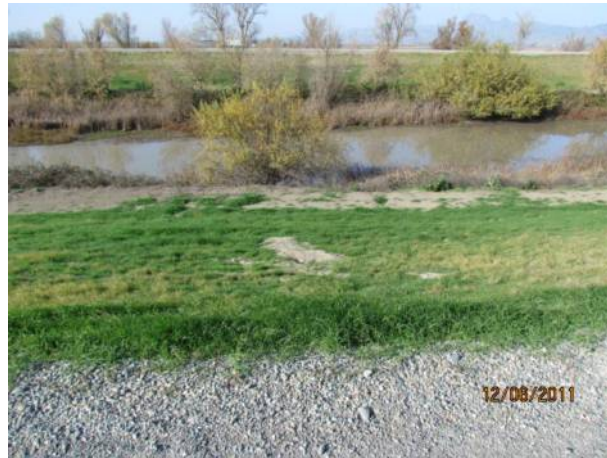
Levee Mile Report Line	4
Start Levee Mile	0.89
End Levee Mile	0.89
Location	Water Side
Category	Earthen Levee
Item	Animal Control

View of the rodent holes along the W/S slope.

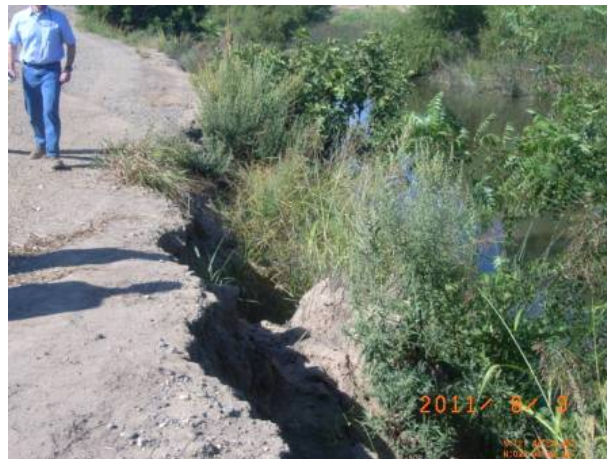
Levee Mile Report Line	5
Start Levee Mile	1.74
End Levee Mile	1.74
Location	Water Side
Category	Supplemental
Item	USACE Erosion Survey

USACE 2011 Photo #1

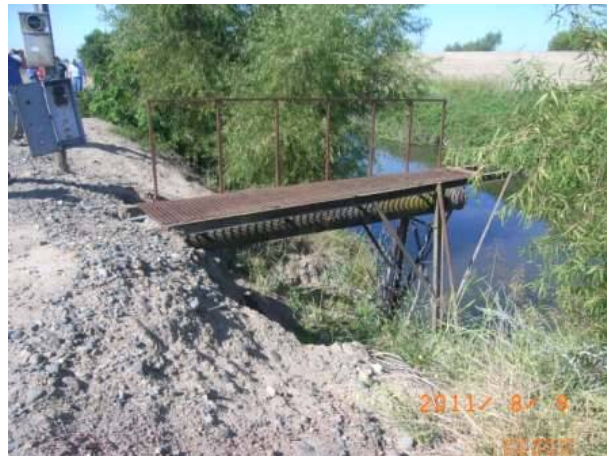
Levee Mile Report Line	5
Start Levee Mile	1.74
End Levee Mile	1.74
Location	Water Side
Category	Supplemental
Item	USACE Erosion Survey

USACE 2011 Photo #2

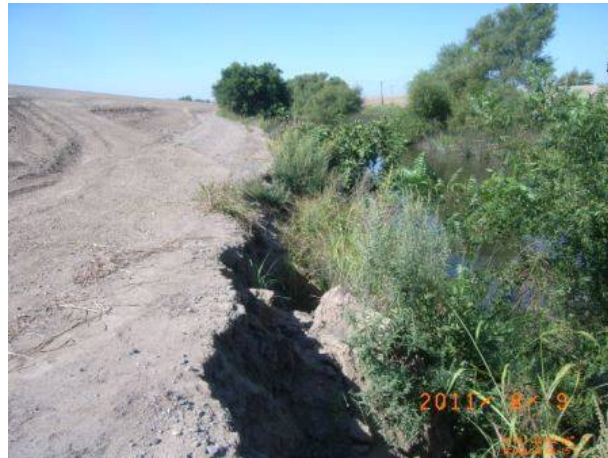
Levee Mile Report Line	5
Start Levee Mile	1.74
End Levee Mile	1.74
Location	Water Side
Category	Supplemental
Item	USACE Erosion Survey

USACE 2011 Photo #3

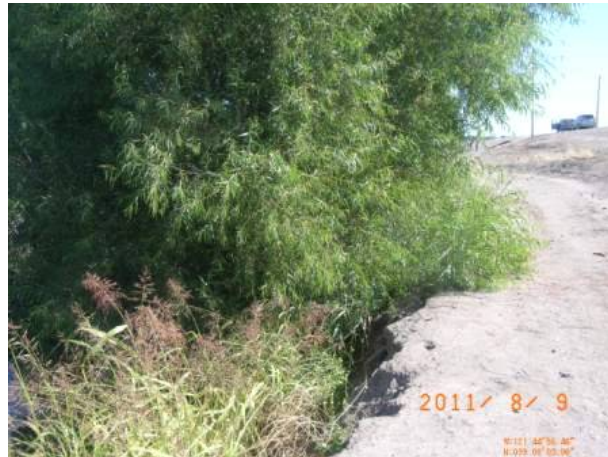
Levee Mile Report Line	5
Start Levee Mile	1.74
End Levee Mile	1.74
Location	Water Side
Category	Supplemental
Item	USACE Erosion Survey

USACE 2011 Photo #4

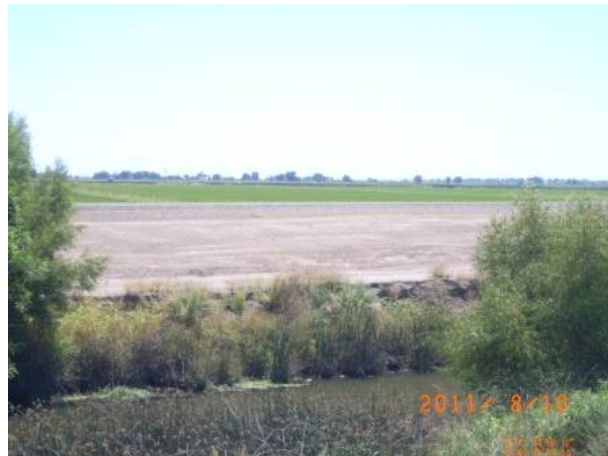
Levee Mile Report Line	5
Start Levee Mile	1.74
End Levee Mile	1.74
Location	Water Side
Category	Supplemental
Item	USACE Erosion Survey

USACE 2011 Photo #5

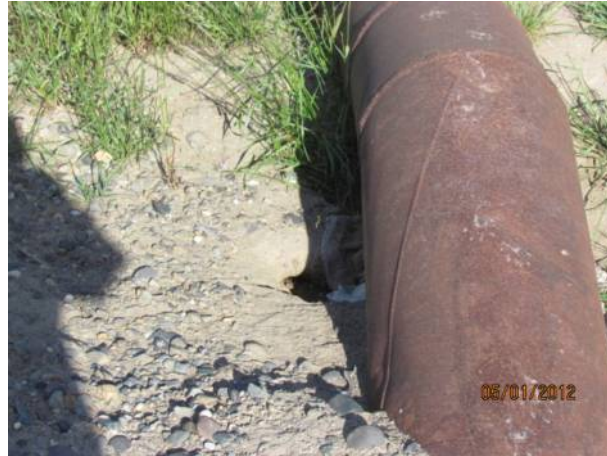
Levee Mile Report Line	6
Start Levee Mile	1.82
End Levee Mile	1.82
Location	Water Side
Category	Earthen Levee
Item	Animal Control

View of the rodent hole next to the pipe.

DWR ID: DWR_ST0010_01_s_2012_7			
6	1.82	1.82	Earthen Levee	Animal Control	WS	A Ma	A1 : Exterminate rodents and backfill and compact or grout burrows.	39.134727 ° -121.748503 °	39.134727 ° -121.748503 °	92 Y	
								DWR ID: DWR_ST0010_01_s_2012_92			
7	1.85	1.85	Earthen Levee	Animal Control	WS	A Ma	A3 : No rodents visible, but rodent burrows visible; need to backfill and compact or grout burrows.	39.135107 ° -121.748210 °	39.135107 ° -121.748210 °	6 Y	
								DWR ID: DWR_ST0010_01_s_2012_6			
8	2.30	2.30	Earthen Levee	Animal Control	LS	A Ma	A1 : Exterminate rodents and backfill and compact or grout burrows.	39.140508 ° -121.743703 °	39.140508 ° -121.743703 °	93	
								DWR ID: DWR_ST0010_01_s_2012_93			
9	2.31	2.31	Earthen Levee	Animal Control	WS	A Ma	A1 : Exterminate rodents and backfill and compact or grout burrows.	39.140553 ° -121.743720 °	39.140553 ° -121.743720 °	94	
								DWR ID: DWR_ST0010_01_s_2012_94

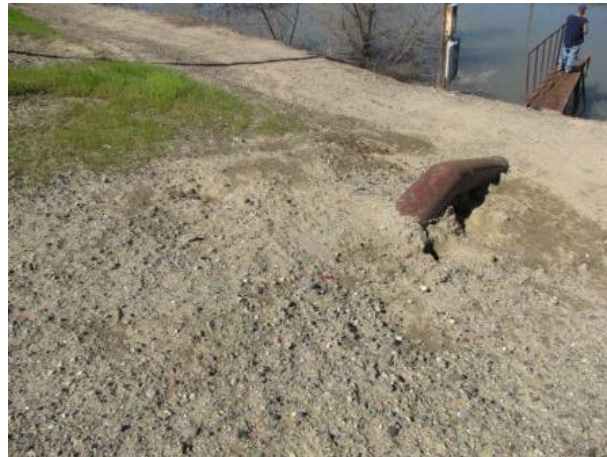
Levee Mile Report Line	7
Start Levee Mile	1.85
End Levee Mile	1.85
Location	Water Side
Category	Earthen Levee
Item	Animal Control

View of rodents burrows along the slope & next to a pipe.

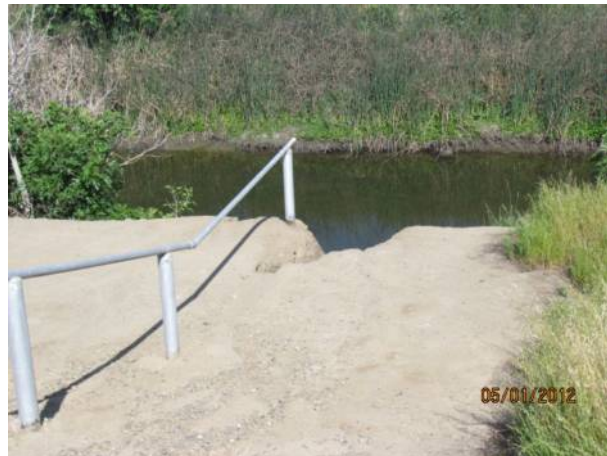
Levee Mile Report Line	10
Start Levee Mile	2.40
End Levee Mile	2.40
Location	Water Side
Category	Earthen Levee
Item	Erosion / Bank Caving

View of the erosion along the fences.

10	2.40	2.40	Earthen Levee	Erosion / Bank Caving	WS	M Ma	E2 : Schedule repair of erosion site prior to the next inspection.	39.141697 ° -121.742819 °	39.141697 ° -121.742819 °	14 Y	
								DWR ID: DWR_ST0010_01_s_2012_14			
11	2.41	2.41	Supplemental	USACE Erosion Survey	WS	M Ma	Inspector Comments: 2010 - Over steepened levees, some slumping, reach-wide problem. 2011: Still a reach-wide problem. [2011 Site ID: WAC_2-4_L]	39.142235 ° -121.742609 °	39.153095 ° -121.734390 °	8 Y	
								DWR ID: DWR_ST0010_01_s_2012_8			
12	2.76	2.76	Earthen Levee	Erosion / Bank Caving	WS	M Ma	E1 : Note and monitor erosion site.	39.146063 ° -121.739288 °	39.146063 ° -121.739288 °	1 Y	
								DWR ID: DWR_ST0010_01_s_2012_1			
13	3.31	3.31	Earthen Levee	Erosion / Bank Caving	WS	M Ma	E2 : Schedule repair of erosion site prior to the next inspection.	39.152875 ° -121.734320 °	39.152875 ° -121.734320 °	13 Y	
								DWR ID: DWR_ST0010_01_s_2012_13

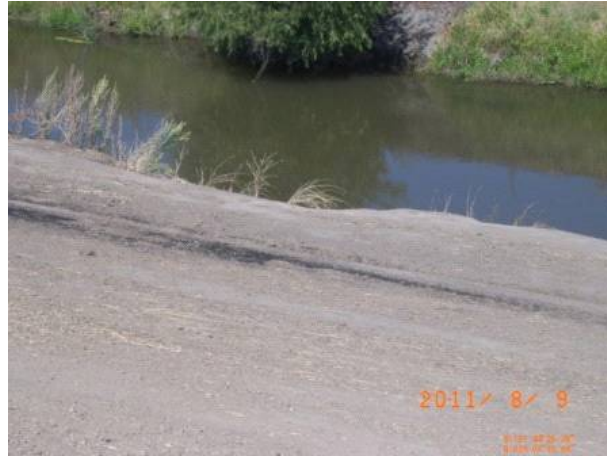
Levee Mile Report Line	11
Start Levee Mile	2.41
End Levee Mile	2.41
Location	Water Side
Category	Supplemental
Item	USACE Erosion Survey

USACE 2011 Photo #1

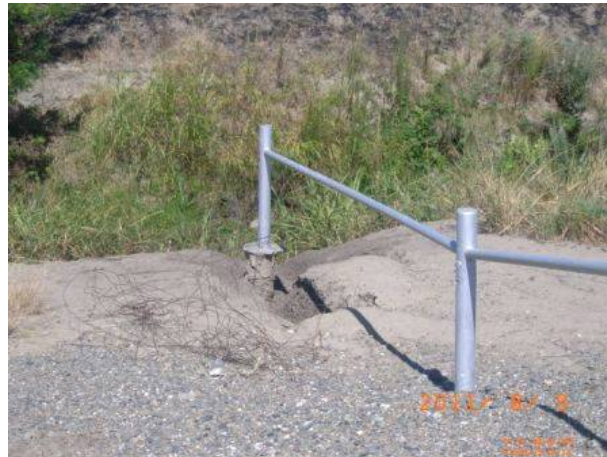
Levee Mile Report Line	11
Start Levee Mile	2.41
End Levee Mile	2.41
Location	Water Side
Category	Supplemental
Item	USACE Erosion Survey

USACE 2011 Photo #2

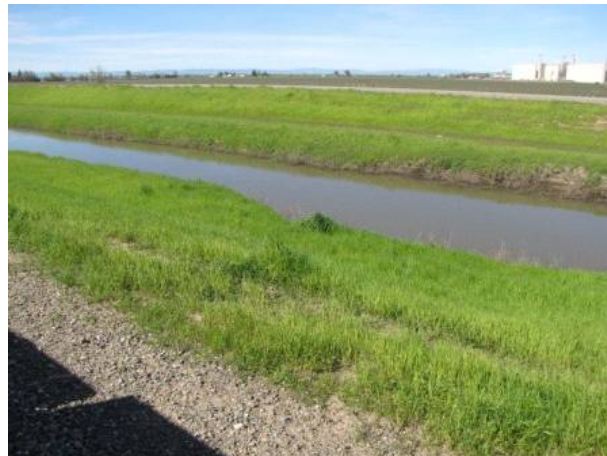
Levee Mile Report Line	12
Start Levee Mile	2.76
End Levee Mile	2.76
Location	Water Side
Category	Earthen Levee
Item	Erosion / Bank Caving

View of erosion along W/S toe.

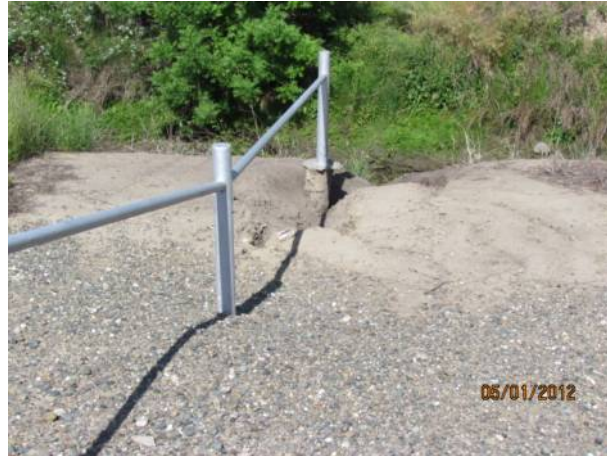
Levee Mile Report Line	13
Start Levee Mile	3.31
End Levee Mile	3.31
Location	Water Side
Category	Earthen Levee
Item	Erosion / Bank Caving

View of the erosion along the fences.

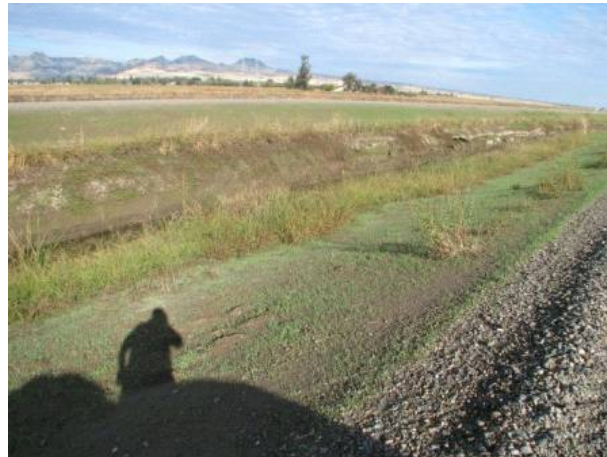
Levee Mile Report Line	14
Start Levee Mile	3.56
End Levee Mile	3.59
Location	Water Side
Category	Earthen Levee
Item	Erosion / Bank Caving

View of the erosion along the waterside toe of the levee.

14	3.56	3.59	Earthen Levee	Erosion / Bank Caving	WS	M Ma	E1 : Note and monitor erosion site.	39.156225 ° -121.732930 °	39.156639 ° -121.732755 °	3 Y	
								DWR ID: DWR_ST0010_01_s_2012_3

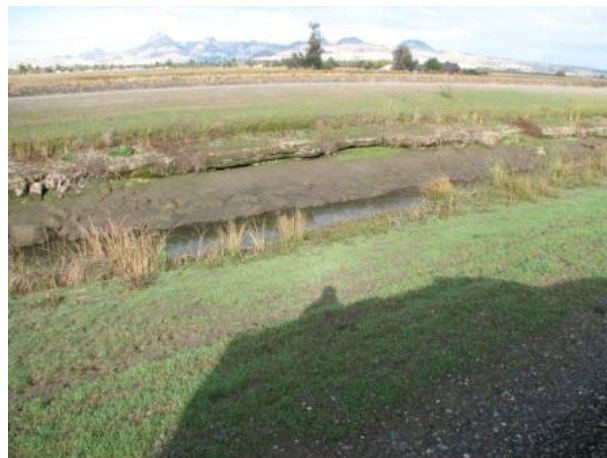
Levee Mile Report Line	15
Start Levee Mile	3.68
End Levee Mile	3.68
Location	Water Side
Category	Earthen Levee
Item	Erosion / Bank Caving

View of the erosion along the waterside toe of the levee.

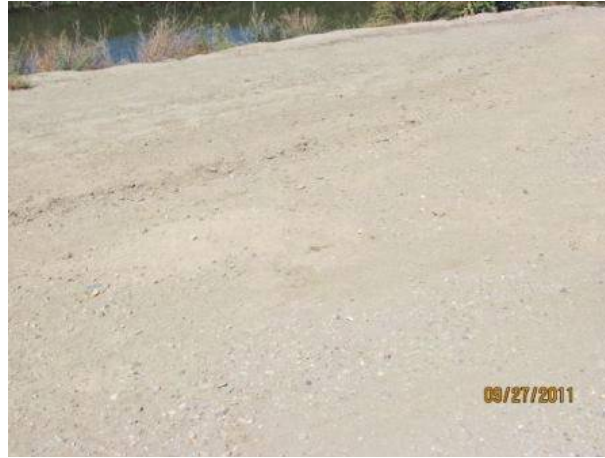
Levee Mile Report Line	1
Start Levee Mile	1.15
End Levee Mile	1.15
Location	Land Side
Category	Earthen Levee
Item	Animal Control

View of the rodent holes along the L/S slope.

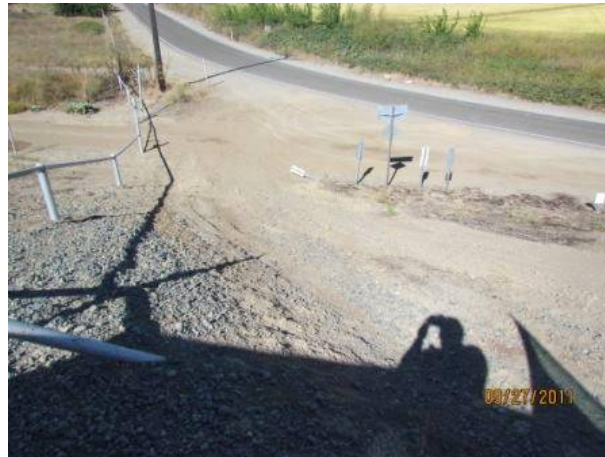
Levee Mile Report Line	2
Start Levee Mile	1.17
End Levee Mile	1.17
Location	Land Side
Category	Earthen Levee
Item	Slope Stability

View of vehicle erosion along L/S slope.

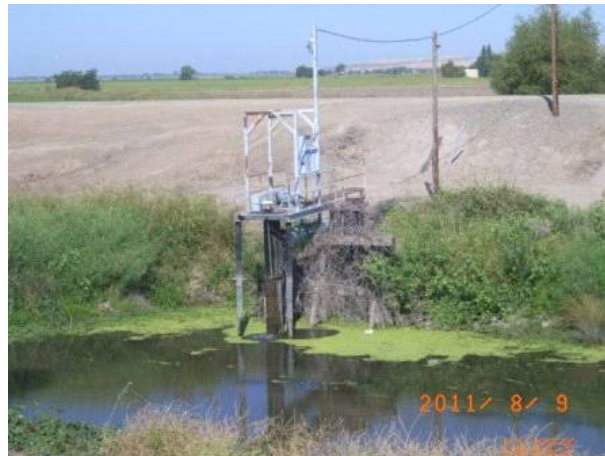
Levee Mile Report Line	3
Start Levee Mile	1.74
End Levee Mile	1.74
Location	Water Side
Category	Supplemental
Item	USACE Erosion Survey

USACE 2011 Photo #1

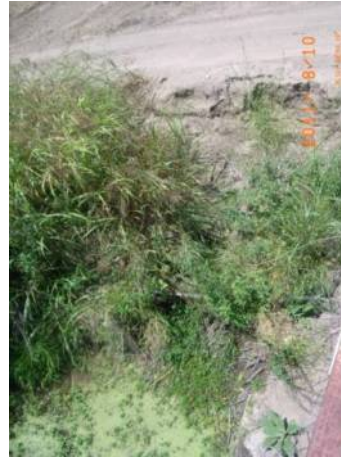
Levee Mile Report Line	3
Start Levee Mile	1.74
End Levee Mile	1.74
Location	Water Side
Category	Supplemental
Item	USACE Erosion Survey

USACE 2011 Photo #2

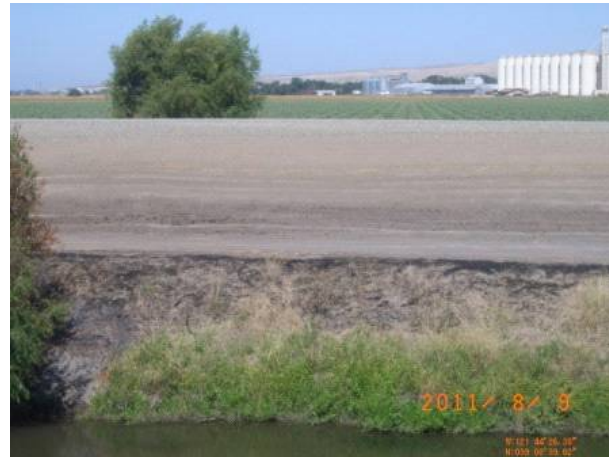
Levee Mile Report Line	5
Start Levee Mile	2.37
End Levee Mile	2.37
Location	Water Side
Category	Supplemental
Item	USACE Erosion Survey

USACE 2011 Photo #1

DWR ID: DWR_ST0010_02_s_2012_11									
4	1.86	1.86	Earthen Levee	Animal Control	LS Ma	A1 : Exterminate rodents and backfill and compact or grout burrows.	39.135535 ° -121.748678 °	39.135535 ° -121.748678 °	8 Y
DWR ID: DWR_ST0010_02_s_2012_8									
5	2.37	2.37	Supplemental	USACE Erosion Survey	WS Ma	M Inspector Comments: 2010 - Over steepened levees, some slumping, reach-wide problem. 2011: Still a reach-wide problem. [2011 Site ID: WAC_2-4_R]	39.142254 ° -121.742847 °	39.153150 ° -121.734611 °	12 Y
DWR ID: DWR_ST0010_02_s_2012_12									
6	3.30	3.30	Earthen Levee	Erosion / Bank Caving	LS Ma	M E1 : Note and monitor erosion site.	39.152903 ° -121.734906 °	39.152903 ° -121.734906 °	14 Y
DWR ID: DWR_ST0010_02_s_2012_14									
7	3.46	3.46	Earthen Levee	Erosion / Bank Caving	WS Ma	M E1 : Note and monitor erosion site.	39.155057 ° -121.733985 °	39.155057 ° -121.733985 °	4 Y
DWR ID: DWR_ST0010_02_s_2012_4

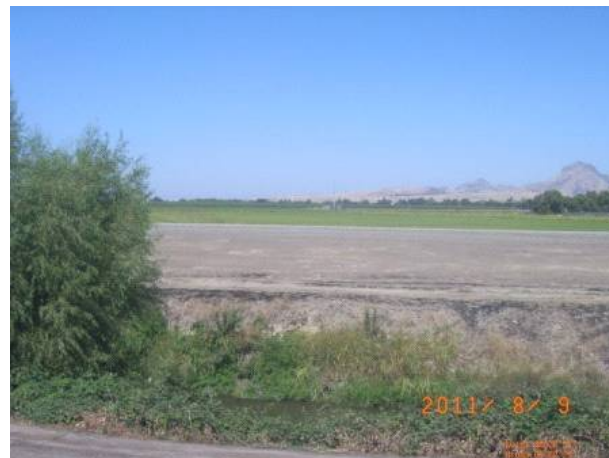
Levee Mile Report Line	5
Start Levee Mile	2.37
End Levee Mile	2.37
Location	Water Side
Category	Supplemental
Item	USACE Erosion Survey

USACE 2011 Photo #2

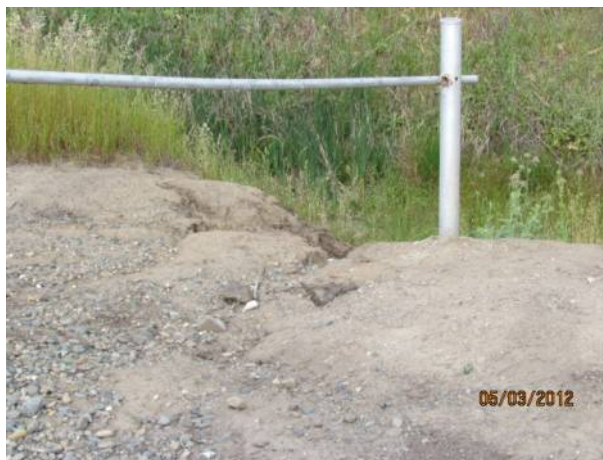
Levee Mile Report Line	6
Start Levee Mile	3.30
End Levee Mile	3.30
Location	Land Side
Category	Earthen Levee
Item	Erosion / Bank Caving

View of the erosion along the W/S toe.

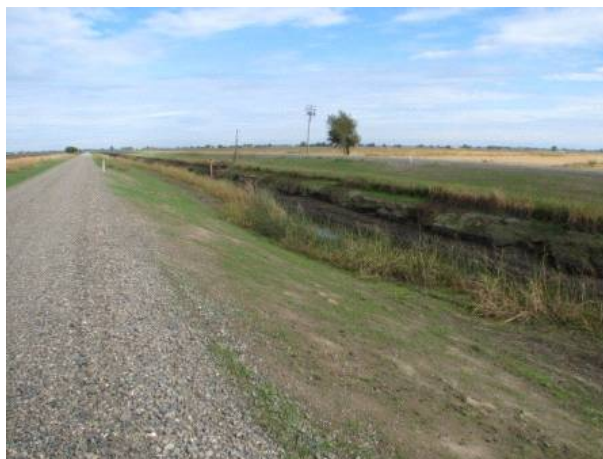
Levee Mile Report Line	7
Start Levee Mile	3.46
End Levee Mile	3.46
Location	Water Side
Category	Earthen Levee
Item	Erosion / Bank Caving

View of the erosion at the waterside toe of the levee.

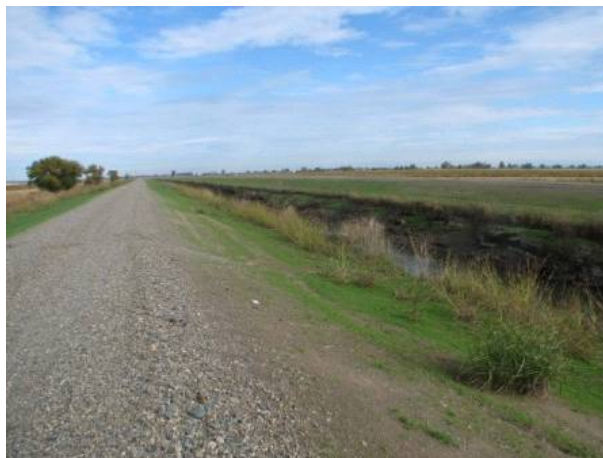
Levee Mile Report Line	8
Start Levee Mile	3.59
End Levee Mile	3.99
Location	Water Side
Category	Earthen Levee
Item	Erosion / Bank Caving

View of the erosion along the waterside toe.

8	3.59	3.99	Earthen Levee	Erosion / Bank Caving	WS Ma	M E1 : Note and monitor erosion site.	39.156753 ° -121.733267 °	39.162113 ° -121.730997 °	5 Y
DWR ID: DWR_ST0010_02_s_2012_5									
9	4.48	4.48	Supplemental	USACE Erosion Survey	WS Ma	M Inspector Comments: 2011: Small erosion pocket. [2011 Site ID: WAC_4-3_R]	39.168659 ° -121.728016 °	39.168937 ° -121.727905 °	13 Y
DWR ID: DWR_ST0010_02_s_2012_13									
10	4.49	4.49	Earthen Levee	Erosion / Bank Caving	WS Ma	M E1 : Note and monitor erosion site.	39.168848 ° -121.728130 °	39.168848 ° -121.728130 °	6 Y
DWR ID: DWR_ST0010_02_s_2012_6									
11	4.55	4.55	Earthen Levee	Erosion / Bank Caving	WSA/W Ma	E1 : Note and monitor erosion site.	39.169670 ° -121.727787 °	39.169670 ° -121.727787 °	7 Y
DWR ID: DWR_ST0010_02_s_2012_7

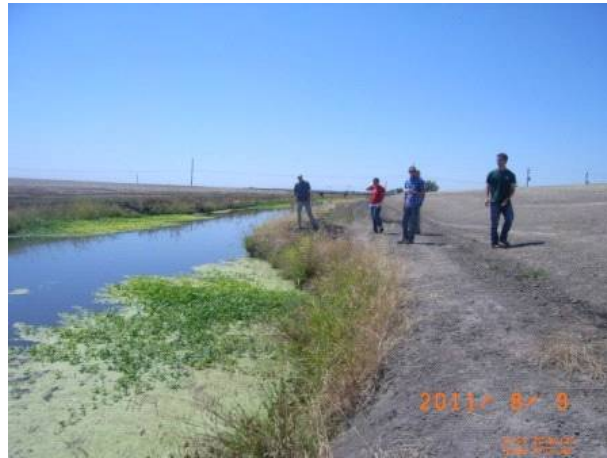
Levee Mile Report Line	9
Start Levee Mile	4.48
End Levee Mile	4.48
Location	Water Side
Category	Supplemental
Item	USACE Erosion Survey

USACE 2011 Photo #1

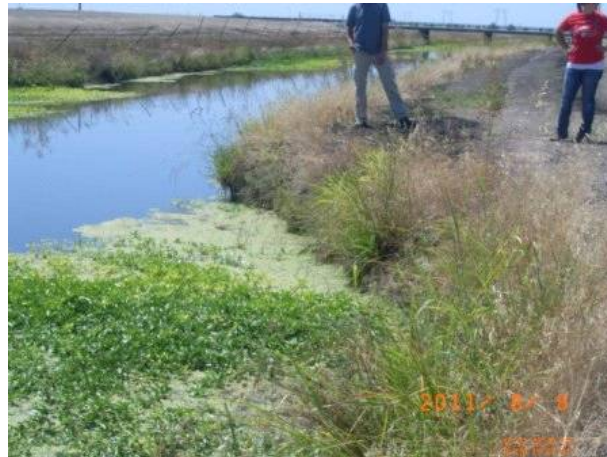
Levee Mile Report Line	9
Start Levee Mile	4.48
End Levee Mile	4.48
Location	Water Side
Category	Supplemental
Item	USACE Erosion Survey

USACE 2011 Photo #2

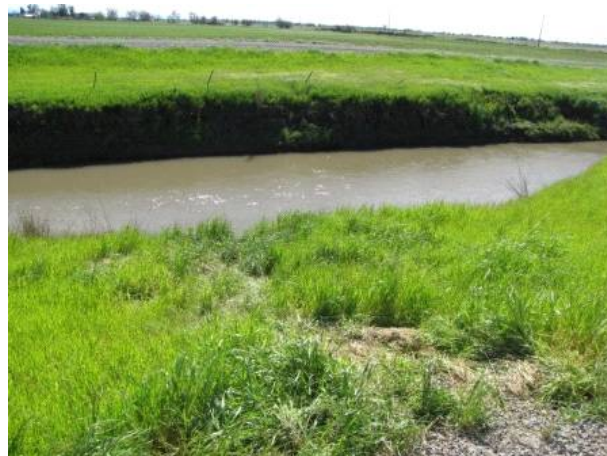
Levee Mile Report Line	10
Start Levee Mile	4.49
End Levee Mile	4.49
Location	Water Side
Category	Earthen Levee
Item	Erosion / Bank Caving

View of erosion along the W/S toe.

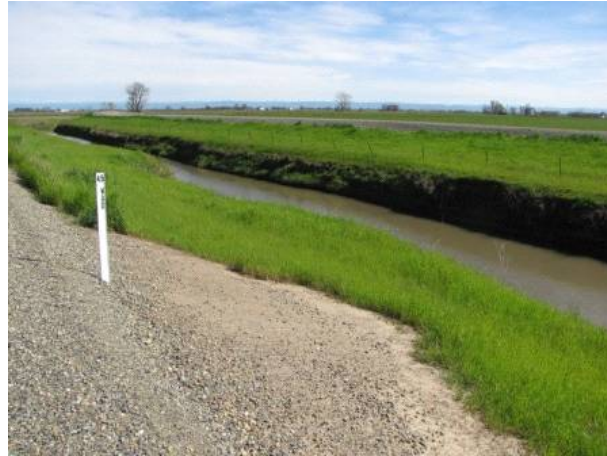
Levee Mile Report Line	11
Start Levee Mile	4.55
End Levee Mile	4.55
Location	Water Side
Category	Earthen Levee
Item	Erosion / Bank Caving

View of the erosion along the W/S toe.
