**Flood Control Project Maintenance  
Levee Inspections****LMA District Cover Sheet****Spring 2013 Levee Inspection Results****Sutter Maintenance Yard Wadsworth Canal**

**Spring 2013 Levee Inspection Results**

**Sutter Maintenance Yard Wadsworth Canal**

**Levee Inspection Report By Mile - Spring 2013**

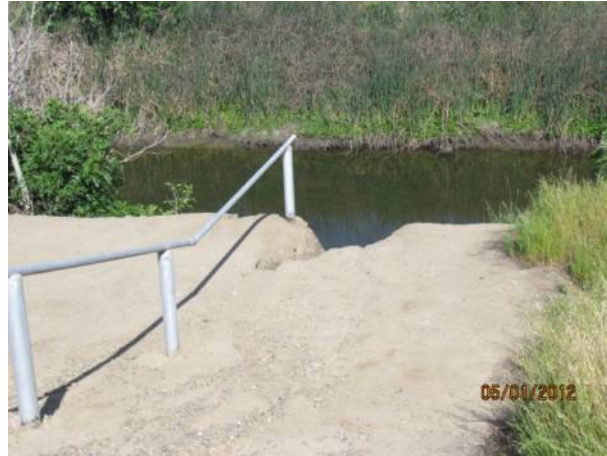
Levee Mile Report Line	5
Start Levee Mile	2.40
End Levee Mile	2.40
Location	Water Side
Category	
Item	Erosion / Bank Caving

View of the erosion along the fences.

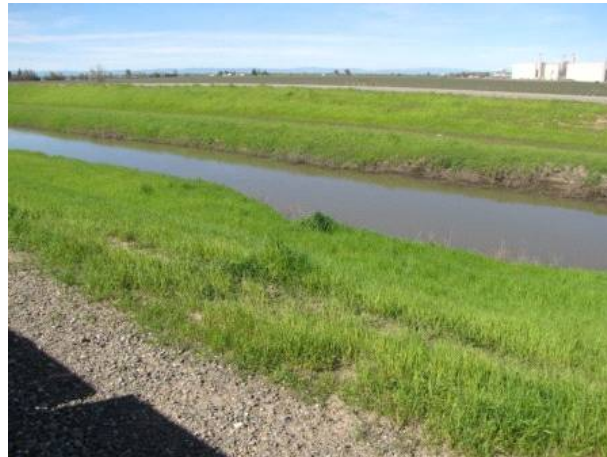
Levee Mile Report Line	7
Start Levee Mile	2.76
End Levee Mile	2.76
Location	Water Side
Category	
Item	Erosion / Bank Caving

View of erosion along W/S toe.

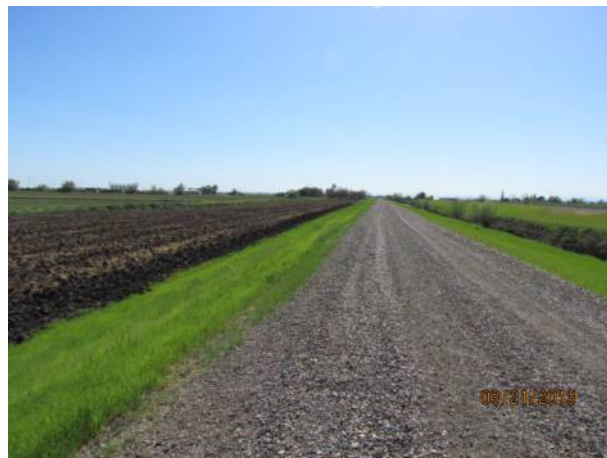
Levee Mile Report Line	8
Start Levee Mile	2.84
End Levee Mile	2.84
Location	Land Side
Category	
Item	Vegetation

View of the native grass on both slopes.

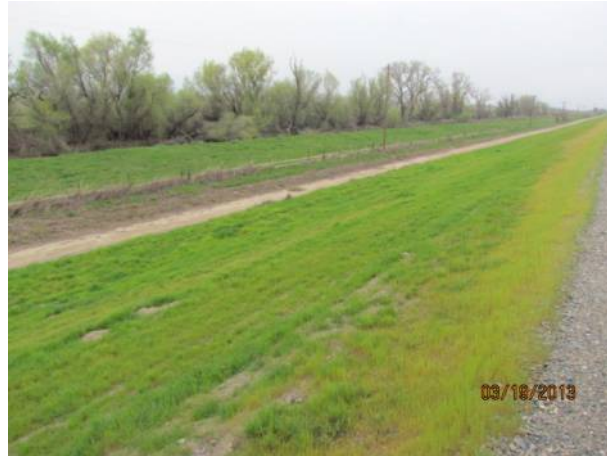
Levee Mile Report Line	1
Start Levee Mile	0.78
End Levee Mile	0.78
Location	Land Side
Category	
Item	Animal Control
View of the repaired rodent holes along the landside slope.	
rduffey_s_20130402_345.JPG

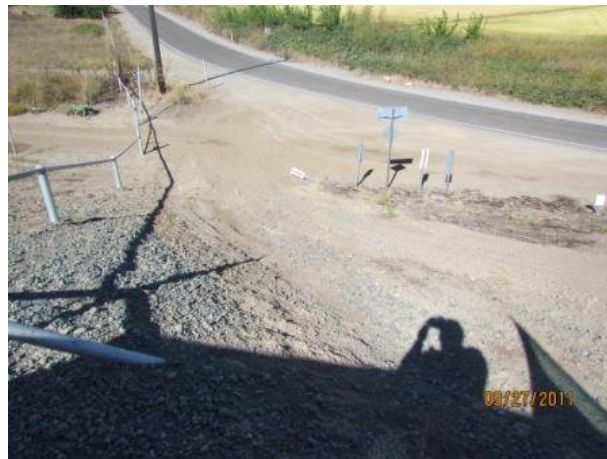
Levee Mile Report Line	2
Start Levee Mile	1.17
End Levee Mile	1.17
Location	Land Side
Category	
Item	Slope Stability
View of vehicle erosion along L/S slope.	
rduffey_s_20130225_292.jpg

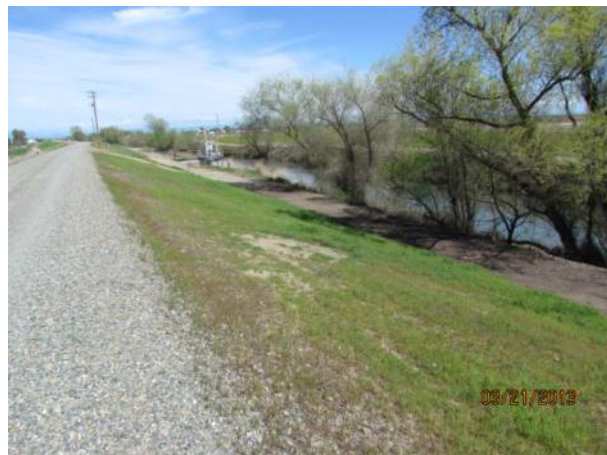
Levee Mile Report Line	3
Start Levee Mile	1.72
End Levee Mile	1.72
Location	Water Side
Category	
Item	Animal Control
View of the grouted rodent holes.	
rduffey_s_20130403_350.JPG

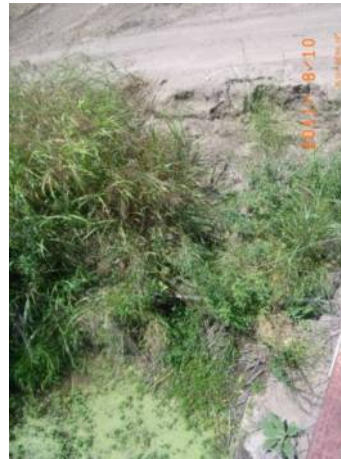
DWR ID: DWR_ST0010_02_s_2013_12										
5	1.77	1.77		Animal Control	LS	M Ma	A3 : No rodents visible, but rodent burrows visible; need to backfill and compact or grout burrows.	39.134490 ° -121.749716 °	39.134490 ° -121.749716 °	11 Y
DWR ID: DWR_ST0010_02_f_2012_11										
6	1.86	1.86		Animal Control	LS A/W	Ma	A1 : Exterminate rodents and backfill and compact or grout burrows.	39.135535 ° -121.748678 °	39.135535 ° -121.748678 °	8 Y
DWR ID: DWR_ST0010_02_s_2012_8										
7	2.44	2.44	Supplemental	USACE Erosion Survey	WS	M Ma	Inspector Comments: 2010 - Over steepened levees, some slumping, reach-wide problem. 2011 - Still a reach-wide problem. 2012: Site is part of the extended inventory, last inspected 2011. [2012 Site ID: WAD_2-4_R]	39.153150 ° -121.734611 °	39.142254 ° -121.742847 °	13
DWR ID: DWR_ST0010_02_s_2013_13										
8	2.63	2.63		Vegetation	LS	A Ma	V1 : Control annual grass and weeds on the levee slopes and easements.	39.144612 ° -121.741205 °	39.144612 ° -121.741205 °	9 Y

Levee Mile Report Line	5
Start Levee Mile	1.77
End Levee Mile	1.77
Location	Land Side
Category	
Item	Animal Control
USACE 2011 Photo #2	
rduffey_s_20130225_300.jpg

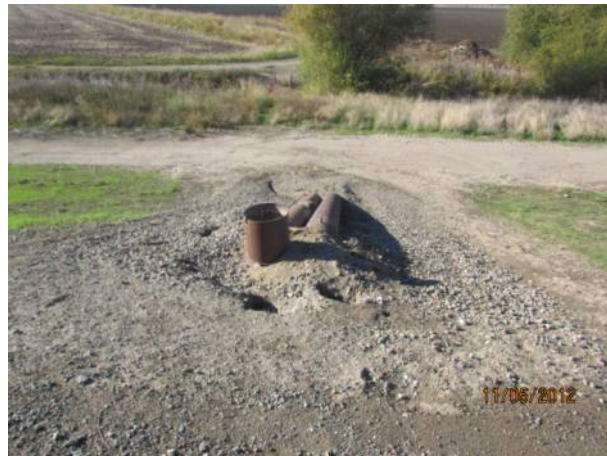
Levee Mile Report Line	5
Start Levee Mile	1.77
End Levee Mile	1.77
Location	Land Side
Category	
Item	Animal Control
View of the rodent holes on both sides of the irrigation pipe.	
rduffey_s_20130225_301.JPG

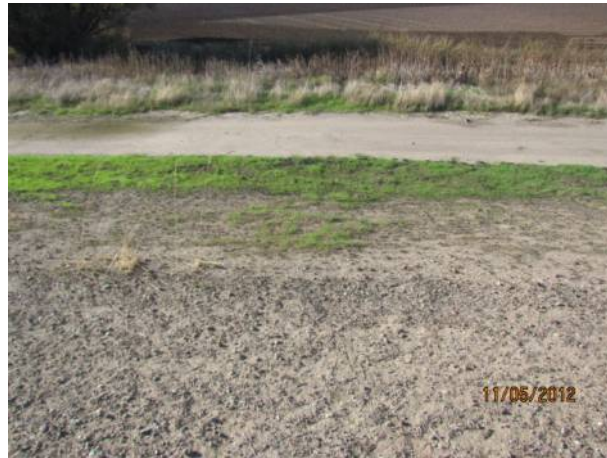
Levee Mile Report Line	6
Start Levee Mile	1.86
End Levee Mile	1.86
Location	Land Side
Category	
Item	Animal Control

View of the area where the rodent holes have been grouted.

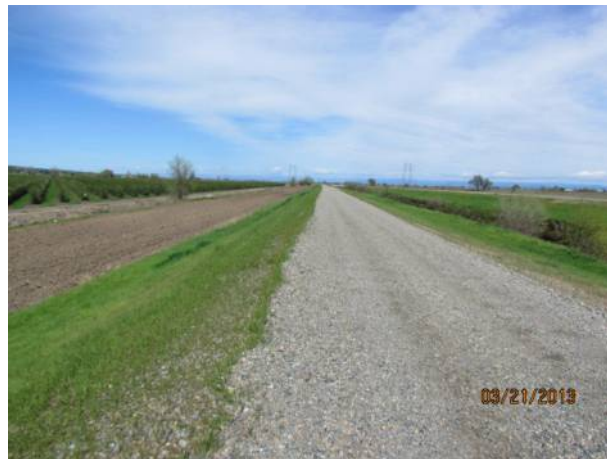
Levee Mile Report Line	8
Start Levee Mile	2.63
End Levee Mile	2.63
Location	Land Side
Category	
Item	Vegetation

View of the native grass on both slope.

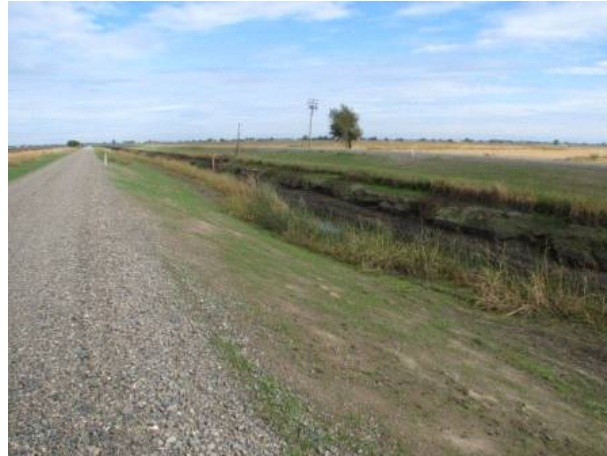
Levee Mile Report Line	10
Start Levee Mile	3.46
End Levee Mile	3.46
Location	Water Side
Category	
Item	Erosion / Bank Caving
View of the erosion at the waterside toe of the levee.	
rduffey_s_20130225_293.jpg

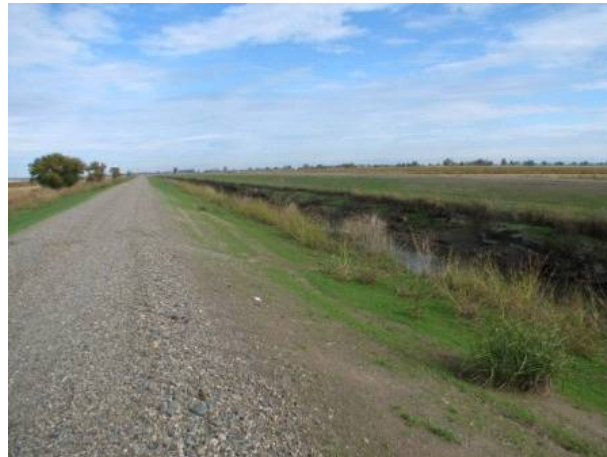
Levee Mile Report Line	11
Start Levee Mile	3.59
End Levee Mile	3.99
Location	Water Side
Category	
Item	Erosion / Bank Caving
View of the erosion along the waterside toe.	
rduffey_s_20130225_294.jpg
