**Flood Control Project Maintenance
Levee Inspections****LMA District Cover Sheet****Spring 2014 Levee Inspection Results****Sutter Maintenance Yard Wadsworth Canal**

Levee Inspection Report By Mile - Spring 2014

Sutter Maintenance Yard Wadsworth Canal

Waterway	Bank	Unit Miles	Inspection Start/End	Inspector
Unit No. 01 Wadsworth Canal	Left	4.66	03/19/2014 03/19/2014	Bob Duffey

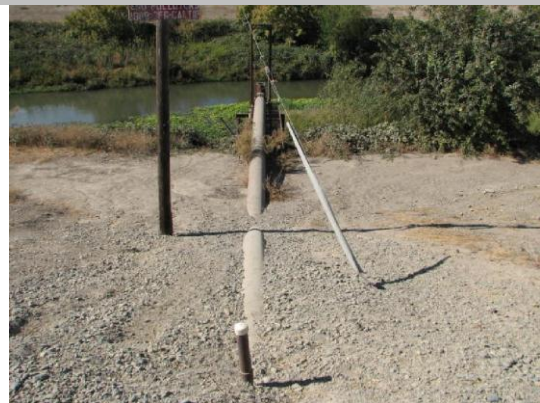
Photo 1 of 1 : UCIP_3606.jpg

LM Start	1.20	Rating **	M	Issue No.	13
LM End	1.20	Issue Type +	En	Location *	WS
Category	Supplemental			GPS Latitude/Longitude	
				Start	End
Item	DWR UCIP Field Study			39.127566 °	39.127566 °
				-121.755282 °	-121.755282 °
DWR ID	DWR_ST0010_01_s _ 2014_13				
Action/Comments					
Inspector Comments: FS_ID:23694					
EP_NO: 1605					
Repair Type:					
Crossing Status:					
UCIP Comments: No pump on Pier and power lines cut. Apparently abandoned-should be abandoned properly 5/16/2013 Same as last inspection10/29/2013 Same as last inspection.					
FIELD_STRUCT_DESC: 18-inch steel irrigation pipe through the levee, 3.7 feet below the crown. Siphon breaker on the waterward slope. Pump on channel bank on steel structure. (App. 1605 - Schnable) Service pole at the waterward toe. Anchor in waterward slope. (App 1631-Schnable).					
FS Date: 11/6/2013 7:31:35 AM

Pipe on WS slope with siphon breaker at WS shoulder.

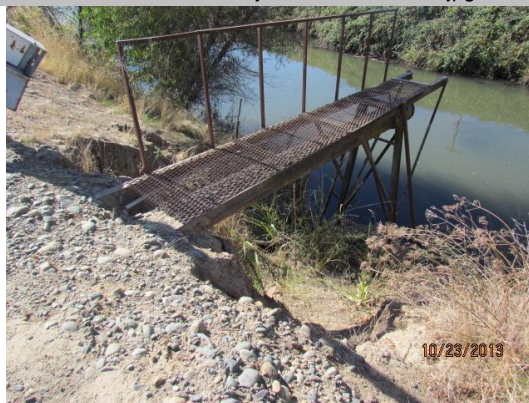
Photo 1 of 1 : rduffey_s_20140304_839.jpg

LM Start	1.85	Rating **	M	Issue No.	107
LM End	1.85	Issue Type +	Ma	Location *	WS
Category	Earthen Levee			GPS Latitude/Longitude	
				Start	End
Item	Erosion / Bank Caving			39.135110 °	39.135110 °
				-121.748230 °	-121.748230 °
DWR ID	DWR_ST0010_01_f_2013_107				
Action/Comments					
Note and monitor erosion site.

View of the erosion along both sides of the abandoned pump.

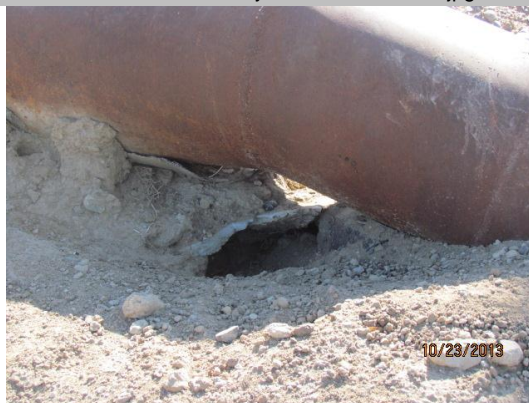
Photo 1 of 1 : rduffey_s_20140304_838.jpg

LM Start	1.85	Rating **	M	Issue No.	106
LM End	1.85	Issue Type +	Ma	Location *	WS
Category	Earthen Levee			GPS Latitude/Longitude	
				Start	End
Item	Animal Control			39.135110 °	39.135110 °
				-121.748229 °	-121.748229 °
DWR ID	DWR_ST0010_01_f_2013_106				
Action/Comments					
No rodents visible, but rodent burrows visible; need to backfill and compact or grout burrows.

View of the rodent holes under the irrigation pipe.

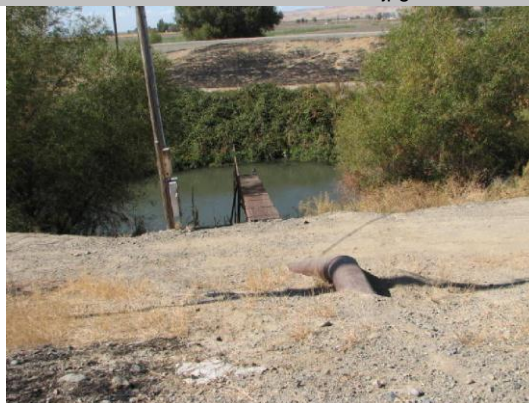
Photo 1 of 1 : UCIP_3611.jpg

UCIP Comments: Pipe abandoned. Pipe open and not plugged. Pipe should be removed or abandoned properly. Extensive animal burrowing occurring along pipe alignment 5/16/2013 Same as last inspection. Steve Beckley is looking into finding pipe owner to properly abandon pipe 4/29/2013 Same as last inspection.

FIELD_STRUCT_DESC: 14-inch steel irrigation pipe through the levee, 5.7 feet below the crown. Siphon breaker on landward side. Vertical pump on waterward side. Meter pole on berm. Originally in O+M manual, asbuilt available.

Pump missing from steel pier on WS toe.

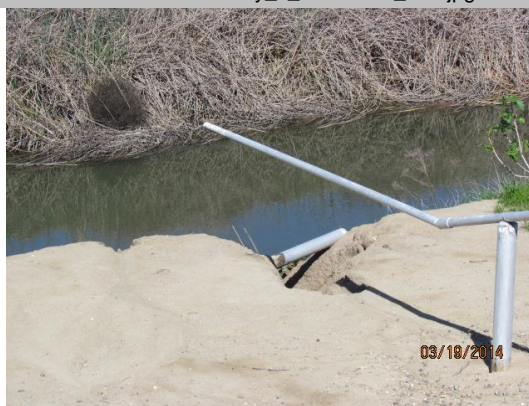
Photo 1 of 1 : rduffey_s_20140407_163.jpg

LM Start	2.40	Rating **	M	Issue No.	14
LM End	2.40	Issue Type +	Ma	Location *	WS
Category	Earthen Levee		GPS Latitude/Longitude		
			Start	End	
Item	Erosion / Bank Caving		39.141697 °	39.141697 °	
			-121.742819 °	-121.742819 °	
DWR ID	DWR_ST0010_01_s _ 2012_14

View of the erosion along the fence.

Schedule repair of erosion site prior to the next inspection.

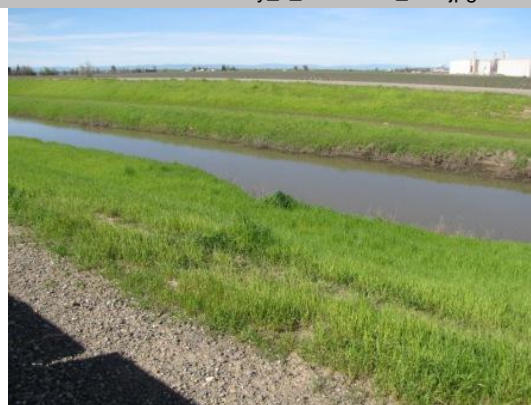
Photo 1 of 1 : rduffey_s_20140304_834.jpg

LM Start	2.76	Rating **	M	Issue No.	1
LM End	2.76	Issue Type +	Ma	Location *	WS
Category	Earthen Levee			GPS Latitude/Longitude	
				Start	End
Item	Erosion / Bank Caving			39.146063 °	39.146063 °
				-121.739288 °	-121.739288 °
DWR ID	DWR_ST0010_01_s _ 2012_1				
Action/Comments					
Note and monitor erosion site.

View of erosion along W/S toe.

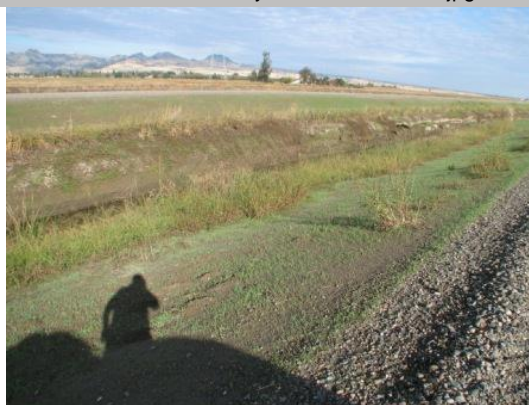
Photo 1 of 1 : rduffey_s_20140304_835.jpg

LM Start	3.56	Rating **	M	Issue No.	3
LM End	3.59	Issue Type +	Ma	Location *	WS
Category	Earthen Levee			GPS Latitude/Longitude	
				Start	End
Item	Erosion / Bank Caving			39.156225 °	39.156639 °
				-121.732930 °	-121.732755 °
DWR ID	DWR_ST0010_01_s _ 2012_3				
Action/Comments					
Note and monitor erosion site.

View of the erosion along the waterside toe of the levee.

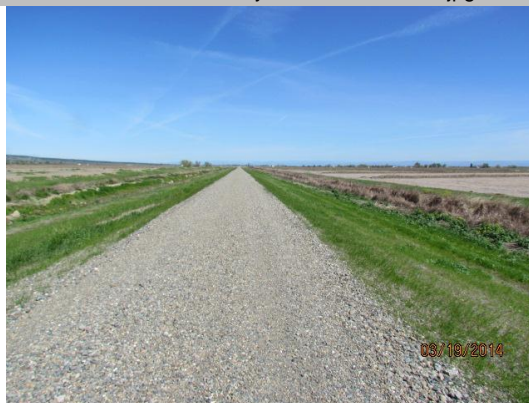
Photo 1 of 1 : rduffey_s_20140407_164.jpg

LM Start	3.61	Rating **	A	Issue No.	17
LM End	3.61	Issue Type +	Ma	Location *	LS
Category	Earthen Levee			GPS Latitude/Longitude	
				Start	End
Item	Vegetation			39.157029 °	39.157029 °
				-121.732594 °	-121.732594 °
DWR ID	DWR_ST0010_01_s _ 2014_17				
Action/Comments					
Control annual grass and weeds on the levee slopes and easements.

View of the native grasses on both slopes.

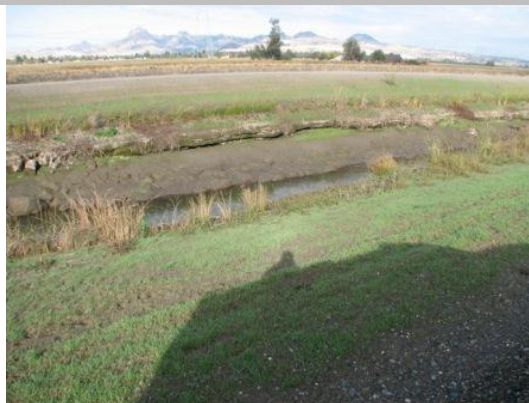
Photo 1 of 1 : rduffey_s_20140304_836.jpg

LM Start	3.68	Rating **	M	Issue No.	4
LM End	3.68	Issue Type +	Ma	Location *	WS
Category	Earthen Levee			GPS Latitude/Longitude	
				Start	End
Item	Erosion / Bank Caving			39.157861 °	39.157861 °
				-121.732238 °	-121.732238 °
DWR ID	DWR_ST0010_01_s _ 2012_4				
Action/Comments					
Note and monitor erosion site.

View of the erosion along the waterside toe of the levee.

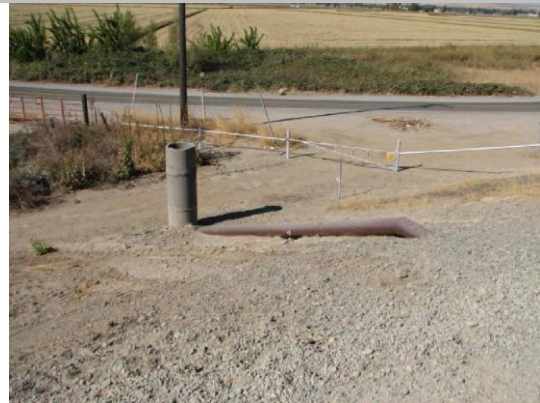
Photo 1 of 1 : UCIP_3615.jpg

LM Start	1.15	Rating **	M	Issue No.	139
LM End	1.15	Issue Type +	En	Location *	WS
Category	Supplemental			GPS Latitude/Longitude	
				Start	End
Item	DWR UCIP Field Study			39.127487 °	39.127487 °
				-121.756485 °	-121.756485 °
DWR ID	DWR_ST0010_02_s _ 2014_139				
Action/Comments					
Inspector Comments: FS_ID:23708					
EP_NO: N/A					
Repair Type:					
Crossing Status:					
UCIP Comments: Pipe appears improperly abandoned. No motor present, electrical equipment is stripped. Heavy rodent activity along pipe WS and LS. Pipe needs to be removed or properly abandoned5/16/2013 Same as last inspection10/29/2013 Same as last inspection.					
FIELD_STRUCT_DESC: 10-inch steel irrigation pipe through the levee, 4.8-feet below the crown. Pump mounted on concrete pad near canal bank. Service pole on berm. 30-inch diameter concrete standpipe at landward toe. Originally in O+M manual, asbuilt available.					
FS Date: 11/6/2013 7:44:09 AM

Pipe and Standpipe on LS toe.

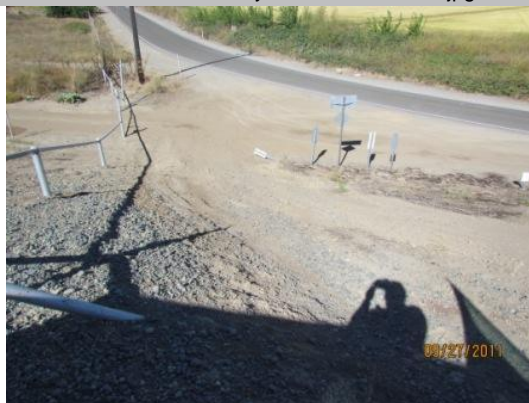
Photo 1 of 1 : rduffey_s_20140304_840.jpg

LM Start	1.17	Rating **	M	Issue No.	3
LM End	1.17	Issue Type +	Ma	Location *	LS
Category	Earthen Levee			GPS Latitude/Longitude	
				Start	End
Item	Slope Stability			39.127648 °	39.127648 °
				-121.756345 °	-121.756345 °
DWR ID	DWR_ST0010_02_s_2012_3				
Action/Comments					
Repair the levee slope damaged by vehicle traffic and prevent access where possible.

View of vehicle erosion along L/S slope.

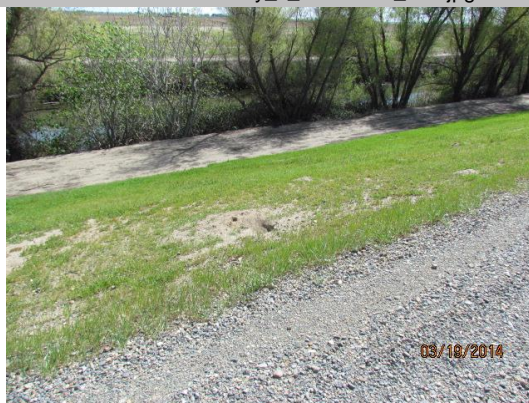
Photo 1 of 1 : rduffey_s_20140407_165.jpg

LM Start	1.72	Rating **	A/W	Issue No.	15
LM End	1.72	Issue Type +	Ma	Location *	WS
Category	Earthen Levee			GPS Latitude/Longitude	
				Start	End
Item	Animal Control			39.133945 °	39.133945 °
				-121.750250 °	-121.750250 °
DWR ID	DWR_ST0010_02_f_2012_15				
Action/Comments					
No rodents visible, but rodent burrows visible; need to backfill and compact or grout burrows.

View of the rodent activity on the w/s slope.

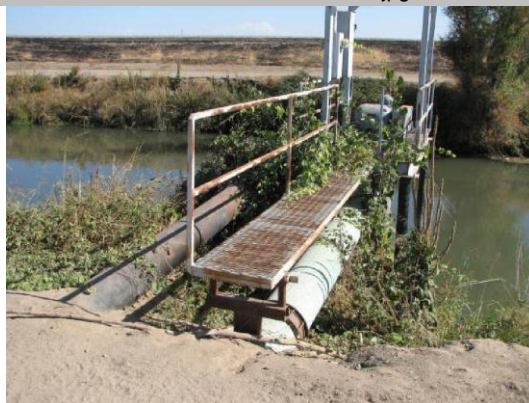
Photo 1 of 1 : UCIP_3621.jpg

UCIP Comments: Heavy rodent activity on LS slope along pipe alignment 5/16/2013 Same as last inspection 10/29/2013 Same as last inspection.

FIELD_STRUCT_DESC: 16-inch steel irrigation pipe through the levee, 4.4-feet below the crown. Pump mounted on a steel structure on the bank. Siphon breaker on the landward slope. unable to locate 48-inch concrete standpipe on the landward berm that was listed in permit. (Permit No. 1096 - Brown). Asbuilt available.

Pump on steel platform with walkway on WS berm.

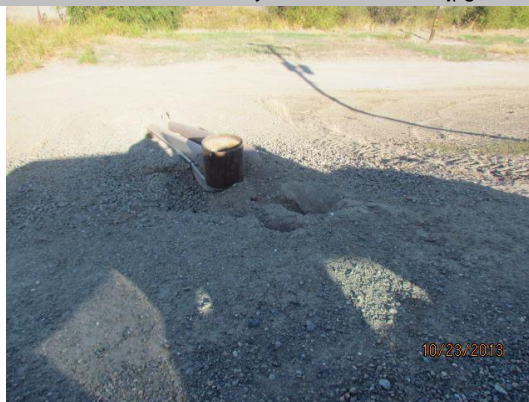
Photo 1 of 1 : rduffey_s_20140304_847.jpg

LM Start	1.77	Rating **	M	Issue No.	11
LM End	1.77	Issue Type +	Ma	Location *	LS
Category	Earthen Levee			GPS Latitude/Longitude	
				Start	End
Item	Animal Control			39.134490 °	39.134490 °
				-121.749716 °	-121.749716 °
DWR ID	DWR_ST0010_02 f _ 2012_11

View of the rodent holes above the irrigation pipe.

No rodents visible, but rodent burrows visible; need to backfill and compact or grout burrows.

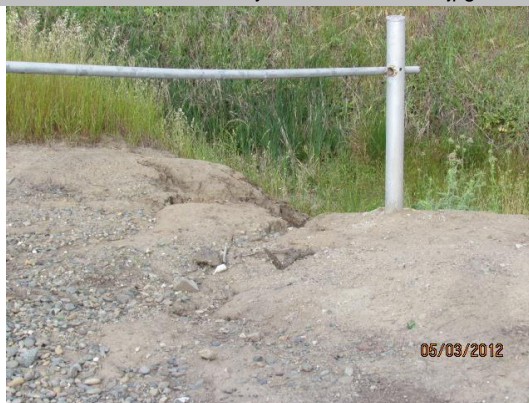
Photo 1 of 1 : rduffey_s_20140304_848.jpg

LM Start	3.30	Rating **	M	Issue No.	14
LM End	3.30	Issue Type +	Ma	Location *	LS
Category	Earthen Levee			GPS Latitude/Longitude	
				Start	End
Item	Erosion / Bank Caving			39.152903 °	39.152903 °
				-121.734906 °	-121.734906 °
DWR ID	DWR_ST0010_02_s_2012_14				
Action/Comments					
Note and monitor erosion site.

View of the erosion along the W/S toe.

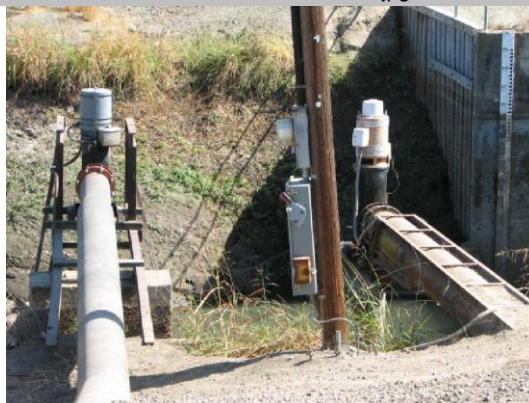
Photo 1 of 1 : UCIP_3627.jpg

Action/Comments					
Inspector Comments: FS_ID:23719					
EP_NO: 10473					
Repair Type:					
Crossing Status:					
UCIP Comments: Pipe shows signs of heavy rust at outlet in channel.					
Good candidate for video inspection 5/16/2013 Same as last inspection 10/29/2013 Same as last inspection.					
FIELD_STRUCT_DESC: 16-inch steel, irrigation pipe through the levee, 2.7-feet below the crown. Vertical pump in the channel with a service pole on the berm. Discharges into channel at the landward toe of the levee. (App. 5622 & 10473). Originally included in O+M Manual As-built available.					
FS Date: 11/6/2013 7:51:00 AM

Pump on steel pier at WS toe.

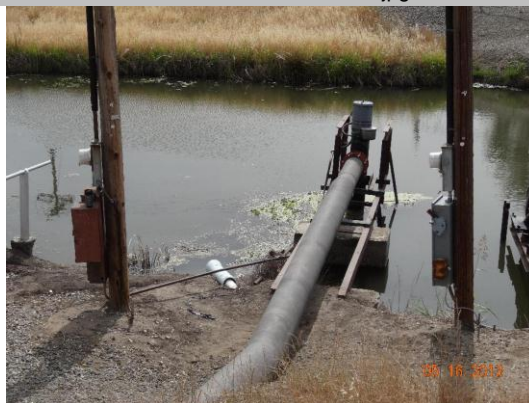
Photo 1 of 1 : UCIP_3630.jpg

UCIP Comments: 5/16/2013 Signs of leaks near concrete stand pipe on LS toe-road. Area about 20ft. long is muddy and there has not been any rain for a few weeks. 10/29/2013 Same as last inspection.

Pump station in channel on WS

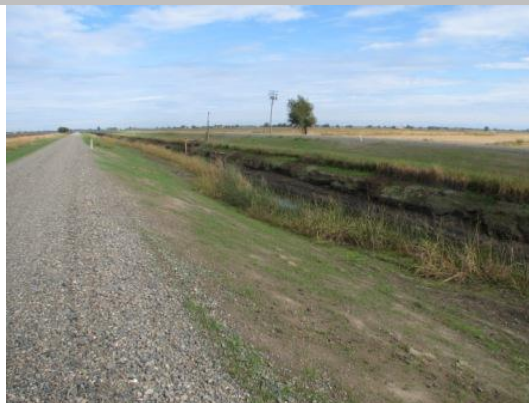
Photo 1 of 1 : rduffey_s_20140304_841.jpg

LM Start	3.46	Rating **	M	Issue No.	4
LM End	3.46	Issue Type +	Ma	Location *	WS
Category	Earthen Levee			GPS Latitude/Longitude	
				Start	End
Item	Erosion / Bank Caving			39.155057 °	39.155057 °
				-121.733985 °	-121.733985 °
DWR ID	DWR_ST0010_02_s_2012_4				
Action/Comments

View of the erosion at the waterside toe of the levee.

Note and monitor erosion site.

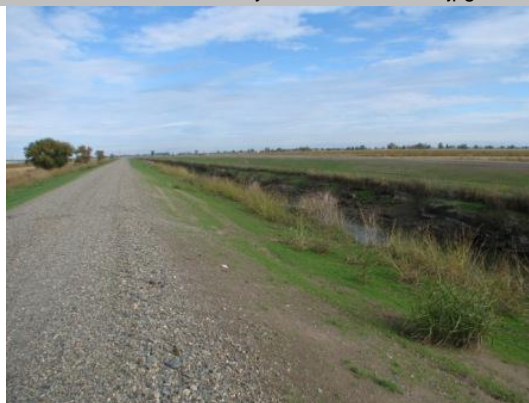
Photo 1 of 1 : rduffey_s_20140304_842.jpg

LM Start	3.59	Rating **	M	Issue No.	5
LM End	3.99	Issue Type +	Ma	Location *	WS
Category	Earthen Levee			GPS Latitude/Longitude	
				Start	End
Item	Erosion / Bank Caving			39.156753 °	39.162113 °
				-121.733267 °	-121.730997 °
DWR ID	DWR_ST0010_02_s _ 2012_5				
Action/Comments					
Note and monitor erosion site.

View of the erosion along the waterside toe.

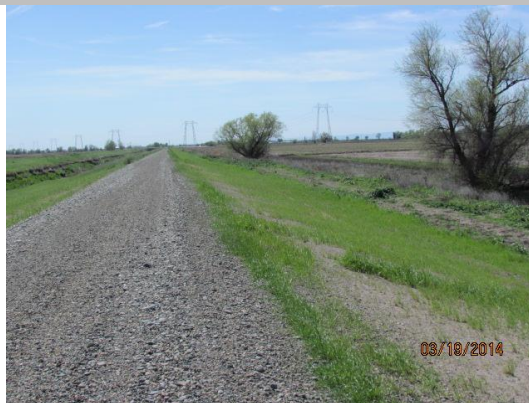
Photo 1 of 1 : rduffey_s_20140505_238.jpg

LM Start	4.05	Rating **	A	Issue No.	145
LM End	4.05	Issue Type +	Ma	Location *	LS
Category	Earthen Levee			GPS Latitude/Longitude	
				Start	End
Item	Vegetation			39.162959 °	39.162959 °
				-121.730621 °	-121.730621 °
DWR ID	DWR_ST0010_02_s _ 2014_145				
Action/Comments					
Control annual grass and weeds on the levee slopes and easements.

View of the native grasses on both slopes.

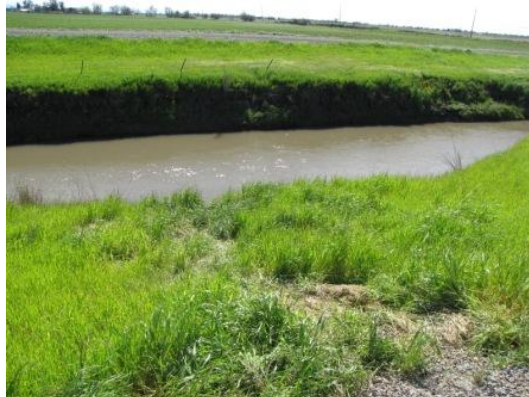
Photo 1 of 1 : rduffey_s_20140304_843.jpg

LM Start	4.49	Rating **	M	Issue No.	6
LM End	4.49	Issue Type +	Ma	Location *	WS
Category	Earthen Levee			GPS Latitude/Longitude	
				Start	End
Item	Erosion / Bank Caving			39.168848 °	39.168848 °
				-121.728130 °	-121.728130 °
DWR ID	DWR_ST0010_02_s_2012_6				
Action/Comments					
Note and monitor erosion site.

View of erosion along the W/S toe.

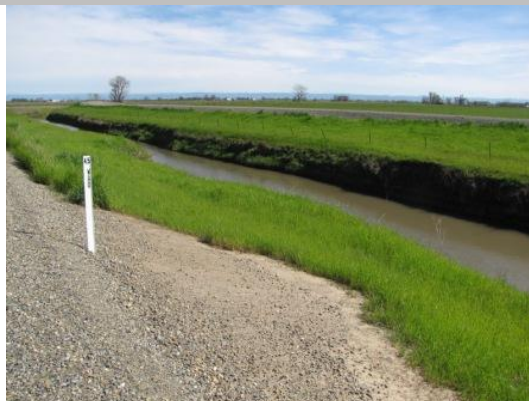
Photo 1 of 1 : rduffey_s_20140304_844.jpg

LM Start	4.55	Rating **	A/W	Issue No.	7
LM End	4.55	Issue Type +	Ma	Location *	WS
Category	Earthen Levee			GPS Latitude/Longitude	
				Start	End
Item	Erosion / Bank Caving			39.169670 °	39.169670 °
				-121.727787 °	-121.727787 °
DWR ID	DWR_ST0010_02_s_2012_7				
Action/Comments					
Note and monitor erosion site.

View of the erosion along the W/S toe.
