**Flood Control Project Maintenance  
Levee Inspections****LMA District Cover Sheet****Spring 2015 Levee Inspection Results****Sutter Maintenance Yard Wadsworth Canal**

**Levee Inspection Report By Mile - Spring 2015**

**Sutter Maintenance Yard Wadsworth Canal**

Waterway	Bank	Unit Miles	Inspection Start/End	Inspector
Unit No. 01 Wadsworth Canal	Left	4.63	04/15/2015 04/15/2015	Bob Duffey

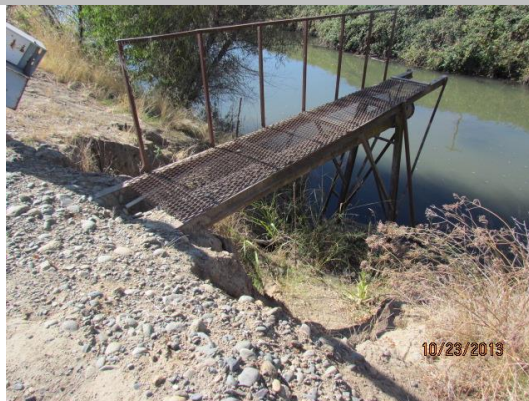
Photo 1 of 2 : SP\_2015\_ST0010\_42\_107\_20150310\_00009.jpg

LM Start	1.85	Rating **	U	Issue No.	107
LM End	1.85	Issue Type +	Ma	Location *	WS
Category	Earthen Levee			GPS Latitude/Longitude	
				Start	End
Item	Erosion / Bank Caving			39.135110 °	39.135110 °
				-121.748230 °	-121.748230 °
DWR ID	DWR_ST0010_01_f_2013_107				
Action/Comments					
Schedule repair of erosion site prior to the next inspection.					
Inspector Comments: Repair the erosion under the abandoned pump.

View of the erosion along both sides of the abandoned pump.

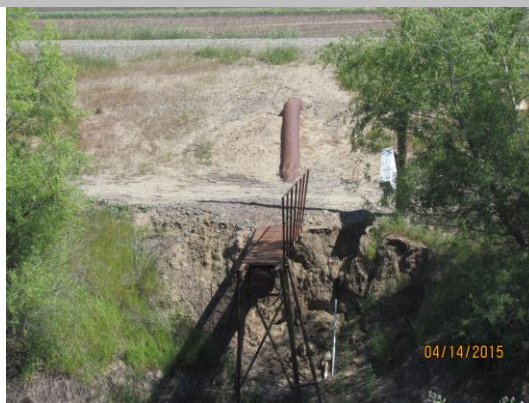
Photo 2 of 2 : SP\_2015\_ST0010\_42\_107\_20150420\_00010.jpg

LM Start	<b>1.85</b>	Rating **	U	Issue No.	<b>107 (cont)</b>
LM End	<b>1.85</b>	Issue Type +	Ma	Location *	WS

View of the erosion along both sides of the abandoned pump.

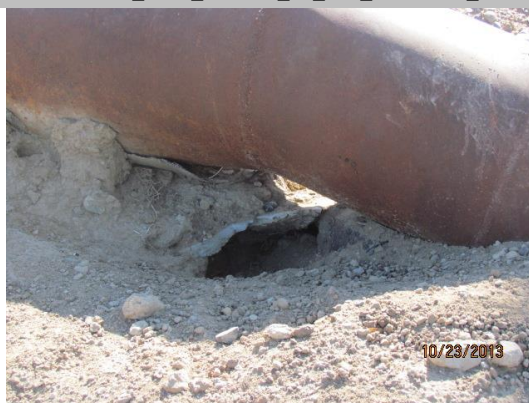
Photo 1 of 1 : SP\_2015\_ST0010\_42\_106\_20150310\_00008.jpg

LM Start	1.85	Rating **	M	Issue No.	106
LM End	1.85	Issue Type +	Ma	Location *	WS
Category	Earthen Levee			GPS Latitude/Longitude	
				Start	End
Item	Animal Control			39.135110 °	39.135110 °
				-121.748229 °	-121.748229 °
DWR ID	DWR_ST0010_01_f_2013_106				
Action/Comments					
No rodents visible, but rodent burrows visible; need to backfill and compact or grout burrows.

View of the rodent holes under the irrigation pipe.

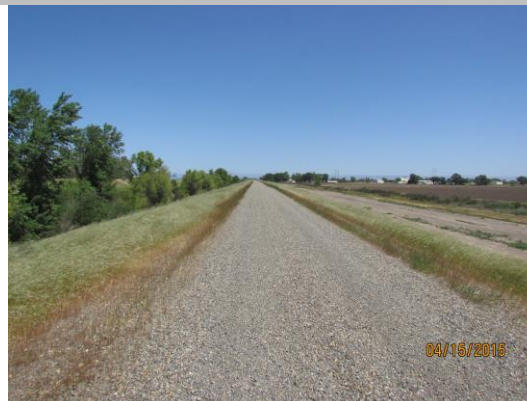
Photo 1 of 1 : SP\_2015\_ST0010\_42\_19\_20150420\_00011.jpg

LM Start	2.00	Rating **	M	Issue No.	19
LM End	2.00	Issue Type +	Ma	Location *	LS
Category	Earthen Levee			GPS Latitude/Longitude	
				Start	End
Item	Vegetation			39.136928 °	39.136928 °
				-121.746728 °	-121.746728 °
DWR ID	DWR_ST0010_01_s _ 2015_19				
Action/Comments					
Control annual grass and weeds on the levee slopes and easements.

View of the vegetation on both slopes.

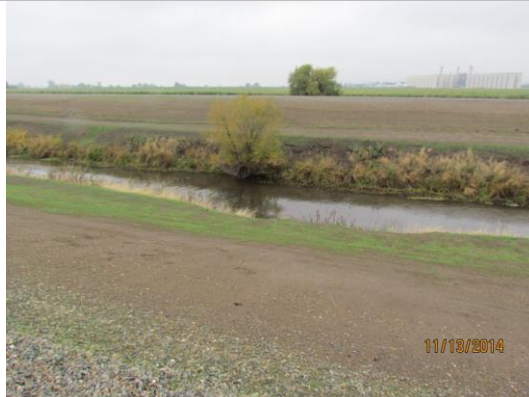
Photo 1 of 1 : SP\_2015\_ST0010\_42\_18\_20150310\_00007.jpg

LM Start	2.61	Rating **	M	Issue No.	18
LM End	2.61	Issue Type +	Ma	Location *	WS
Category	Earthen Levee			GPS Latitude/Longitude	
				Start	End
Item	Erosion / Bank Caving			39.144313 °	39.144313 °
				-121.740758 °	-121.740758 °
DWR ID	DWR_ST0010_01_f_2014_18				
Action/Comments					
Note and monitor erosion site.					
Inspector Comments: The erosion is scheduled for repair in 2015.

View of the erosion along the waterside toe.

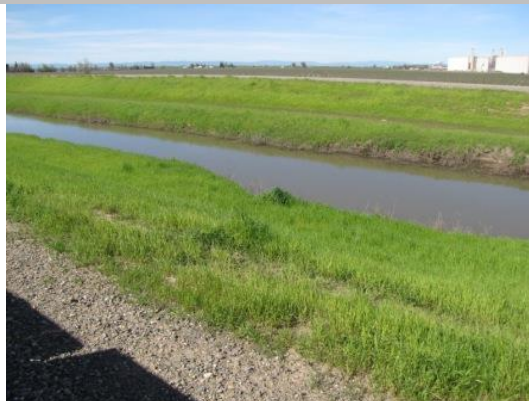
Photo 1 of 1 : SP\_2015\_ST0010\_42\_1\_20150310\_00001.jpg

LM Start	2.75	Rating **	M	Issue No.	1
LM End	2.75	Issue Type +	Ma	Location *	WS
Category	Earthen Levee			GPS Latitude/Longitude	
				Start	End
Item	Erosion / Bank Caving			39.146063 °	39.146063 °
				-121.739288 °	-121.739288 °
DWR ID	DWR_ST0010_01_s _ 2012_1				
Action/Comments					
Note and monitor erosion site.

View of erosion along W/S toe.

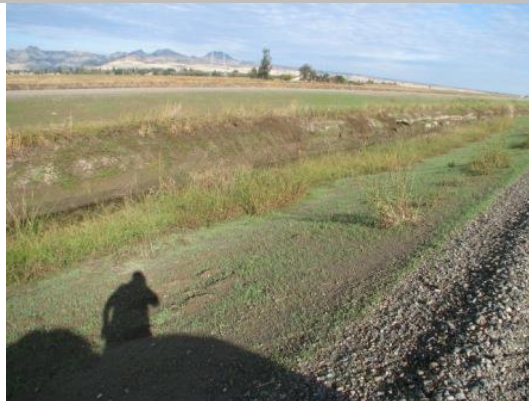
Photo 1 of 1 : SP\_2015\_ST0010\_42\_3\_20150310\_00002.jpg

LM Start	3.53	Rating **	M	Issue No.	3
LM End	3.56	Issue Type +	Ma	Location *	WS
Category	Earthen Levee			GPS Latitude/Longitude	
				Start	End
Item	Erosion / Bank Caving			39.156225 °	39.156639 °
				-121.732930 °	-121.732755 °
DWR ID	DWR_ST0010_01_s _ 2012_3				
Action/Comments					
Note and monitor erosion site.

View of the erosion along the waterside toe of the levee.

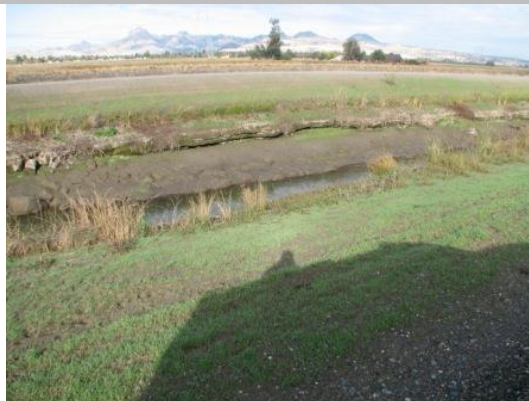
Photo 1 of 1 : SP\_2015\_ST0010\_42\_4\_20150310\_00003.jpg

LM Start	3.65	Rating **	M	Issue No.	4
LM End	3.65	Issue Type +	Ma	Location *	WS
Category	Earthen Levee			GPS Latitude/Longitude	
				Start	End
Item	Erosion / Bank Caving			39.157861 °	39.157861 °
				-121.732238 °	-121.732238 °
DWR ID	DWR_ST0010_01_s _ 2012_4				
Action/Comments					
Note and monitor erosion site.

View of the erosion along the waterside toe of the levee.

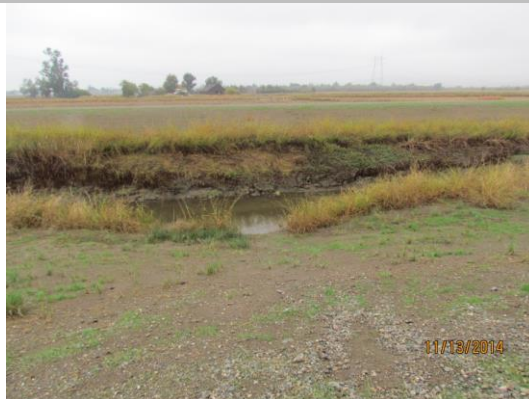
Photo 1 of 1 : SP\_2015\_ST0010\_42\_17\_20150310\_00006.jpg

LM Start	3.84	Rating **	M	Issue No.	17
LM End	3.84	Issue Type +	Ma	Location *	WS
Category	Earthen Levee			GPS Latitude/Longitude	
				Start	End
Item	Erosion / Bank Caving			39.160442 °	39.160442 °
				-121.731067 °	-121.731067 °
DWR ID	DWR_ST0010_01_f _ 2014_17				
Action/Comments					
Note and monitor erosion site.

View of the erosion along the waterside toe.

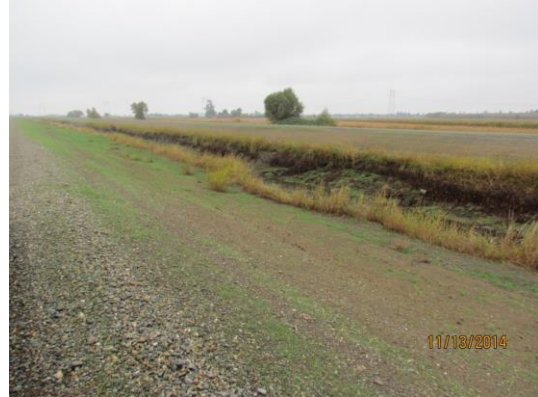
Photo 1 of 1 : SP\_2015\_ST0010\_42\_5\_20150310\_00004.jpg

LM Start	4.23	Rating **	M	Issue No.	5
LM End	4.23	Issue Type +	Ma	Location *	WS
Category	Earthen Levee			GPS Latitude/Longitude	
				Start	End
Item	Erosion / Bank Caving			39.165845 °	39.165845 °
				-121.728877 °	-121.728877 °
DWR ID	DWR_ST0010_01_s _ 2012_5				
Action/Comments					
Note and monitor erosion site.

View of the erosion along the waterside toe.

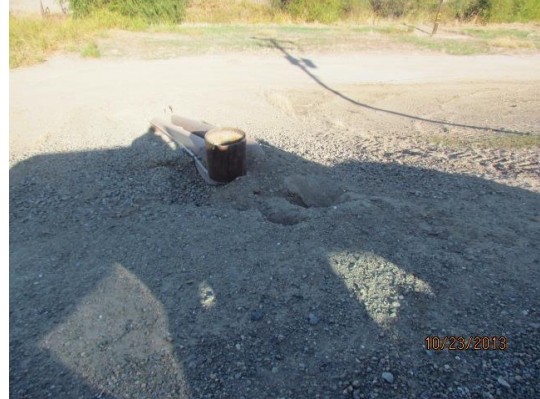
Photo 1 of 1 : SP\_2015\_ST0010\_43\_11\_20150310\_00006.jpg

LM Start	1.76	Rating **	M	Issue No.	11
LM End	1.76	Issue Type +	Ma	Location *	LS
Category	Earthen Levee			GPS Latitude/Longitude	
				Start	End
Item	Animal Control			39.134490 °	39.134490 °
				-121.749716 °	-121.749716 °
DWR ID	DWR_ST0010_02_f_2012_11				
Action/Comments					
No rodents visible, but rodent burrows visible; need to backfill and compact or grout burrows.

View of the rodent holes above the irrigation pipe.

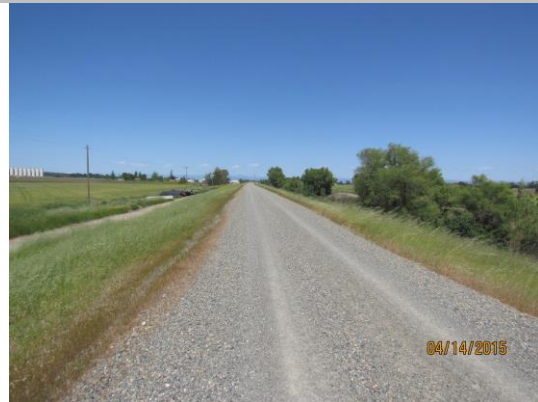
Photo 1 of 1 : SP\_2015\_ST0010\_43\_21\_20150420\_00010.jpg

Action/Comments					
Control annual grass and weeds on the levee slopes and easements.

View of the vegetation on both slopes.

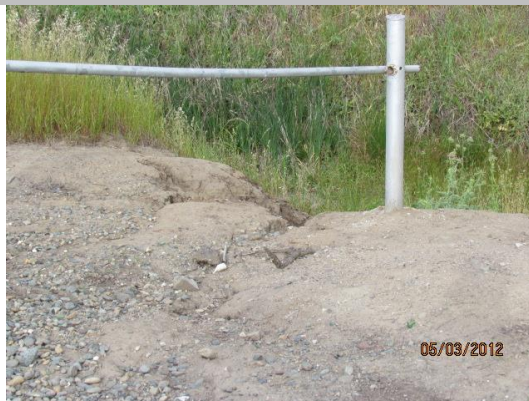
Photo 1 of 1 : SP\_2015\_ST0010\_43\_14\_20150310\_00007.jpg

LM Start	3.26	Rating **	M	Issue No.	14
LM End	3.26	Issue Type +	Ma	Location *	LS
Category	Earthen Levee			GPS Latitude/Longitude	
				Start	End
Item	Erosion / Bank Caving			39.152903 °	39.152903 °
				-121.734906 °	-121.734906 °
DWR ID	DWR_ST0010_02_s _ 2012_14				
Action/Comments					
Note and monitor erosion site.					
Inspector Comments: The erosion is scheduled for repair in 2015

View of the erosion along the W/S toe.

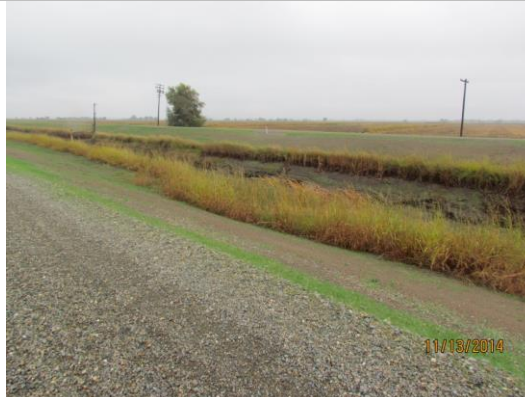
Photo 1 of 1 : SP\_2015\_ST0010\_43\_4\_20150310\_00002.jpg

LM Start	3.42	Rating **	M	Issue No.	4
LM End	3.42	Issue Type +	Ma	Location *	WS
Category	Earthen Levee			GPS Latitude/Longitude	
				Start	End
Item	Erosion / Bank Caving			39.155057 °	39.155057 °
				-121.733985 °	-121.733985 °
DWR ID	DWR_ST0010_02_s _ 2012_4				
Action/Comments					
Note and monitor erosion site.

View of the erosion at the waterside toe.

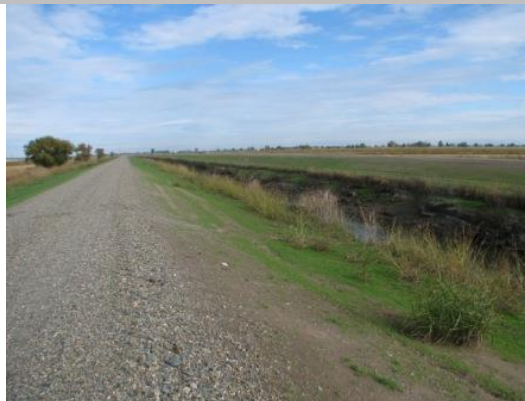
Photo 1 of 1 : SP\_2015\_ST0010\_43\_5\_20150310\_00003.jpg

LM Start	3.54	Rating **	M	Issue No.	5
LM End	3.93	Issue Type +	Ma	Location *	WS
Category	Earthen Levee			GPS Latitude/Longitude	
				Start	End
Item	Erosion / Bank Caving			39.156753 °	39.162113 °
				-121.733267 °	-121.730997 °
DWR ID	DWR_ST0010_02_s _ 2012_5				
Action/Comments					
Note and monitor erosion site.

View of the erosion along the waterside toe.

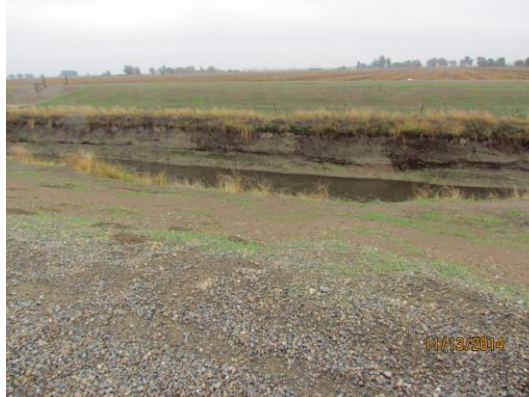
Photo 1 of 1 : SP\_2015\_ST0010\_43\_6\_20150310\_00004.jpg

LM Start	4.42	Rating **	M	Issue No.	6
LM End	4.42	Issue Type +	Ma	Location *	WS
Category	Earthen Levee			GPS Latitude/Longitude	
				Start	End
Item	Erosion / Bank Caving			39.168848 °	39.168848 °
				-121.728130 °	-121.728130 °
DWR ID	DWR_ST0010_02_s _ 2012_6				
Action/Comments					
Note and monitor erosion site.

View of the erosion along the waterside toe.

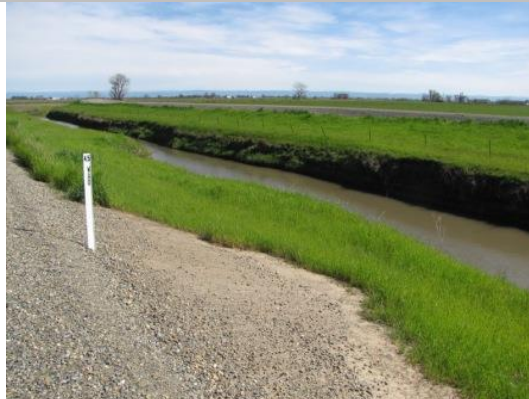
Photo 1 of 1 : SP\_2015\_ST0010\_43\_7\_20150310\_00005.jpg

LM Start	4.48	Rating **	A/W	Issue No.	7
LM End	4.48	Issue Type +	Ma	Location *	WS
Category	Earthen Levee			GPS Latitude/Longitude	
				Start	End
Item	Erosion / Bank Caving			39.169670 °	39.169670 °
				-121.727787 °	-121.727787 °
DWR ID	DWR_ST0010_02_s _ 2012_7				
Action/Comments					
Note and monitor erosion site.

View of the erosion along the W/S toe.
