**Flood Control Project Maintenance
Levee Inspections****LMA District Cover Sheet****Spring 2016 Levee Inspection Results****Sutter Maintenance Yard Wadsworth Canal**

Spring 2016 Levee Inspection Results

Sutter Maintenance Yard Wadsworth Canal

Waterway			Bank	Unit Miles
Unit No. 01 Wadsworth Canal			Left	4.63
	Spring (March - May)	Summer (June - August)	(September - November) Fall	Winter (December - February)
Unit Maintenance Rating (Fall Only)				
Date of Inspection	3/17/2016 - 3/17/2016			
DWR Inspector	Keith Millard			
Accompanied By	Steve Beckley Sutter Maintenance Yard

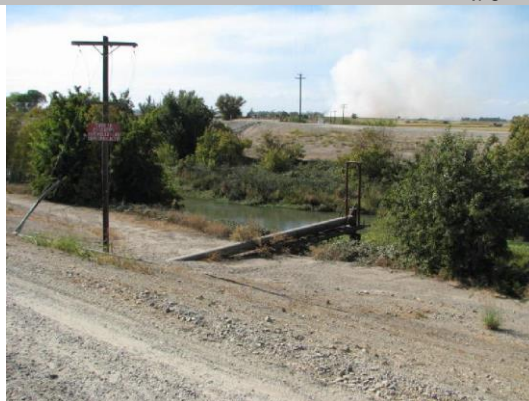
Photo 1 of 2 : UCIP_SP_2016_47263_64702.jpg

FS_ID:47263
DS_ID:17059
EP_NO: 1605
Repair Type: Non-Urgent
Crossing Status: Found
UCIP Comments: 4/16/2016 Abandoned crossing. Ws pipe end is open and should be capped.5/12/2015 Abandoned crossing. Needs to be properly abandoned.No pump on Pier and power lines cut. Apparently abandoned-should be abandoned properly.5/16/2013 Same as last inspection.10/29/2013 Same as last inspection.5/13/2014 Same as last inspection.11/18/2014 Same as last inspection.
FIELD_STRUCT_DESC: 18-inch steel irrigation pipe through the levee, 3.7 feet below the crown. Siphon breaker on the waterward slope. Pump on channel bank on steel structure. (App. 1605 - Schnable) Service pole at the waterward toe. Anchor in waterward slope. (App 1631-Schnable).
FS Date: 5/2/2016 9:08:51 AM

Power pole with cut powerlines, pump missing from steel pier.

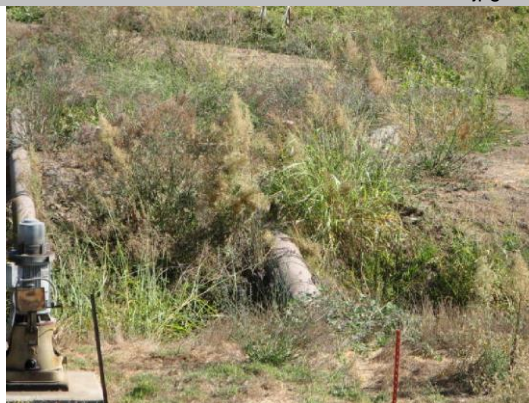
Photo 2 of 2 : UCIP_SP_2016_47263_64701.jpg

Pipe on LS toe.

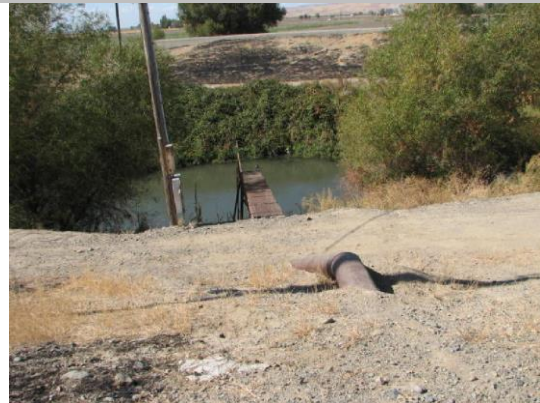
Photo 1 of 2 : UCIP_SP_2016_47267_64711.jpg

Comment Code					
Inspector Comment					
FS_ID:47267 DS_ID:17063 EP_NO: N/A Repair Type: Non-Urgent Crossing Status: Found UCIP Comments: 4/19/2016 Abandoned crossing. No noticeable issues to report.5/12/2015 Abandoned crossing. Cap was made and installed on WS open end of pipe.Pipe abandoned. Pipe open and not plugged. Pipe should be removed or abandoned properly. Extensive animal burrowing occuring along pipe alignment.5/16/2013 Same as last inspection. Steve Beckley is looking into finding pipe owner to properly abandon pipe.10/29/2013 Same as last inspection.5/13/2014 Cap was made and bolted on to WS open end of pipe.11/18/2014 Same as last inspection. FIELD_STRUCT_DESC: 14-inch steel irrigation pipe through the levee, 5.7 feet below the crown. Siphon breaker on landward side. Vertical pump on waterward side. Meter pole on berm. Originally in O+M manual, asbuilt available (Permit No. 572, 1932). FS Date: 5/2/2016 9:22:21 AM

Pump missing from steel pier on WS toe.

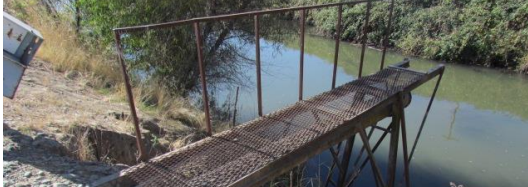
Photo 1 of 2 : SP_2016_ST0010_42_107_20160316_00012.jpg

View of the erosion along both sides of the abandoned pump.

LM Start	1.85	Rating **	U	Issue No.	107 (cont)	
LM End	1.85	Issue Type +	Ma	Location *	WS	
Category	Earthen Levee			GPS Latitude/Longitude		
				Start		End
Item	Erosion / Bank Caving			39.135110 °		39.135110 °
				-121.748230 °		-121.748230 °
DWR ID	DWR_ST0010_01_f_2013_107					
Comment Code						
E2 : Schedule repair of erosion site prior to the next inspection.						
Inspector Comment						
Repair the erosion under the abandoned pump.

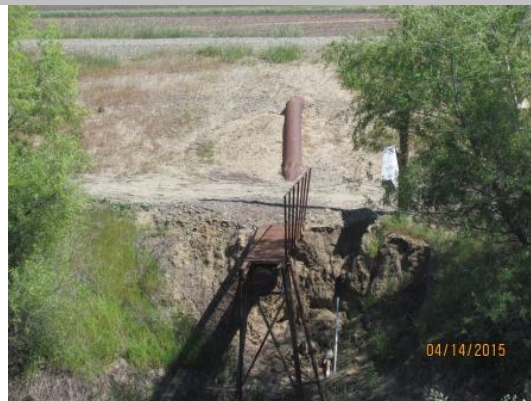
Photo 2 of 2 : SP_2016_ST0010_42_107_20160316_00013.jpg

View of the erosion along both sides of the abandoned pump.

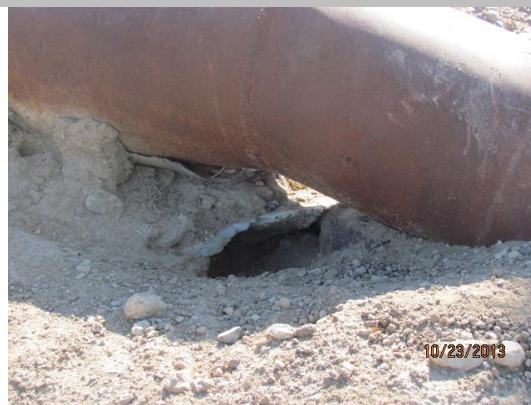
Photo 1 of 1 : SP_2016_ST0010_42_106_20160316_00011.jpg

LM Start	1.85	Rating **	M	Issue No.	106
LM End	1.85	Issue Type +	Ma	Location *	WS
Category	Earthen Levee			GPS Latitude/Longitude	
				Start	End
Item	Animal Control			39.135110 °	39.135110 °
				-121.748229 °	-121.748229 °
DWR ID	DWR_ST0010_01_f_2013_106				
Comment Code					
A3 : No rodents visible, but rodent burrows visible; need to backfill and compact or grout burrows.					
Inspector Comment

View of the rodent holes under the irrigation pipe.

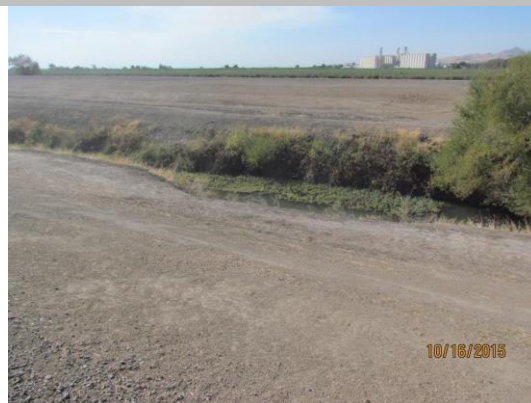
Photo 1 of 4 : SP_2016_ST0010_42_6_20160316_00006.jpg

LM Start	2.43	Rating **	M	Issue No.	6
LM End	3.30	Issue Type +	Ma	Location *	WS
Category	Supplemental			GPS Latitude/Longitude	
				Start	End
Item	2015 USACE Erosion Survey, DRAFT			39.142235 °	39.153095 °
				-121.742609 °	-121.734390 °
DWR ID	DWR_ST0010_01_f_2015_6				
Comment Code					
Inspector Comment					
2010 - Over steepened levees, some slumping, reach-wide problem. 2011 - Still a reach-wide problem. 2015: Site is part of the extended inventory, last inspected 2011. [2015 Site ID: WAD_2-4_L]

View of the erosion along the waterside toe.

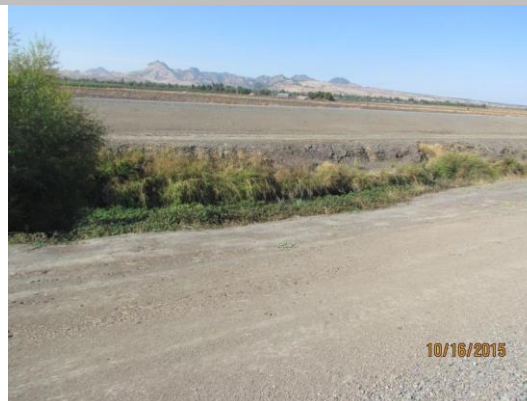
Photo 2 of 4 : SP_2016_ST0010_42_6_20160316_00007.jpg

View of the erosion along the waterside toe.

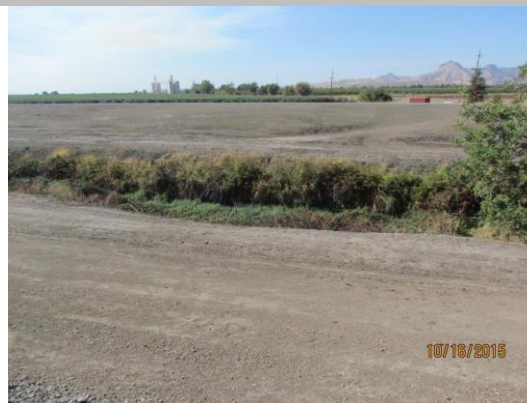
Photo 3 of 4 : SP_2016_ST0010_42_6_20160316_00008.jpg

View of the erosion along the waterside toe.

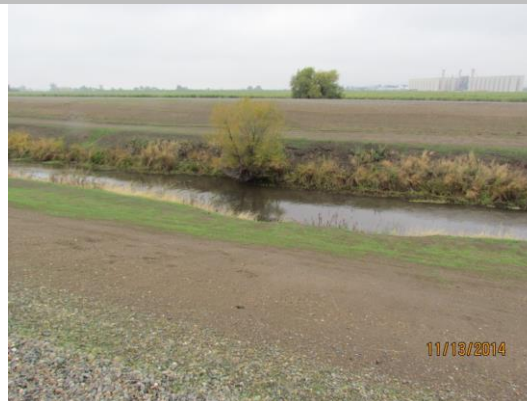
Photo 4 of 4 : SP_2016_ST0010_42_6_20160316_00009.jpg

View of the erosion along the waterside toe.

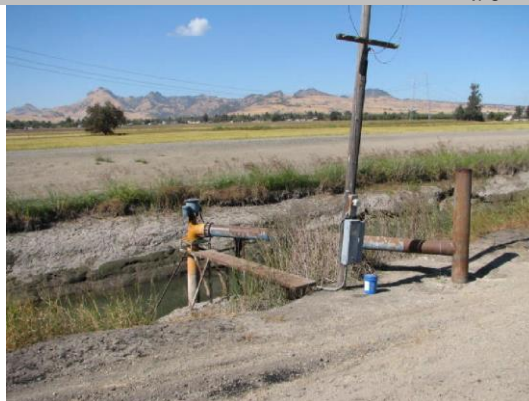
Photo 1 of 2 : UCIP_SP_2016_47271_64720.jpg

FS_ID:47271
DS_ID:17066
EP_NO: N/A
Repair Type: Non-Urgent
Crossing Status: Found
UCIP Comments: 4/19/2016 Crossing has not changed since the last inspection. LS headwall is silted in and not being used. LS pipe end discharges into the rice field. 5/12/2015 Concrete headwall on LS is completely silted in. LS pipe end is located near the edge of rice field. No issues seen on WS. 5/16/2013 Same as last inspection. 10/29/2013 Concrete headwall is silted in and appears to be abandoned. Discharge end of pipe is approx. 100ft. from LS toe on the edge of the rice field. 5/13/2014 Same as last inspection. 11/18/2014 Same as last inspection.
FIELD_STRUCT_DESC: 24-inch steel irrigation pipe through the levee, 11.0 feet below the crown. Vertical pump mounted on a steel structure in channel. Service pole on the berm with 18-inch standpipe on WS toe. Concrete U shaped headwall on LS toe. Originally shown in O+M manual, asbuilt available

Pump, Pipe, walkway, power pole, and standpipe on WS toe.

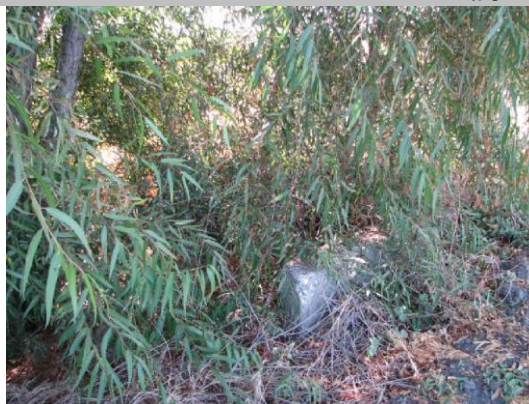
Photo 2 of 2 : UCIP_SP_2016_47271_64719.jpg

Concrete U shaped headwall on LS toe under tree.

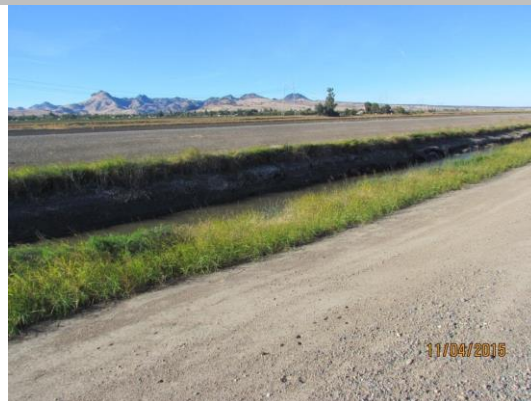
Photo 1 of 1 : SP_2016_ST0010_42_3_20160316_00001.jpg

View of the erosion along the waterside toe.

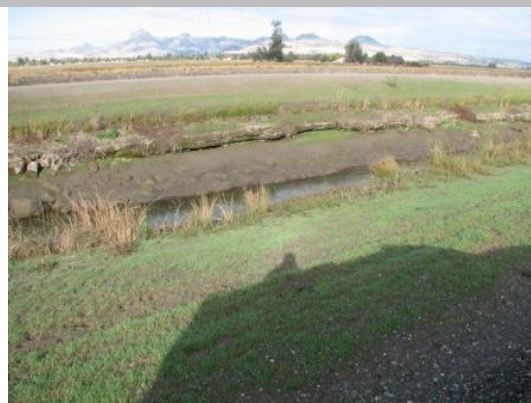
Photo 1 of 2 : SP_2016_ST0010_42_4_20160316_00002.jpg

LM Start	3.65	Rating **	M	Issue No.	4
LM End	3.65	Issue Type +	Ma	Location *	WS
Category	Earthen Levee			GPS Latitude/Longitude	
				Start	End
Item	Erosion / Bank Caving			39.157861 °	39.157861 °
				-121.732238 °	-121.732238 °
DWR ID	DWR_ST0010_01_s_2012_4				
Comment Code					
E1 : Note and monitor erosion site.					
Inspector Comment					
Monitor the erosion along the waterside toe.

View of the erosion along the waterside toe of the levee.

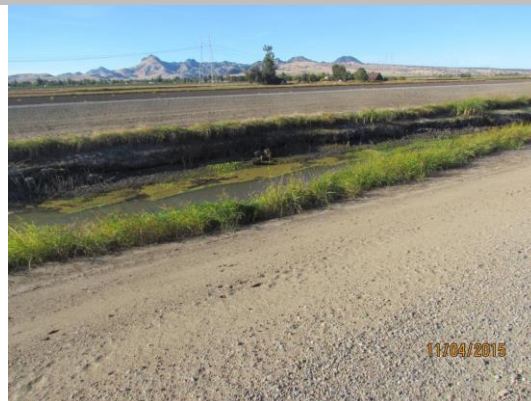
Photo 2 of 2 : SP_2016_ST0010_42_4_20160316_00003.jpg

View of the erosion along the waterside toe.

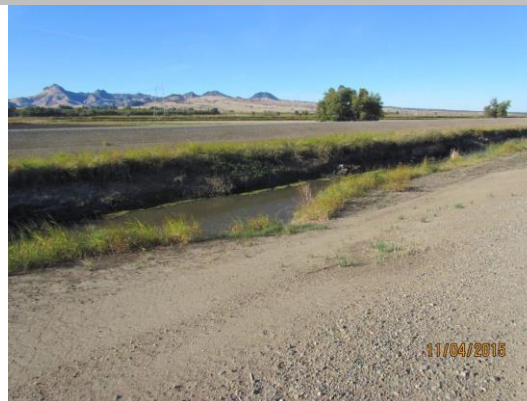
Photo 1 of 1 : SP_2016_ST0010_42_17_20160316_00010.jpg

View of the erosion along the waterside toe.

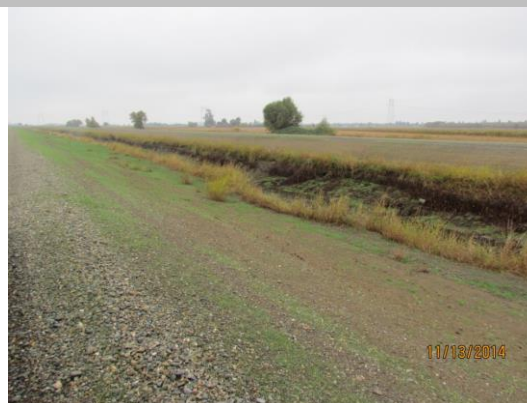
Photo 1 of 2 : SP_2016_ST0010_42_5_20160316_00004.jpg

LM Start	4.23	Rating **	M	Issue No.	5
LM End	4.23	Issue Type +	Ma	Location *	WS
Category	Earthen Levee			GPS Latitude/Longitude	
				Start	End
Item	Erosion / Bank Caving			39.165845 °	39.165845 °
				-121.728877 °	-121.728877 °
DWR ID	DWR_ST0010_01_s_2012_5				
Comment Code					
E1 : Note and monitor erosion site.					
Inspector Comment					
Monitor the erosion along the waterside toe.

View of the erosion along the waterside toe.

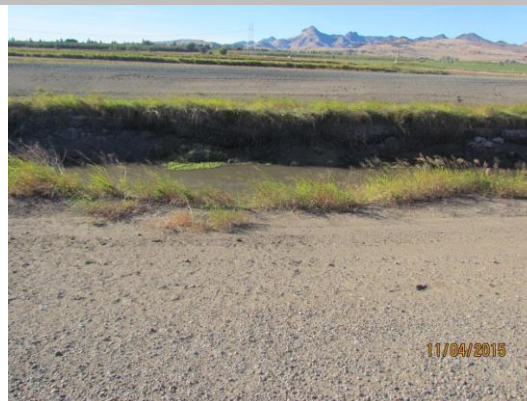
Photo 2 of 2 : SP_2016_ST0010_42_5_20160316_00005.jpg

View of the erosion along the waterside toe.

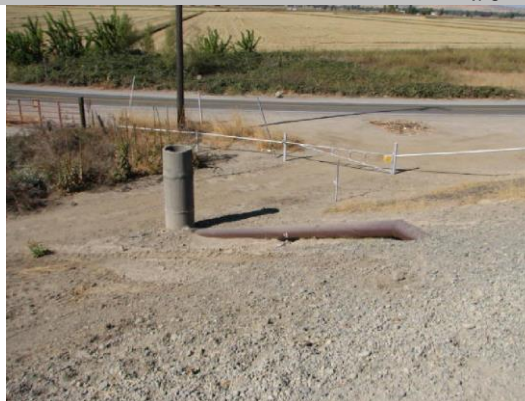
Photo 1 of 2 : UCIP_SP_2016_47276_64728.jpg

FS_ID:47276
DS_ID:17069
EP_NO: N/A
Repair Type: Non-Urgent
Crossing Status: Found
UCIP Comments: 4/19/2016 Abandoned crossing. Rodent activity still present on WS slope.5/12/2015 Abandoned crossing. Signs of rodent activity on both sides of levee.Pipe appears improperly abandoned. No motor present, electrical equipment is stripped. Heavy rodent activity along pipe WS and LS. Pipe needs to be removed or properly abandoned.5/16/2013 Same as last inspection.10/29/2013 Same as last inspection.5/13/2014 Same as last inspection.11/18/2014 Same as last inspection.
FIELD_STRUCT_DESC: 10-inch steel irrigation pipe through the levee, 4.8-feet below the crown. Pump mounted on concrete pad near canal bank. Service pole on berm. 30-inch diameter concrete standpipe at landward toe. Originally in O+M manual, asbuilt available. (Permit No. 945, 1944).
FS Date: 5/2/2016 9:46:25 AM

Pipe and Standpipe on LS toe.

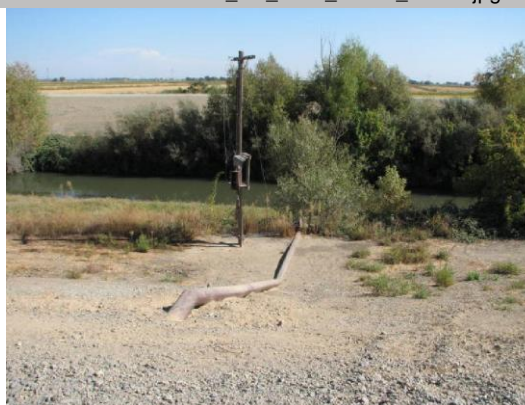
Photo 2 of 2 : UCIP_SP_2016_47276_64727.jpg

Pipe and pump facilities on WS slope.

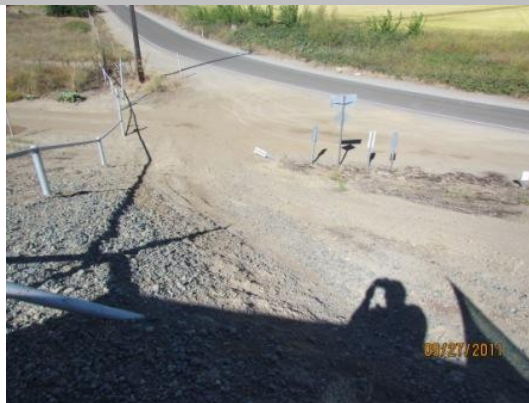
Photo 1 of 1 : SP_2016_ST0010_43_3_20160316_00001.jpg

LM Start	1.17	Rating **	M	Issue No.	3
LM End	1.17	Issue Type +	Ma	Location *	LS
Category	Earthen Levee			GPS Latitude/Longitude	
				Start	End
Item	Slope Stability			39.127648 °	39.127648 °
				-121.756345 °	-121.756345 °
DWR ID	DWR_ST0010_02_s_2012_3				
Comment Code					
S3 : Repair the levee slope damaged by vehicle traffic and prevent access where possible.					
Inspector Comment

View of vehicle erosion along L/S slope.

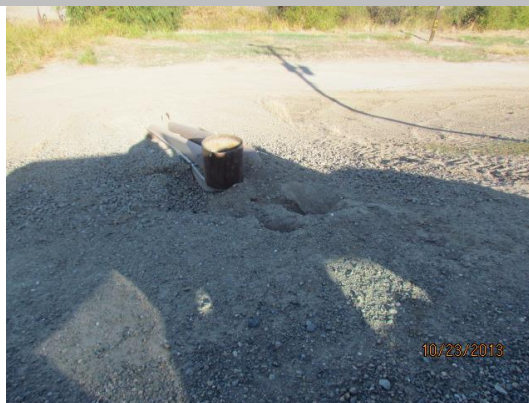
Photo 1 of 2 : SP_2016_ST0010_43_11_20160316_00012.jpg

LM Start	1.76	Rating **	M	Issue No.	11
LM End	1.76	Issue Type +	Ma	Location *	LS
Category	Earthen Levee			GPS Latitude/Longitude	
				Start	End
Item	Animal Control			39.134490 °	39.134490 °
				-121.749716 °	-121.749716 °
DWR ID	DWR_ST0010_02_f_2012_11				
Comment Code					
A3 : No rodents visible, but rodent burrows visible; need to backfill and compact or grout burrows.					
Inspector Comment					
Repair the rodent hole.

View of the rodent holes above the irrigation pipe.

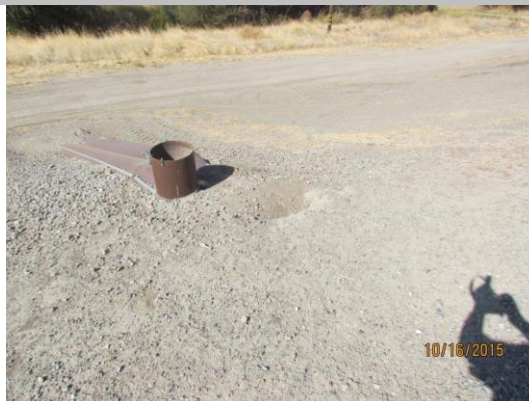
Photo 2 of 2 : SP_2016_ST0010_43_11_20160316_00013.jpg

LM Start	1.76	Rating **	M	Issue No.	11 (cont)	
LM End	1.76	Issue Type +	Ma	Location *	LS	
Category	Earthen Levee			GPS Latitude/Longitude		
				Start		End
Item	Animal Control			39.134490 °		39.134490 °
				-121.749716 °		-121.749716 °
DWR ID	DWR_ST0010_02_f_2012_11					
Comment Code						
A3 : No rodents visible, but rodent burrows visible; need to backfill and compact or grout burrows.						
Inspector Comment						
Repair the rodent hole.

View of the rodent hole above the irrigation pipe.

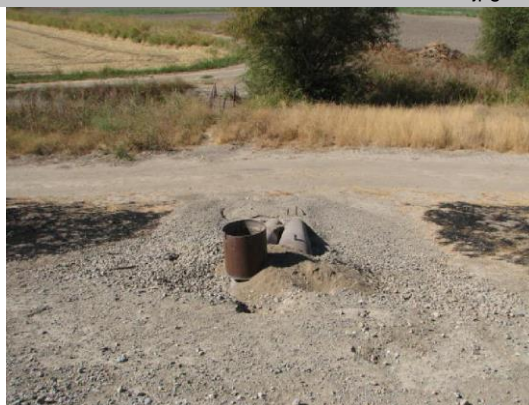
Photo 1 of 2 : UCIP_SP_2016_47281_65356.jpg

Comment Code					
Inspector Comment					
FS_ID:47281 DS_ID:17074 EP_NO: 1096 Repair Type: Non-Urgent Crossing Status: Found UCIP Comments: 4/19/2016 No signs of pipe leaks. Still some minor rodent activity under the pipe on LS slope.5/12/2015 Rodent activity near pipe on LS.Heavy rodent activity on LS slope along pipe alignment.5/16/2013 Same as last inspection.10/29/2013 Same as last inspection.5/13/2014 Air vent on LS shoulder leaks and is causing minor erosion to the LS slope.11/18/2014 Levee inspection is aware of problem and repairs seem to have been made. Slope has also been rocked to prevent erosion. FIELD_STRUCT_DESC: 16-inch steel irrigation pipe through the levee, 4.4-feet below the crown. Pump mounted on a steel structure on the bank. Siphon breaker on the landward slope. unable to locate 48-inch concrete standpipe on the landward berm that was listed in permit. (Permit No. 1096 - Brown and PN: 1479). Asbuilt available. FS Date: 5/2/2016 9:50:15 AM

Pipe on LS with rodent activity shown.

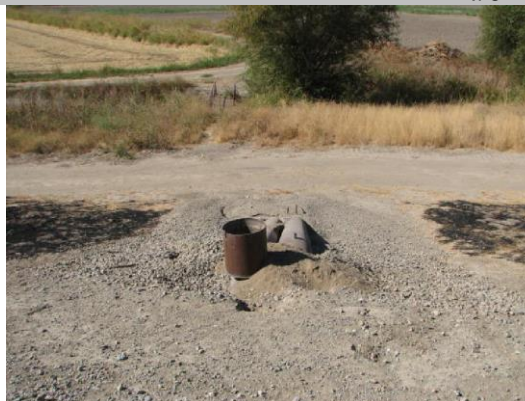
Photo 1 of 2 : UCIP_SP_2016_47282_64736.jpg

FS_ID:47282
DS_ID:17082
EP_NO: N/A
Repair Type: Non-Urgent
Crossing Status: Found
UCIP Comments: 4/19/2016 Corssing appears abandoned. Minor rodent activity under pipe on LS slope.5/12/2015 Abandoned crossing that needs to be properly abandoned. Rodent activity near LS pipe.Heavy rodent activity along LS alignment of pipe. No pump on structure and it appears to be abandoned. Should be abandoned properly.5/16/2013 Same as last inspection.10/29/2013 Same as last inspection.5/13/2014 Same as last inspection.11/18/2014 Same as last inspection.
FIELD_STRUCT_DESC: 16-inch steel irrigation pipe through the levee, 4.4-feet below the crown. Pump mounted on a timber structure on the bank. Siphon breaker on the landward slope. Unable to locate 48-inch concrete standpipe on the landward berm that was listed in O+M manual. Asbuilt available. Asbuilt available. Permit No. 1104, 1946.
FS Date: 5/2/2016 9:51:43 AM

Pipe on LS showing rodent activity.

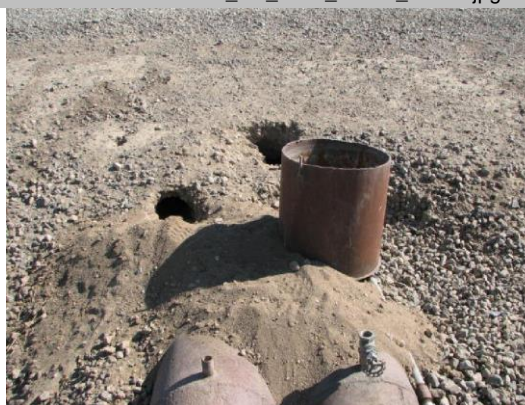
Photo 2 of 2 : UCIP_SP_2016_47282_64735.jpg

Pipe on LS showing rodent activity.

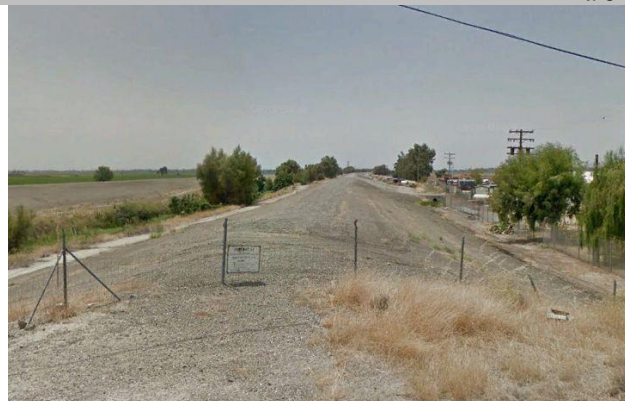
Photo 1 of 1 : SP_2016_ST0010_43_20_20160517_00032.jpg

3/17/2016: Vegetation maintained to acceptable level.

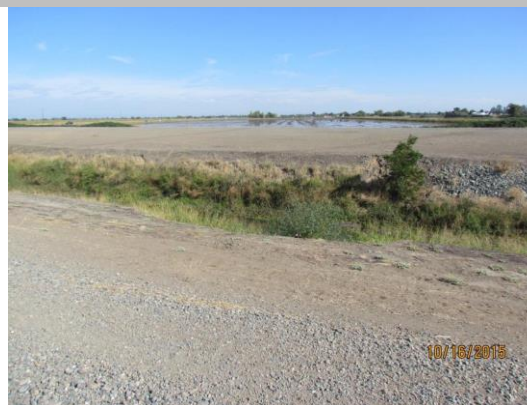
Photo 1 of 2 : SP_2016_ST0010_43_8_20160316_00008.jpg

LM Start	2.41	Rating **	M	Issue No.	8
LM End	3.28	Issue Type +	Ma	Location *	WS
Category	Supplemental			GPS Latitude/Longitude	
				Start	End
Item	2015 USACE Erosion Survey, DRAFT			39.142254 °	39.153150 °
				-121.742847 °	-121.734611 °
DWR ID	DWR_ST0010_02_s_2016_8				
Comment Code					
Inspector Comment					
2010 - Over steepened levees, some slumping, reach-wide problem.					
2011 - Still a reach-wide problem. 2015: Site is part of the extended inventory, last inspected 2011. [2015 Site ID: WAD_2-4_R]

View of erosion along the waterside toe.

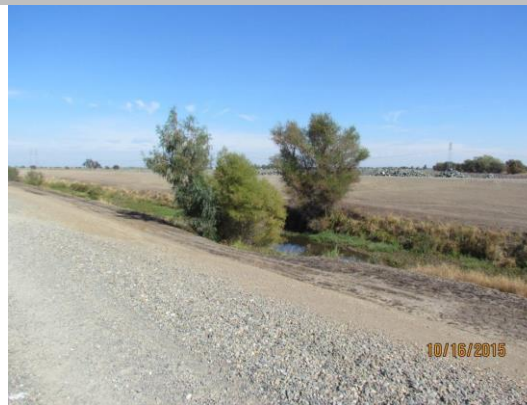
Photo 2 of 2 : SP_2016_ST0010_43_8_20160316_00009.jpg

View of the erosion along the landside toe.

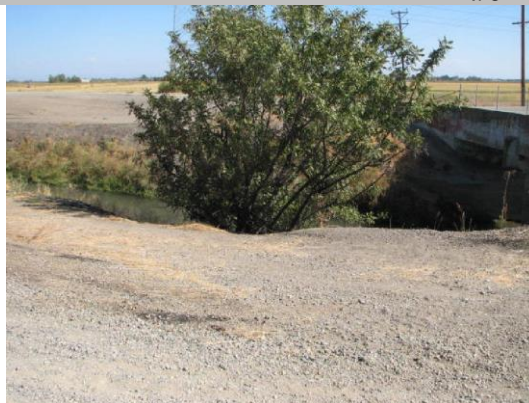
Photo 1 of 2 : UCIP_SP_2016_47285_64744.jpg

LM Start	3.00	Rating **	M	Issue No.	27
LM End	3.00	Issue Type +	En	Location *	WS
Category	Supplemental			GPS Latitude/Longitude	
				Start	End
Item	DWR UCIP Field Study			39.149561 °	39.149561 °
				-121.737080 °	-121.737080 °
DWR ID					
Comment Code					
Inspector Comment					
FS_ID:47285 DS_ID:17077 EP_NO: 7209 Repair Type: Non-Urgent Crossing Status: Found UCIP Comments: 4/19/2016 Tree at WS pipe end needs to be trimmed back and/or removed. 5/12/2015 Tree growing near WS pipe end is getting too big and will affect the crossing. It needs to be cut back or removed.5/16/2013 Same as last inspection.10/29/2013 Same as last inspection.5/13/2014 Same as last inspection.11/18/2014 Same as last inspection. FIELD_STRUCT_DESC: 36-inch CM drainpipe through the levee, 14-feet below the crown. Flap gate on the waterward end. Pipe replaced under permit No. 7209. FS Date: 5/2/2016 9:57:10 AM

Bush camouflaging outlet of pipe on WS slope.

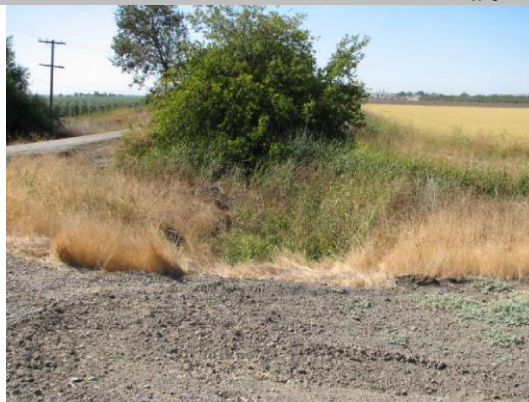
Photo 2 of 2 : UCIP_SP_2016_47285_64743.jpg

Heavy vegetation at LS inlet at channel.

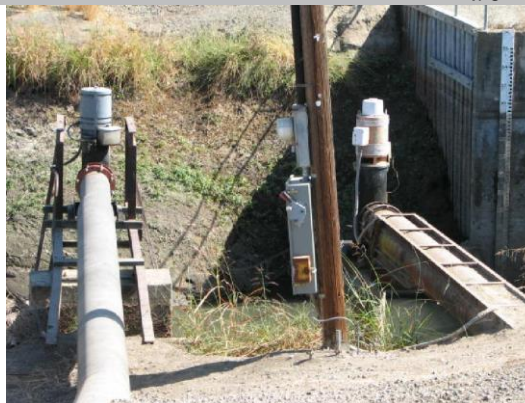
Photo 1 of 2 : UCIP_SP_2016_47287_64761.jpg

FS_ID:47287
DS_ID:17078
EP_NO: 10473
Repair Type: Non-Urgent
Crossing Status: Found
UCIP Comments: 4/19/2016 No changes have been made to this crossing. LS pipe outlet is still very rusted. 5/12/2015 Pipe is very rusty at Outlet in LS channel. No noticeable issues with WS.Pipe shows signs of heavy rust at outlet in channel. Good candidate for video inspection.5/16/2013 Same as last inspection.10/29/2013 Same as last inspection.5/13/2014 Same as last inspection.11/18/2014 Same as last inspection.
FIELD_STRUCT_DESC: 16-inch steel, irrigation pipe through the levee, 2.7-feet below the crown. Vertical pump in the channel with a service pole on the berm. Discharges into channel at the landward toe of the levee. (App. 5622 & 10473). Originally included in O+M Manual As-built available.
FS Date: 5/2/2016 10:00:45 AM

Pump on steel pier at WS toe.

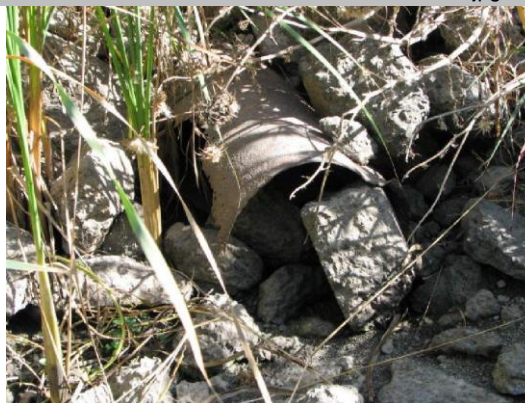
Photo 2 of 2 : UCIP_SP_2016_47287_64760.jpg

Rusted outlet at LS channel. Unclear if this is same pipe as one under investigation.

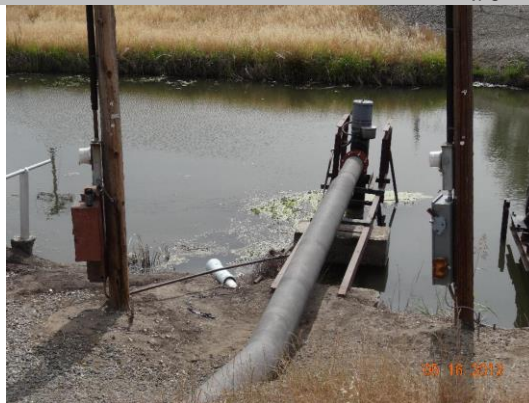
Photo 1 of 2 : UCIP_SP_2016_47288_64764.jpg

FS_ID:47288
DS_ID:17081
EP_NO: 5622
Repair Type: Urgent
Crossing Status: Found
UCIP Comments: 4/19/2016 No repairs seem to have been made yet. Pipe still appears to be leaking under the LS toe road.5/12/2015 Pipe appears to have not yet been repaired. Still looks to be leaking under the LS toe road.5/16/2013 Signs of leaks near concrete stand pipe on LS toe-road. Area about 20ft. long is muddy and there has not been any rain for a few weeks.10/29/2013 Same as last inspection.5/13/2014 Same as last inspection.11/18/2014 Same as last inspection.
FIELD_STRUCT_DESC: 15-inch steel irrigation pipe through the levee, 2.7-feet below the crown. Vertical pumps in the channel (likely sleeved through a 22-inch steel pipe). Power pole on the WS slope. Discharges into 36-inch concrete standpipe at the landward toe of the levee. 16-inch CMP riser on LS shoulder. (Permit No. 5622 & 10473). Originally included in O+M Manual As-built available.

Pump station in channel on WS

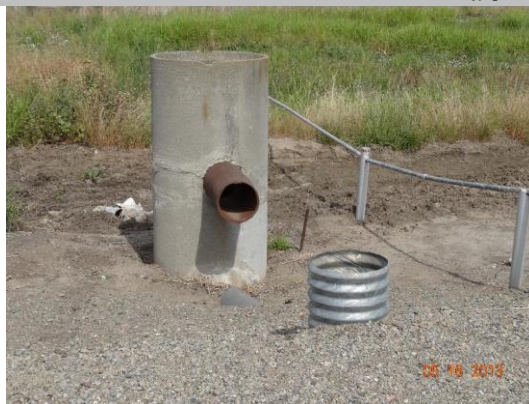
Photo 2 of 2 : UCIP_SP_2016_47288_64763.jpg

36in. concrete standpipe and 12in. cm riser on LS.

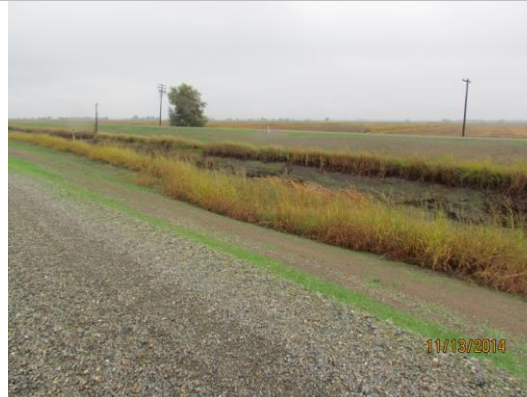
Photo 1 of 2 : SP_2016_ST0010_43_4_20160316_00002.jpg

View of the erosion at the waterside toe.

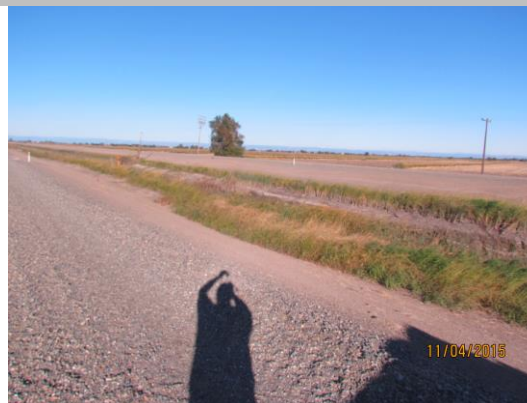
Photo 2 of 2 : SP_2016_ST0010_43_4_20160316_00003.jpg

View of the erosion at the waterside toe.

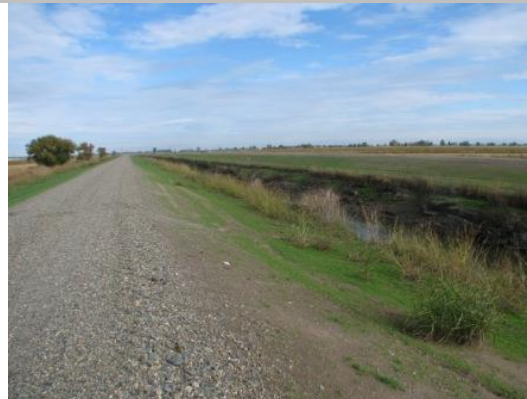
Photo 1 of 2 : SP_2016_ST0010_43_5_20160316_00004.jpg

LM Start	3.54	Rating **	M	Issue No.	5
LM End	3.93	Issue Type +	Ma	Location *	WS
Category	Earthen Levee			GPS Latitude/Longitude	
				Start	End
Item	Erosion / Bank Caving			39.156753 °	39.162113 °
				-121.733267 °	-121.730997 °
DWR ID	DWR_ST0010_02_s_2012_5				
Comment Code					
E1 : Note and monitor erosion site.					
Inspector Comment					
Monitor is the erosion at the waterside toe.

View of the erosion along the waterside toe.

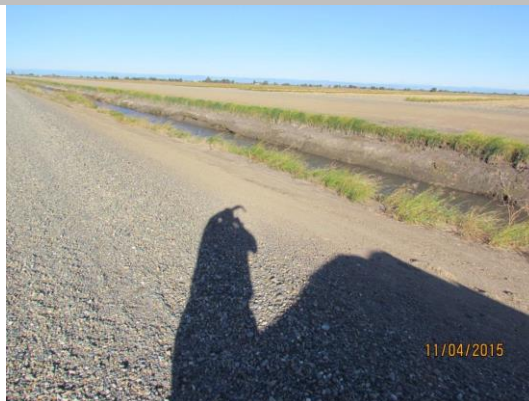
Photo 2 of 2 : SP_2016_ST0010_43_5_20160316_00005.jpg

View of erosion at the waterside toe

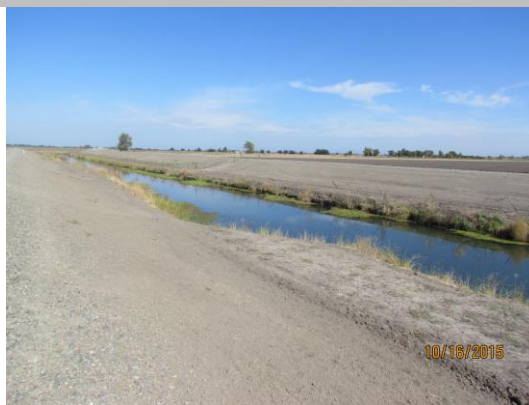
Photo 1 of 2 : SP_2016_ST0010_43_9_20160316_00010.jpg

LM Start	4.41	Rating **	M	Issue No.	9
LM End	4.43	Issue Type +	Ma	Location *	WS
Category	Supplemental			GPS Latitude/Longitude	
				Start	End
Item	2015 USACE Erosion Survey, DRAFT			39.168659 °	39.168937 °
				-121.728016 °	-121.727905 °
DWR ID	DWR_ST0010_02_s_2016_9				
Comment Code					
Inspector Comment					
2011 - Small erosion pocket. 2015: Site is part of the extended inventory, last inspected 2011. [2015 Site ID: WAD_4-3_R]

View of the erosion along the waterside toe.

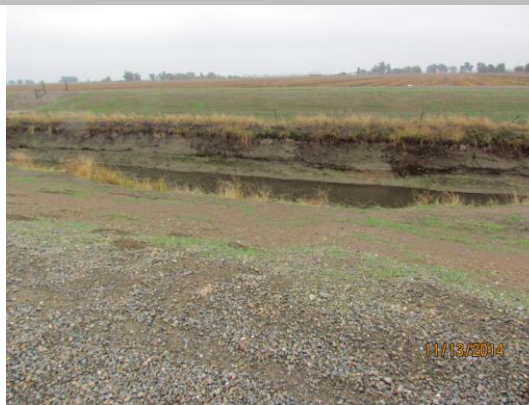
Photo 2 of 2 : SP_2016_ST0010_43_9_20160316_00011.jpg

View of the erosion along the waterside toe.

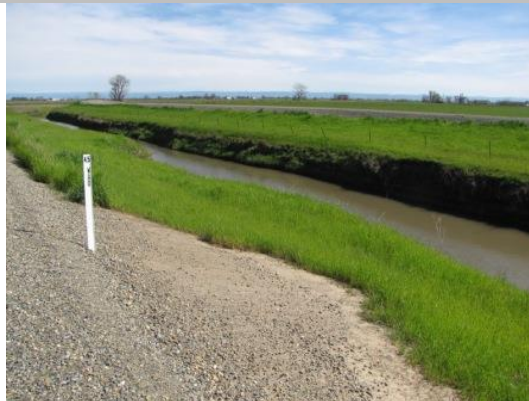
Photo 1 of 2 : SP_2016_ST0010_43_7_20160316_00006.jpg

View of the erosion along the W/S toe.

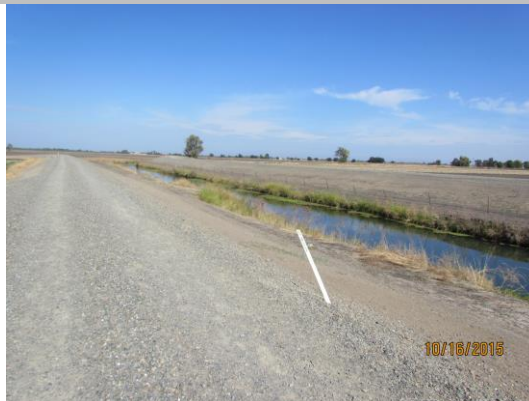
Photo 2 of 2 : SP_2016_ST0010_43_7_20160316_00007.jpg

View of the erosion along the waterside toe.
